**VOLVO V60: 1YNF926**

**Limited Technical Inspection**

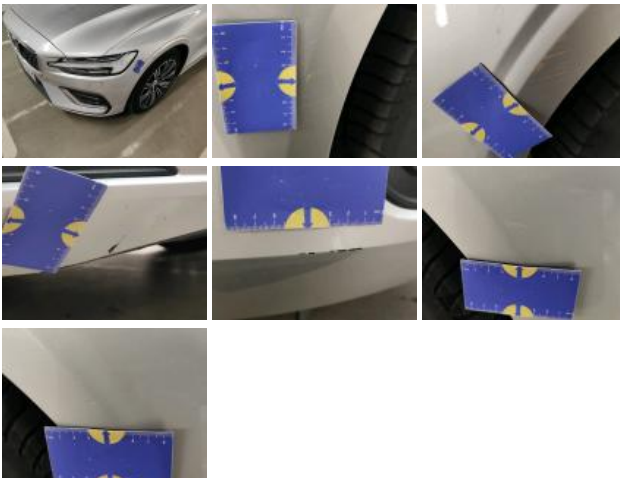
Bumper F, Scratch(es), Spot repair

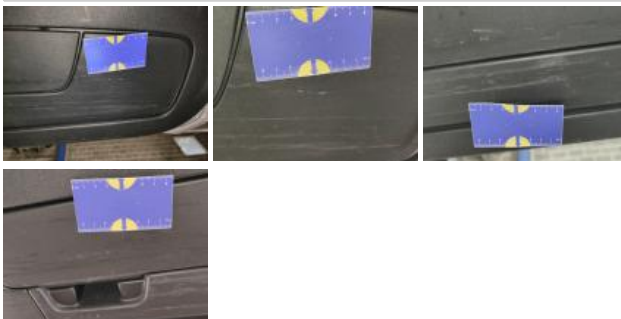
Boot lid covering R, Scratch(es), Smart repair
