JEEP Compass Compass 1.3 T-GDI 4xe PLUG-IN HYBRID Automatik

VIN NO ZACNJDEW9LPR04190 Registration Number W9LPR04190

Inspection Report Summary

Customer	BCA Online	Report Number	P20250923144030
Inspection Date / Place	2025-09-23 / BCA Berlin	Cosmetic Grade	3

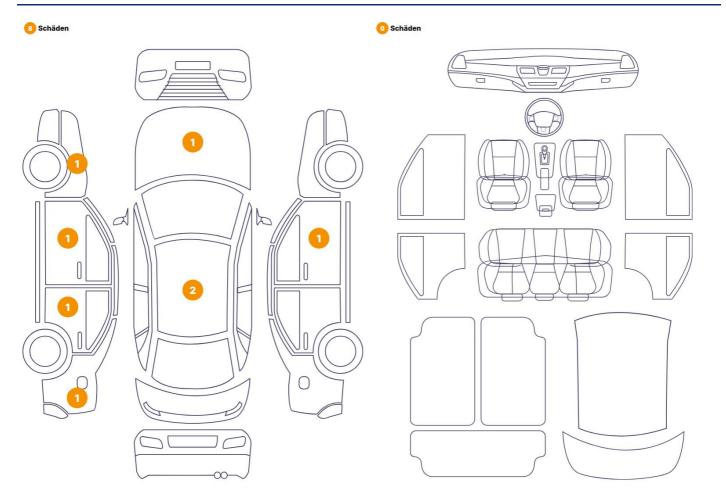
Component	Damage	Comments
1	Fender / Front Left	Paint / Poor Previous Repair	
2	Door / Front Left	Paint / Poor Previous Repair	
3	Door / Back Left	Paint / Poor Previous Repair	
4	Side Panel / Back Left	Paint / Poor Previous Repair	
5	Door / Front Right	Paint / Scratch / Scuff	
6	Hood	Paint / Poor Previous Repair	
7	Roof	Bodywork / Dent / Hail Area	
8	Roof	Paint / Scratch / Line

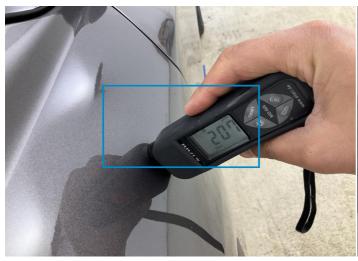
1. Fender / Front Left
Paint / Poor Previous Repair -

2. Door / Front Left Paint / Poor Previous Repair -

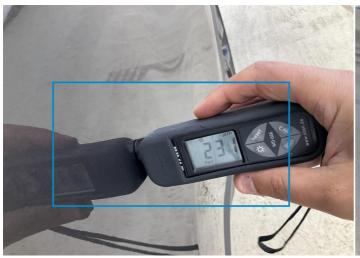
3. Door / Back Left Paint / Poor Previous Repair -

4. Side Panel / Back Left Paint / Poor Previous Repair -

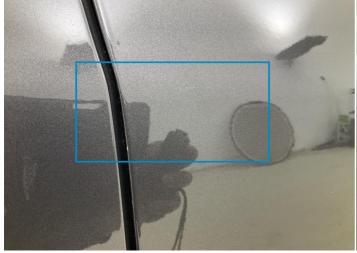
5. Door / Front Right Paint / Scratch / Scuff -

6. Hood Paint / Poor Previous Repair -

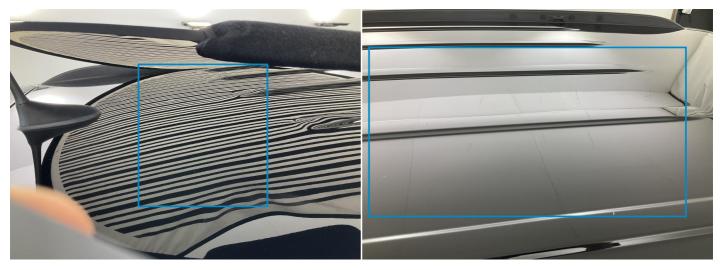
7. Roof Bodywork / Dent / Hail Area -

8. Roof Paint / Scratch / Line -
