MASERATI Ghibli

VIN NO ZAMZS57B001373056
Registration Number GPKW5000

Inspection Report Summary

| Customer | BCA Online | Report Number | P20250814115152 |

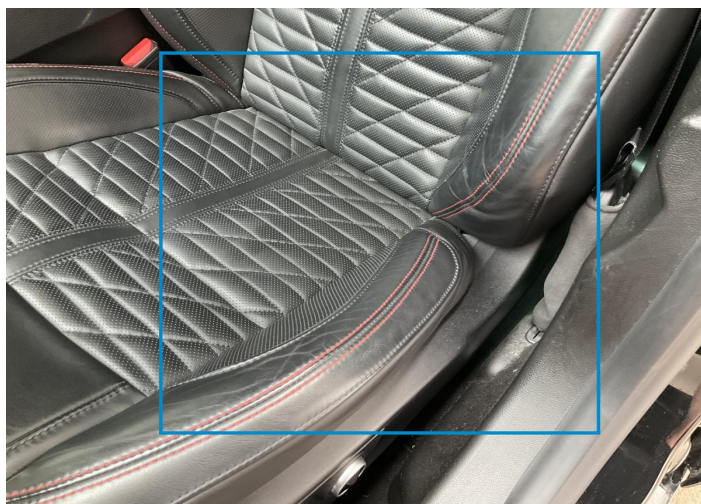
1. Seat / Front Left
Interior / Worn - out -

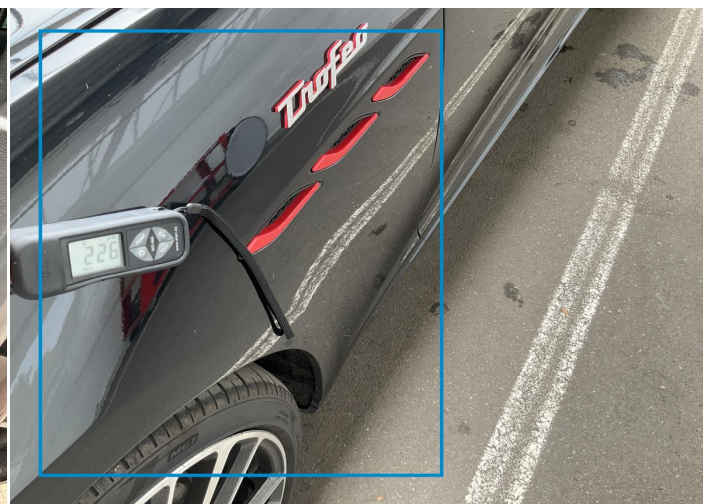
2. Fender / Front Left
Paint / Poor Previous Repair -

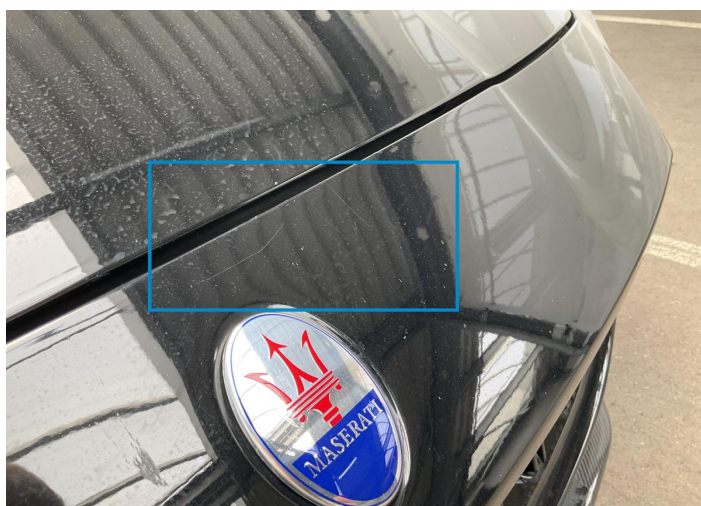
3. Bumper / Front
Paint / Scratch / Scuff -

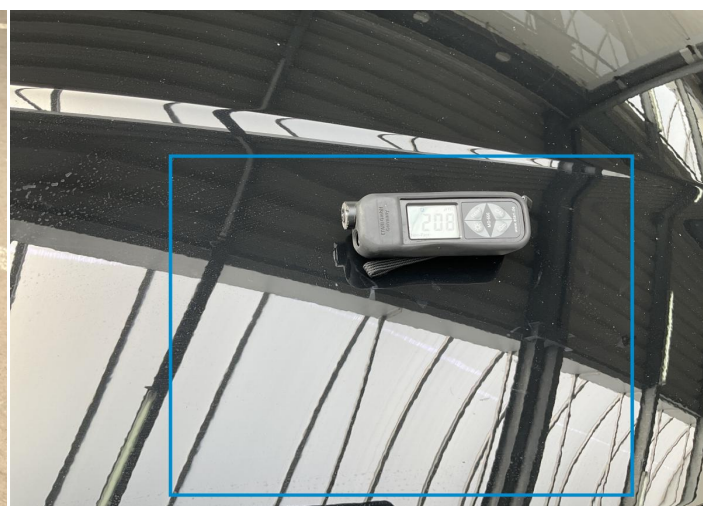
4. Hood
Paint / Poor Previous Repair -

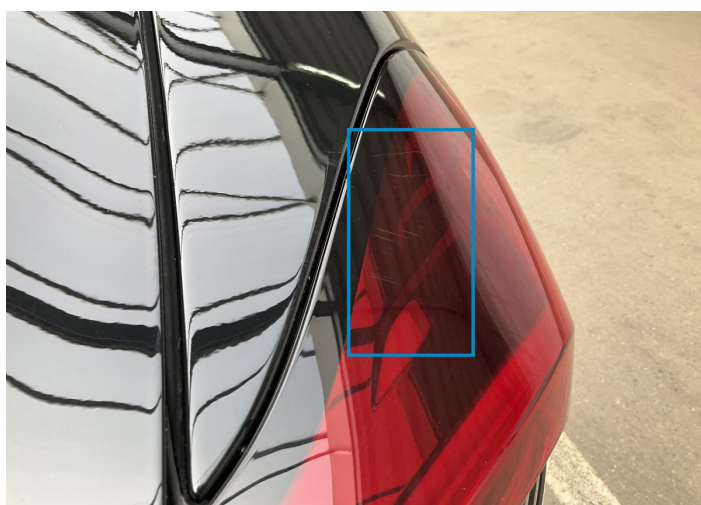
5. Back Light / Right
Glass Break -

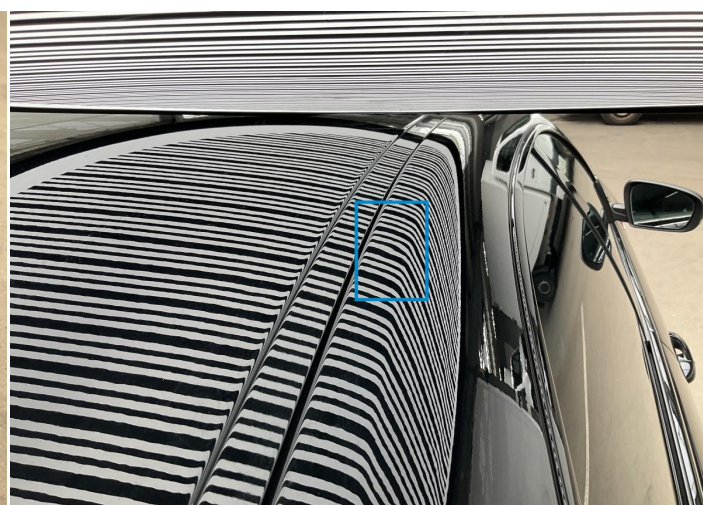
6. Pillar / Back Right
Bodywork / Dent / Dent -

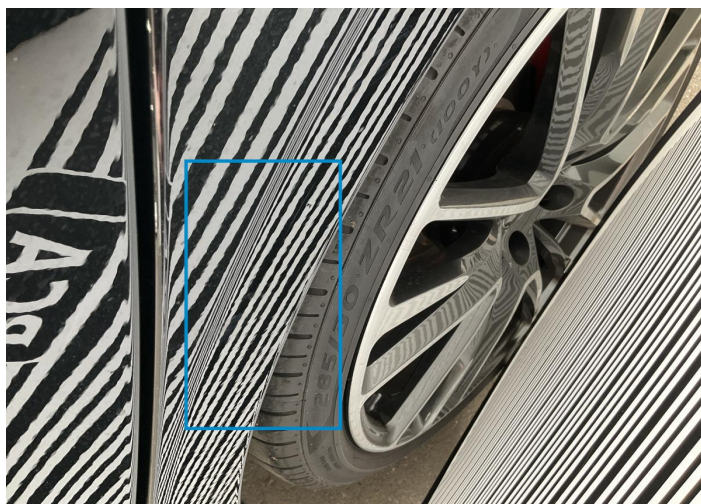
7. Side Panel / Back Left
Paint / Poor Previous Repair -

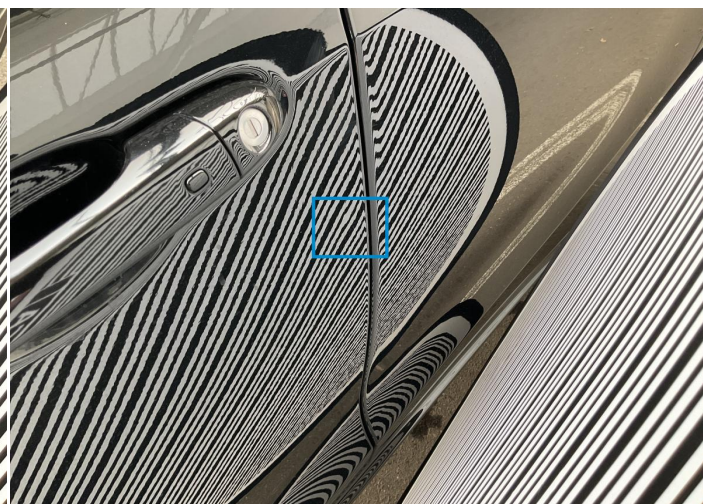
8. Door / Front Left
Bodywork / Dent / Dent -

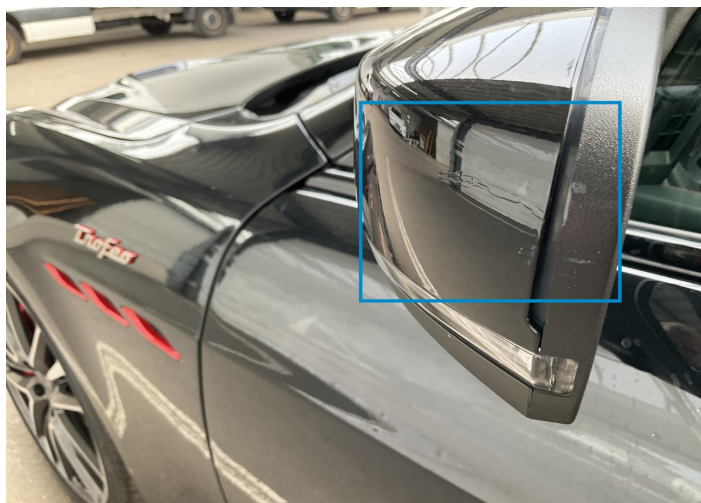
9. Mirror Shell / Front Left
Paint / Scratch / Scuff -

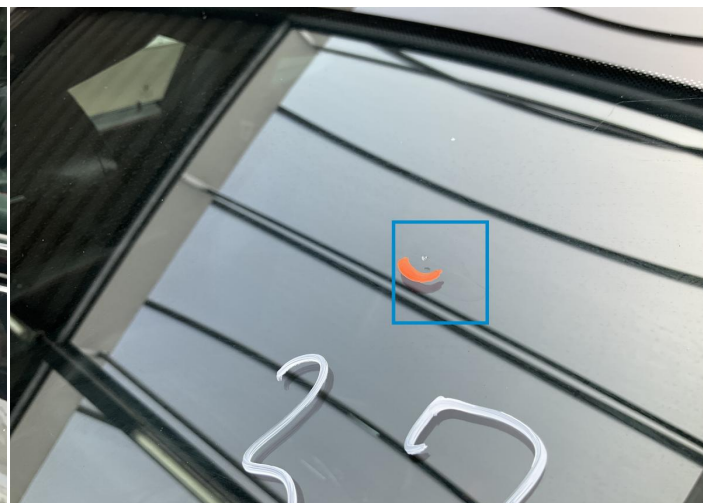
10. Windshield / Front
Glass Break / Impact -
