## status report

**customer:** Bank 11, Neuss  
**contract number:** 760667230  
**reference:**

#### Alfa Romeo Giulietta Sprint

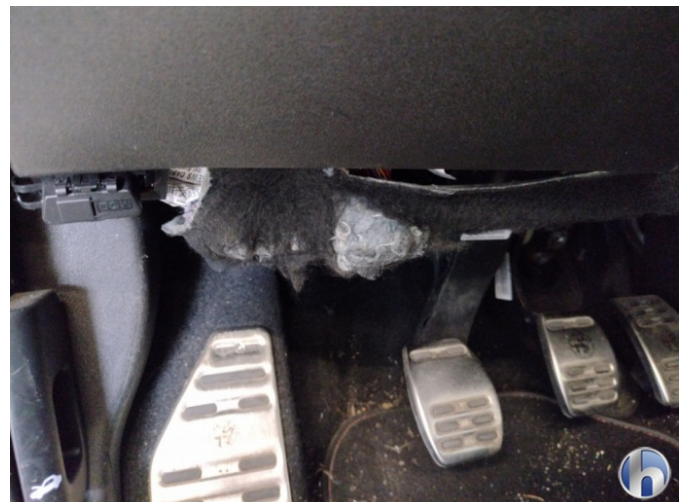
| component | Damage | Rep kind |
|---|---|---|
| 2. Polster Fußraum VL | Damaged | Replace |

2. Polster Fußraum VL

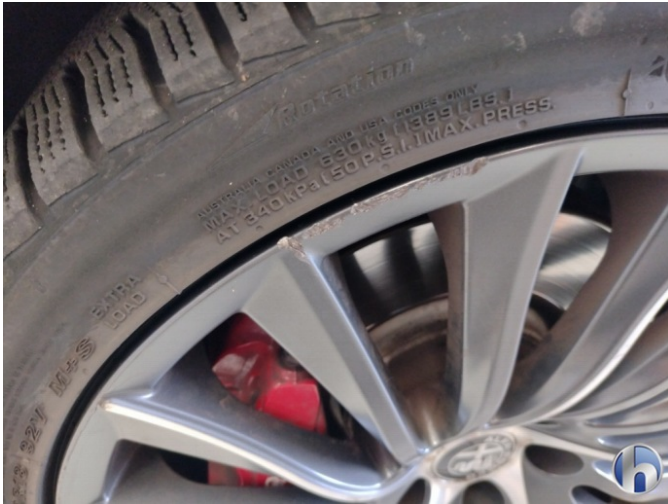
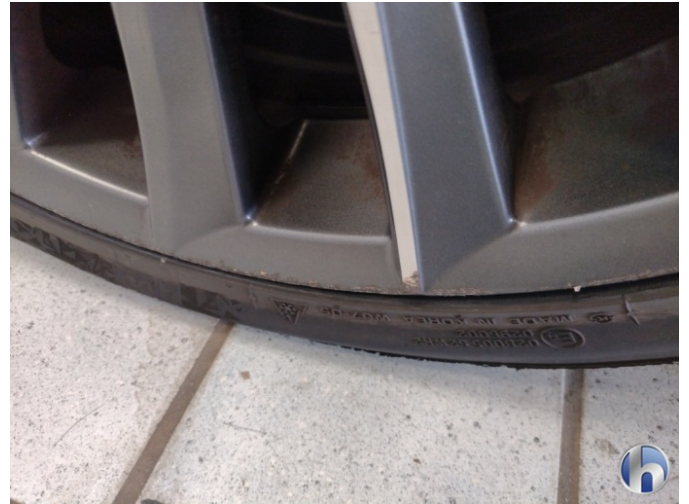
| component | Damage | Rep kind |
|---|---|---|
| 3. Rim front - left | Damaged | Replace |

3. Rim front - left

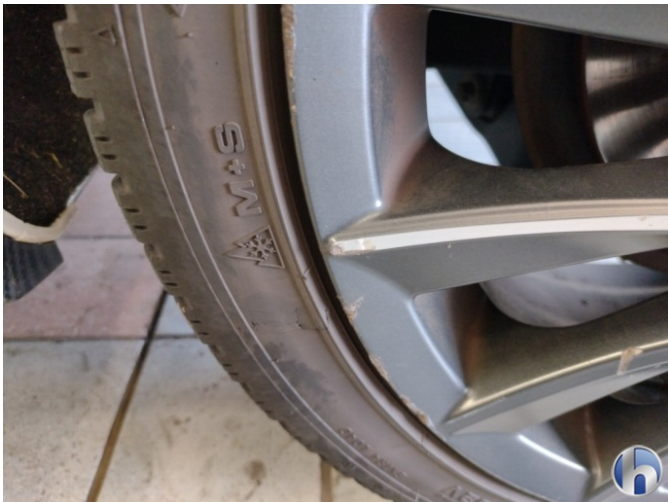
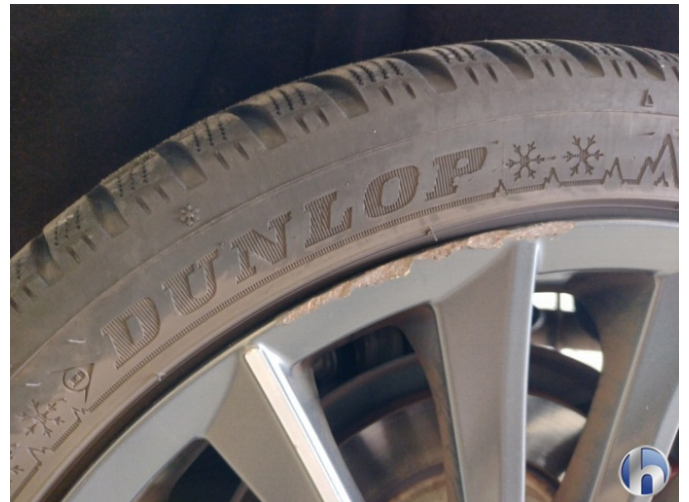
| component | Damage | Rep kind |
|---|---|---|
| 4. Rim rear - left | Damaged | Replace |

4. Rim rear - left

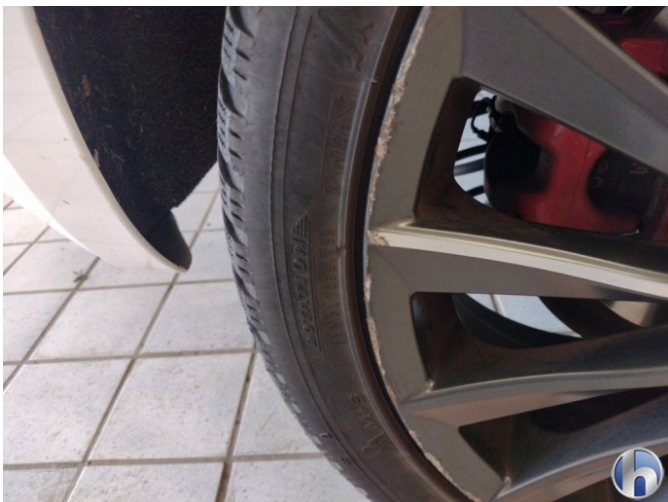
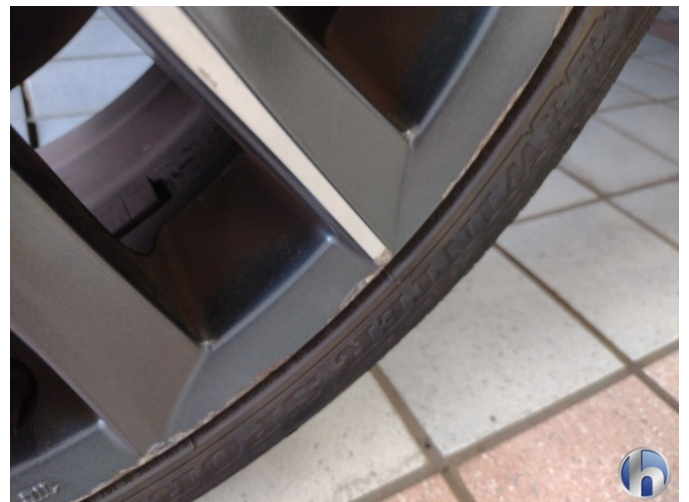
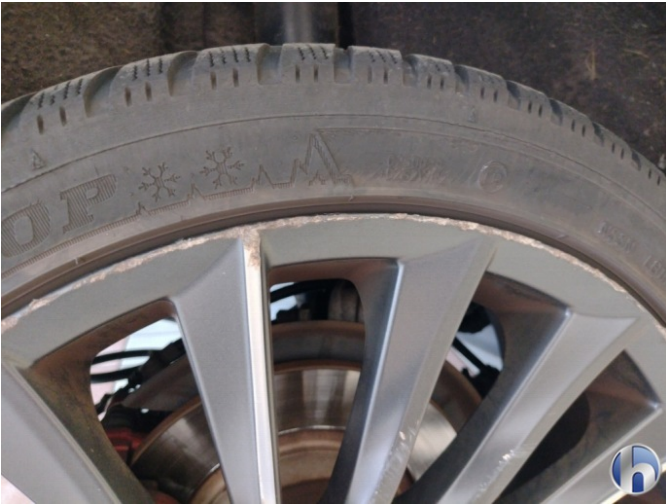
| component | Damage | Rep kind |
|---|---|---|
| 5. Rim rear - right | Damaged | Replace |

5. Rim rear - right

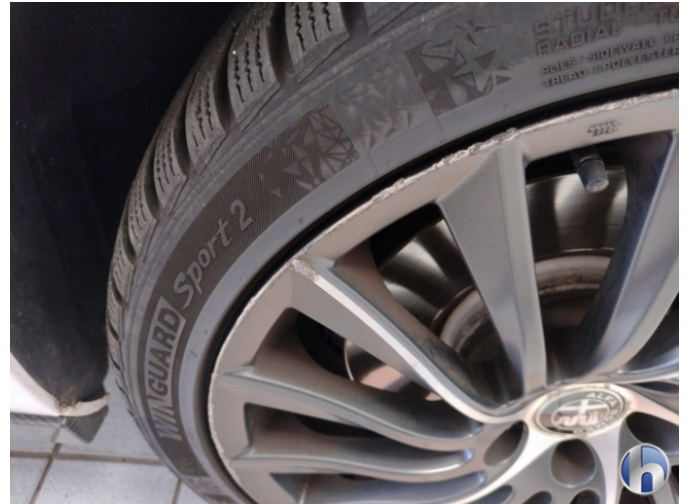
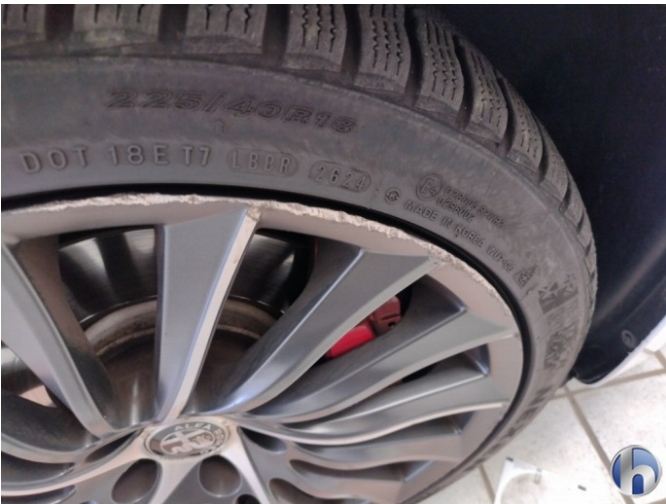
| component | Damage | Rep kind |
|---|---|---|
| 6. Rim front - right | Damaged | Replace |

6. Rim front - right

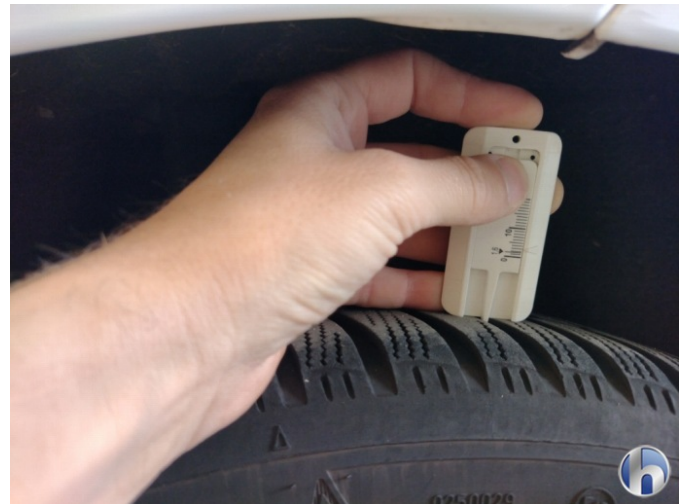
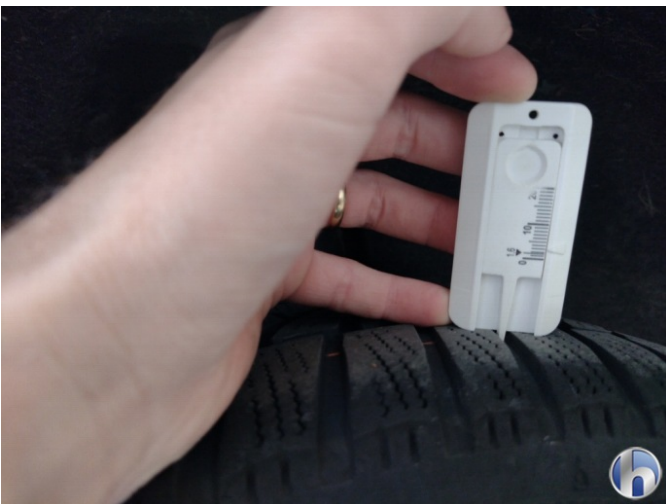
| component | Damage | Rep kind |
|---|---|---|
| 8. Beide Reifen Vorne | Worn | Replace |

8. Beide Reifen Vorne

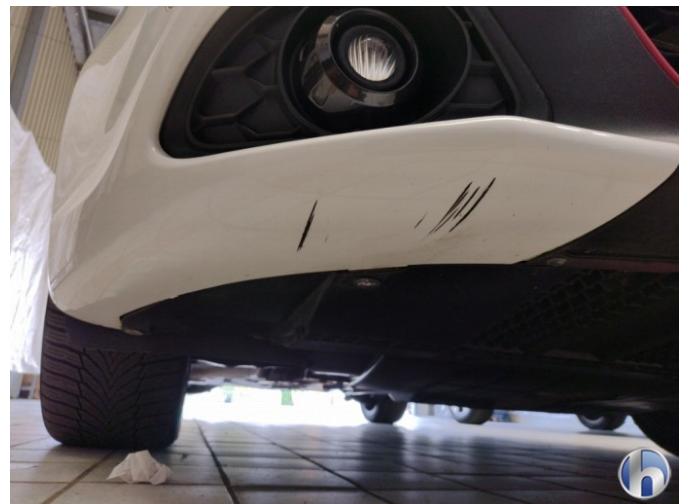
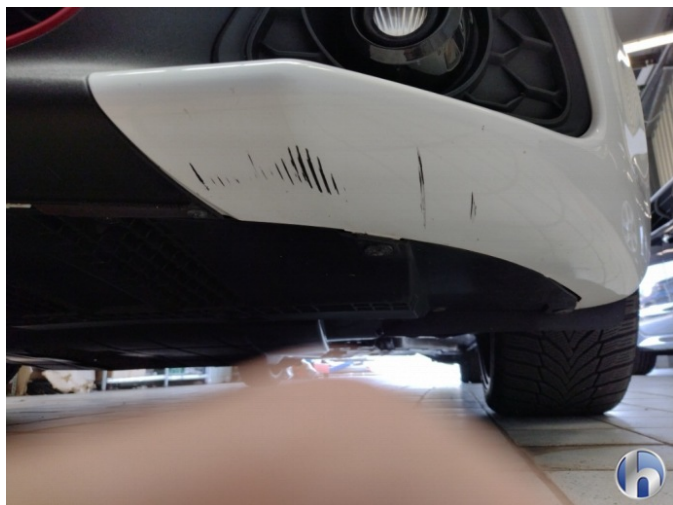
| component | Damage | Rep kind |
|---|---|---|
| 9. Front bumper | Scrape | Paint |

9. Front bumper

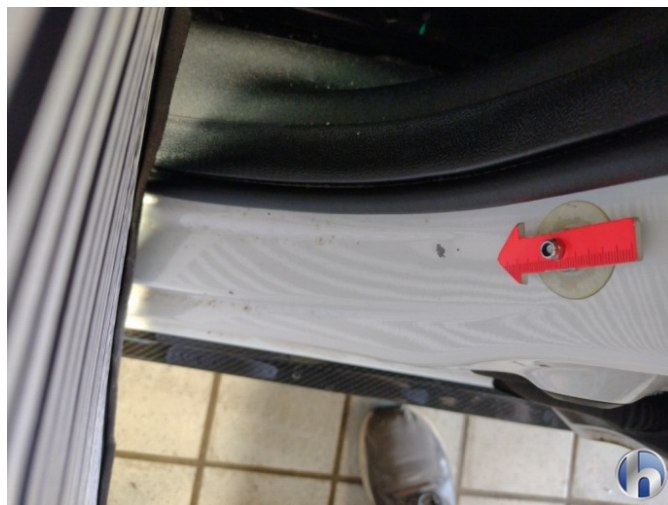
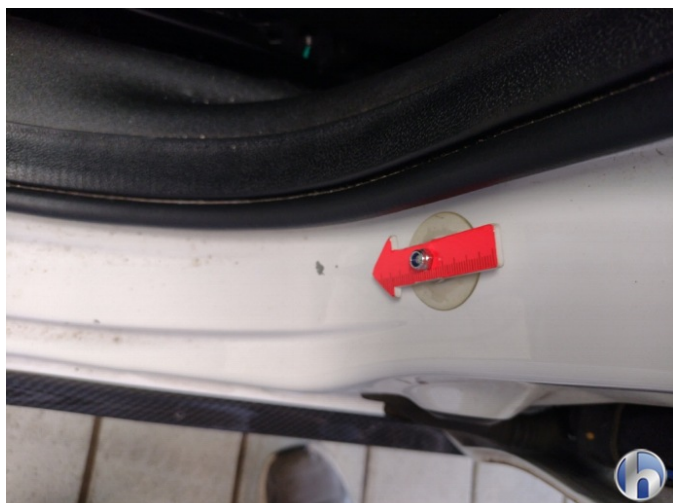
| component | Damage | Rep kind |
|---|---|---|
| 10. Türeinstieg Vorne - Links | Damaged | Refurbish and paint |

10. Türeinstieg Vorne - Links

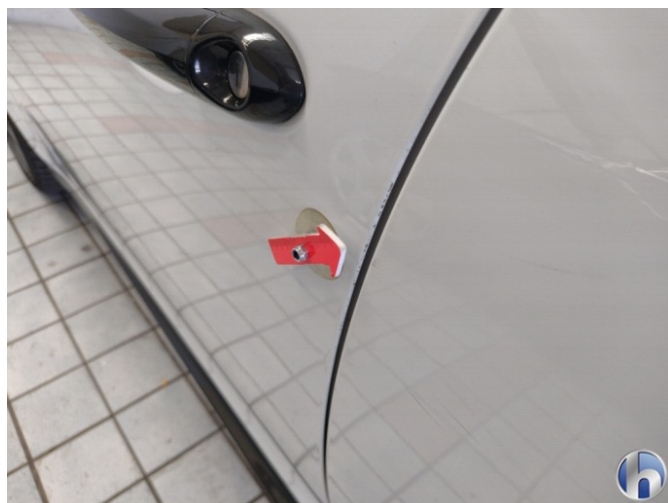
| component | Damage | Rep kind |
|---|---|---|
| 11. Front door - left | Scratch(es) | Smart repair |

11. Front door - left

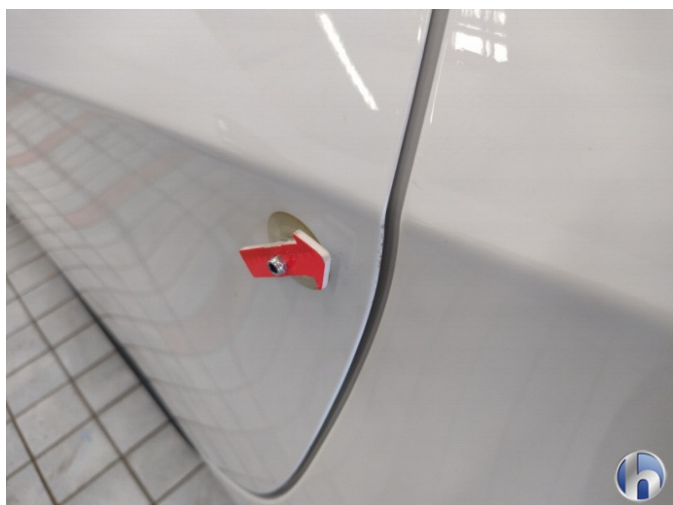
| component | Damage | Rep kind |
|---|---|---|
| 12. Rear door - left | Scratch(es) | Smart repair |

12. Rear door - left

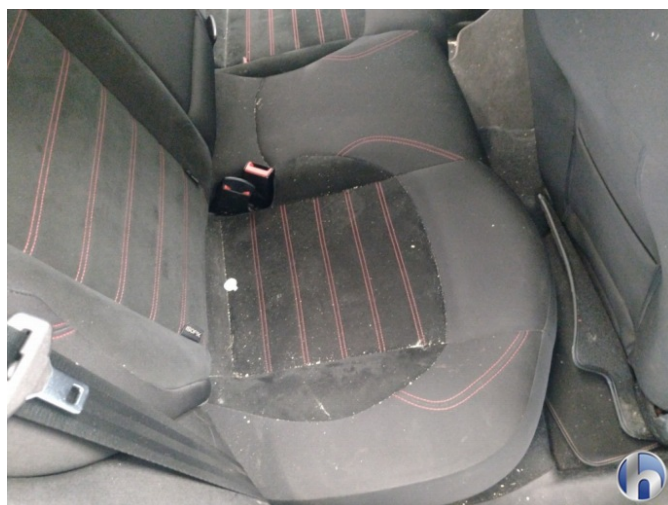
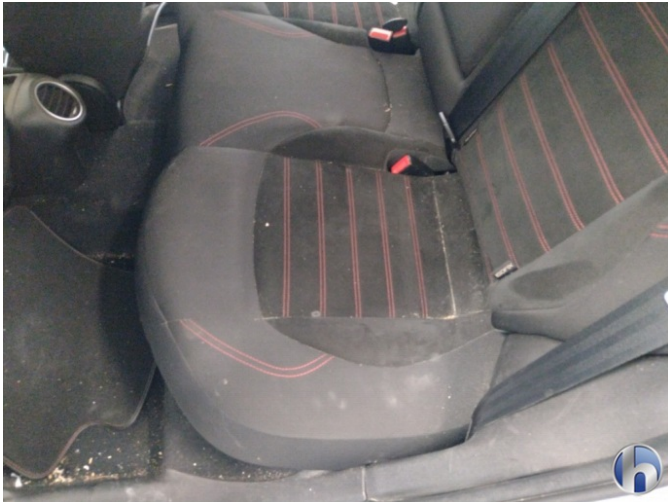
| component | Damage | Rep kind |
|---|---|---|
| 13. Sitzreihe Hinten | Dirty | |

13. Sitzreihe Hinten

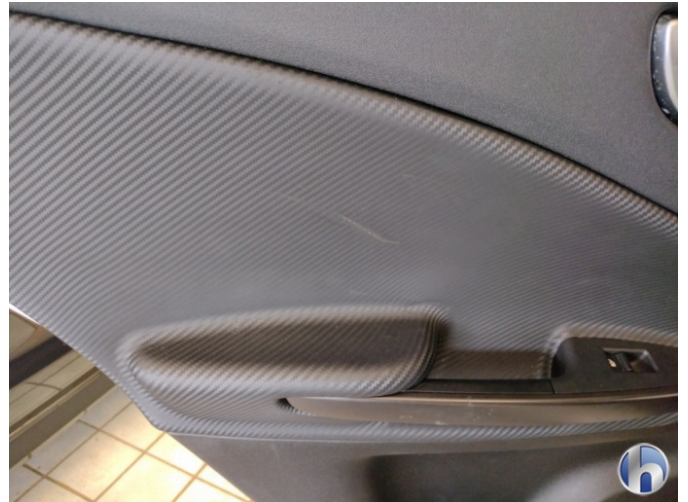
| component | Damage | Rep kind |
|---|---|---|
| 14. Rear door trim - left | Damaged | Smart repair |

14. Rear door trim - left

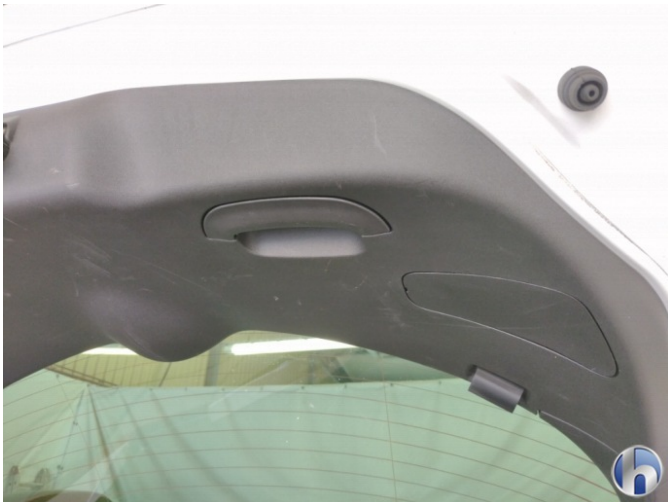
| component | Damage | Rep kind |
|---|---|---|
| 15. tailgate trim | Wear and tear | acceptable |

15. tailgate trim

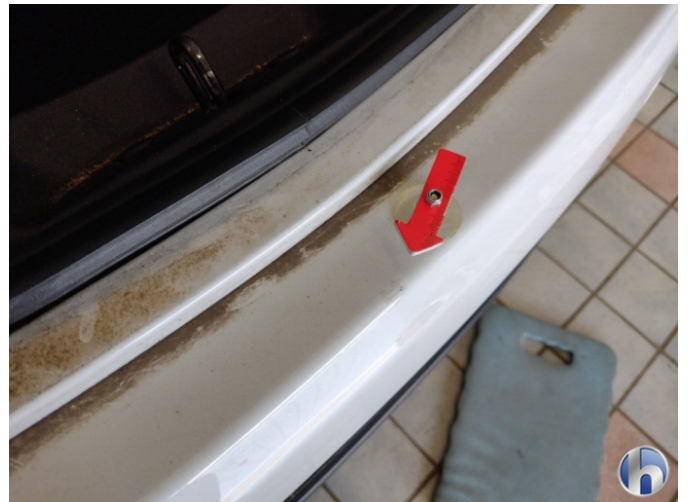
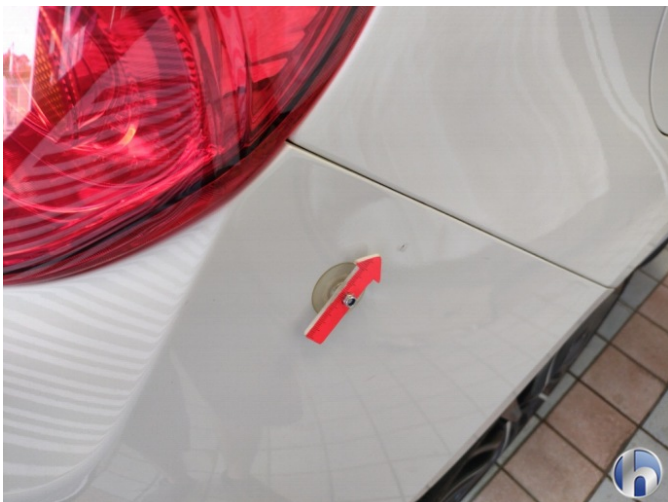
| component | Damage | Rep kind |
|---|---|---|
| 16. Rear bumper | Scratch(es) | Paint |

16. Rear bumper

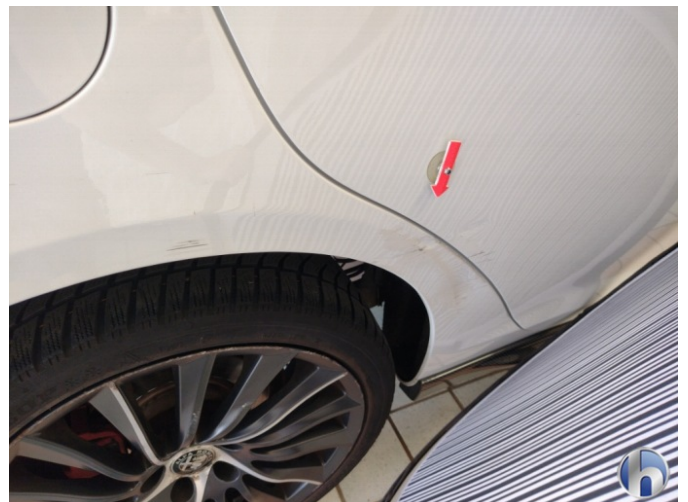
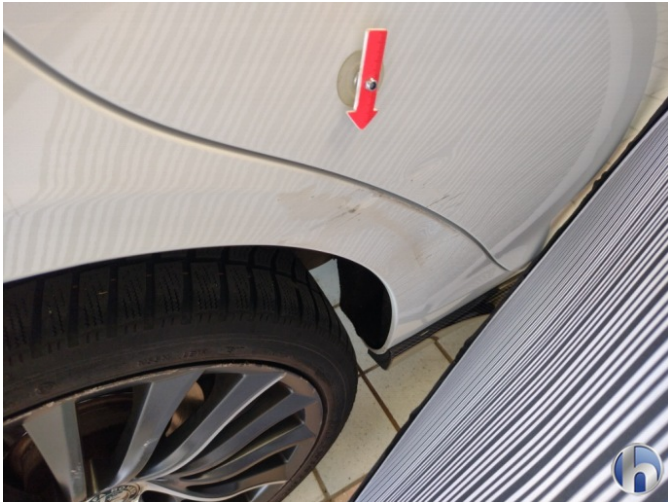
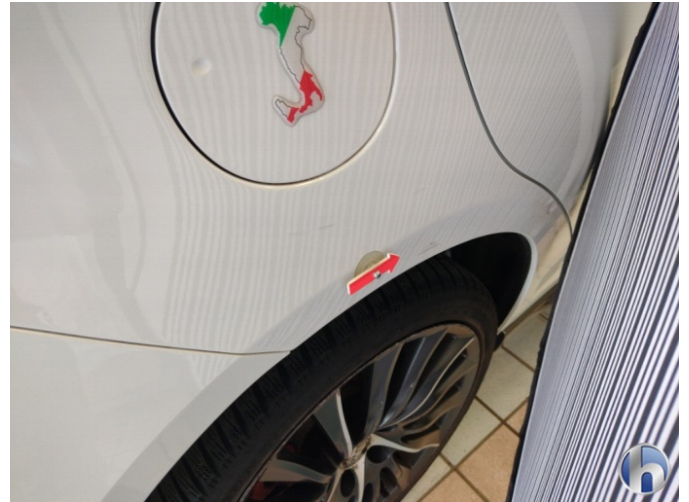
| component | Damage | Rep kind |
|---|---|---|
| 17. Sidewall - Rear - right | Deformed | Refurbish and paint |

17. Sidewall - Rear - right

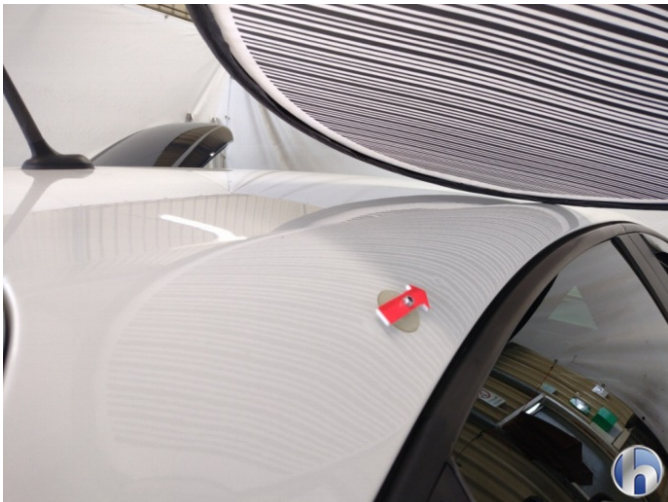
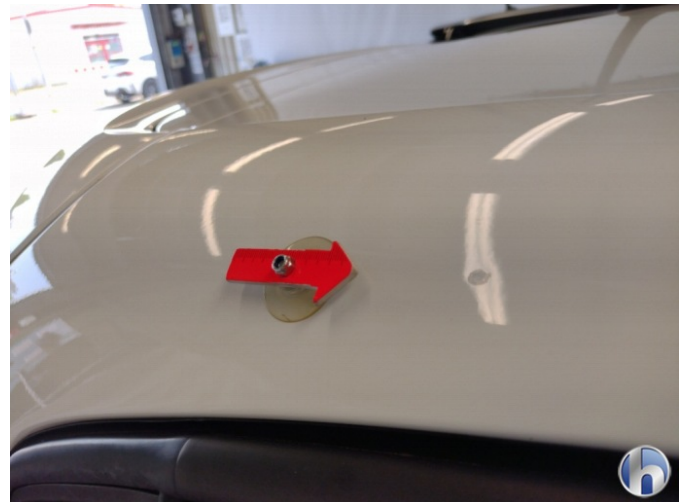
| component | Damage | Rep kind |
|---|---|---|
| 18. Roof frame - right | Damaged | Refurbish and paint |

18. Roof frame - right

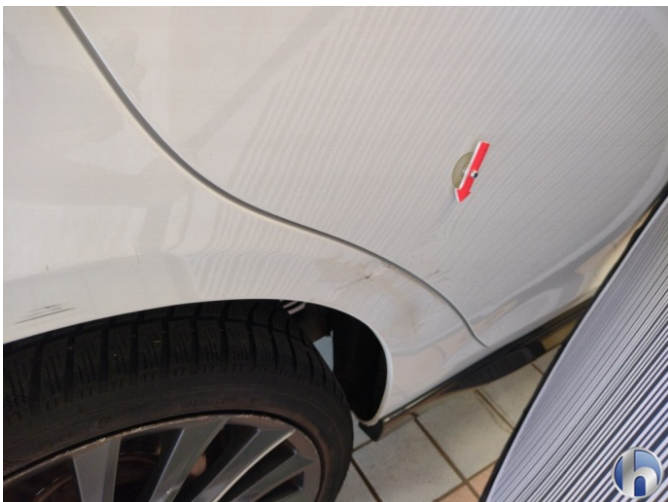
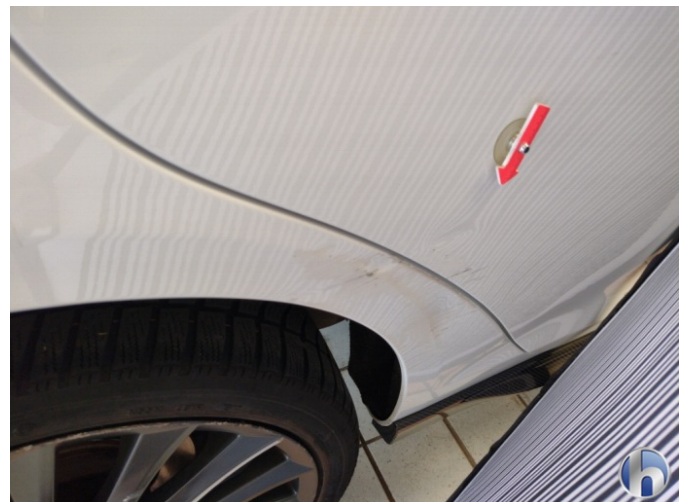
| component | Damage | Rep kind |
|---|---|---|
| 19. Door Rear - right | Deformed | Refurbish and paint |

19. Door Rear - right

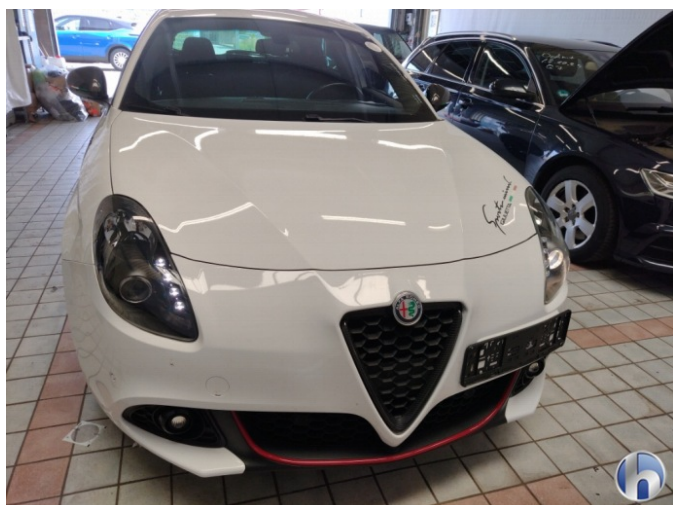
| General examination | |
|---|---|
| <b>Note Road Safe:</b> | Abblendlicht Rechts ohne Funktion |

| component | Damage | Rep kind |
|---|---|---|
| 20. Abblendlicht Rechts | No functionality | Carry out a fault diagnosis |

20. Abblendlicht Rechts

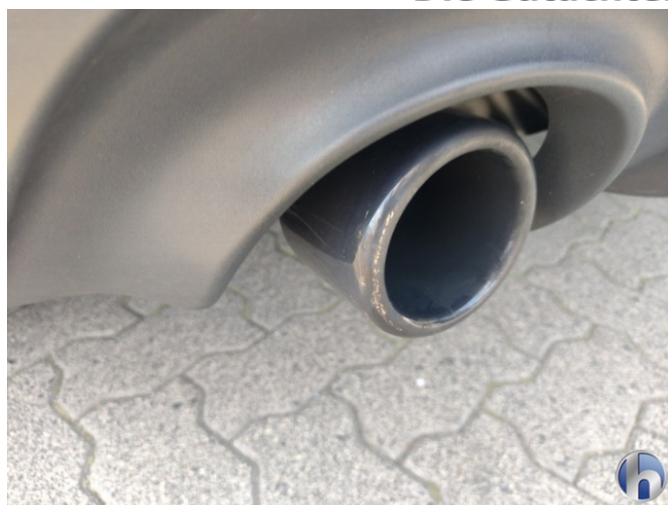
| component | Damage | Rep kind |
|---|---|---|
| 21. silencer | Damaged | Replace |

21. silencer

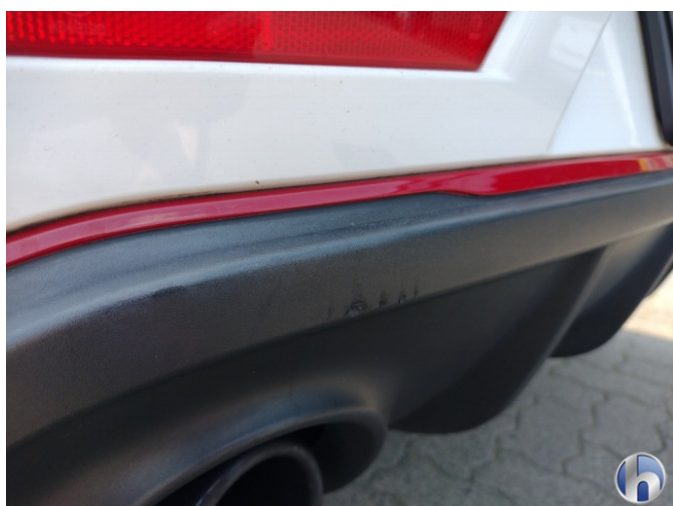
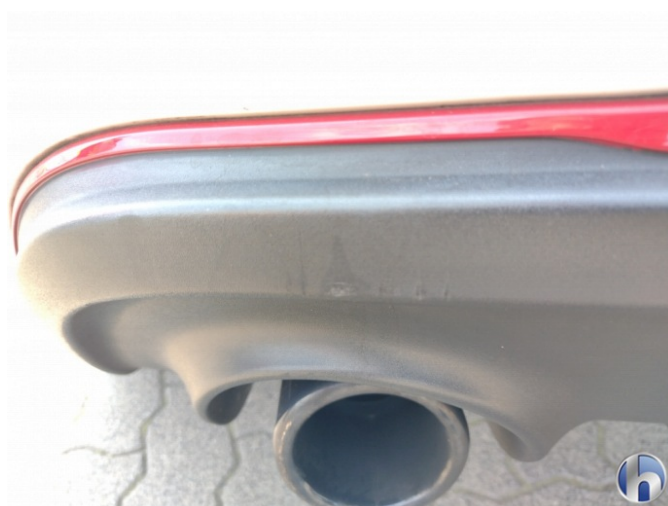
| component | Damage | Rep kind |
|---|---|---|
| 22. Stoßfänger Hinten Unterer Teil | Damaged | Replace |

22. Stoßfänger Hinten Unterer Teil
