# ALFA ROMEO TONALE Tonale 1.5 Hybrid 160 ch VGT TCT7 Edizione Speciale

VIN NO ZARNASSA5N3023175 Registration Number GN113KY

## **Inspection Report Summary**

| Customer | BCAuto Encheres | Report Number | P20250801002254 |

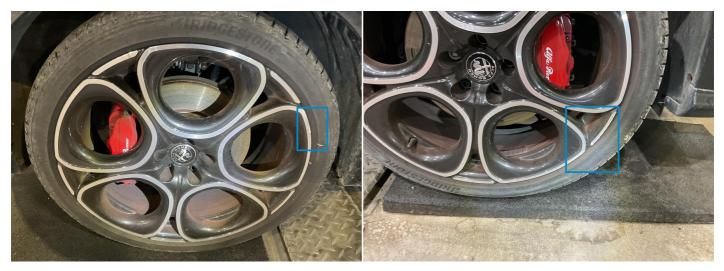
1. Rim / Front Left Paint / Chipping -

2. Rim / Front Right Out of Bodywork / Scratch -

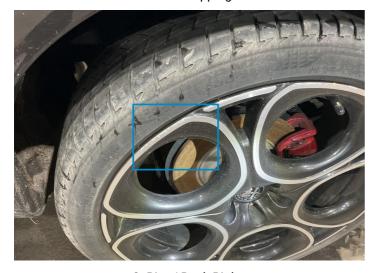
3. Rim / Back Right Out of Bodywork / Scratch -
