IVECO DAILY
DAILY BP FGN 35 C 14S EMP 3520L V12
H2 Q-TOR BVM6

VIN NO ZCFCL35A305558010
Registration Number GP376RD

Inspection Report Summary

Customer	BCAuto Encheres	Report Number	P20250513164336
Inspection Date / Place	2025-05-13 / BCA ROPPE	Cosmetic Grade	4

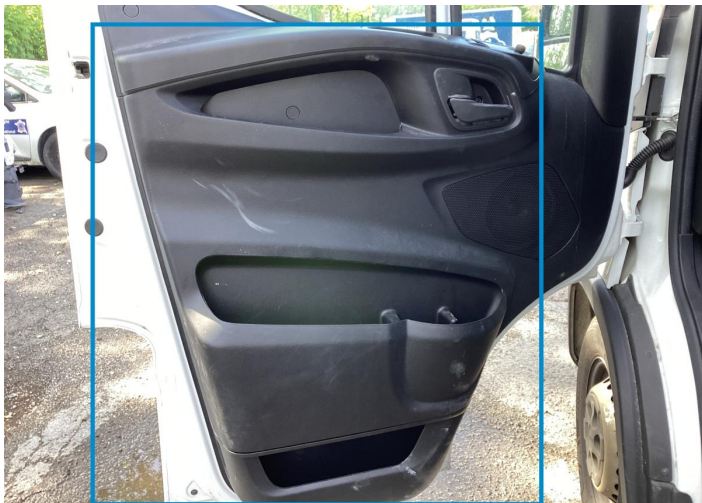
1. Panel Filling / Front Left
Interior / Scraped -

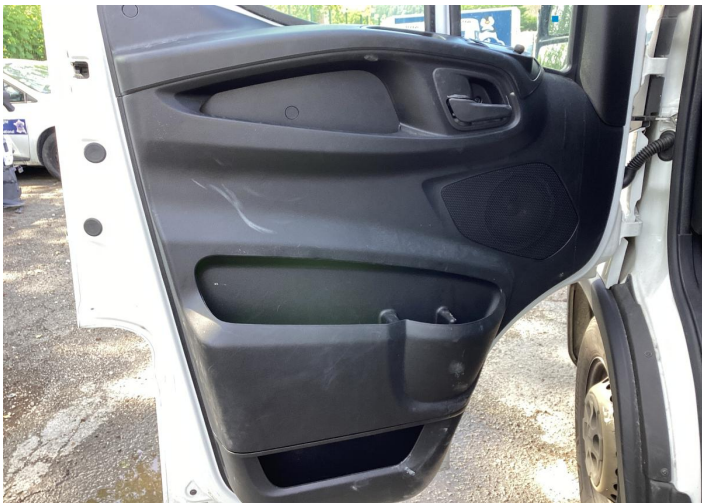
2. Panel Filling / Front Left
Interior / Dirty -

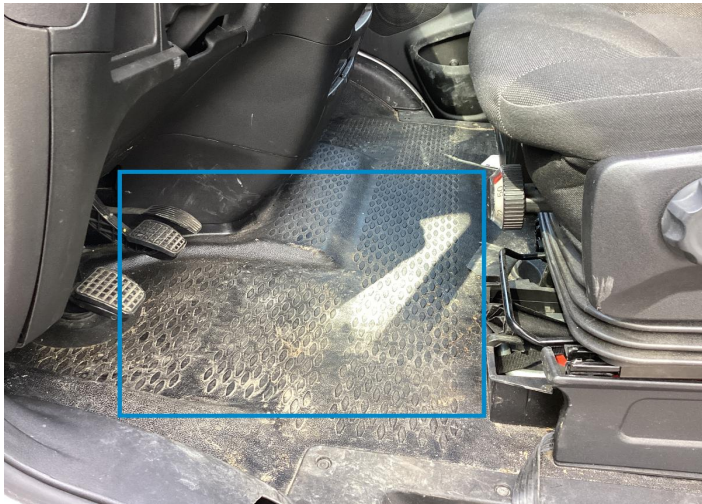
3. Floor Carpet
Interior / Dirty -

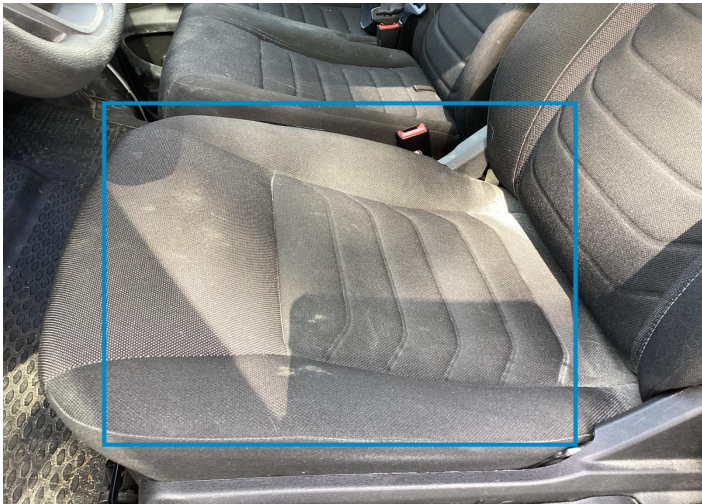
4. Seat Cushion / Front Left
Interior / Dirty -

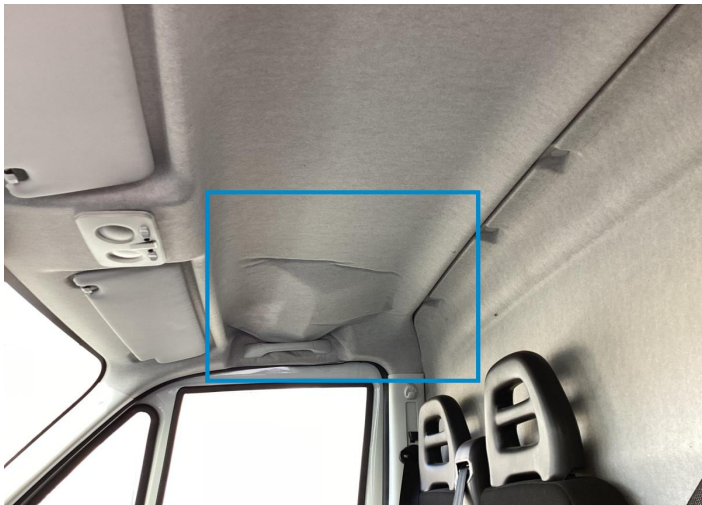
5. Roof Upholstery
Interior / Distorted -

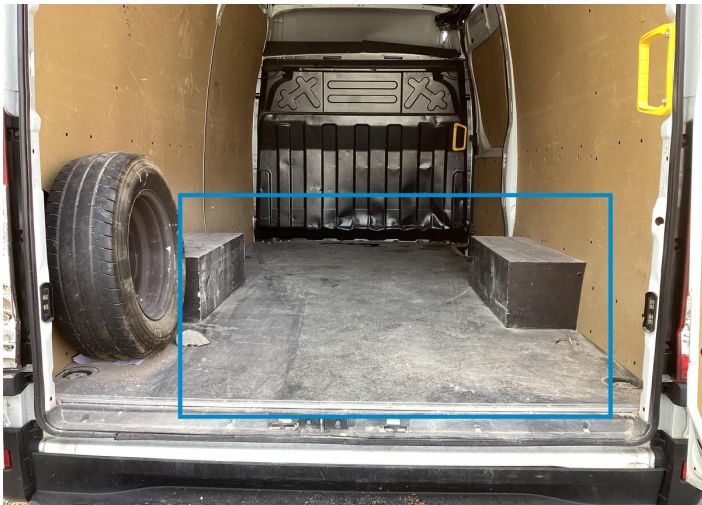
6. Trunk Carpet
Interior / Dirty -

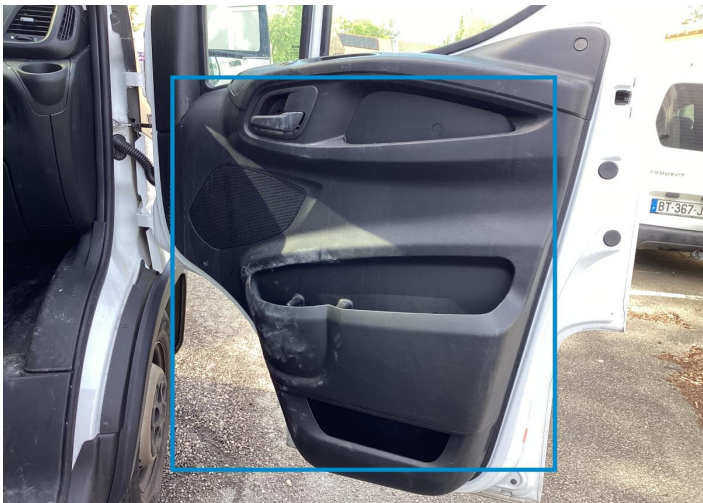
7. Panel Filling / Front Right Interior / Scraped -

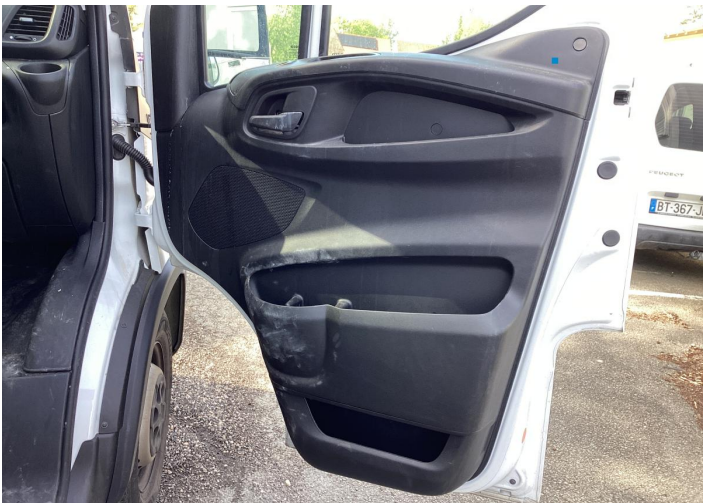
8. Panel Filling / Front Right Interior / Dirty -

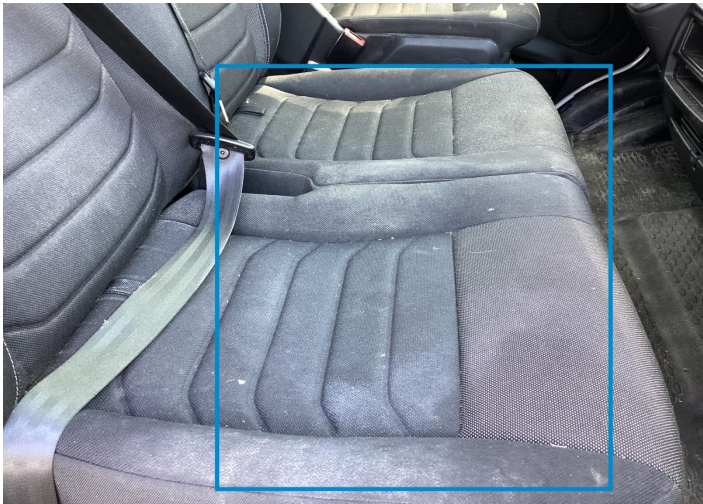
9. Seat / Front Right Interior / Dirty -

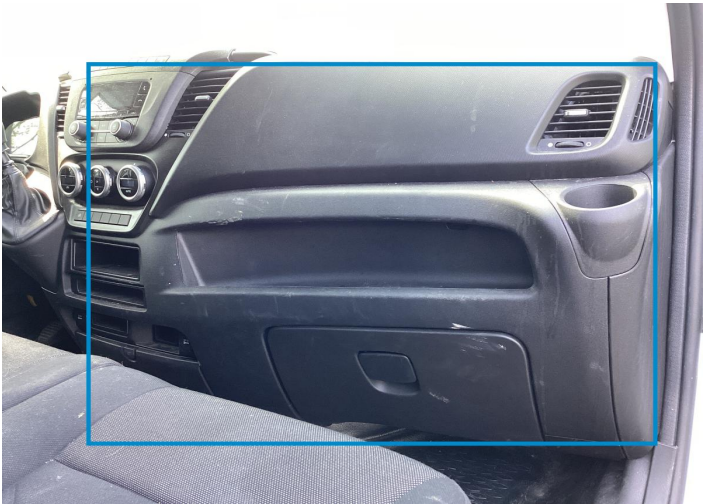
10. Dashboard / Front Interior / Scraped -

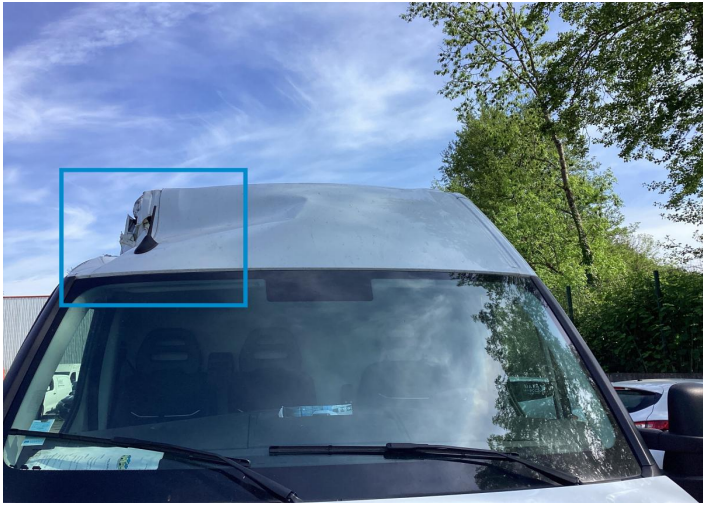
11. Cant Rail / Right Bodywork / Breakage -

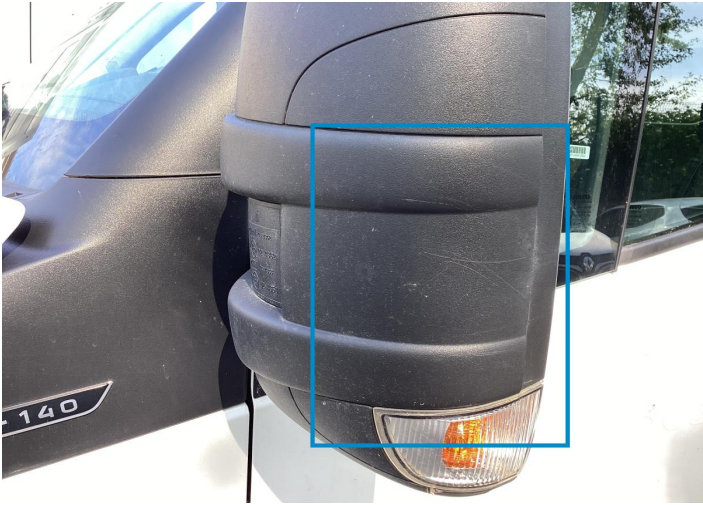
12. Mirror / Front Left Paint / Scratch / Line -

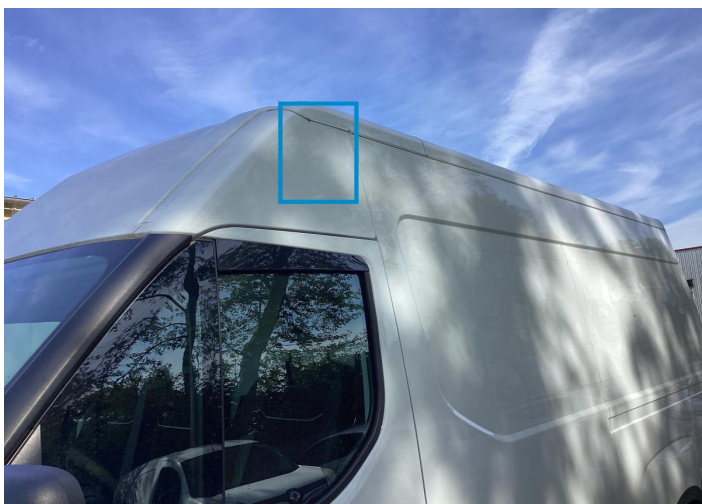
13. Cant Rail / Right
Bodywork / Dent / Deformation -

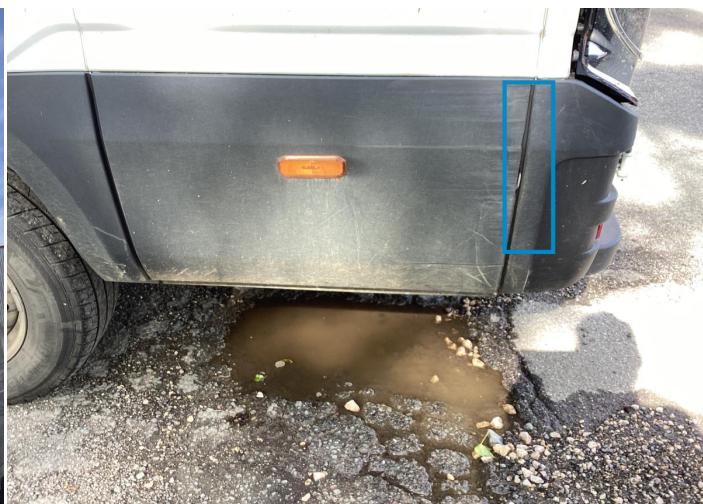
14. Corner Bumper / Back Left
Bodywork / Breakage / Hole -

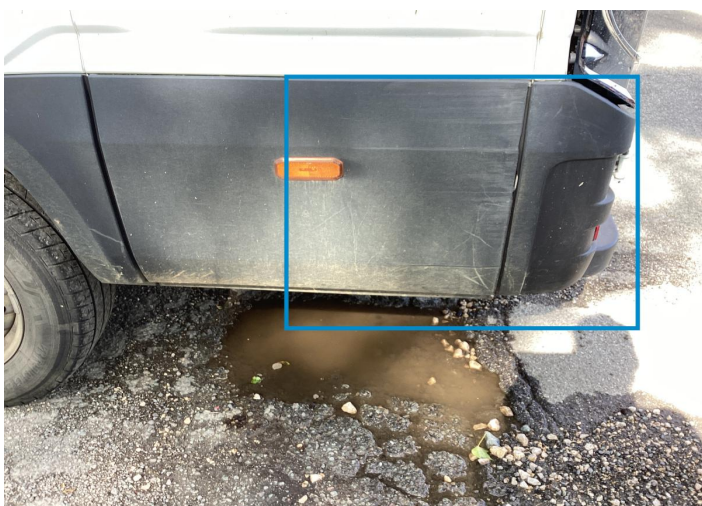
15. Corner Bumper / Back Left
Paint / Scratch / Line -

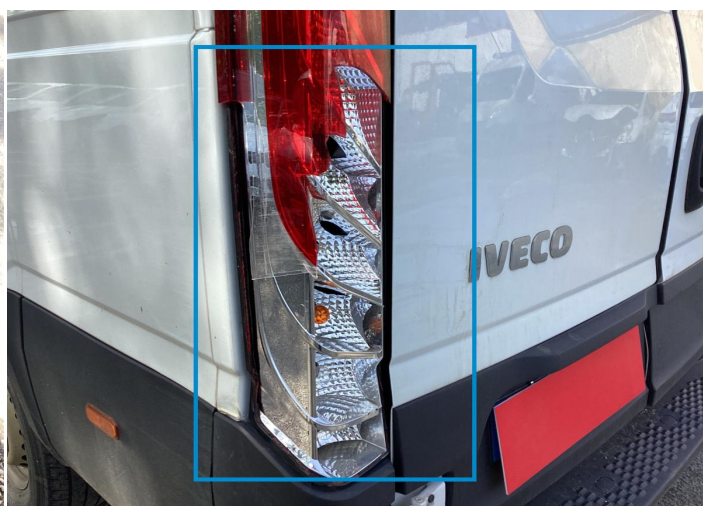
16. Back Light / Left
Glass Break -

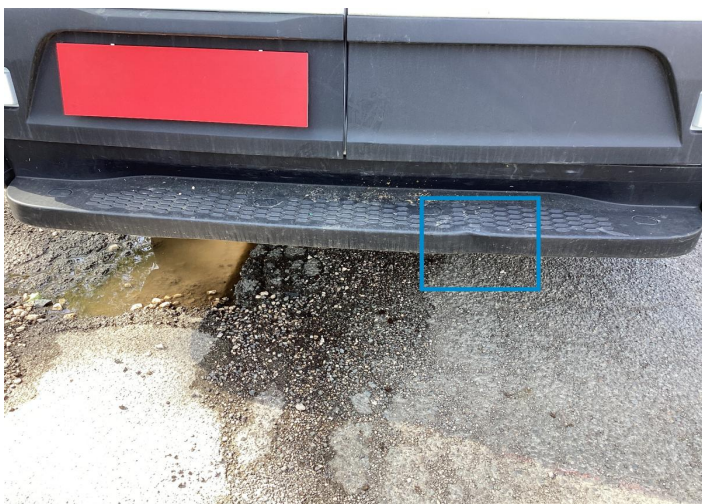
17. Bumper / Back
Bodywork / Dent / Deformation -

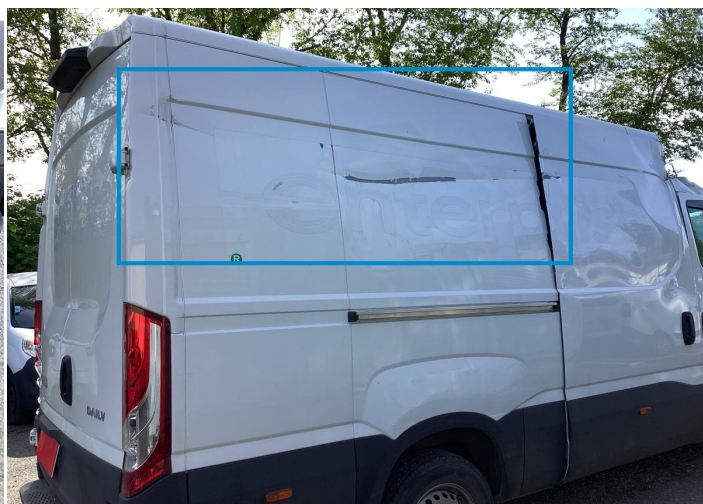
18. Side Panel / Back Right
Bodywork / Dent / Deformation -

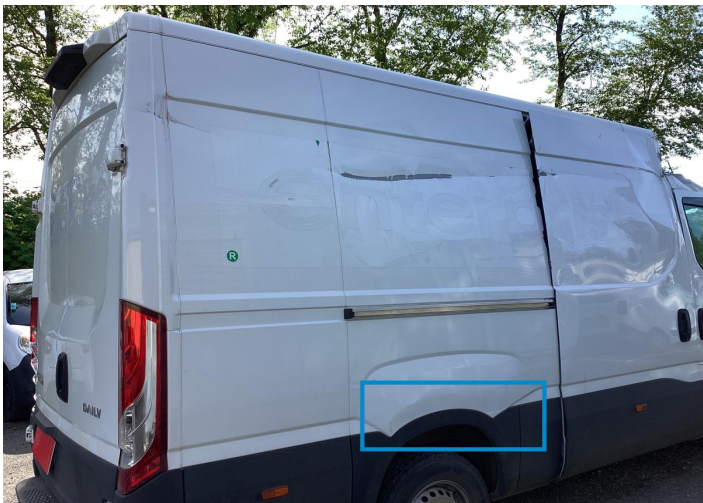
19. Side Panel / Back Right
Bodywork / Dent / Deformation -

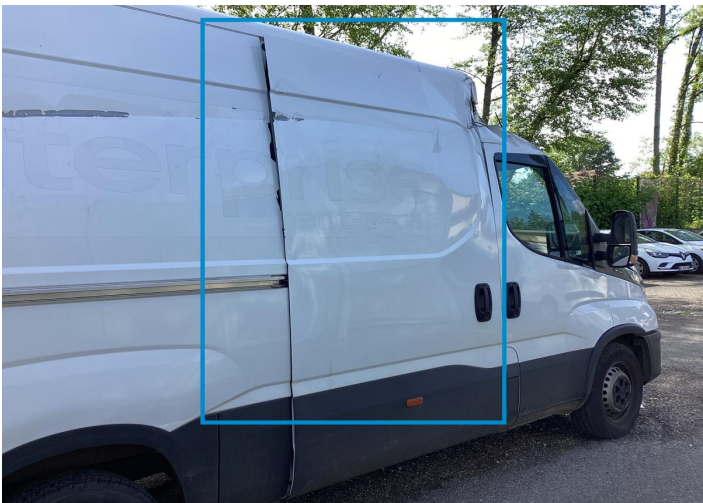
20. Door / Back Right
Bodywork / Dent / Deformation -

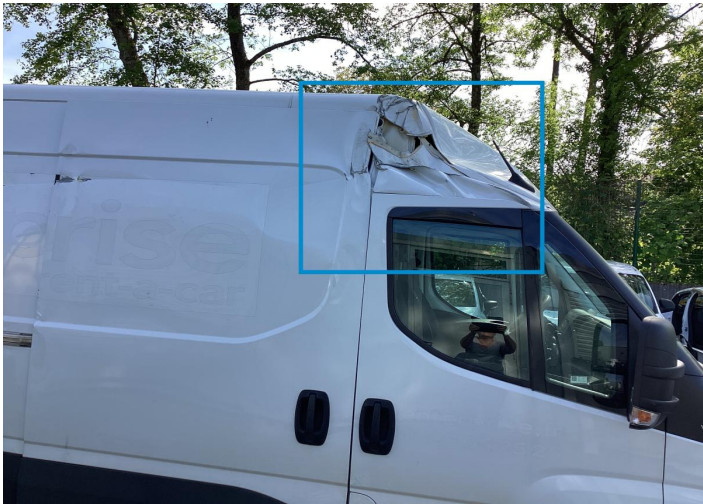
21. Cant Rail / Right
Bodywork / Dent / Deformation -

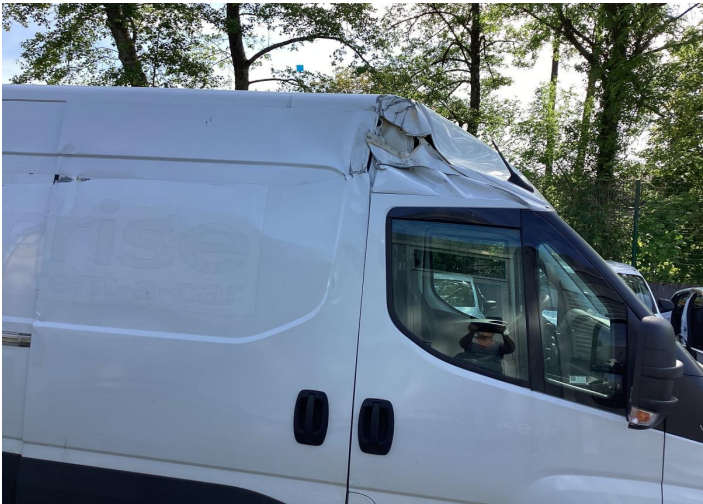
22. Cant Rail / Right
Bodywork / Breakage -

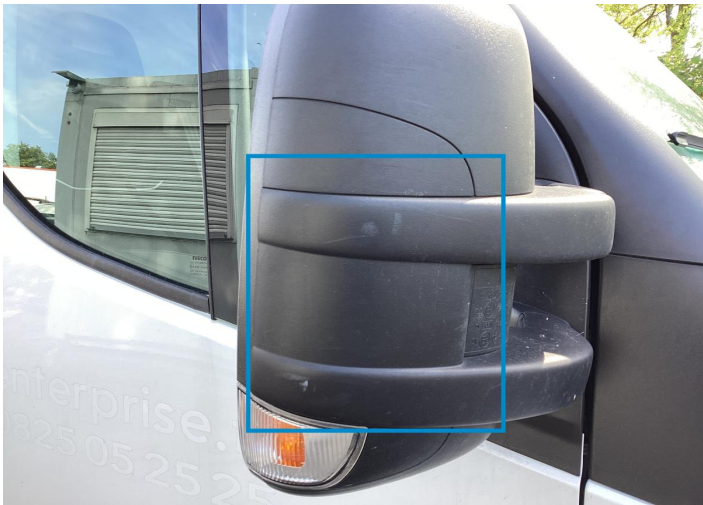
23. Mirror / Front Right
Paint / Scratch / Line -

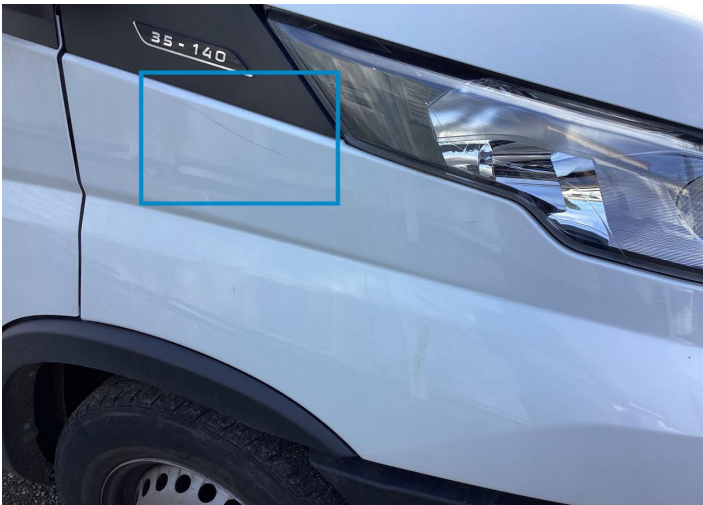
24. Fender / Front Right
Paint / Scratch / Line -
