## status report

| vehicle data | | | |
|---|---|---|---|
| <b>Fiat Punto Lim. 1.4 16V Emotion</b> | | | |
| Vehicle identification number | <b>ZFA18800004916760</b> | mileage read: | <b>98964 km</b> |
| First Registration / construction year: | <b>08.03.2005 / 0</b> | Visit Date / place of birth: | <b>21.07.2025 Dorfmark</b> |

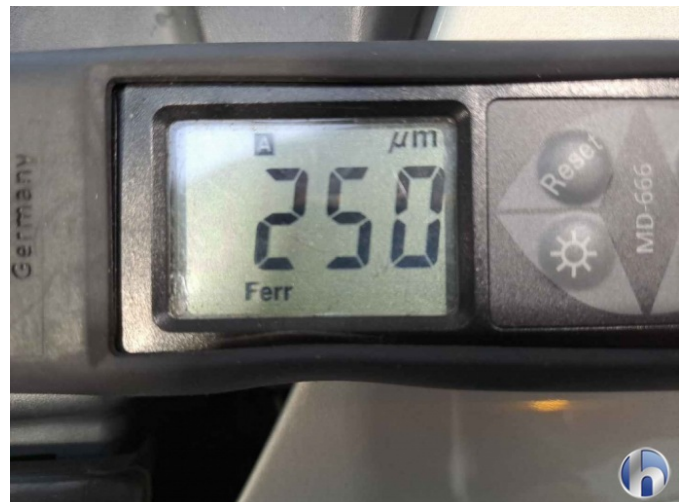
| component | Damage | Rep kind |
|---|---|---|
| 1. Front fender - right | Subsequently painted | acceptable |

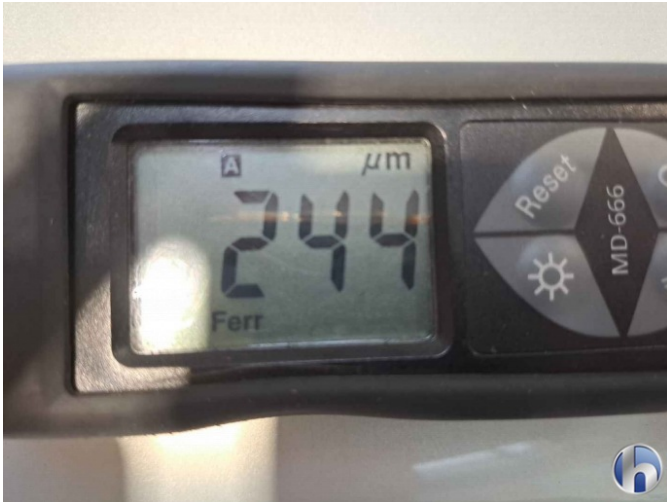
| component | Damage | Rep kind |
|---|---|---|
| 2. Front door - right | Subsequently painted | acceptable |

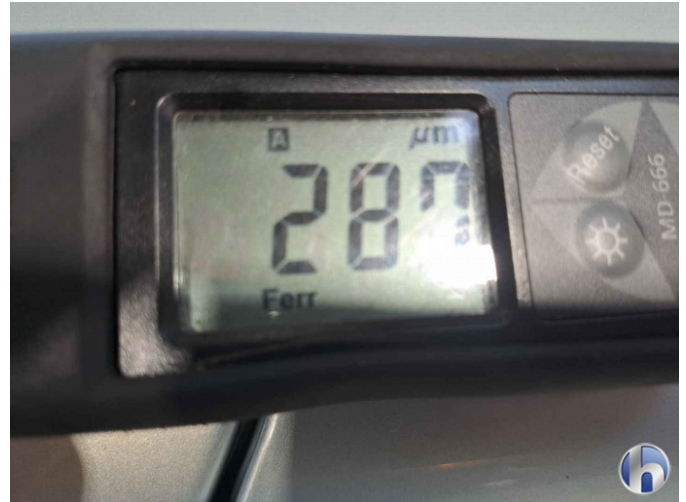
| component | Damage | Rep kind |
|---|---|---|
| 3. Door Rear - right | Subsequently painted | acceptable |

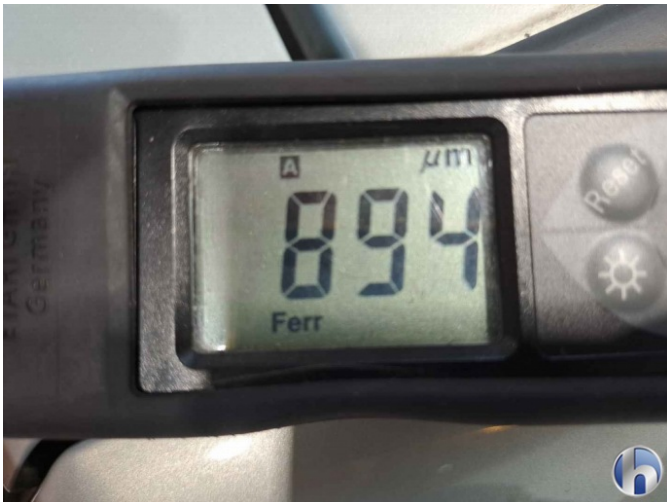
| component | Damage | Rep kind |
|---|---|---|
| 4. Sidewall - Rear - right | Subsequently painted | acceptable |

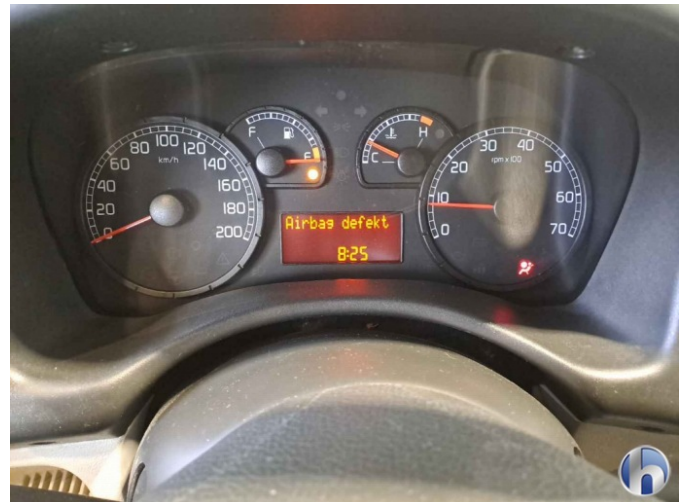
| component | Damage | Rep kind |
|---|---|---|
| 6. | Error message | Carry out a fault diagnosis |

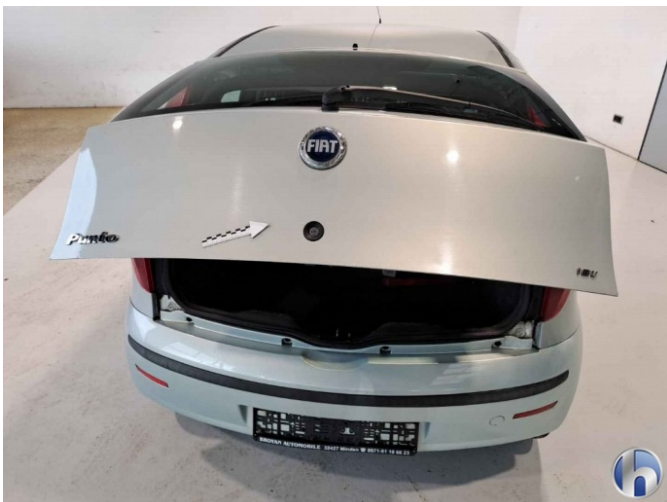
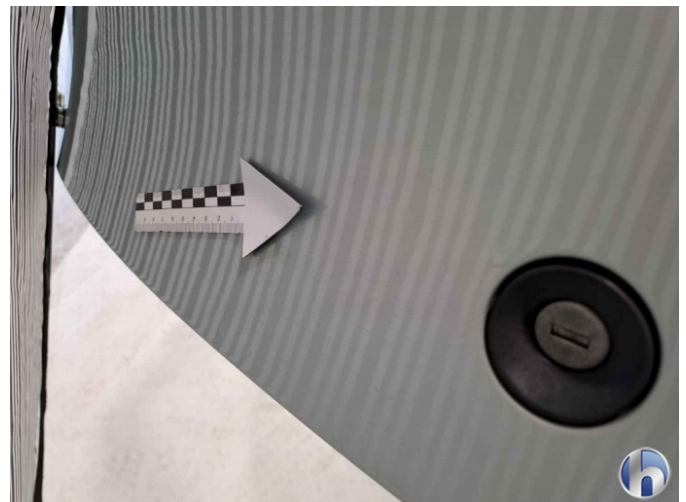
| component | Damage | Rep kind |
|---|---|---|
| 8. tailgate | Delle | Smart repair |

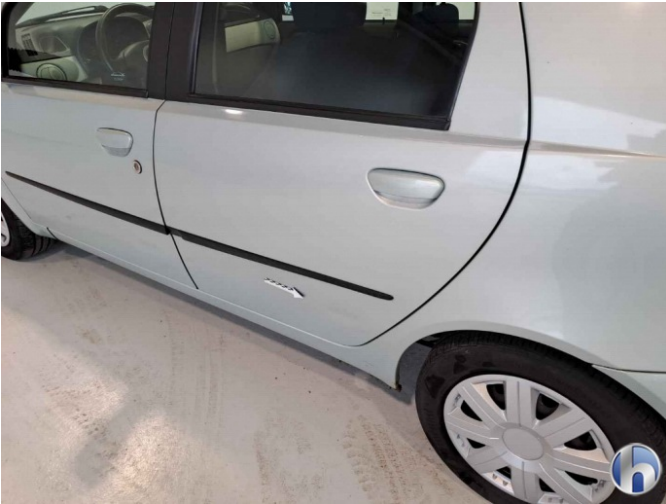
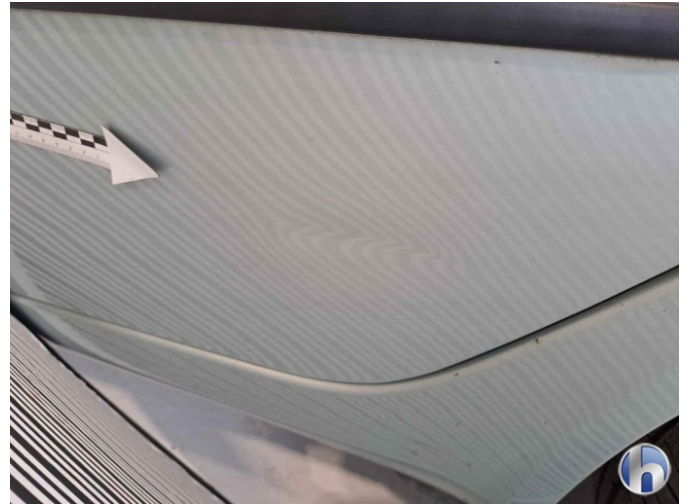
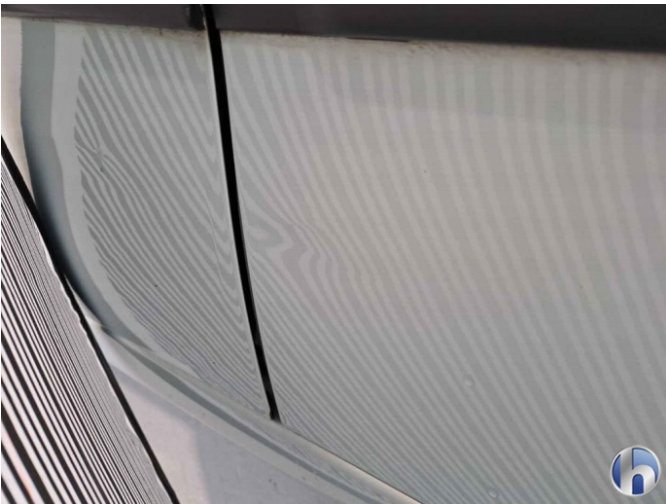
| component | Damage | Rep kind |
|---|---|---|
| 9. Rear door - left | Deformed | Refurbish and paint |

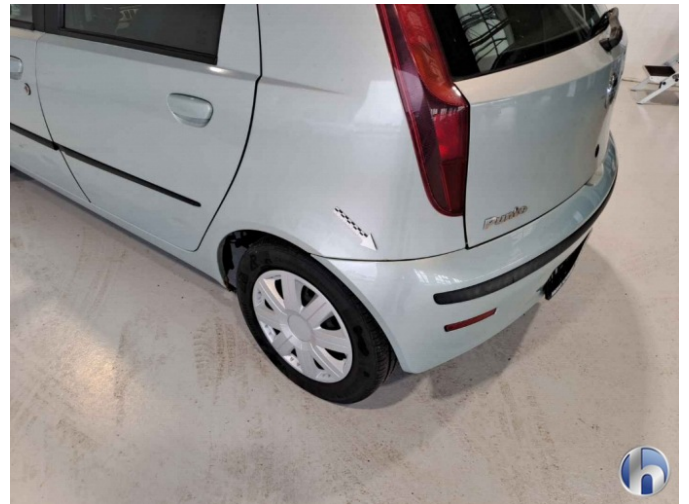
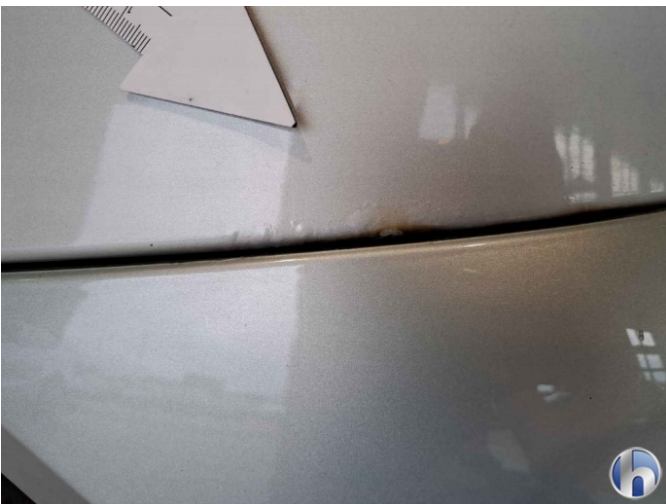
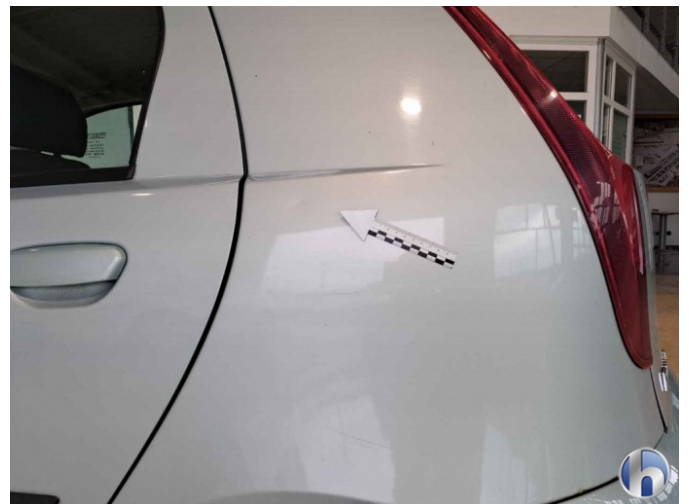
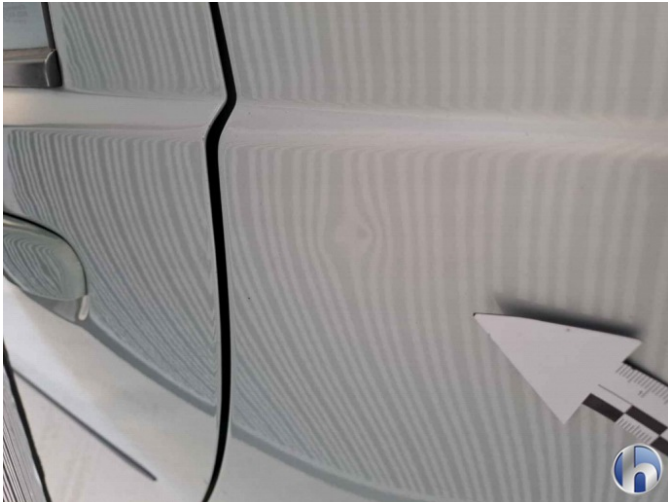
| component | Damage | Rep kind |
|---|---|---|
| 10. Sidewall - Rear - Left | Damaged | Refurbish and paint |

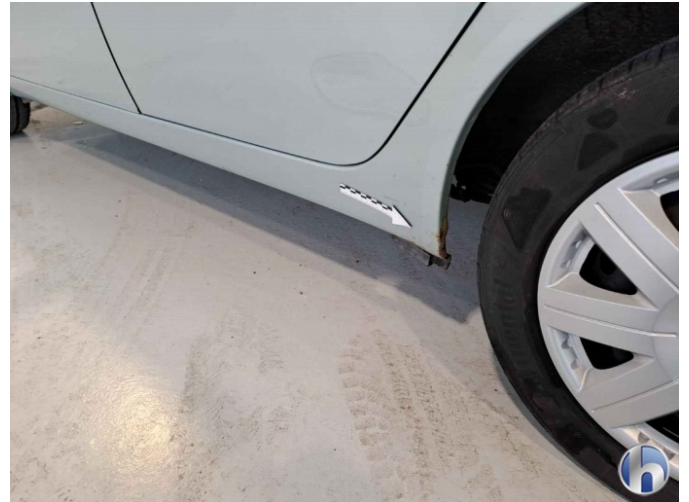
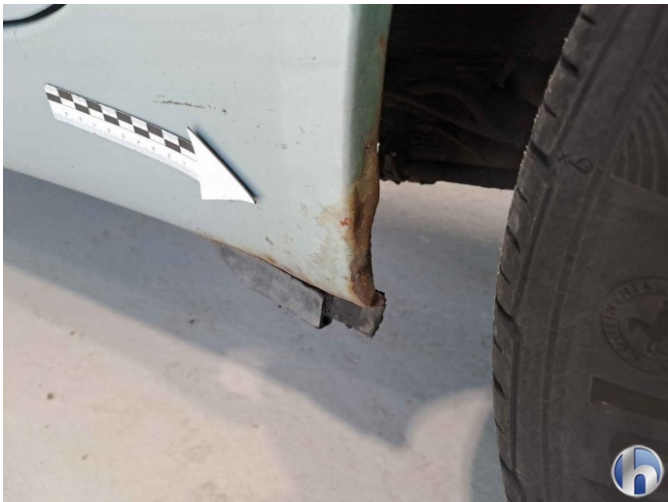
| component | Damage | Rep kind |
|---|---|---|
| 11. side skirt - left | Rust | Smart repair |

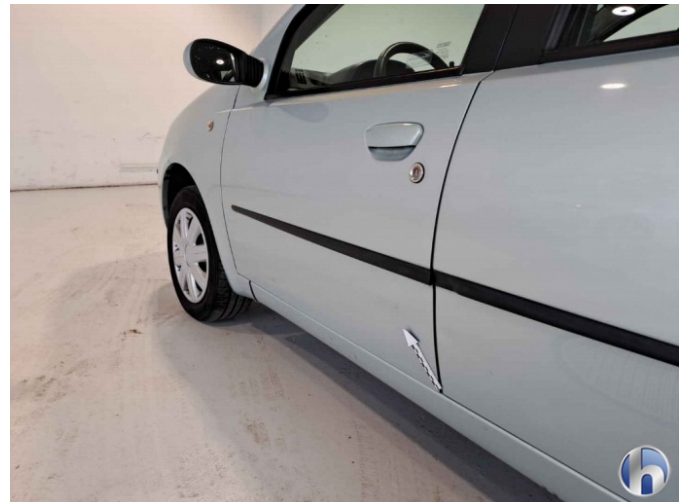
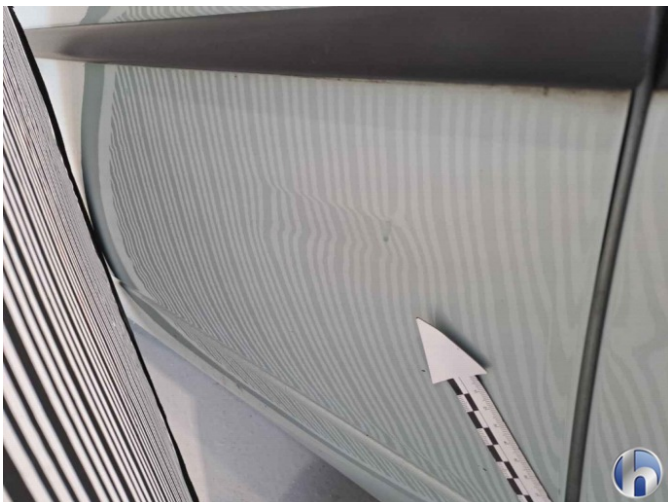
| component | Damage | Rep kind |
|---|---|---|
| 12. Front door - left | Deformed | Refurbish and paint |

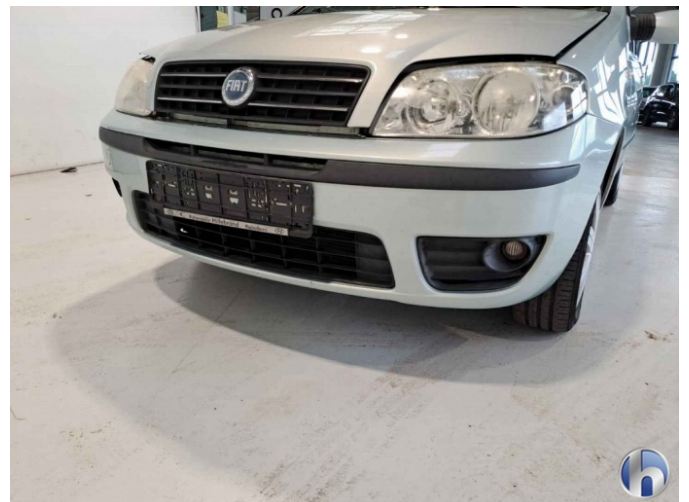
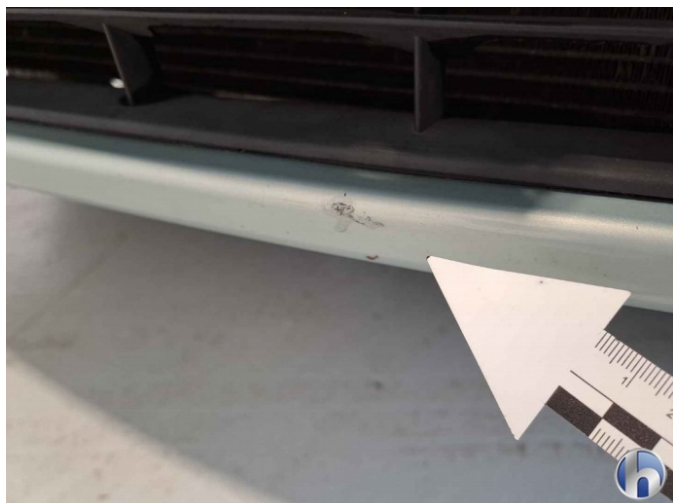
| component | Damage | Rep kind |
|---|---|---|
| 13. Front bumper | Scrape | Smart repair |

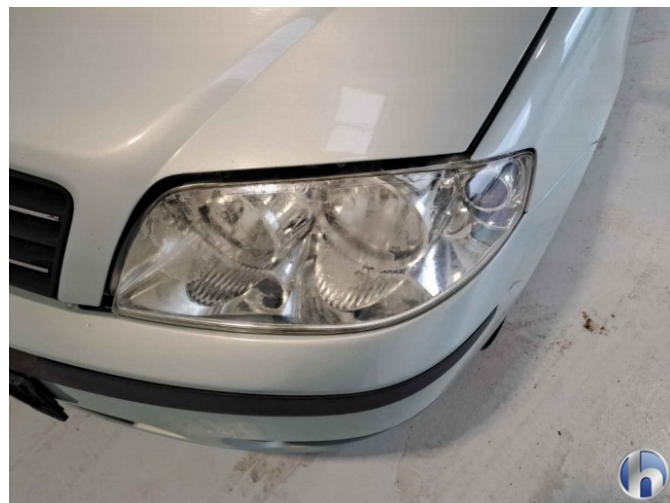
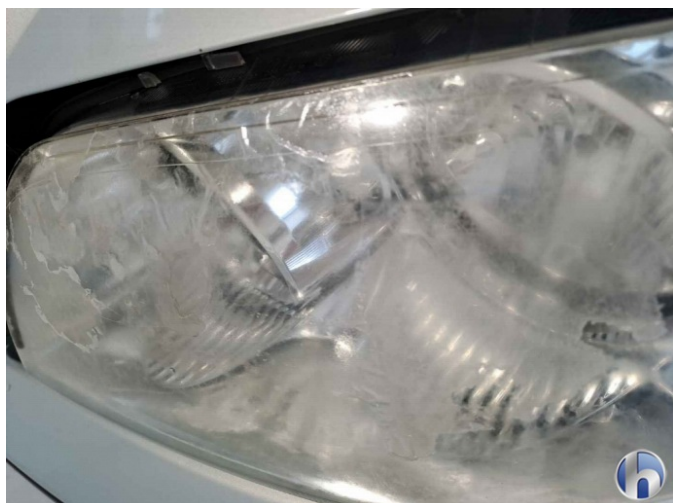
| component | Damage | Rep kind |
|---|---|---|
| 14. Halogen headlights - left | Damaged | Replace |

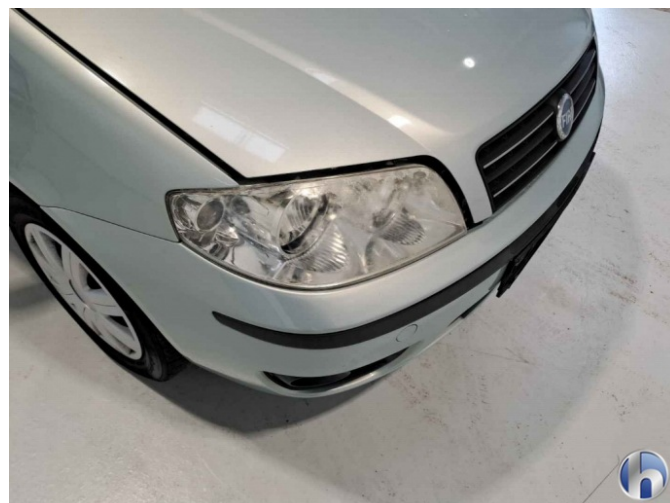
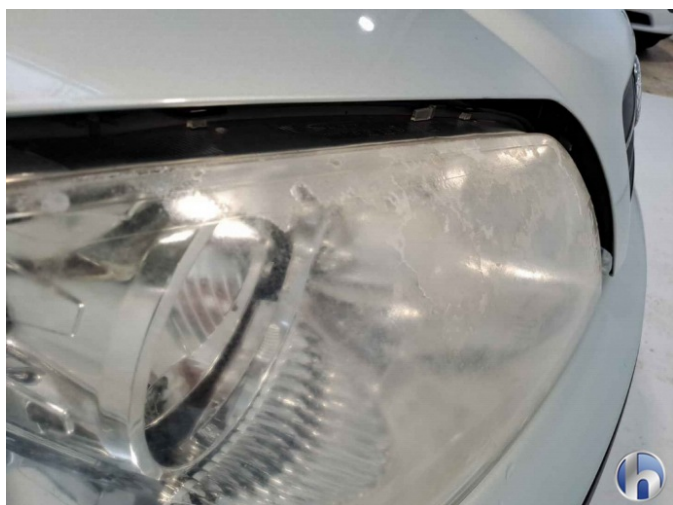
| component | Damage | Rep kind |
|---|---|---|
| 15. Halogen headlights - right | Damaged | Replace |

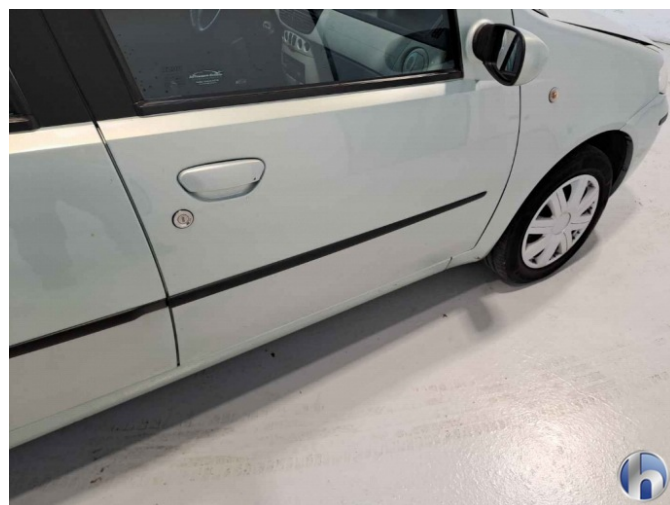
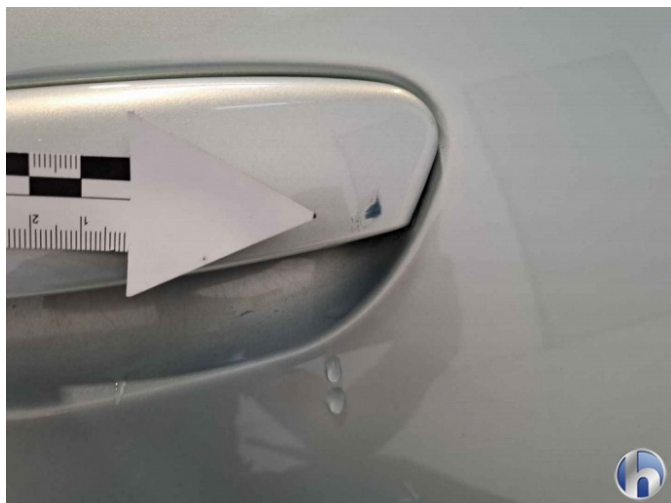
| component | Damage | Rep kind |
|---|---|---|
| 16. Türgriff VR | Scrape | Smart repair |

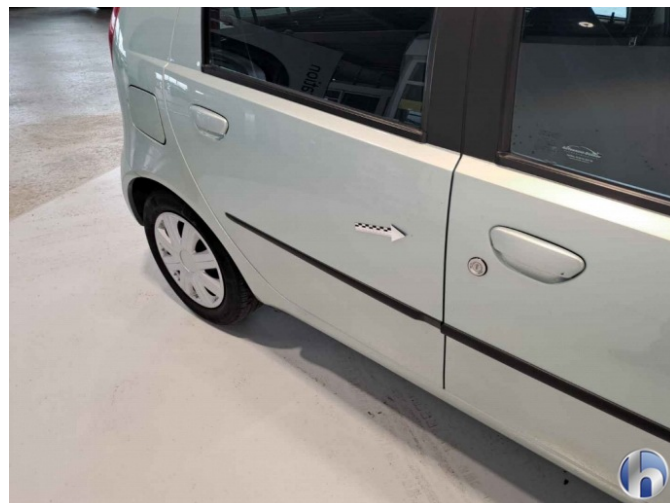
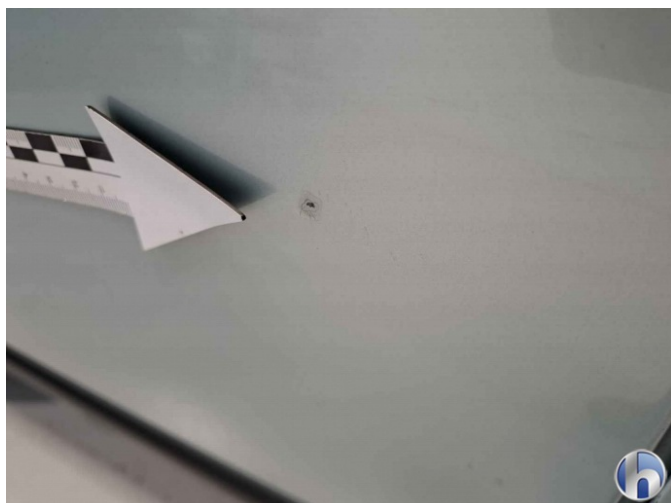
| component | Damage | Rep kind |
|---|---|---|
| 17. Door Rear - right | Damaged | Paint |

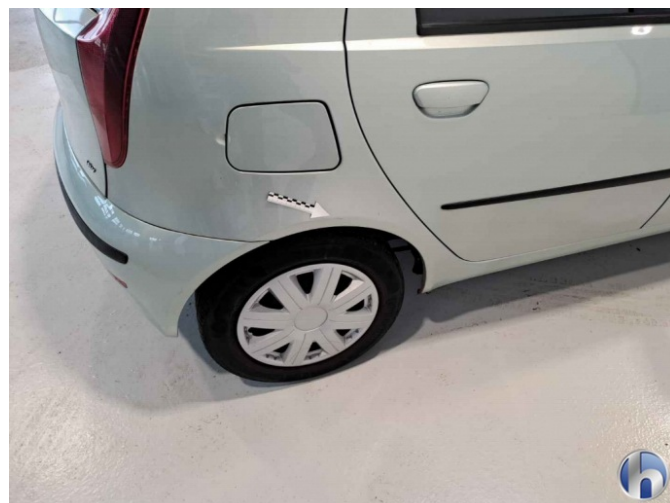
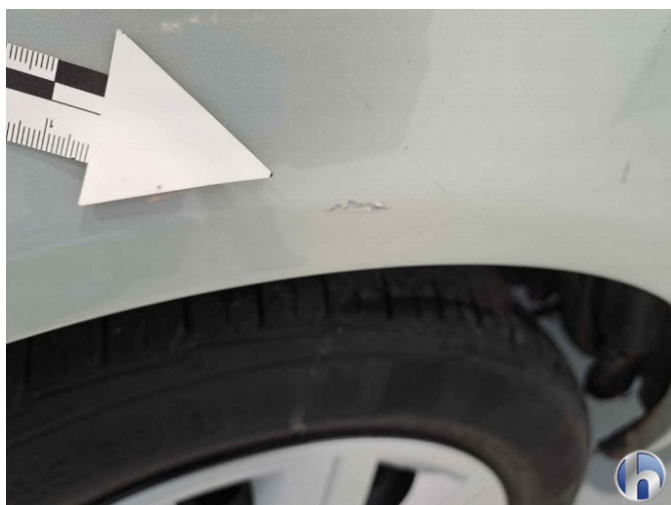
| component | Damage | Rep kind |
|---|---|---|
| 18. Sidewall - Rear - right | Scrape | Smart repair |

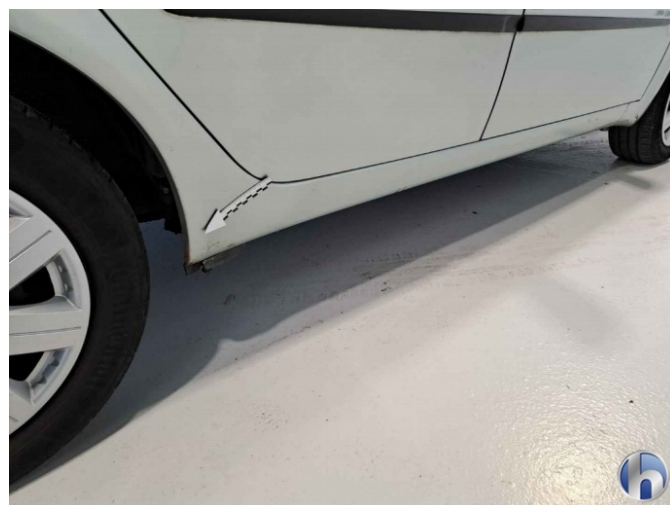
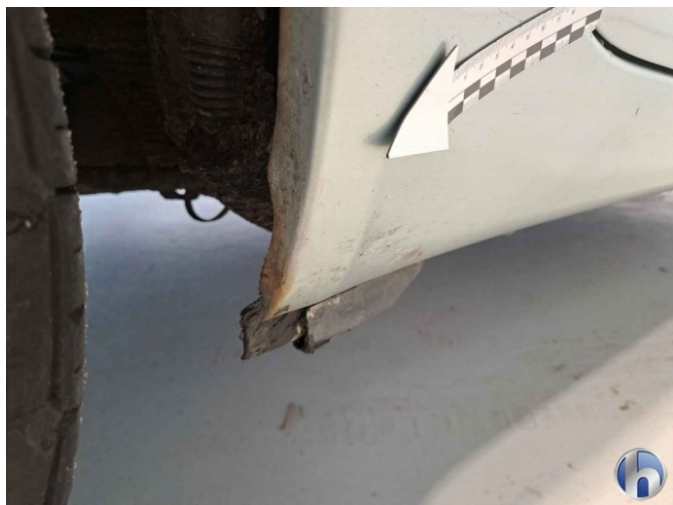
| component | Damage | Rep kind |
|---|---|---|
| 19. side skirt - right | Rust | Smart repair |

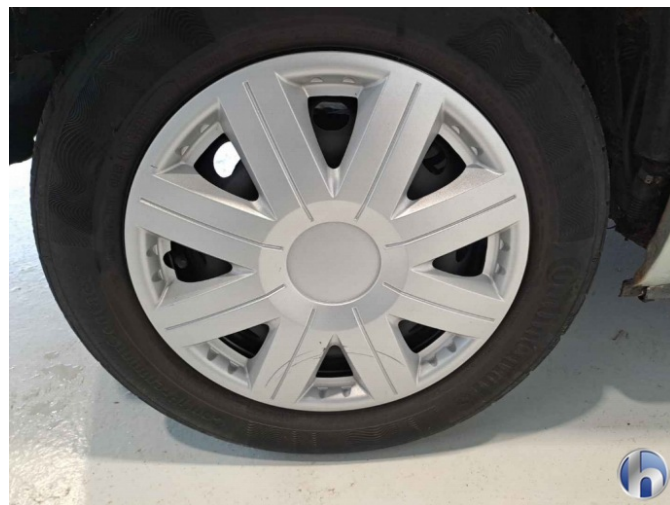
| component | Damage | Rep kind |
|---|---|---|
| 20. Hubcap - Rear - right | Scratch(es) | Replace |

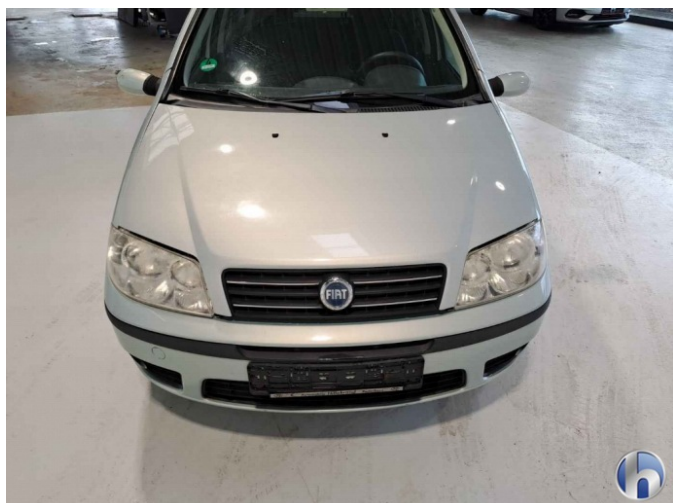
| component | Damage | Rep kind |
|---|---|---|
| 21. exterior body | Surface scratch(es) | |

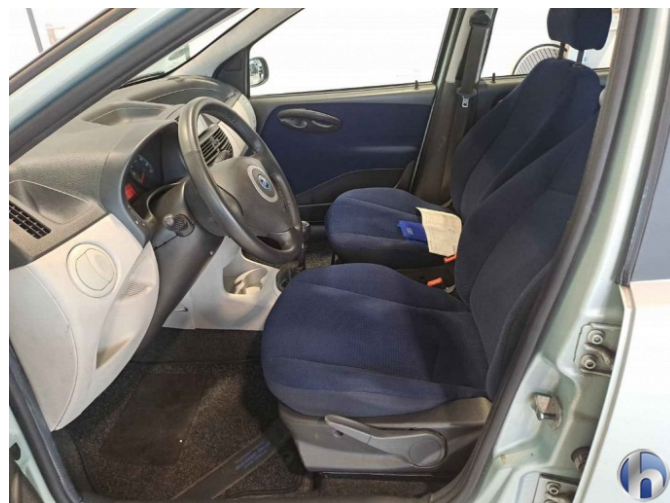
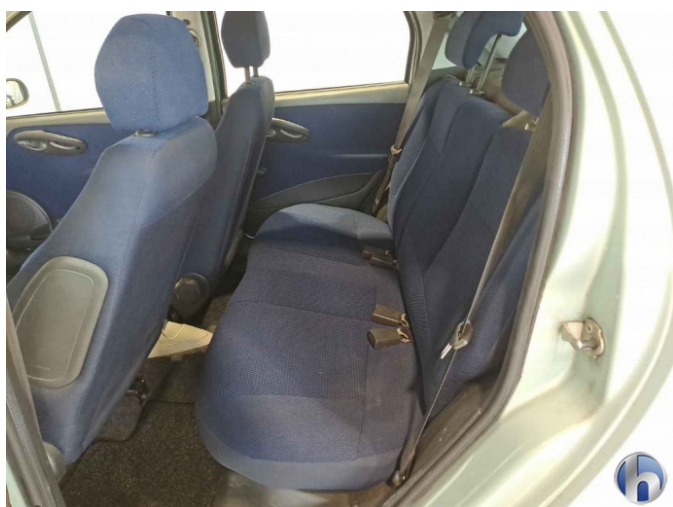
| component | Damage | Rep kind |
|---|---|---|
| 22. | Wear and tear | acceptable |

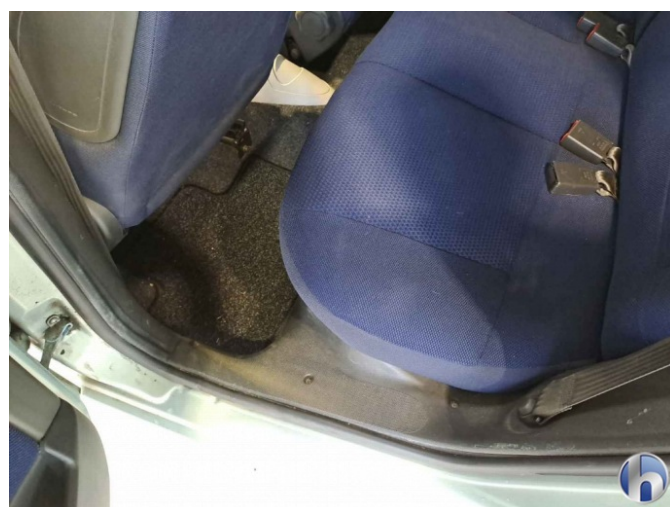
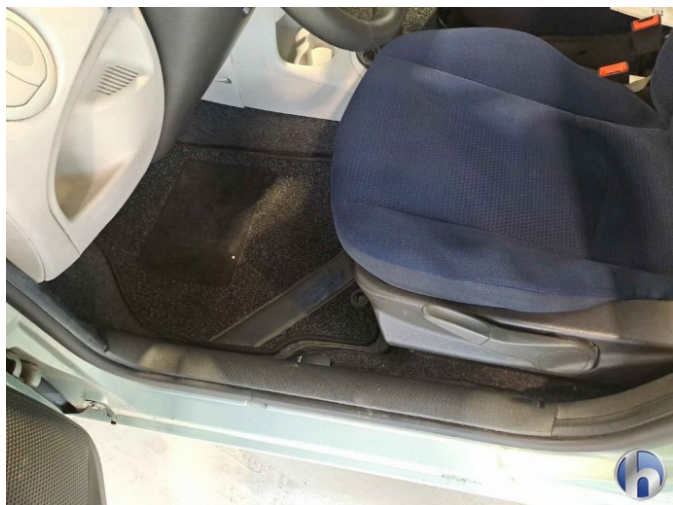
| component | Damage | Rep kind |
|---|---|---|
| 23. | Dirty | |

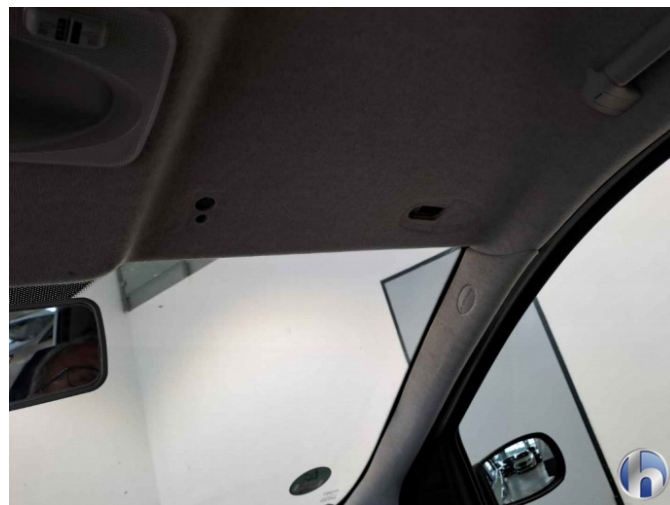
| component | Damage | Rep kind |
|---|---|---|
| 25. Sun visor with mirror | Missing | Replace |

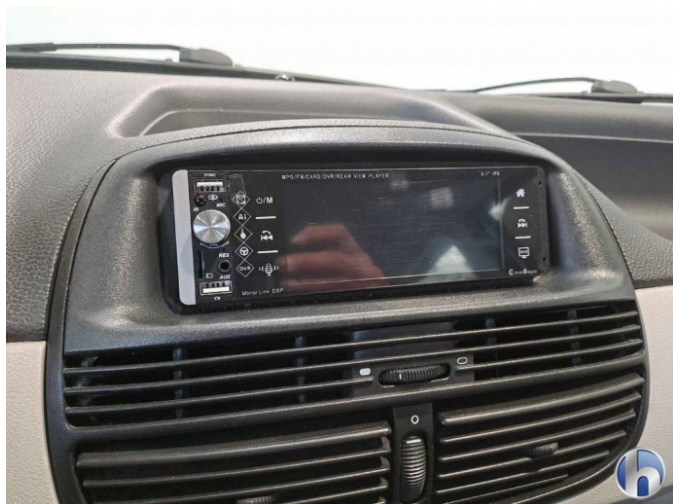
| component | Damage | Rep kind |
|---|---|---|
| 26. Radio | No functionality | Carry out a fault diagnosis |

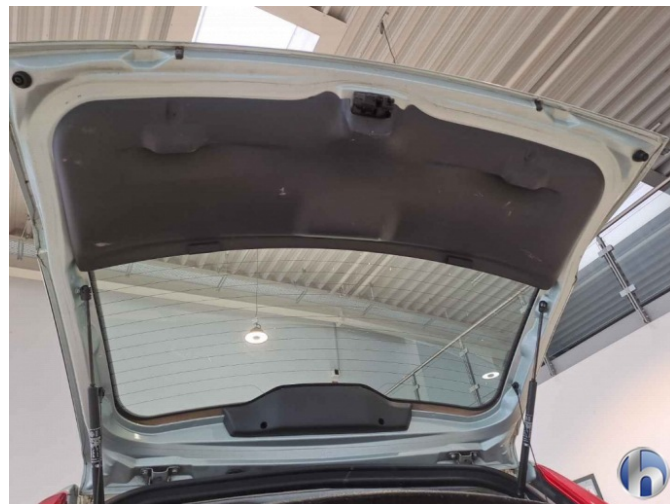
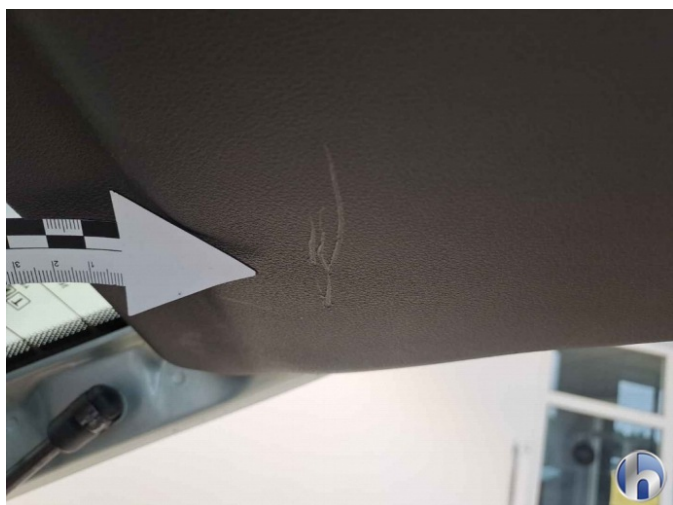
| component | Damage | Rep kind |
|---|---|---|
| 27. tailgate trim | Scrape | Replace |

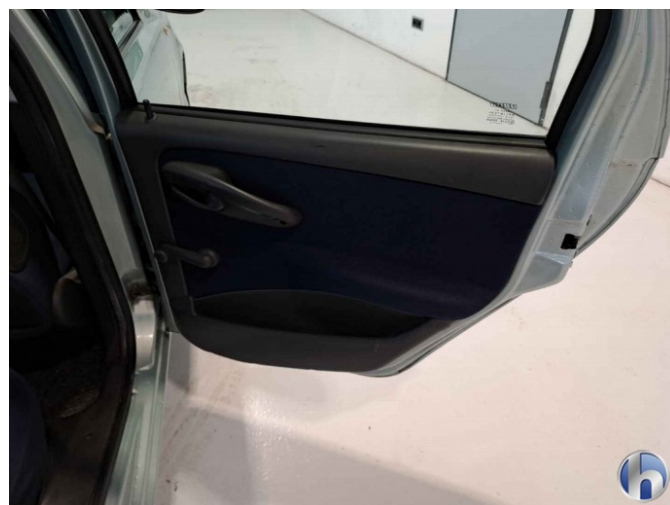
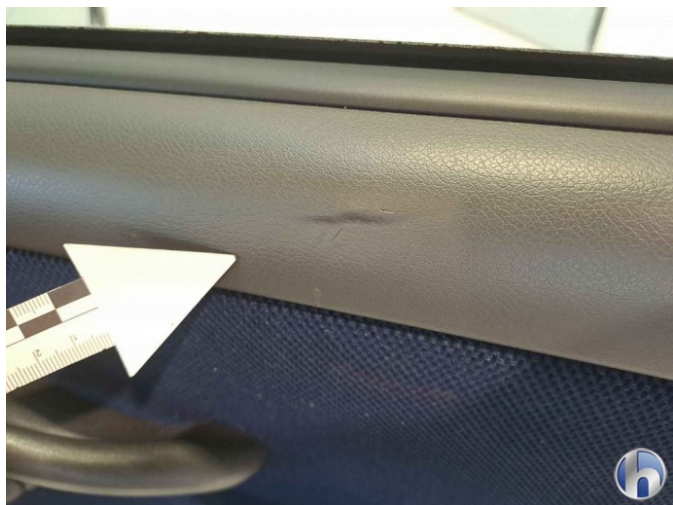
| component | Damage | Rep kind |
|---|---|---|
| 28. Door trim Rear - right | Damaged | Replace |

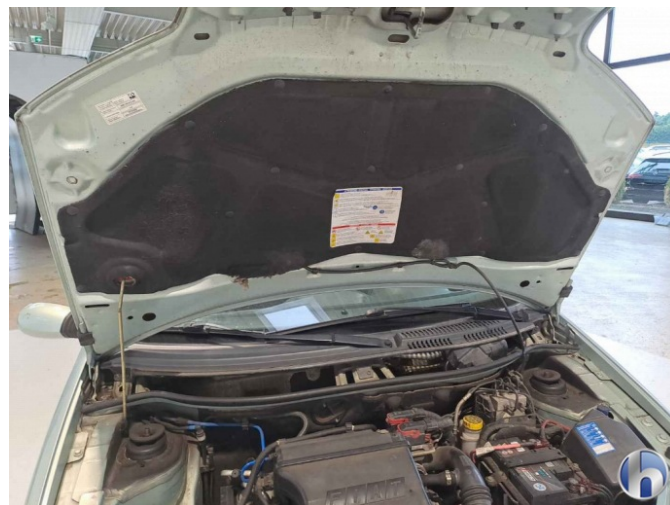
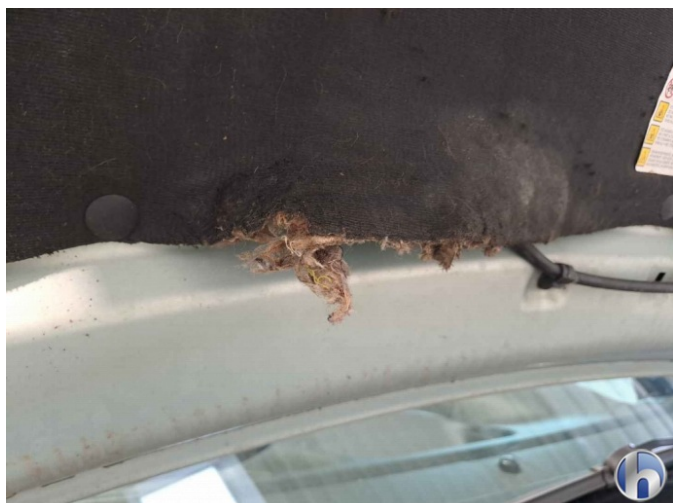
| component | Damage | Rep kind |
|---|---|---|
| 29. motor insulation | | Replace |
