Expertise

Protocol number: 41596295  
Order No. / Reference: 25198329  
Inspection date: 18 Sept 2025

Manufacturer: Fiat

Model: Doblo Cargo Natural Power SX

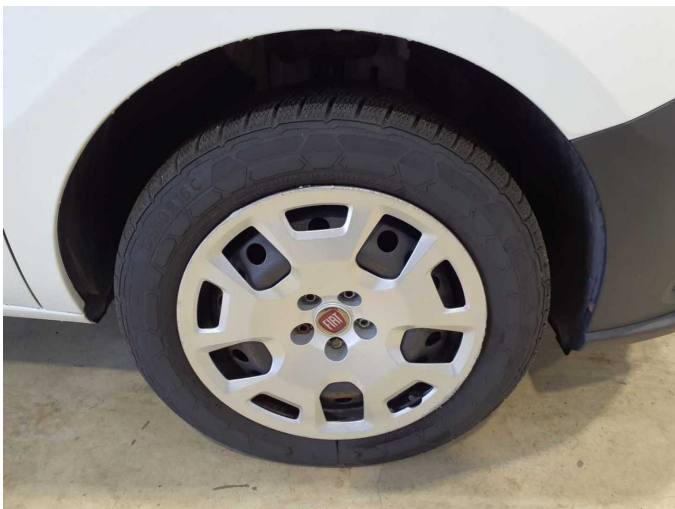
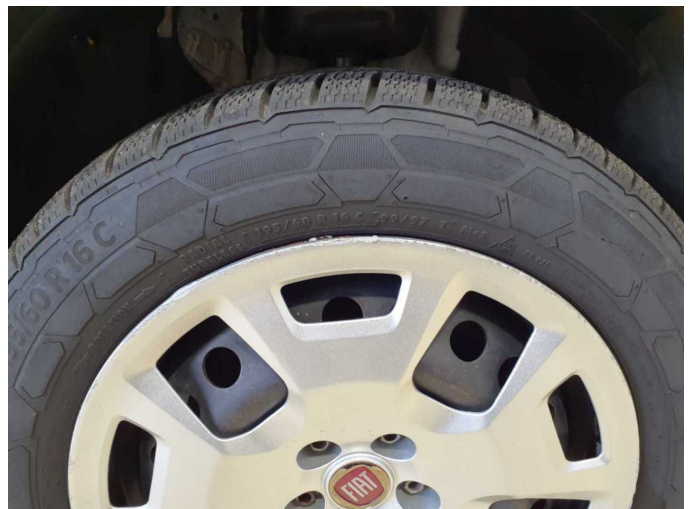
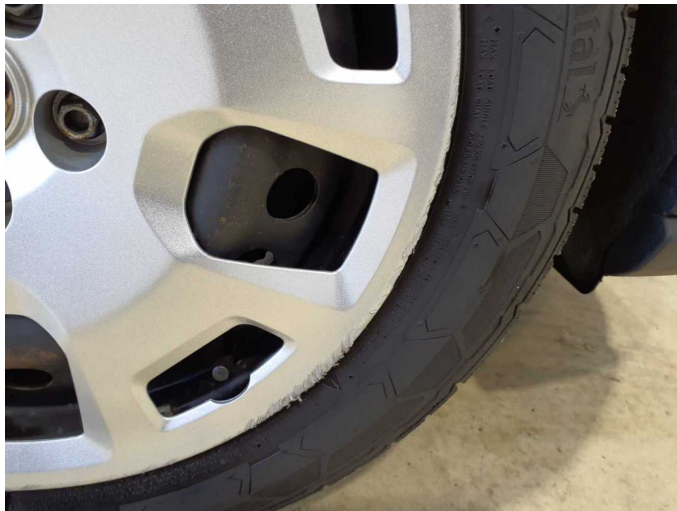
**Damage 1:** Wheel / tyres: Wheel cover - front right side - Scratch(es) - Replace

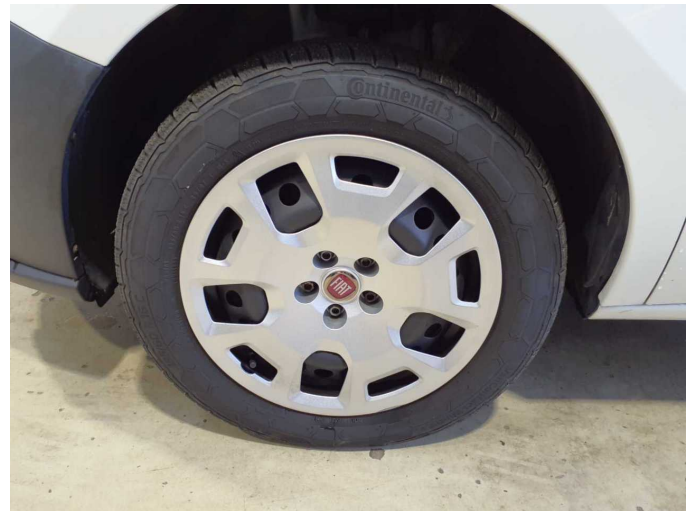
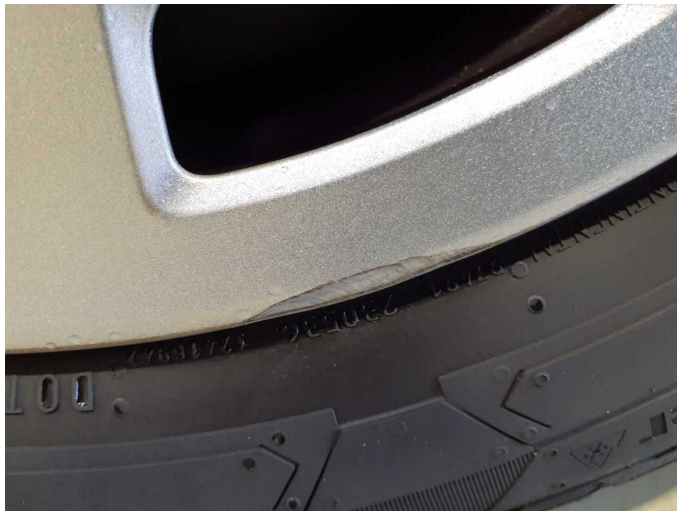
**Damage 2:** Wheel / tyres: Wheel cover - front left side - Scratch(es) - Replace

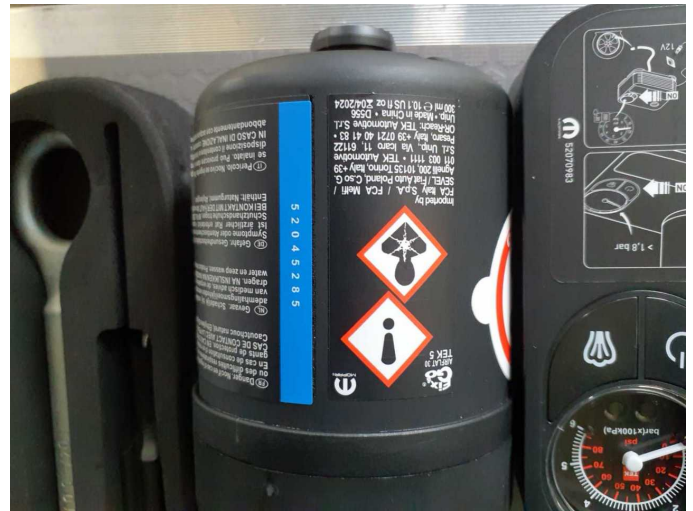
**Damage 3:** Equipment: Tirefiller - Expired - Replace

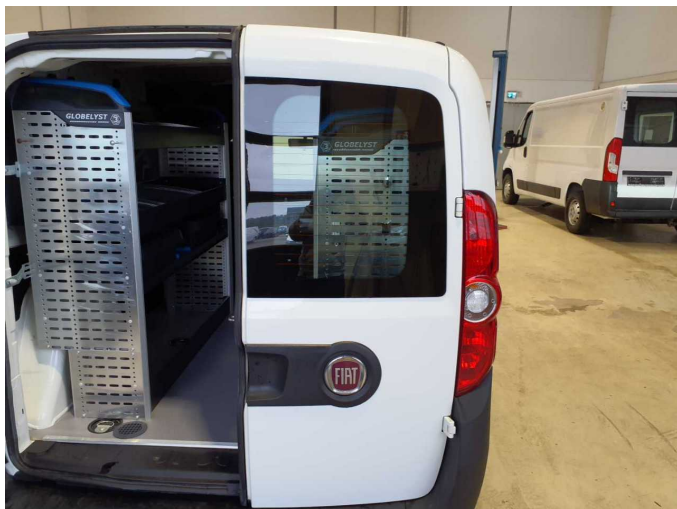
**Damage 4:** Boot lid / rear door: Rear door - right side (Schwergängig) - Functional / admissibility - Perform diagnosis

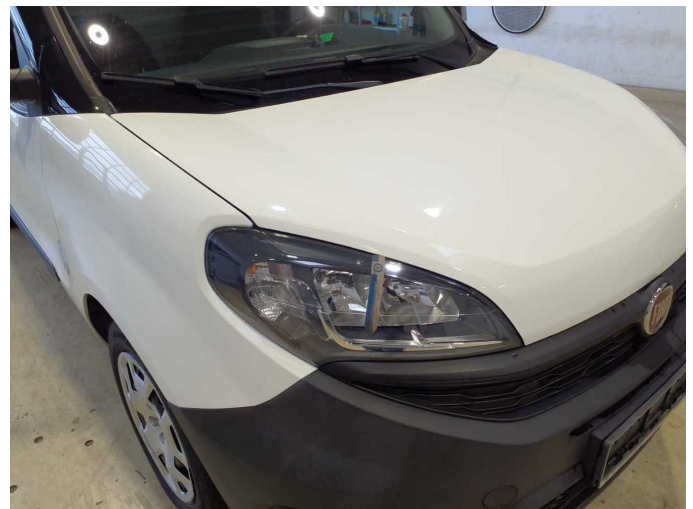
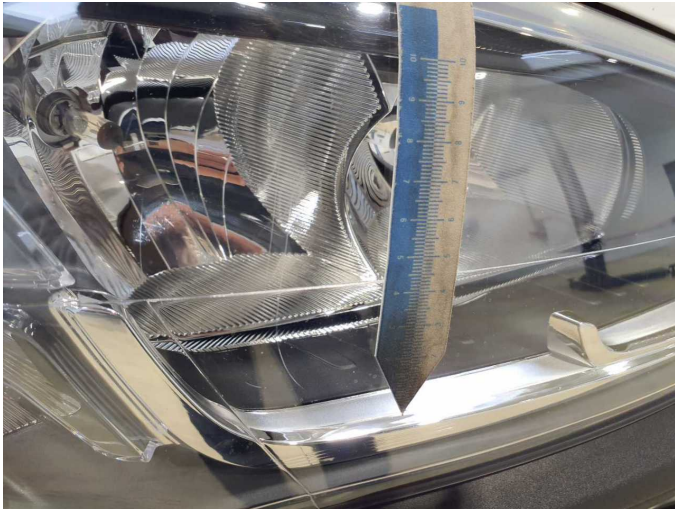
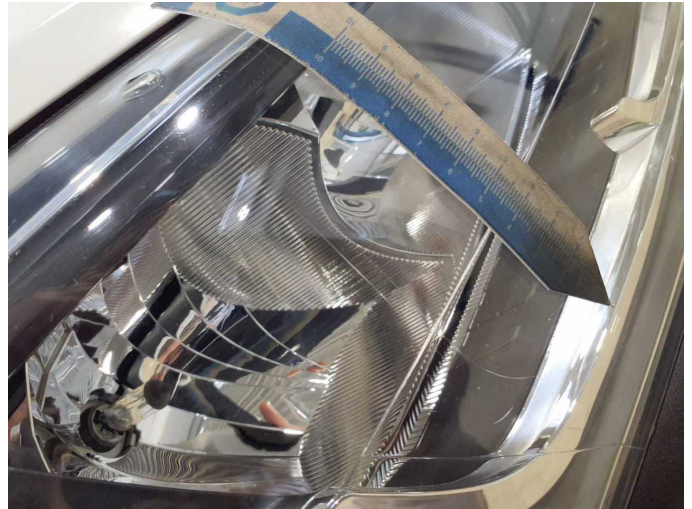
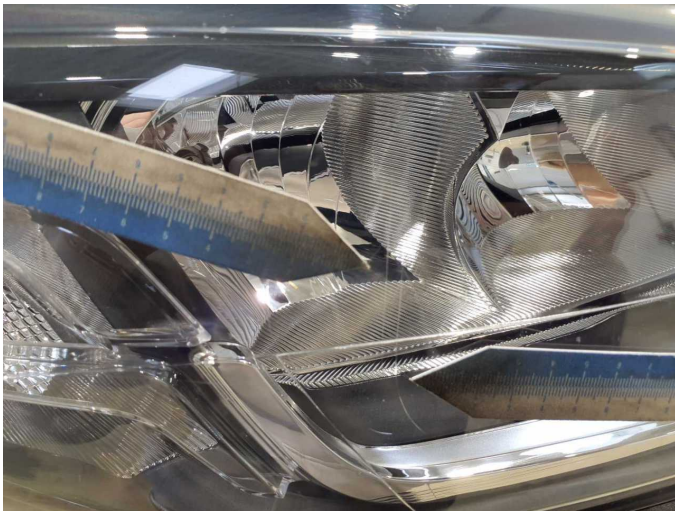
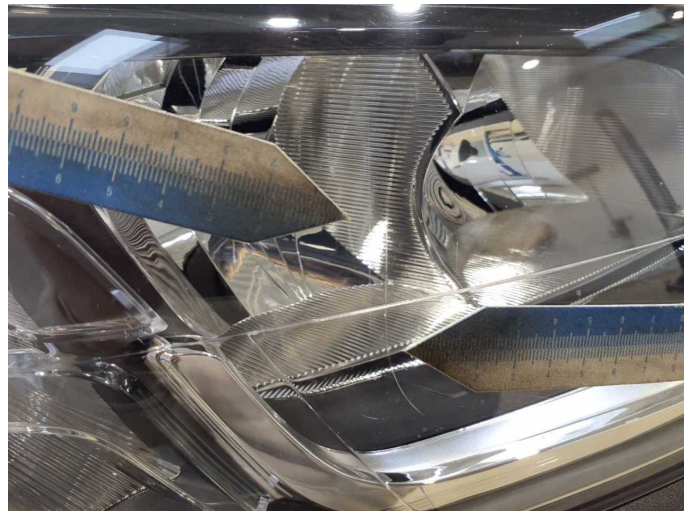
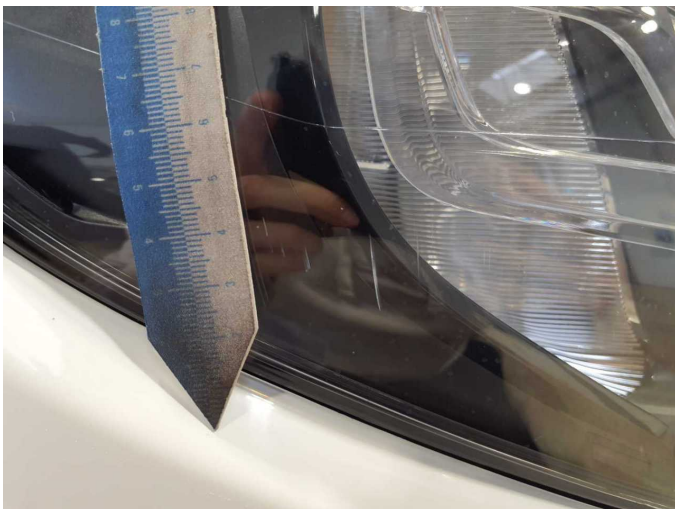
**Damage 5:** Headlight: Headlight - right side (im Streubereich) - Scratch(es) - Replace

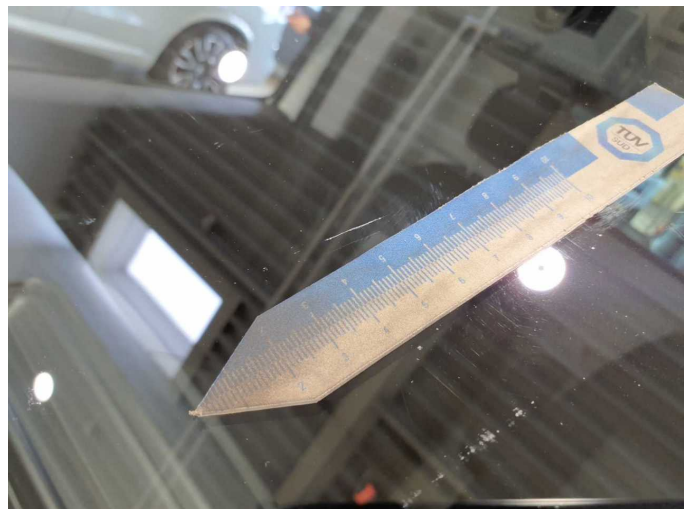
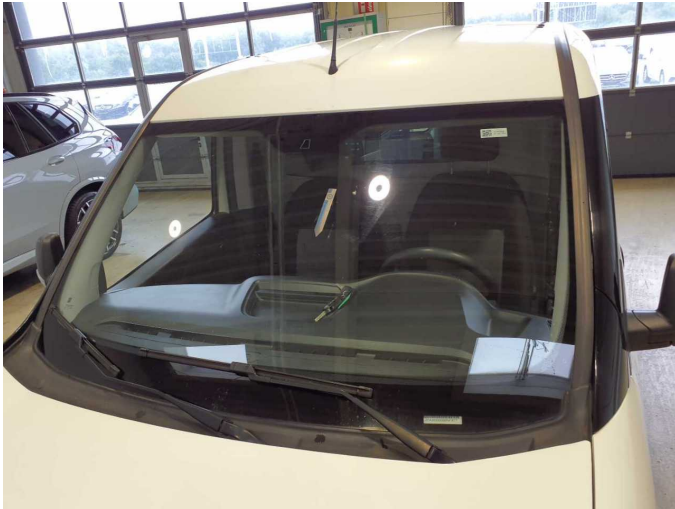
**Damage 6:** Vehicle glazing: Windscreen - Scratch(es) - Replace

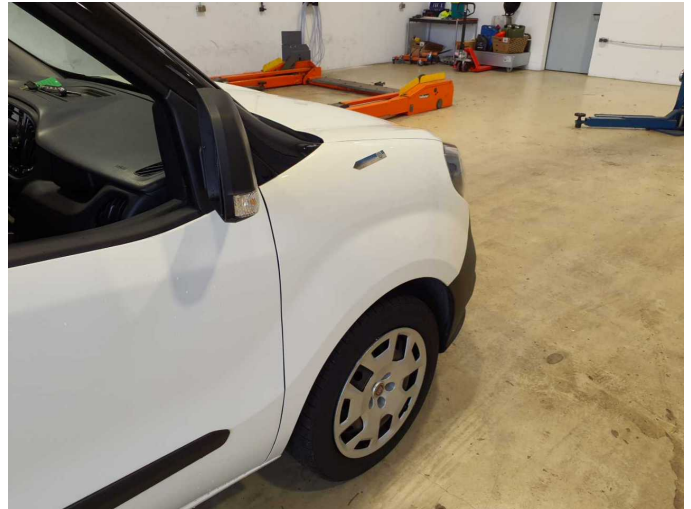
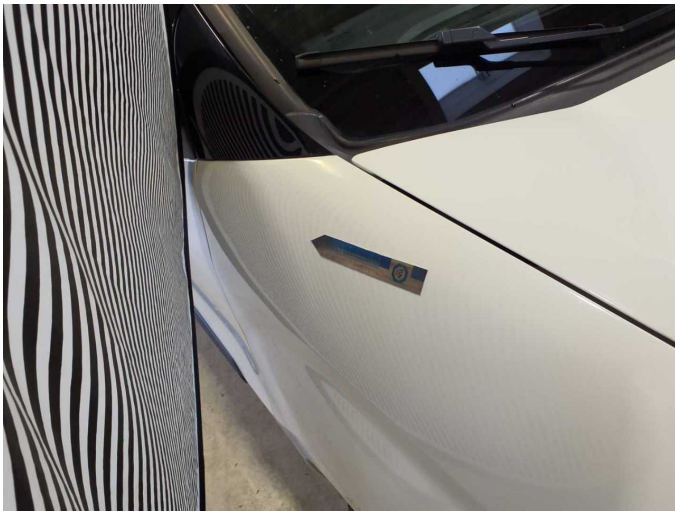
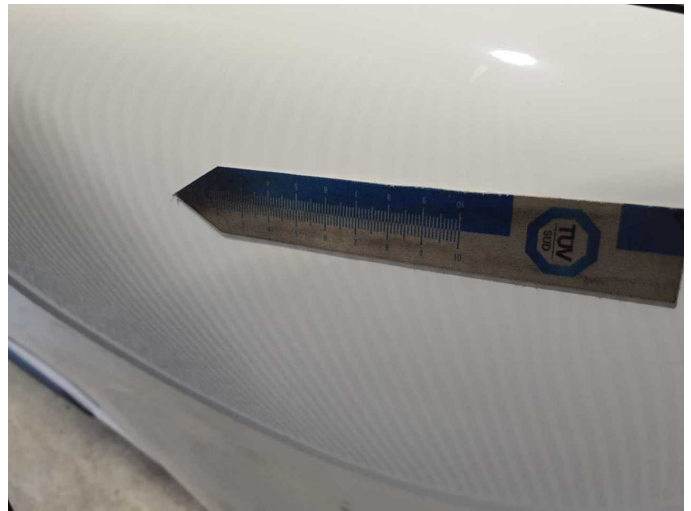
**Wear and tear 4:** Mudguard - right side: Mudguard - right side - dent(s) - No deduction
