Expertise

Protocol number: 41763188
Order number / reference: 25240777
Inspection date: 30 Sept 2025

Manufacturer: Fiat

Model: Doblo Cargo Natural Power SX

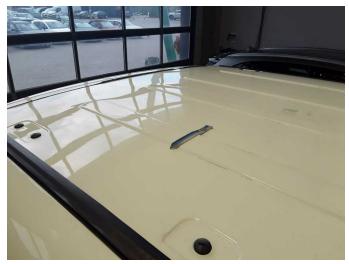
1 Roof Roof - dent(s) - Smart repair

Damage 1: Roof: Roof - dent(s) - Smart repair

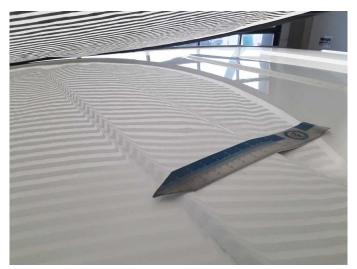
Damage 1: Roof: Roof - dent(s) - Smart repair
