FIAT 500 500 0.9 TwinAir Start&Stopp

VIN NO ZFA31200000877920 Registration Number 0000877920

Inspection Report Summary

| Customer | BCA Online | Report Number | P20251001132930 |

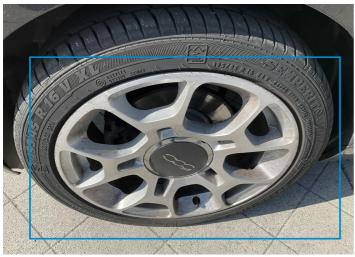
1. Rim / Front Left
Out of Bodywork / Scratch -

2. Fender / Back Left Paint / Scratch / Scuff -

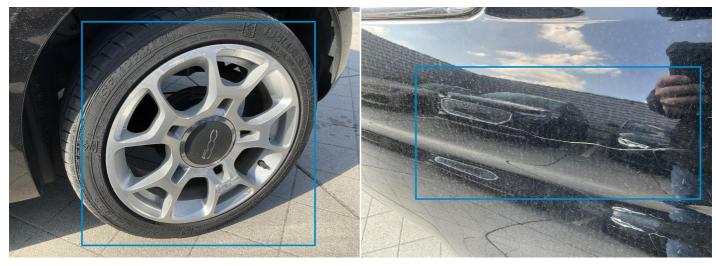
3. Rim / Back Left Out of Bodywork / Scratch -

4. Side Panel / Back Left Paint / Scratch / Scuff -

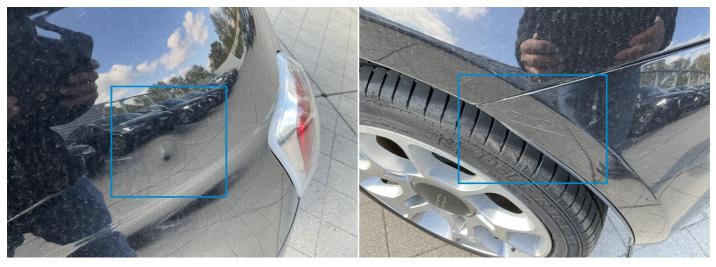
5. Side Panel / Back Left Bodywork / Dent / Deformation -

6. Bumper / Back Paint / Scratch / Scuff -

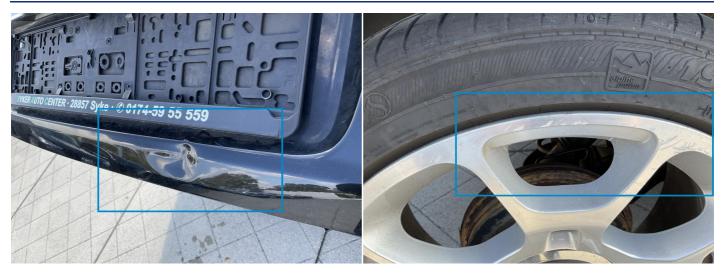
7. Tailgate Bodywork / Dent / Deformation -

8. Rim / Back Right
Out of Bodywork / Scratch -

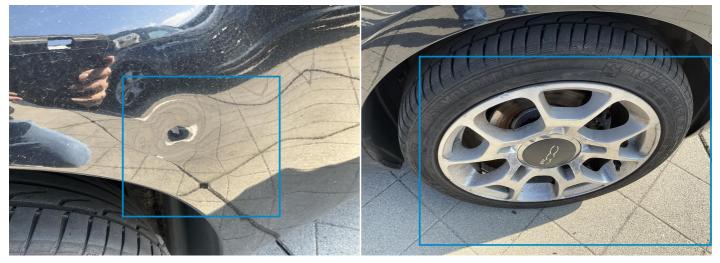
9. Fender / Back Right Bodywork / Dent / Deformation -

10. Rim / Front Right
Out of Bodywork / Scratch -

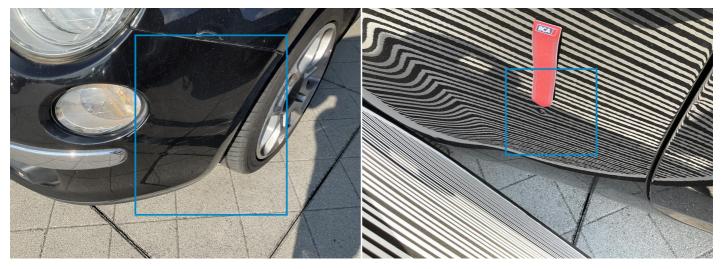
11. Bumper / Front Paint / Scratch / Scuff -

12. Side Panel / Back Right Bodywork / Dent / Deformation -

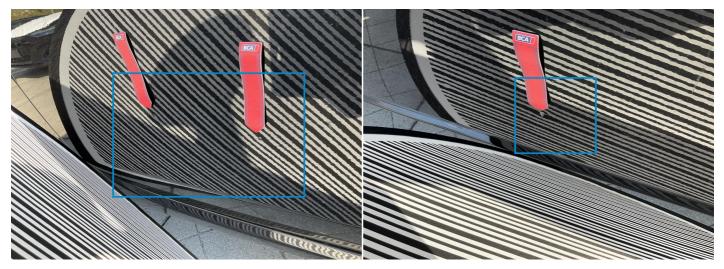
13. Door / Front Right Bodywork / Dent / Deformation -

14. Door / Front Right Bodywork / Dent / Deformation -

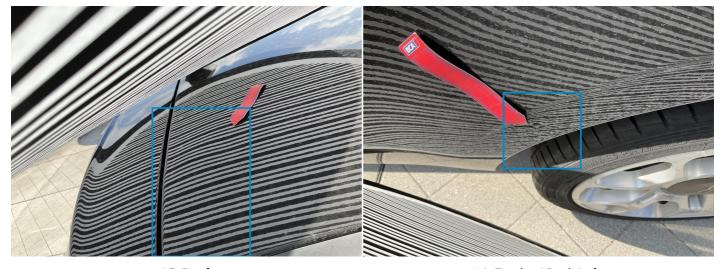
15. Roof Bodywork / Dent / Deformation -

16. Fender / Back Left Bodywork / Dent / Deformation -

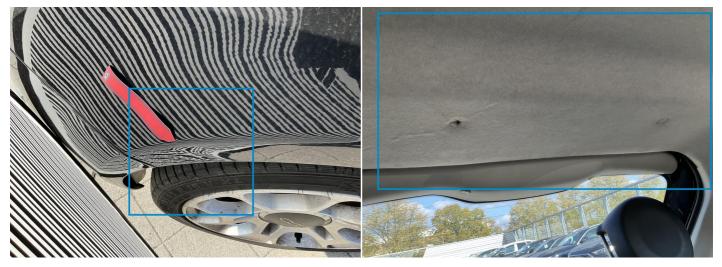
17. Fender / Front Left Bodywork / Dent / Deformation -

18. Roof Upholstery Interior / Non - compliant -
