FIAT 500 Benzina 500 1.2 S 69cv E6

VIN NO ZFA3120000J111656 Registration Number ET212HL

Inspection Report Summary

Customer	BCA Lodi	Report Number	P20250925171018
Inspection Date / Place	2025-09-25 / BCA Lodi	Cosmetic Grade	4

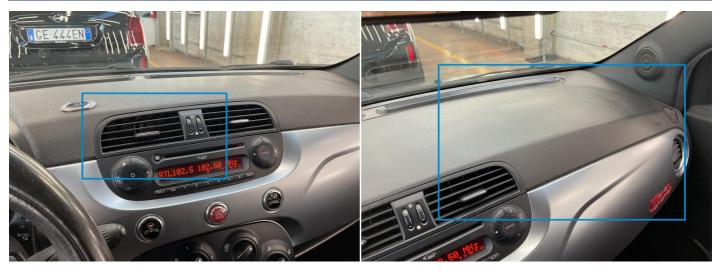
1. Aeration Grid / Front Center Interior / Broken -

2. Dashboard / Front Interior / Scratched -

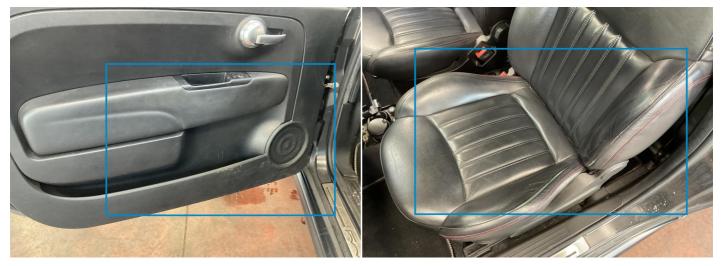
3. Panel Filling / Front Left Interior / Scratched -

4. Seat / Front Left Interior / Worn - out -

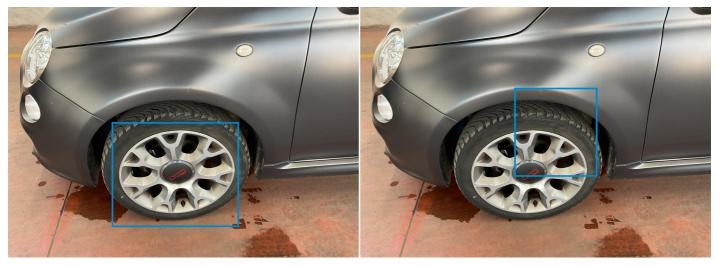
5. Rim / Front Left Out of Bodywork / Scratch -

6. Tire / Front Left Tire - Replace

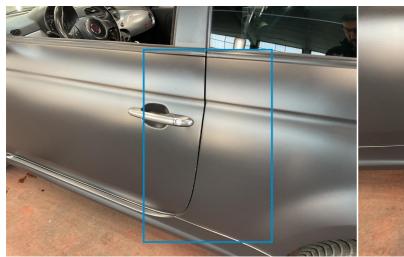
7. Door / Front Left Bodywork / Dent -

8. Rim / Back Left Out of Bodywork / Scratch -

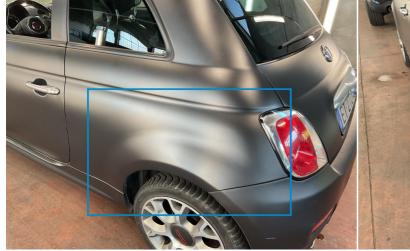
9. Fender / Back Left Paint / Scratch / Line -

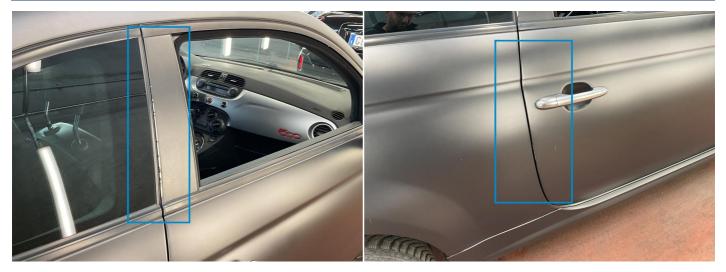
13. Door / Front Right Paint / Scratch / Line -

14. Door / Front Right Bodywork / Dent -

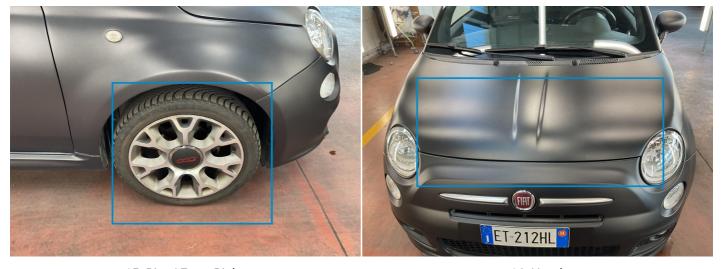
15. Rim / Front Right Out of Bodywork / Scratch -

16. Hood Paint / Chipping -

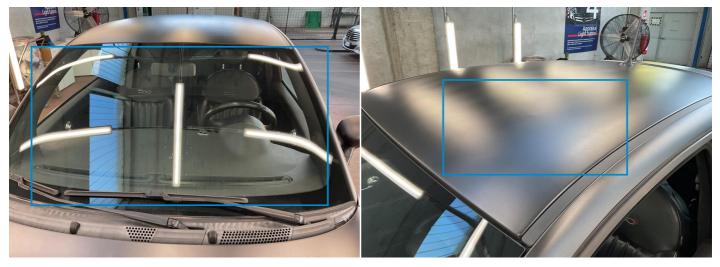
17. Windshield / Front Glass Break / Impact -

18. Roof Bodywork / Dent -
