FIAT 500

500 0.9 TwinAir Turbo Start&Stopp

VIN NO ZFA3120000J181304
Registration Number 000J181304

Inspection Report Summary

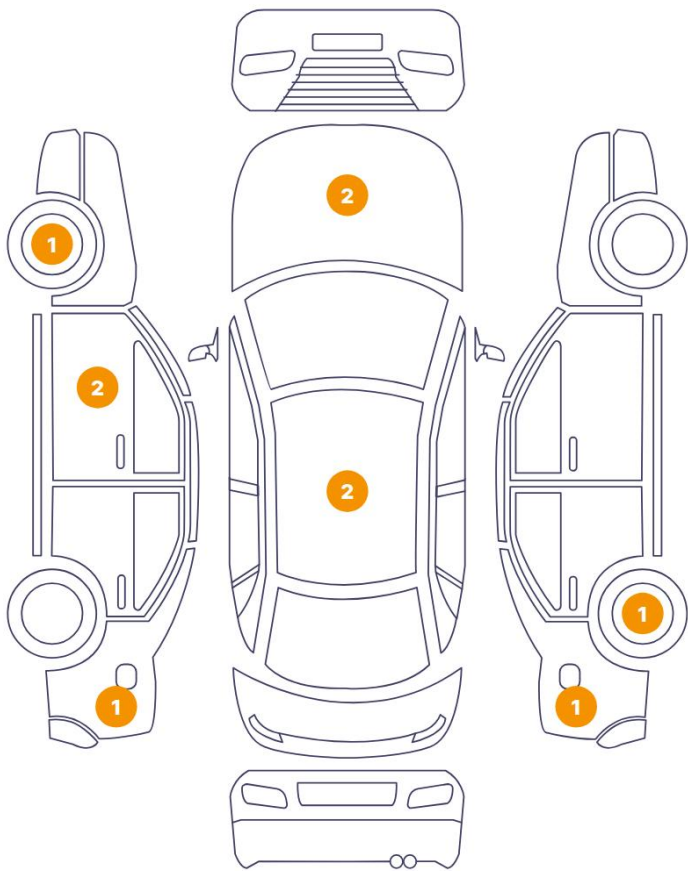
10 Schäden

Component		Damage	Comments
1	Gear Knob	Interior / Dented	
2	Dashboard / Front	Interior / Dented	
3	Roof	Paint / Poor Previous Repair	
4	Rim / Front Left	Out of Bodywork / Scratch	
5	Pillar / Front Left	Paint / Poor Previous Repair	
6	Roof	Bodywork / Dent / Dent	
7	Side Panel / Back Left	Bodywork / Dent / Dent	
8	Door / Front Left	Bodywork / Dent / Dent	
9	Hood	Paint / Poor Previous Repair	
10	Hood	Paint / Stone Chip	
11	Rim / Back Right	Out of Bodywork / Scratch	
12	Side Panel / Back Right	Bodywork / Dent / Dent

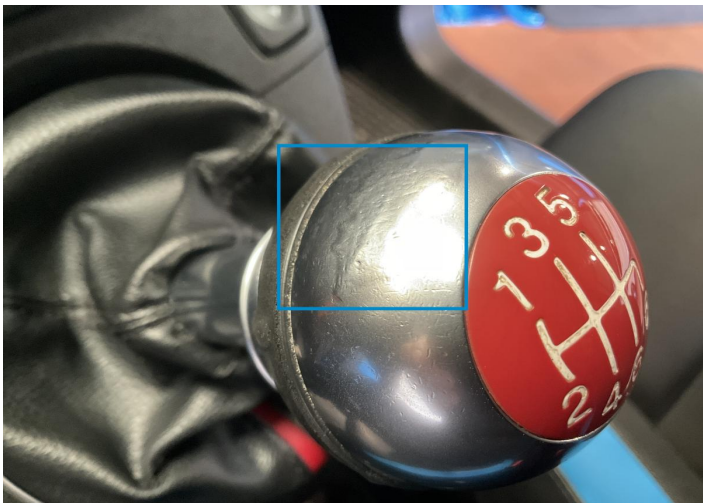
1. Gear Knob
Interior / Dented -

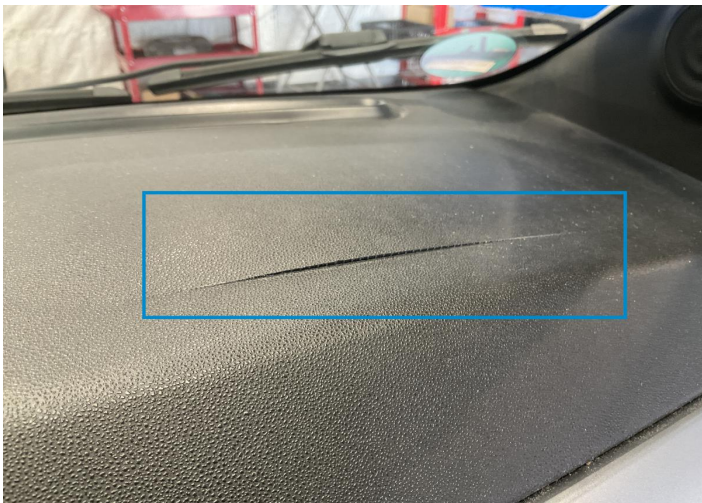
2. Dashboard / Front
Interior / Dented -

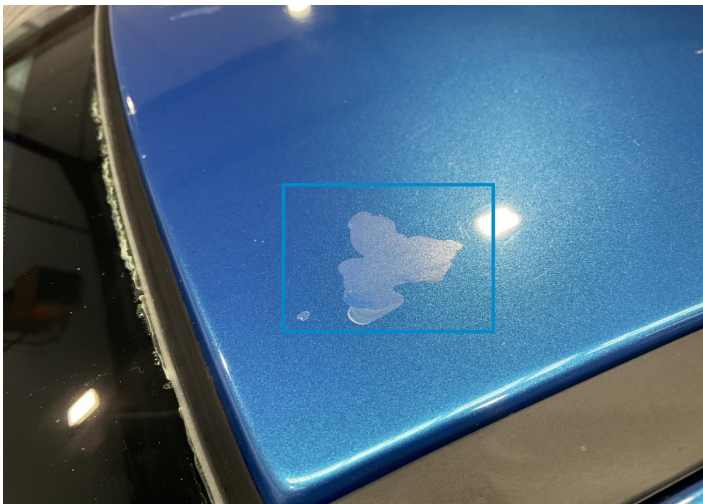
3. Roof
Paint / Poor Previous Repair -

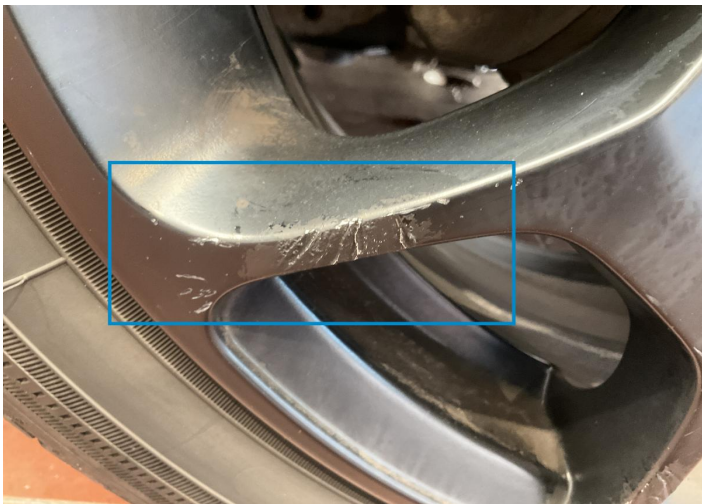
4. Rim / Front Left
Out of Bodywork / Scratch -

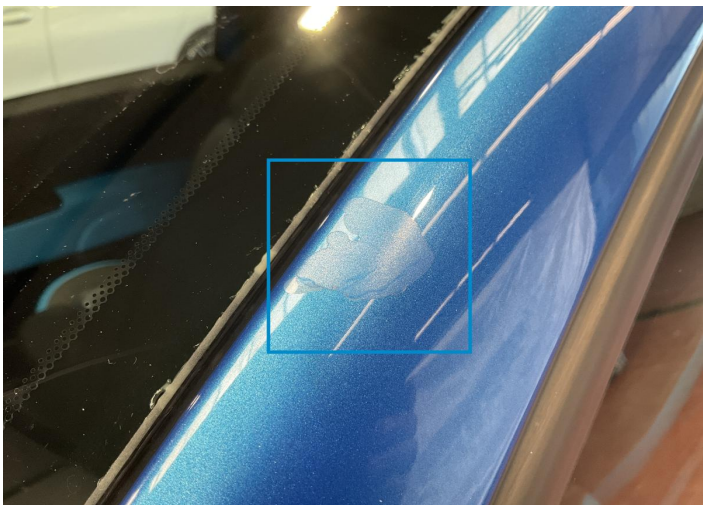
5. Pillar / Front Left
Paint / Poor Previous Repair -

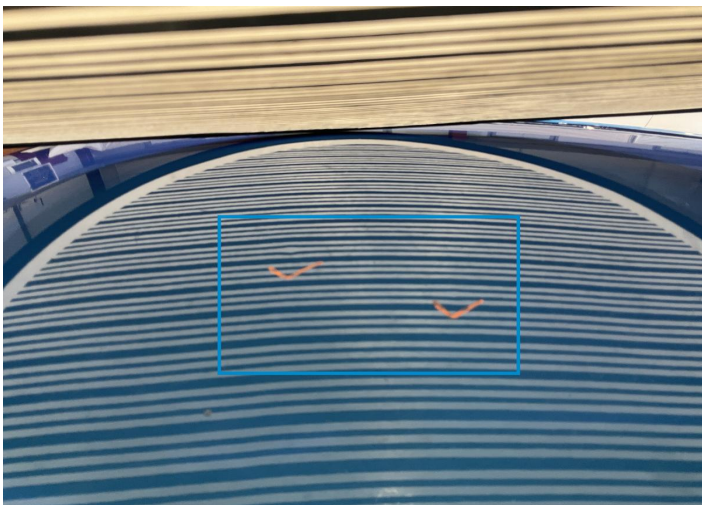
6. Roof
Bodywork / Dent / Dent -

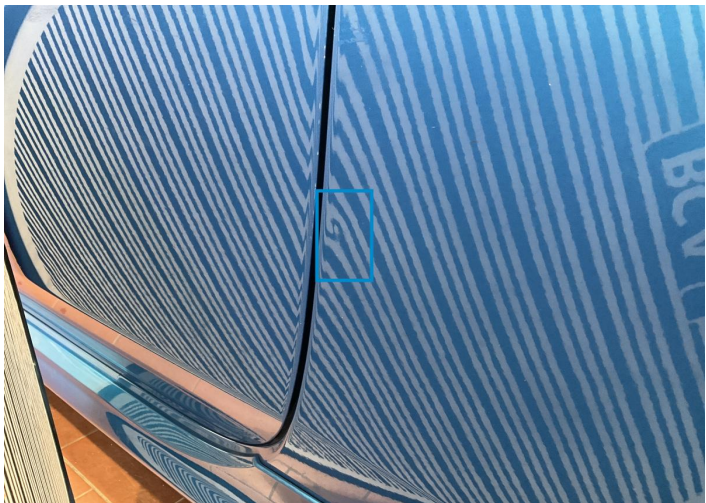
7. Side Panel / Back Left
Bodywork / Dent / Dent -

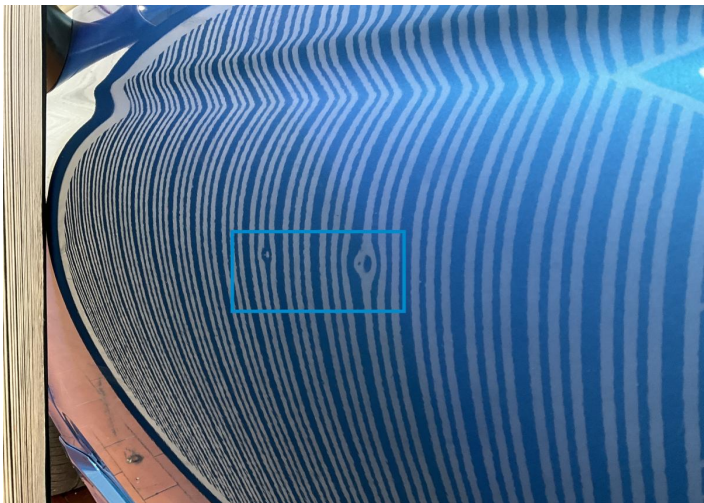
8. Door / Front Left
Bodywork / Dent / Dent -

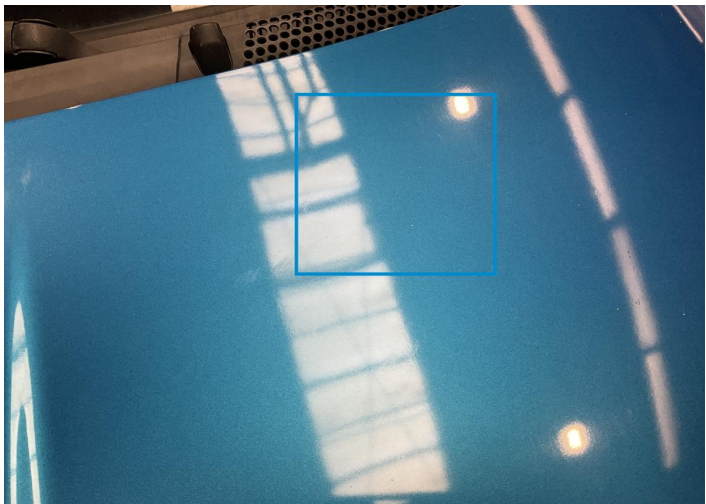
9. Hood
Paint / Poor Previous Repair -

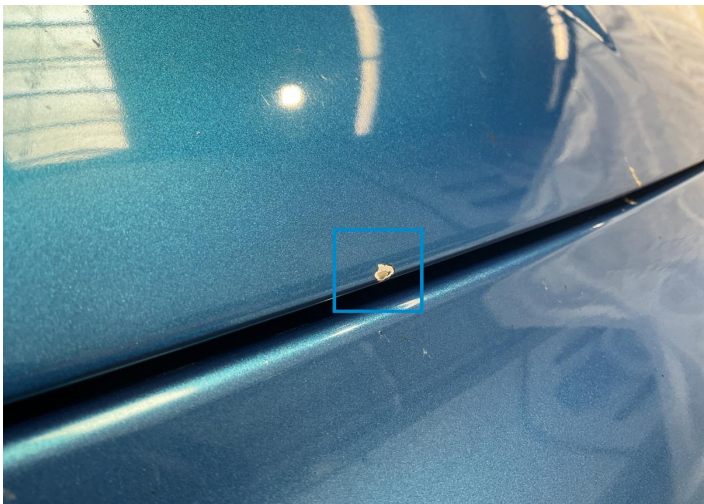
10. Hood
Paint / Stone Chip -

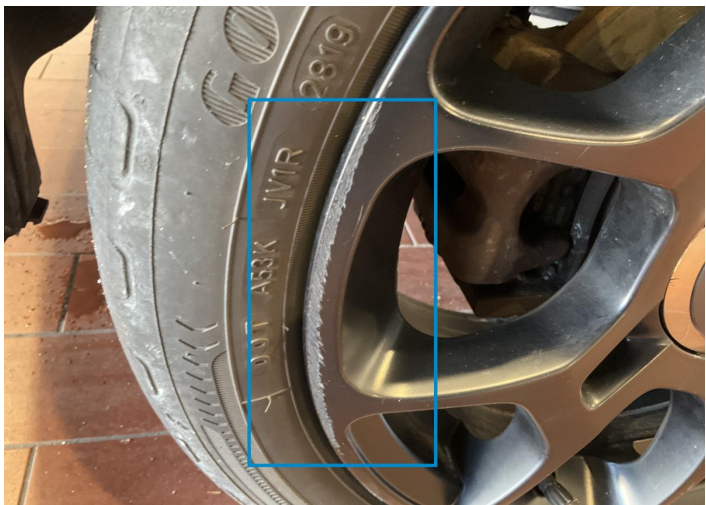
11. Rim / Back Right
Out of Bodywork / Scratch -

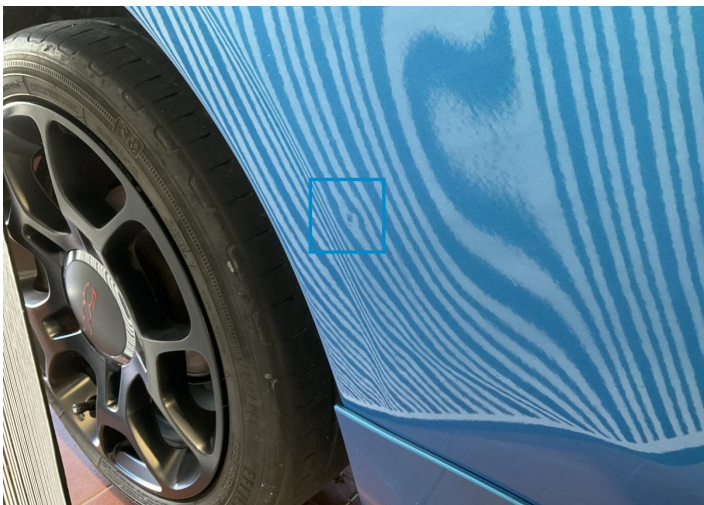
12. Side Panel / Back Right
Bodywork / Dent / Dent -
