FIAT Panda III 2021

Panda 1.0 firefly hybrid City Life s&s 70cv

Inspection Report Summary

Customer	BCA Lodi	Report Number	P20250926123505
Inspection Date / Place	2025-09-26 / BCA Lodi	Cosmetic Grade	5

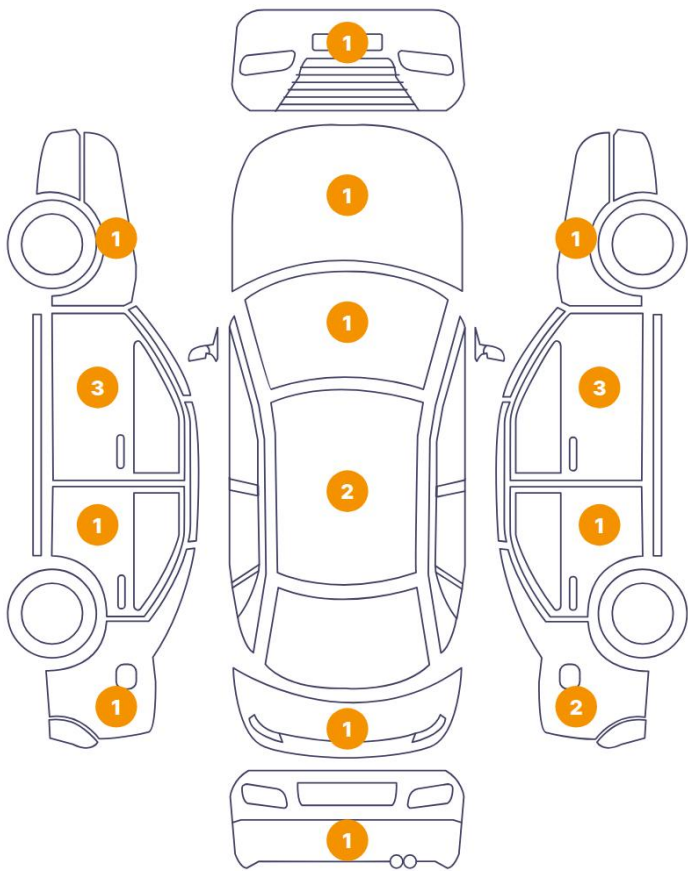
20 Danni

Component		Damage	Comments
1	Windshield / Front	Glass Break / Impact	
2	Hood	Bodywork / Dent / Hail Area	
3	Bumper / Front	Bodywork / Dent	
4	Fender / Front Left	Bodywork / Dent	
5	Mirror Shell / Front Left	Paint / Scratch / Line	
6	Door / Front Left	Bodywork / Poor Previous Repair	
7	Door / Back Left	Bodywork / Poor Previous Repair	
8	Fender / Back Left	Paint / Scratch / Line	
9	Bumper / Back	Paint / Scratch / Line	
10	Tailgate	Bodywork / Dent	
11	Fender / Back Right	Paint / Scratch / Line	
12	Fender / Back Right	Bodywork / Dent

13	Door / Back Right	Bodywork / Dent
14	Door / Front Right	Bodywork / Dent
15	Mirror Shell / Front Right	Paint / Scratch / Line
16	Fender / Front Right	Bodywork / Dent
17	Pillar / Front Right	Bodywork / Dent
18	Roof	Bodywork / Dent / Hail Area
19	Roof	Bodywork / Dent
20	Pillar / Front Left	Bodywork / Dent / Hail Area

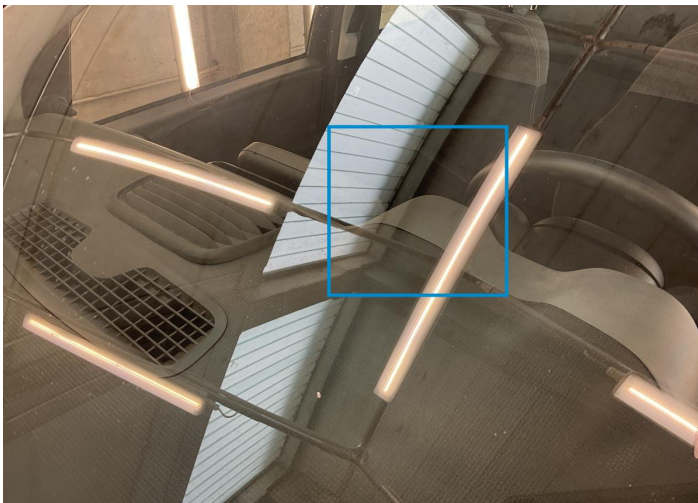
1. Windshield / Front
Glass Break / Impact -

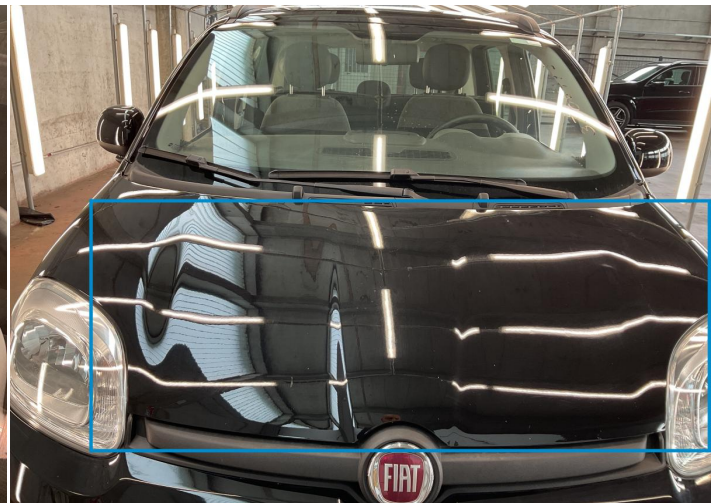
2. Hood
Bodywork / Dent / Hail Area -

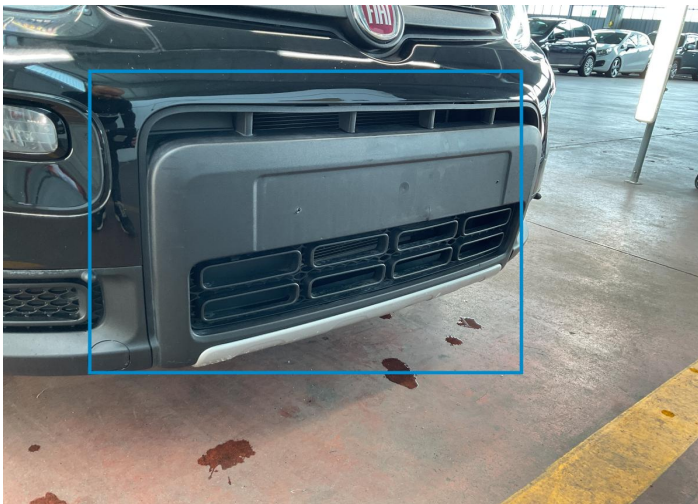
3. Bumper / Front
Bodywork / Dent -

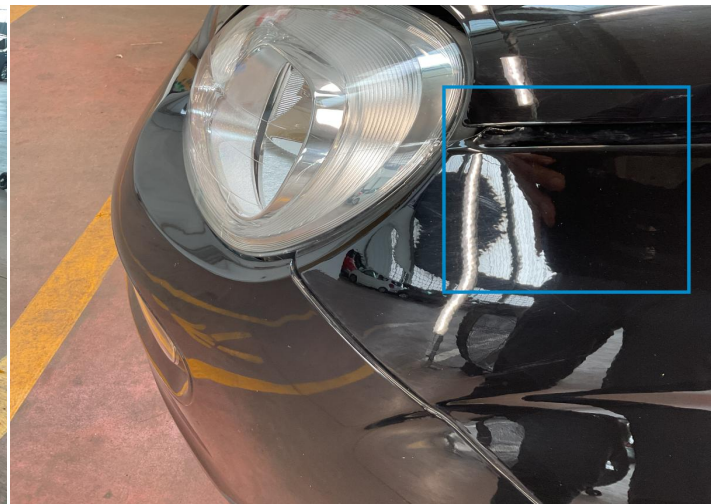
4. Fender / Front Left
Bodywork / Dent -

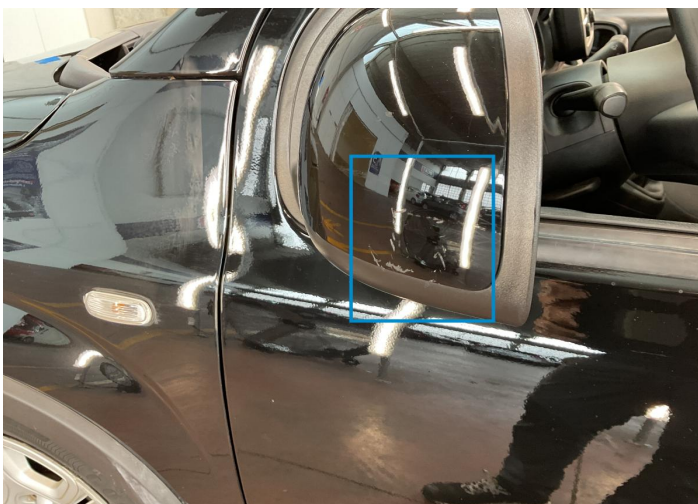
5. Mirror Shell / Front Left
Paint / Scratch / Line -

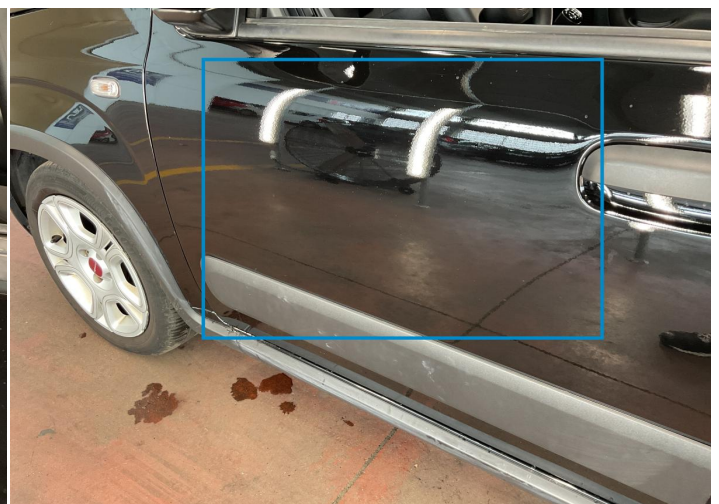
6. Door / Front Left
Bodywork / Poor Previous Repair -

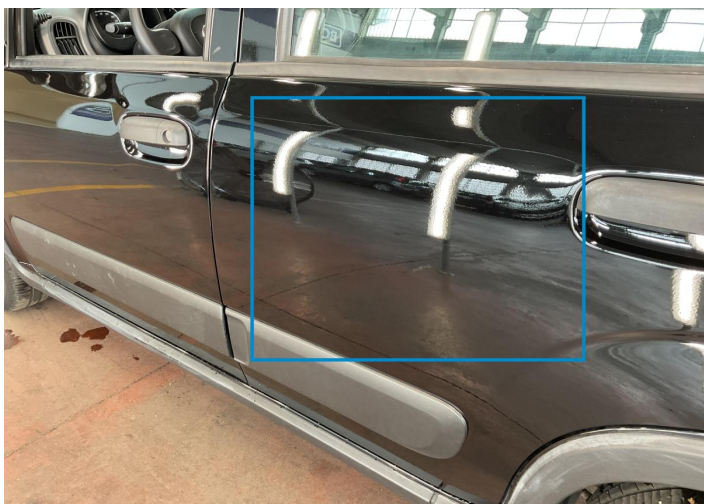
7. Door / Back Left
Bodywork / Poor Previous Repair -

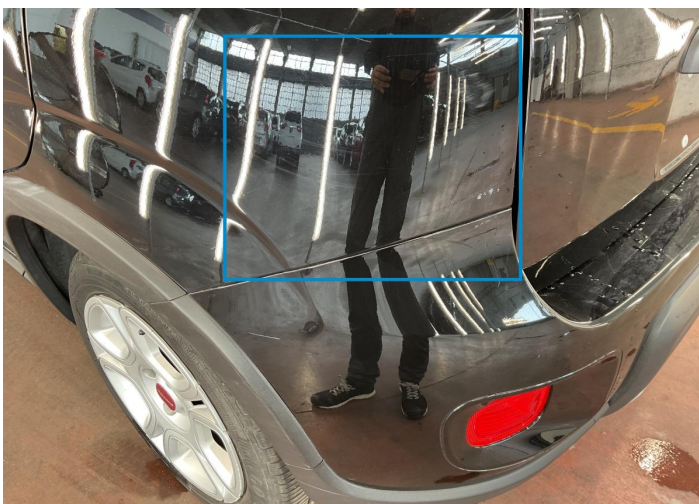
8. Fender / Back Left
Paint / Scratch / Line -

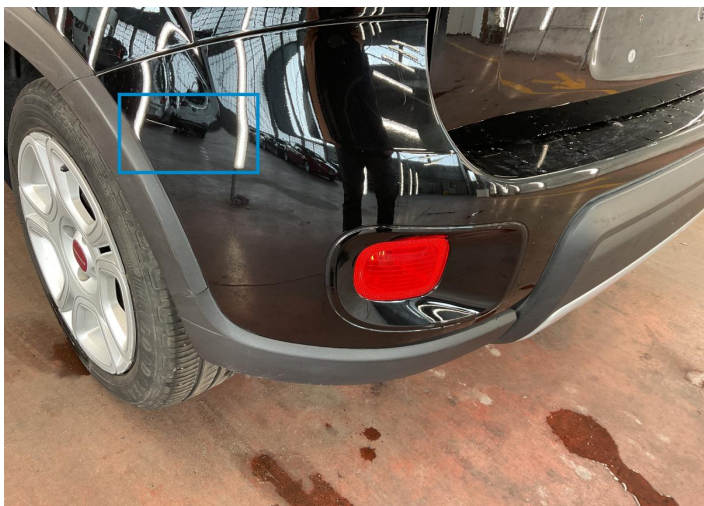
9. Bumper / Back
Paint / Scratch / Line -

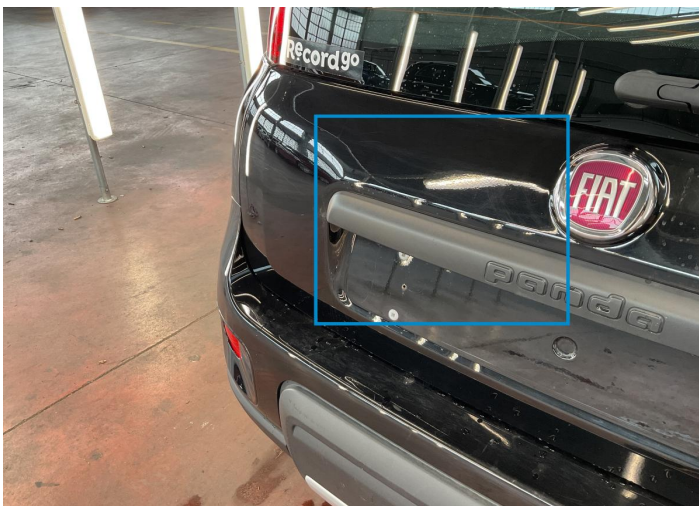
10. Tailgate
Bodywork / Dent -

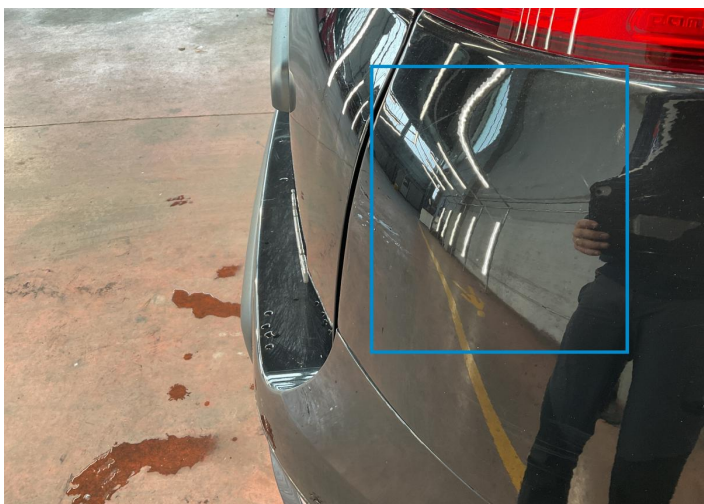
11. Fender / Back Right
Paint / Scratch / Line -

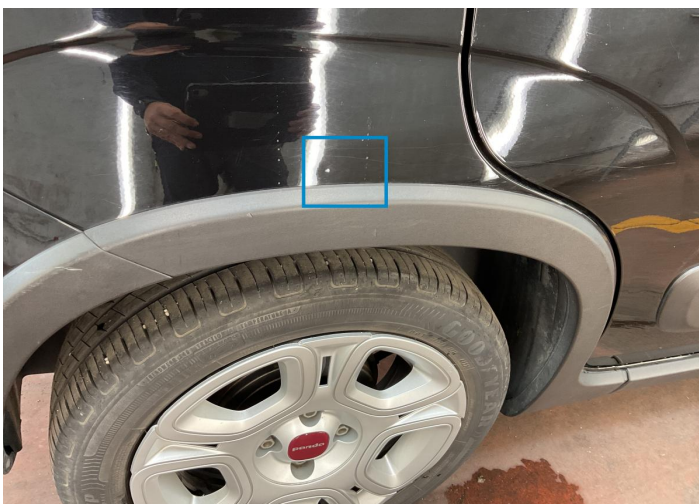
12. Fender / Back Right
Bodywork / Dent -

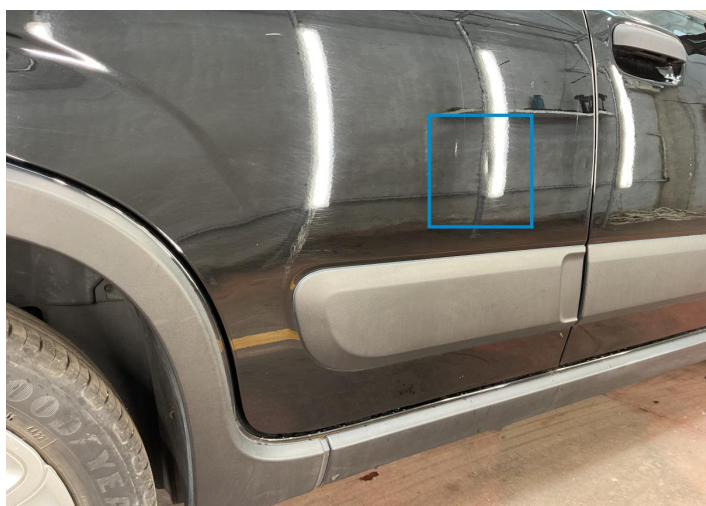
13. Door / Back Right
Bodywork / Dent -

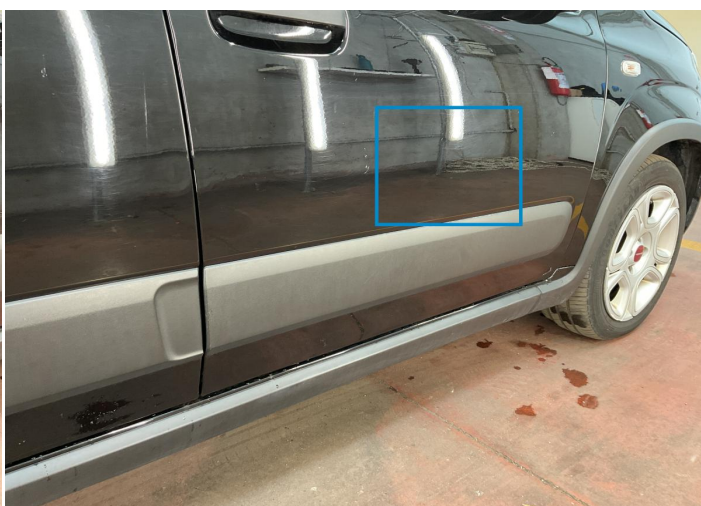
14. Door / Front Right
Bodywork / Dent -

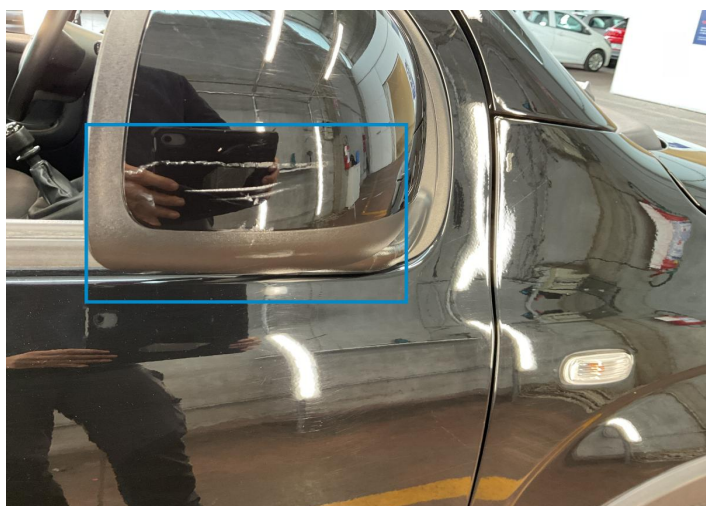
15. Mirror Shell / Front Right
Paint / Scratch / Line -

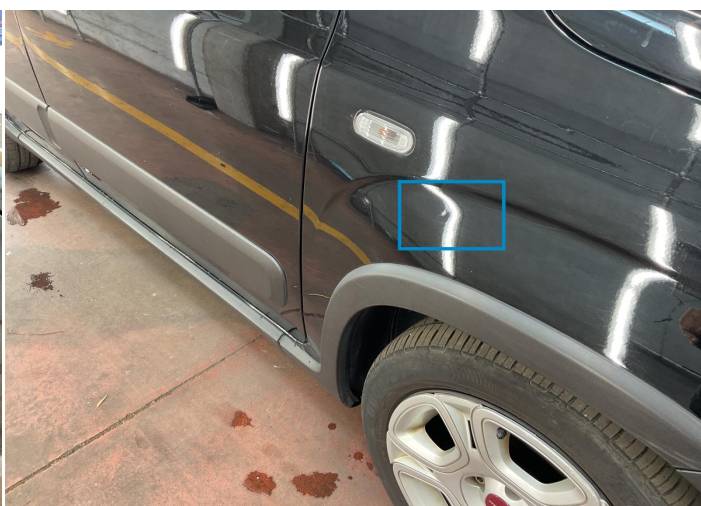
16. Fender / Front Right
Bodywork / Dent -

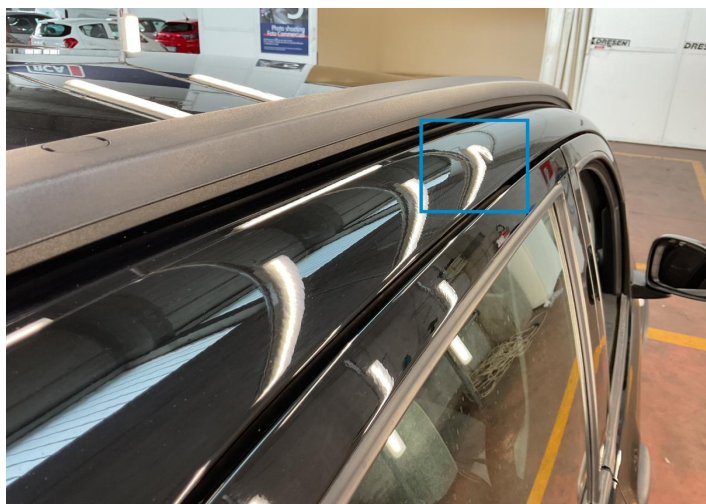
17. Pillar / Front Right
Bodywork / Dent -

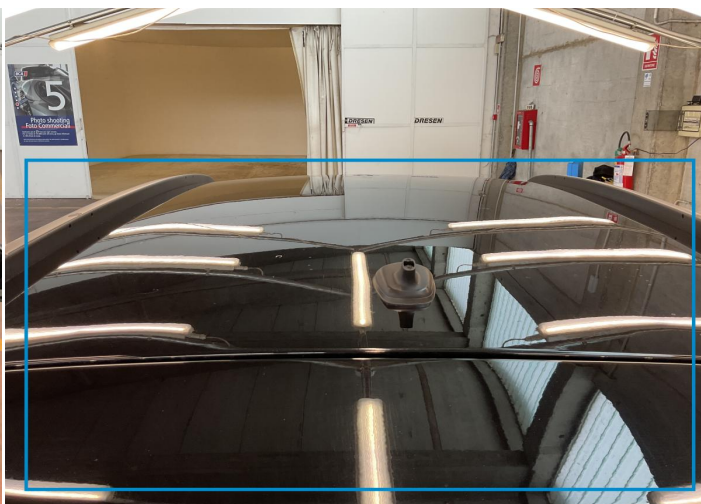
18. Roof
Bodywork / Dent / Hail Area -

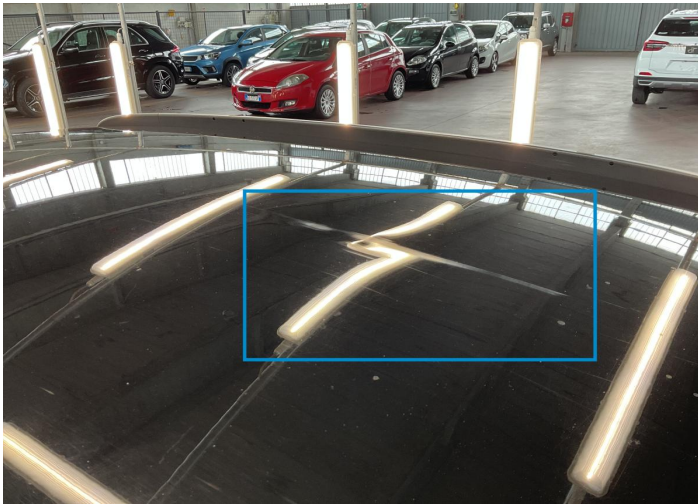
19. Roof
Bodywork / Dent -

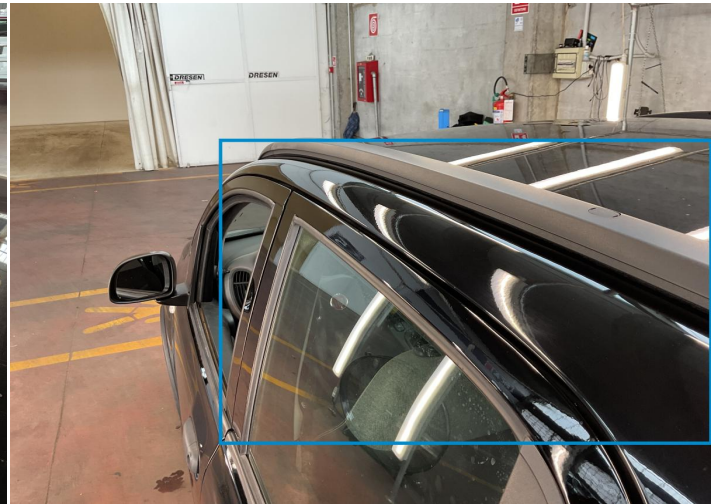
20. Pillar / Front Left
Bodywork / Dent / Hail Area -
