## Fiat Talento: VNG39P

| Vinnumber: | ZFAFFL006M5176657 | Versionname: | Talento 2.0 MJ 107kW Pro L2H1 GB |

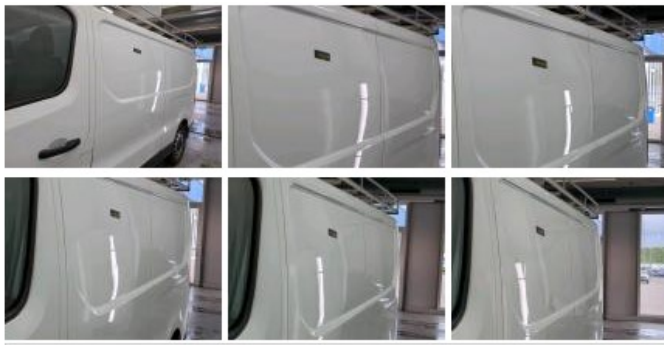
Side wall FL (LCV), Dent(s), Repair and paint (complete)

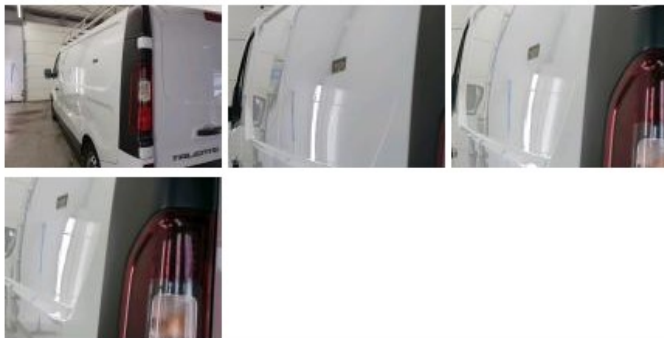
Side wall RL, Dent(s), Repair and paint (complete)

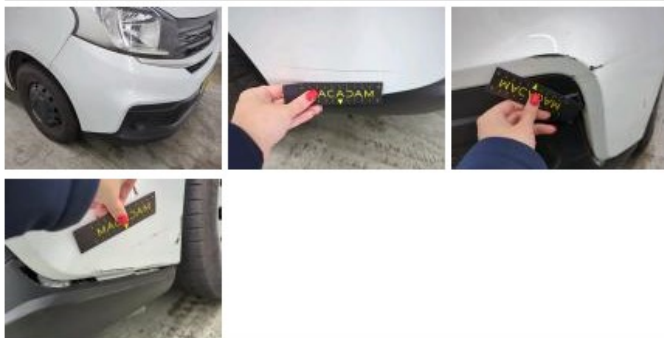
Bumper FM, Scratch(es), Repair and paint (complete)

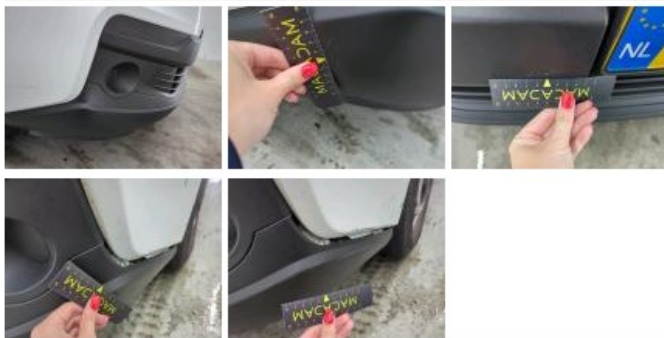
Bumper F, Scratch(es), Smart repair

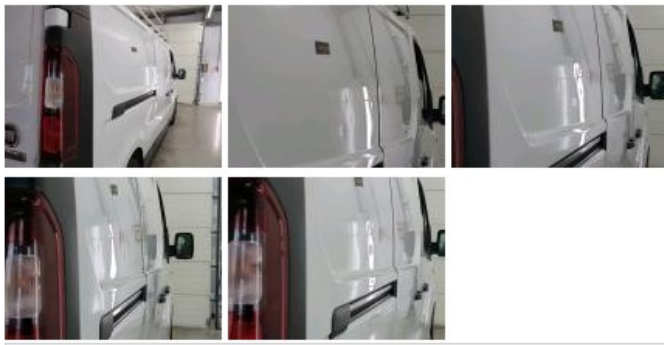
Side wall RR, Dent(s), Repair and paint (complete)

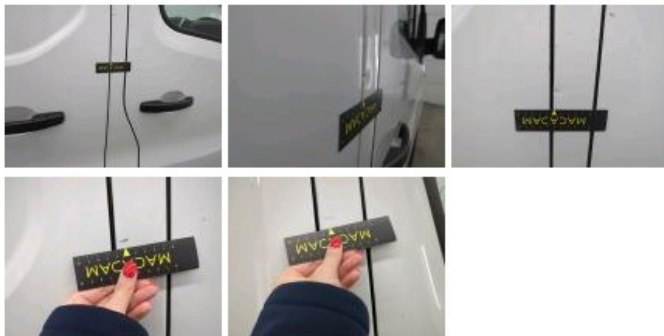
Central pillar R, Dent(s) and scratch(es), Repair and paint (complete)

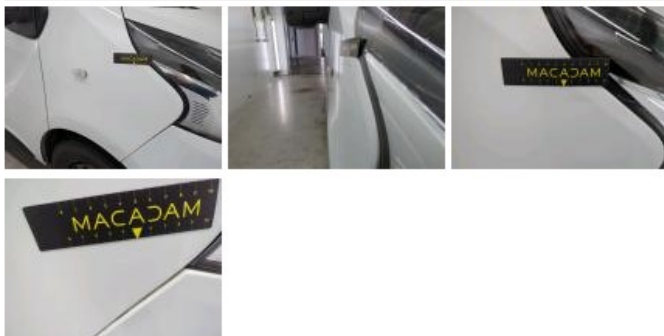
Wing FR, Dent(s) and scratch(es), Repair and paint (complete)

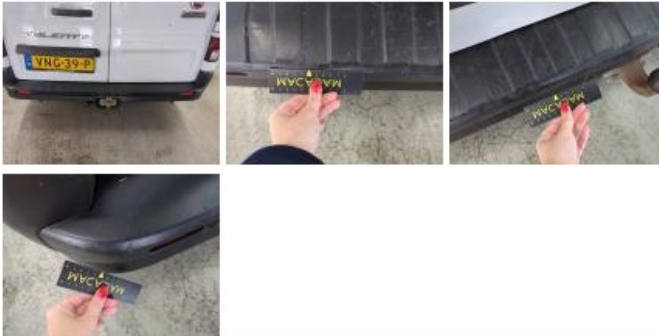
Bumper R, Scratch(es), Smart repair

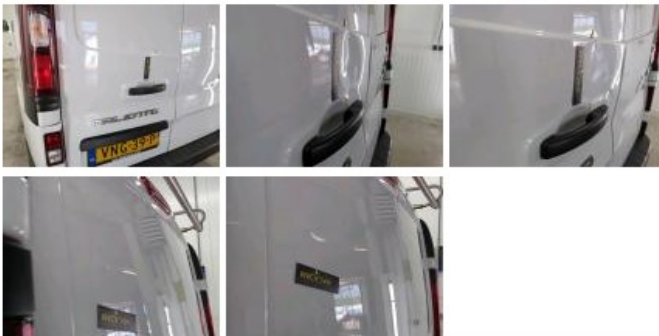
Boot door panel RL, Dent(s) and scratch(es), Repair and paint (complete)

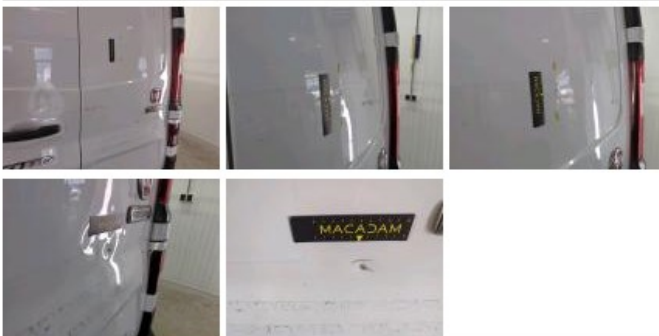
Boot door panel RR, Dent(s) and scratch(es), Repair and paint (complete)
