# LANCIA Musa 2007 Benzina musa 1.4 8v Oro ecochic Gpl

VIN NO ZLA35000001206095  
Registration Number EF961LM

## Inspection Report Summary

| Customer | BCA Lodi | Report Number | P20251010113440 |

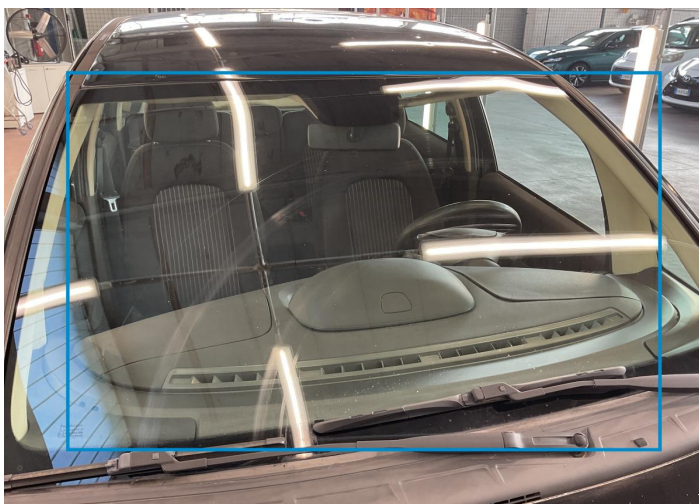
| Component | | Damage | Comments |
|---|---|---|---|
| 1 | Windshield / Front | Glass Break | |

1. Windshield / Front  
Glass Break -

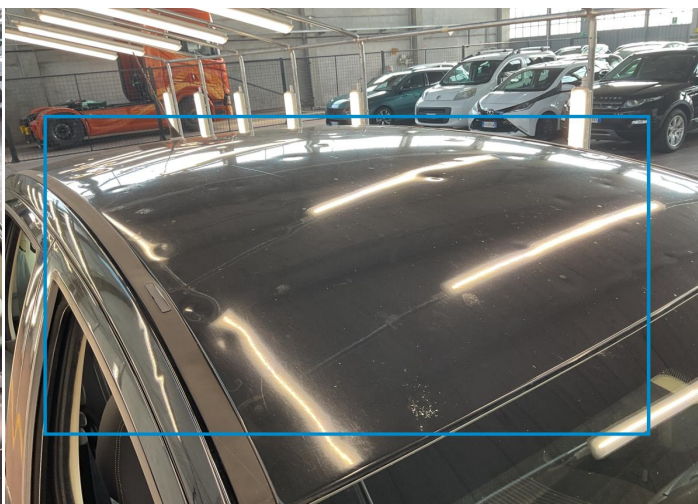
| Component | | Damage | Comments |
|---|---|---|---|
| 2 | Roof | Bodywork / Dent / Hail Area | |

2. Roof  
Bodywork / Dent / Hail Area -

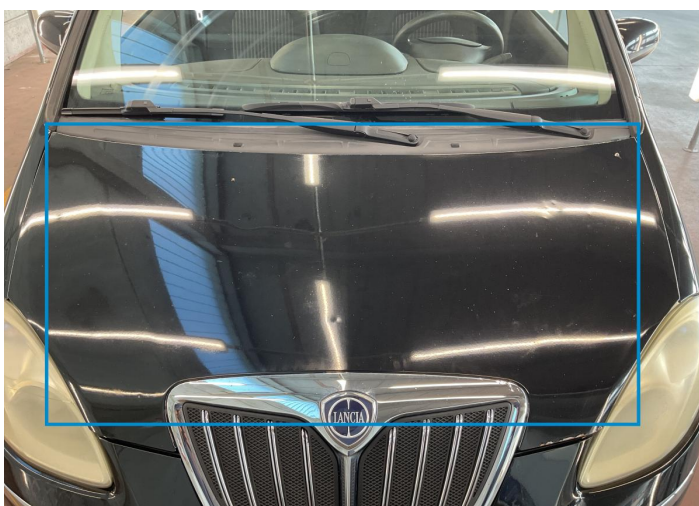
| Component | | Damage | Comments |
|---|---|---|---|
| 3 | Hood | Bodywork / Dent / Hail Area | |

3. Hood  
Bodywork / Dent / Hail Area -

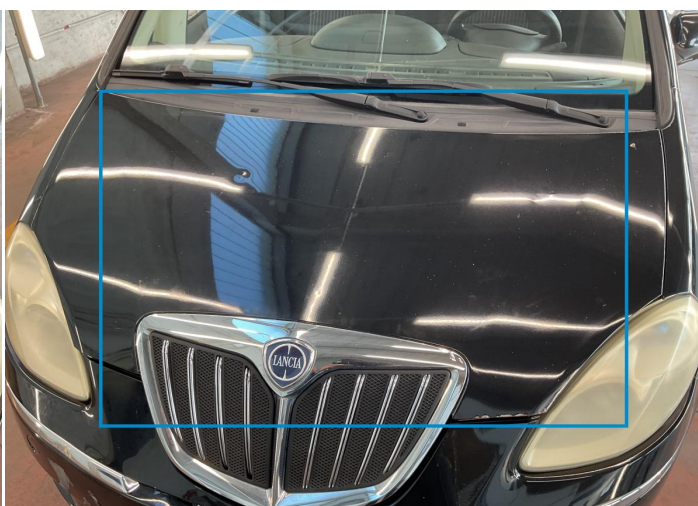
| Component | | Damage | Comments |
|---|---|---|---|
| 4 | Hood | Bodywork / Dent / Hail Area | |

4. Hood  
Bodywork / Dent / Hail Area -

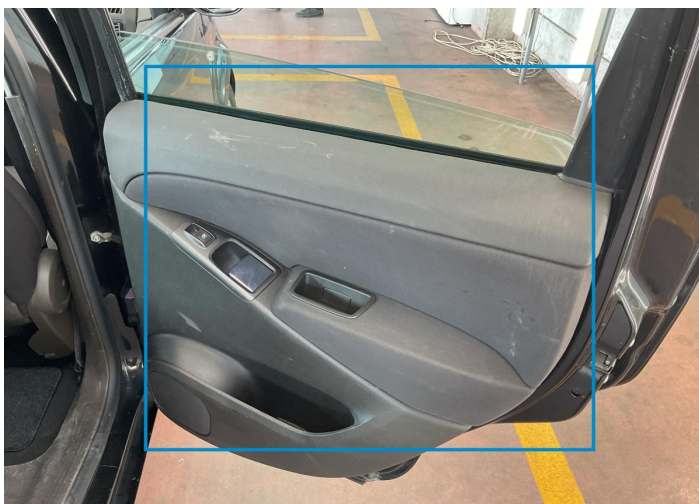
| Component | | Damage | Comments |
|---|---|---|---|
| 5 | Panel Filling / Back Right | Interior / Scratched | |

5. Panel Filling / Back Right  
Interior / Scratched -

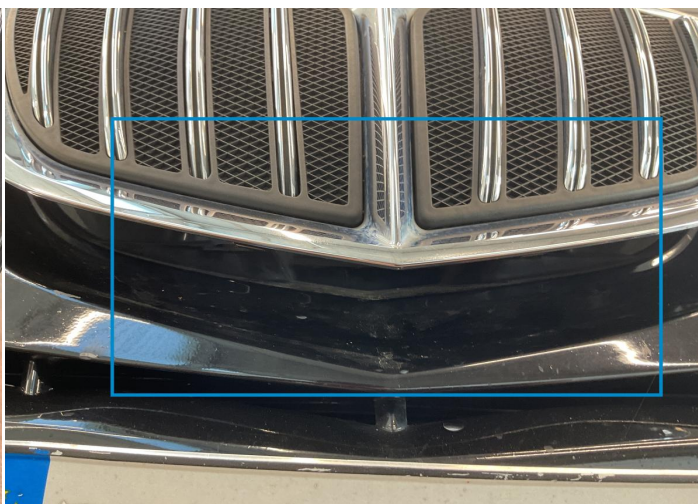
| Component | | Damage | Comments |
|---|---|---|---|
| 6 | Hood | Bodywork / Breakage | LEVA ROTTA NON SI APRE |

6. Hood  
Bodywork / Breakage -  
LEVA ROTTA NON SI APRE

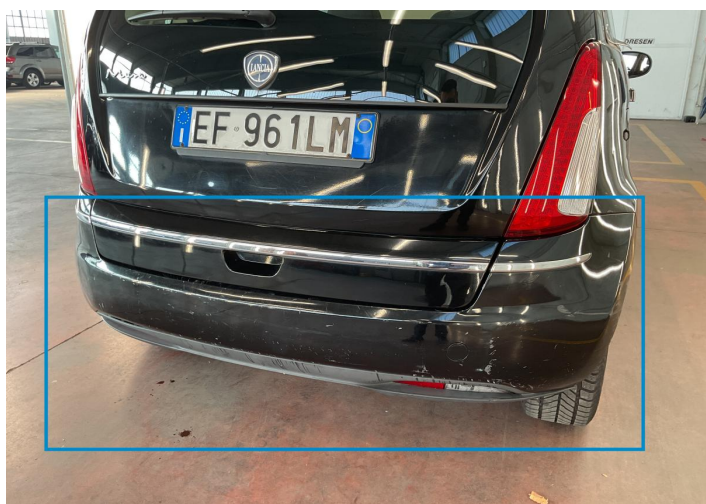
| Component | | Damage | Comments |
|---|---|---|---|
| 7 | Bumper / Back | Bodywork / Breakage | |

7. Bumper / Back  
Bodywork / Breakage -

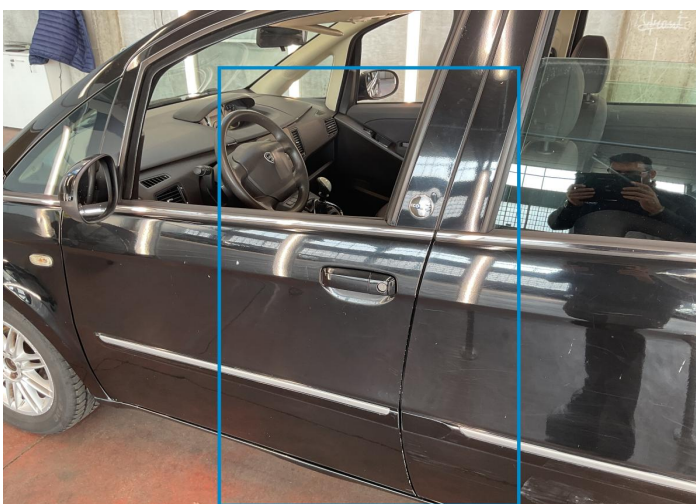
| Component | | Damage | Comments |
|---|---|---|---|
| 8 | Door / Front Left | Bodywork / Dent | |

8. Door / Front Left  
Bodywork / Dent -

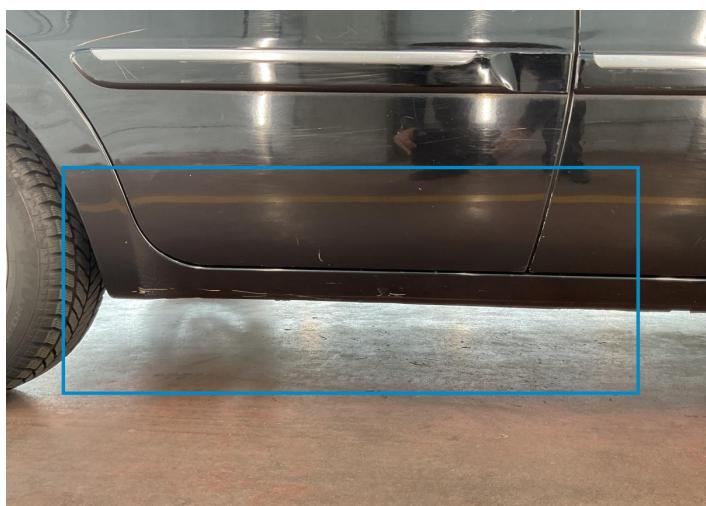
| Component | | Damage | Comments |
|---|---|---|---|
| 9 | Rocker Panel / Center Right | Bodywork / Dent | |

9. Rocker Panel / Center Right  
Bodywork / Dent -

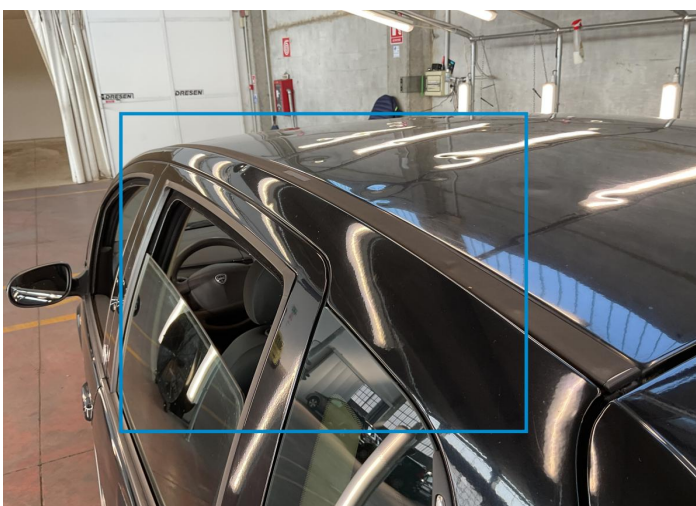
| Component | | Damage | Comments |
|---|---|---|---|
| 10 | Pillar / Front Left | Bodywork / Dent / Hail Area | |

10. Pillar / Front Left  
Bodywork / Dent / Hail Area -

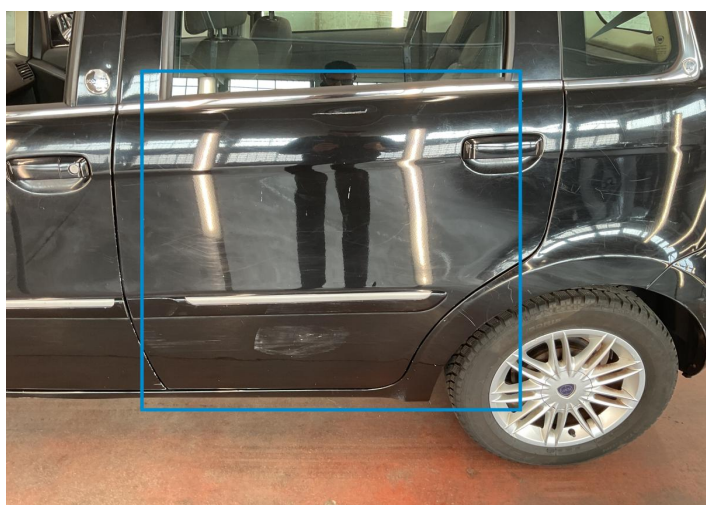
| Component | | Damage | Comments |
|---|---|---|---|
| 11 | Door / Back Left | Bodywork / Dent | |

11. Door / Back Left  
Bodywork / Dent -

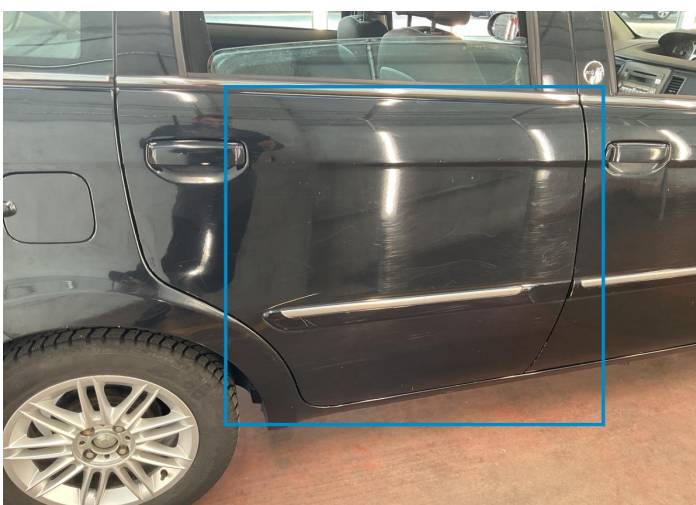
| Component | | Damage | Comments |
|---|---|---|---|
| 12 | Door / Back Right | Bodywork / Dent | |

12. Door / Back Right  
Bodywork / Dent -

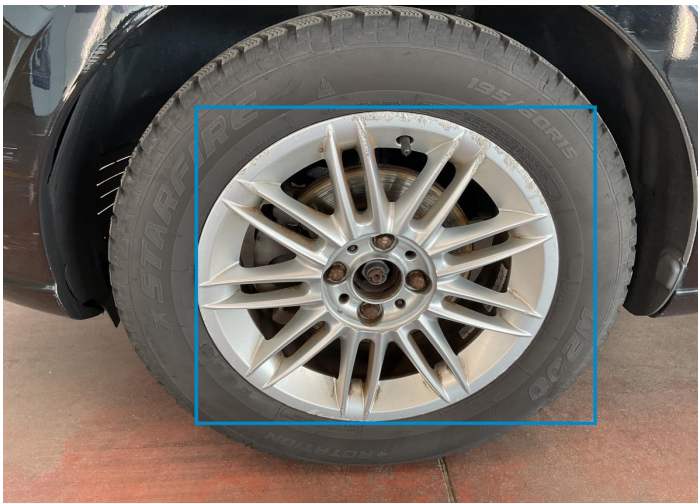
| 13 | Rim / Front Left | Out of Bodywork / Scratch |

13. Rim / Front Left  
Out of Bodywork / Scratch -

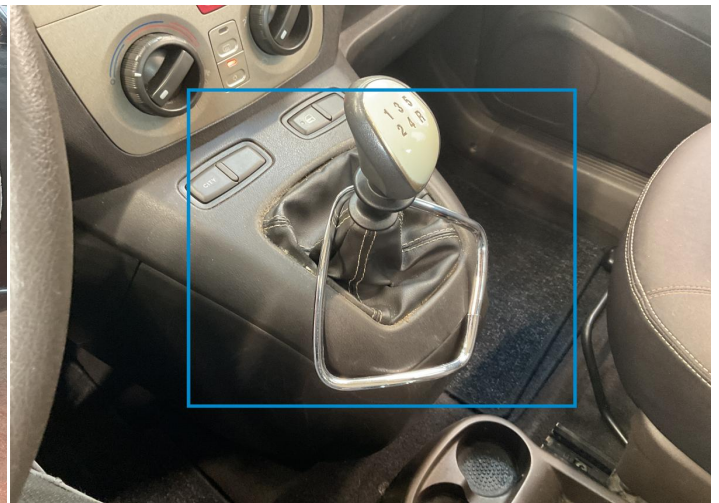
| 14 | Center Console | Interior / Broken |

14. Center Console  
Interior / Broken -

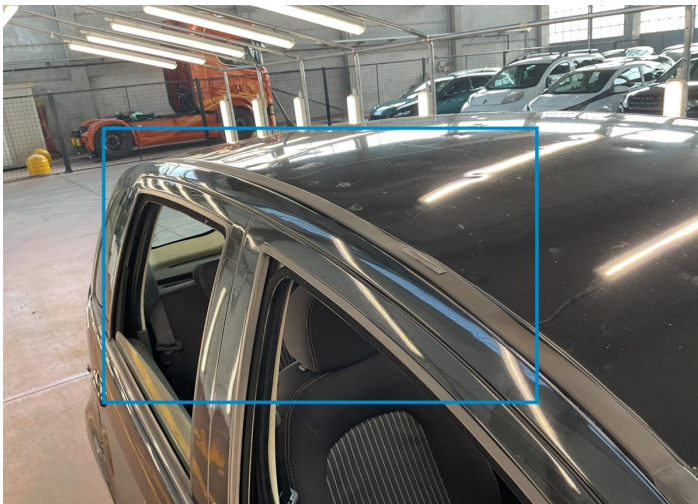
| 15 | Pillar / Front Right | Bodywork / Dent / Hail Area |

15. Pillar / Front Right  
Bodywork / Dent / Hail Area -

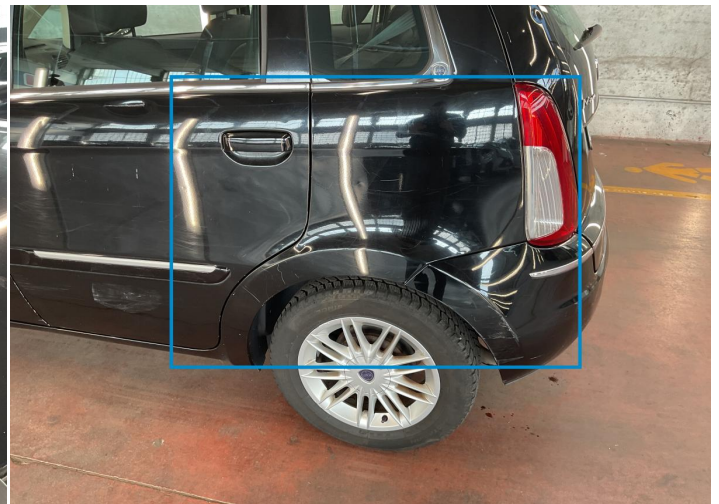
| 16 | Fender / Back Left | Bodywork / Dent |

16. Fender / Back Left  
Bodywork / Dent -

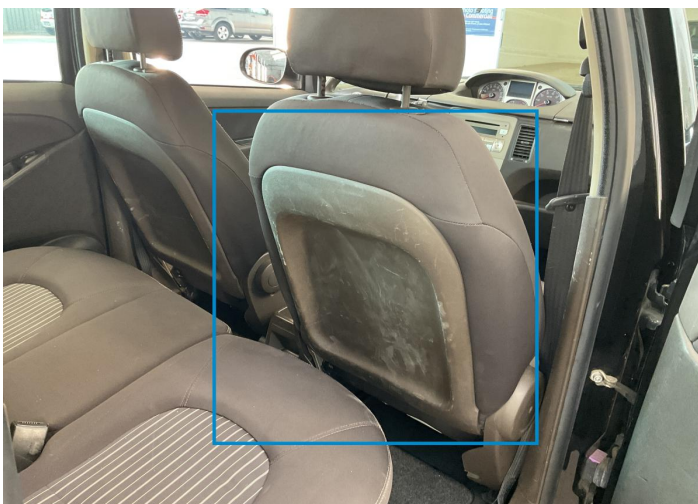
| 17 | Seat / Front Right | Interior / Scratched |

17. Seat / Front Right  
Interior / Scratched -

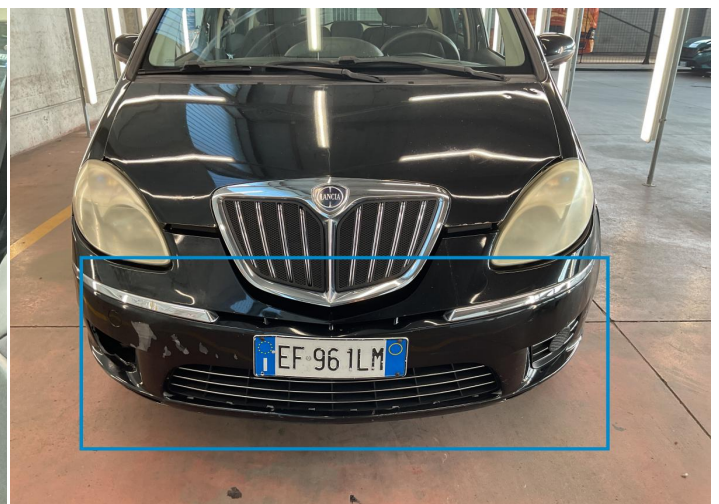
| 18 | Bumper / Front | Bodywork / Breakage |

18. Bumper / Front  
Bodywork / Breakage -

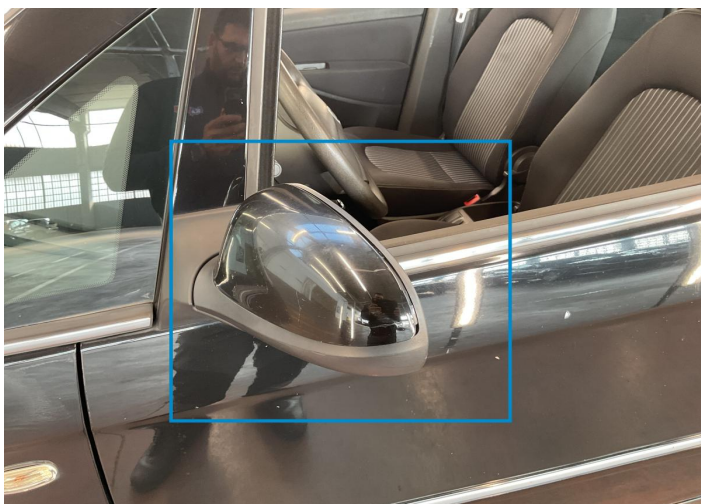
| 19 | Mirror Shell / Front Left | Bodywork / Breakage |

19. Mirror Shell / Front Left  
Bodywork / Breakage -

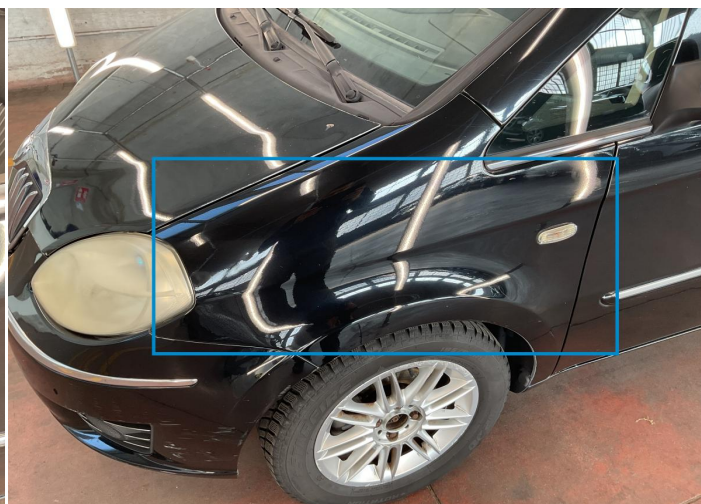
| 20 | Fender / Front Left | Bodywork / Dent / Hail Area |

20. Fender / Front Left  
Bodywork / Dent / Hail Area -

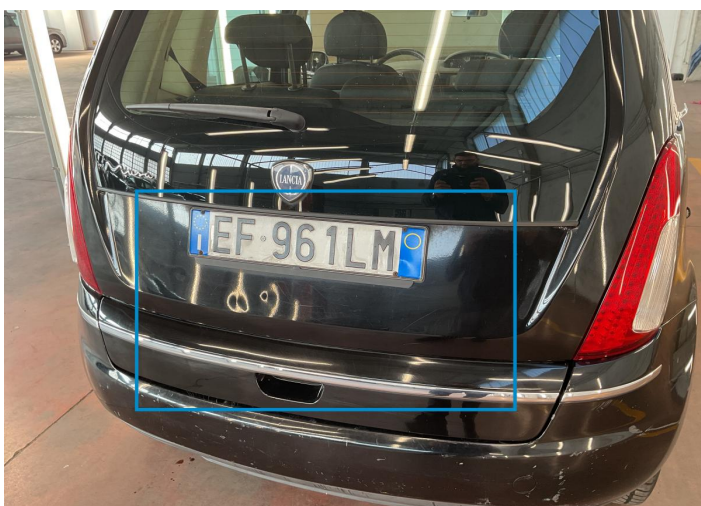
| 21 | Tailgate | Bodywork / Dent / Hail Area |

21. Tailgate  
Bodywork / Dent / Hail Area -

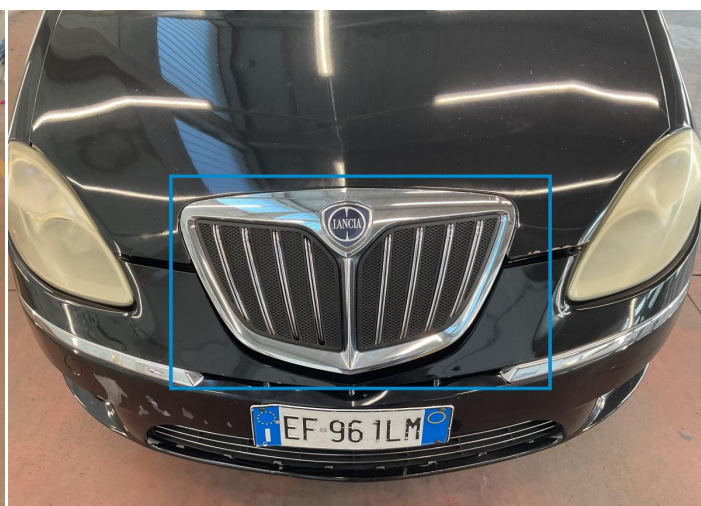
| 22 | Grille / Front | Bodywork / Breakage |

22. Grille / Front  
Bodywork / Breakage -

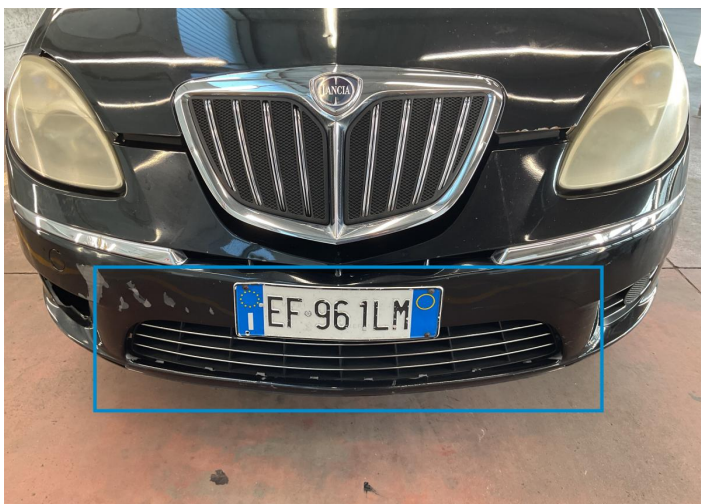
| 23 | Shield Grid / Front Center | Bodywork / Breakage |

23. Shield Grid / Front Center  
Bodywork / Breakage -

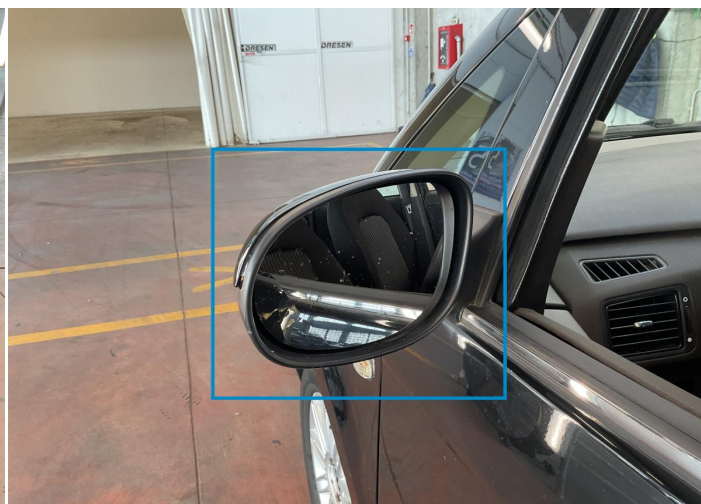
| 24 | Mirror Glass / Front Left | Bodywork / Breakage |

24. Mirror Glass / Front Left  
Bodywork / Breakage -

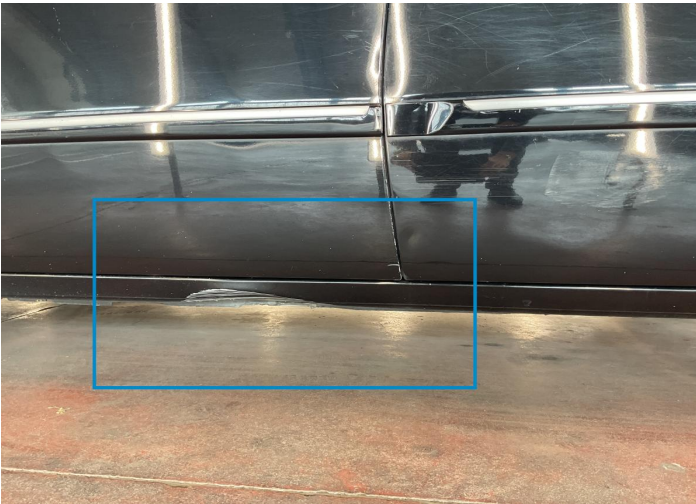
| 25 | Rocker Panel / Center Left | Bodywork / Dent |

25. Rocker Panel / Center Left  
Bodywork / Dent -

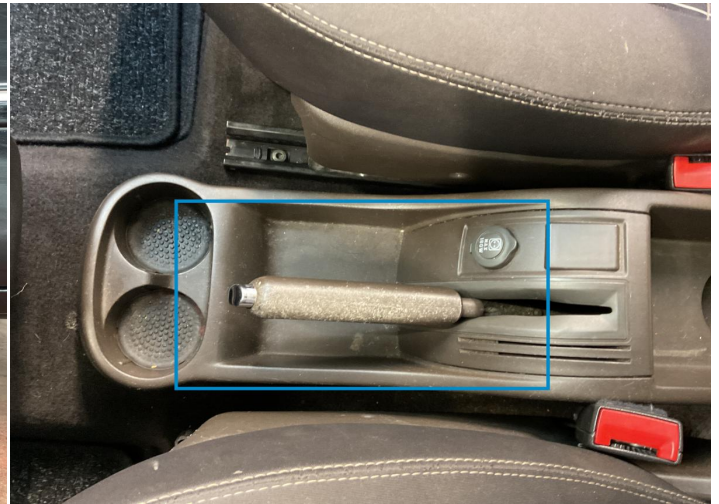
| 26 | HandBrake Handle | Interior / Worn - out |

26. HandBrake Handle  
Interior / Worn - out -

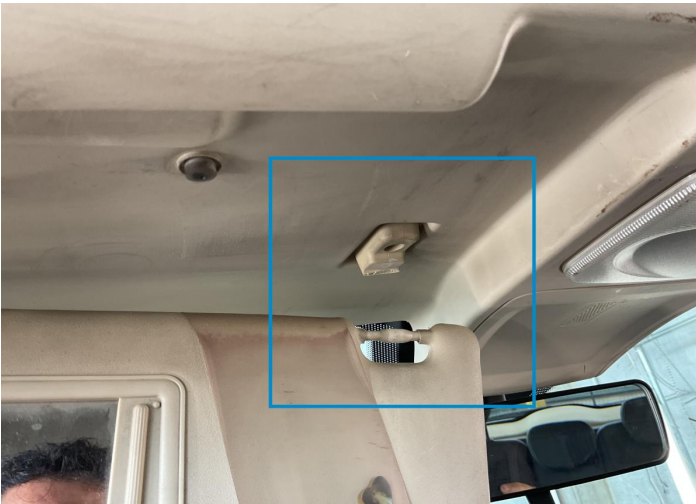
| 27 | Sun Visor / Front Left | Interior / Broken |

27. Sun Visor / Front Left  
Interior / Broken -

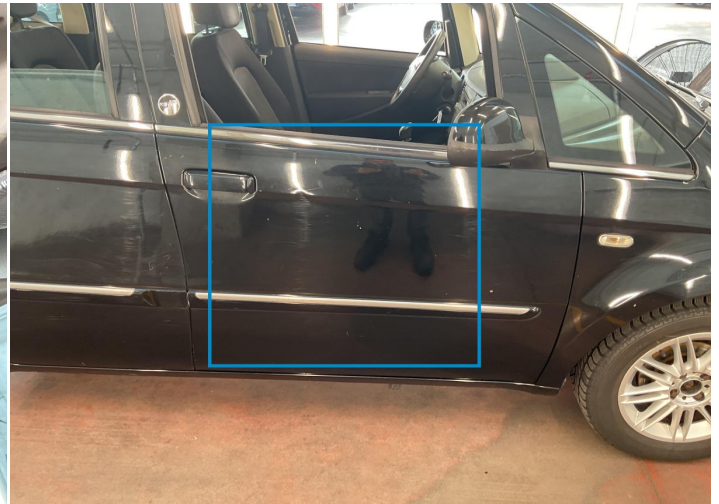
| 28 | Door / Front Right | Bodywork / Dent |

28. Door / Front Right  
Bodywork / Dent -

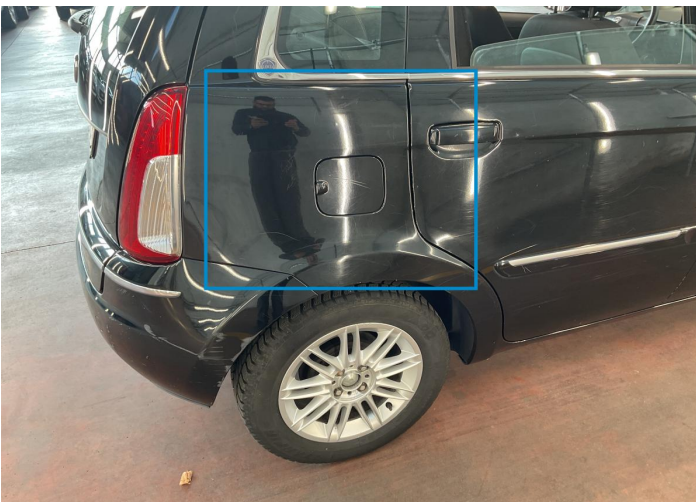
| 29 | Fender / Back Right | Bodywork / Dent |

29. Fender / Back Right  
Bodywork / Dent -

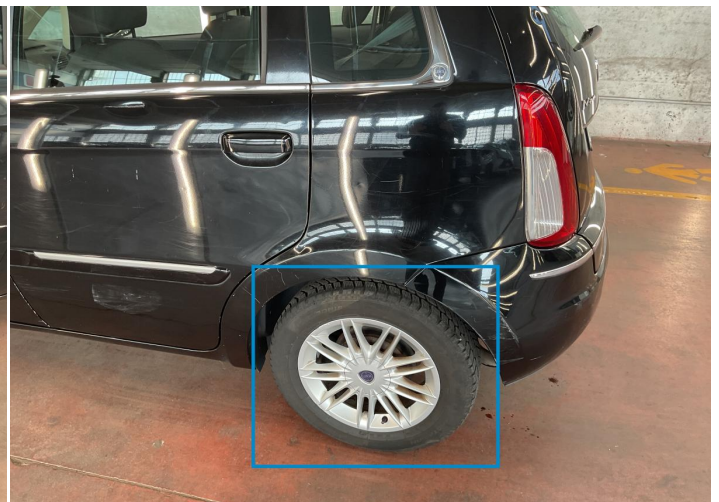
| 30 | Rim / Back Left | Out of Bodywork / Scratch |

30. Rim / Back Left  
Out of Bodywork / Scratch -

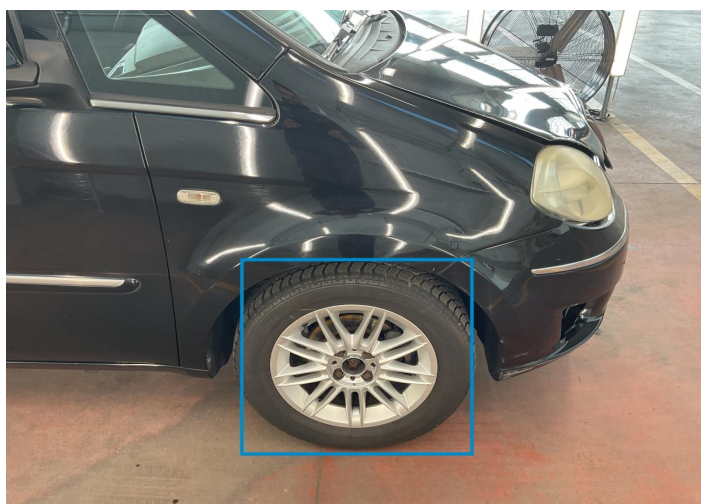
| 31 | Rim / Front Right | Out of Bodywork / Scratch |

31. Rim / Front Right  
Out of Bodywork / Scratch -

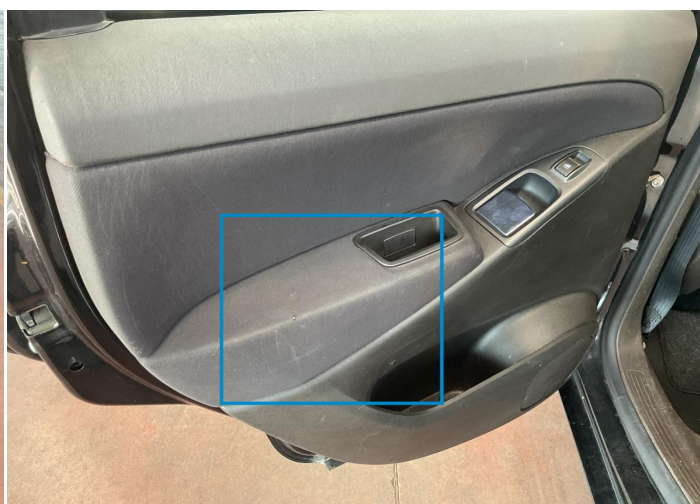
| 32 | Panel Filling / Back Left | Interior / Broken |

32. Panel Filling / Back Left  
Interior / Broken -

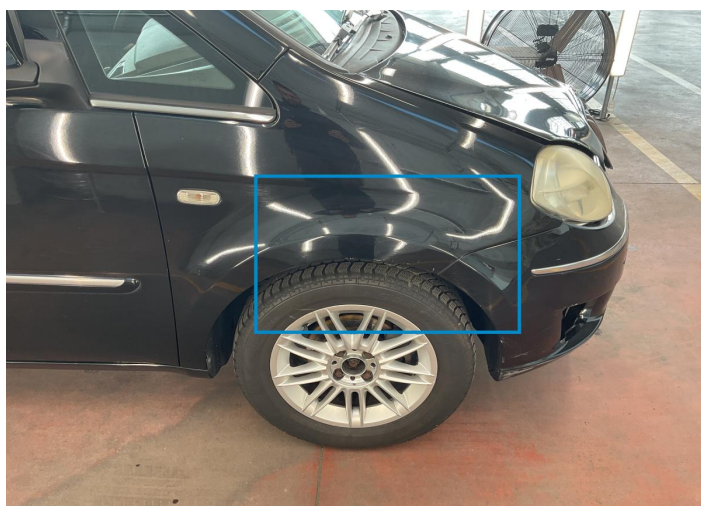
| 33 | Fender / Front Right | Bodywork / Dent |

33. Fender / Front Right  
Bodywork / Dent -

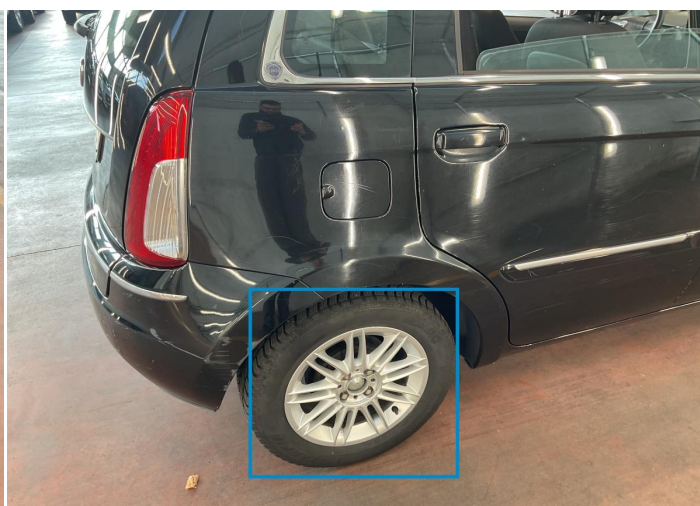
| 34 | Rim / Back Right | Out of Bodywork / Scratch |

34. Rim / Back Right  
Out of Bodywork / Scratch -

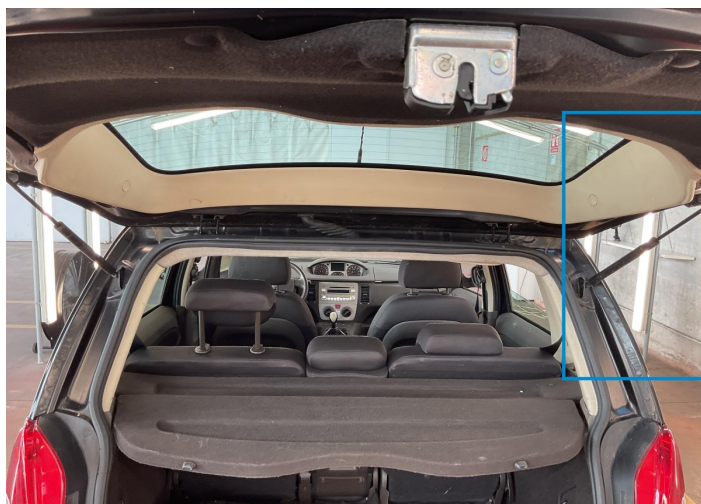
| 35 | Trunk Stick | Bodywork / Breakage |

35. Trunk Stick  
Bodywork / Breakage -

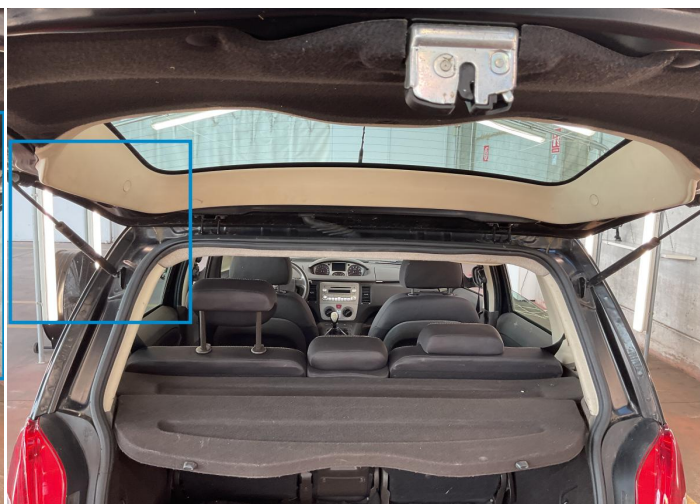
| 36 | Trunk Stick | Bodywork / Breakage |

36. Trunk Stick  
Bodywork / Breakage -

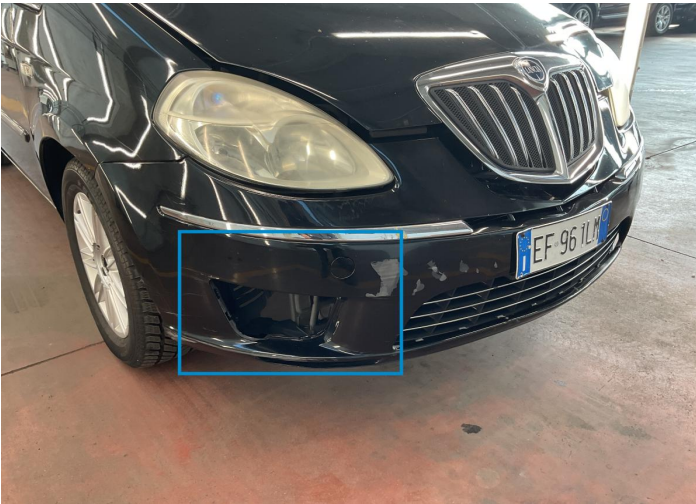
| 37 | Shield Grid / Front Center | Missing Part |

37. Shield Grid / Front Center  
Missing Part -

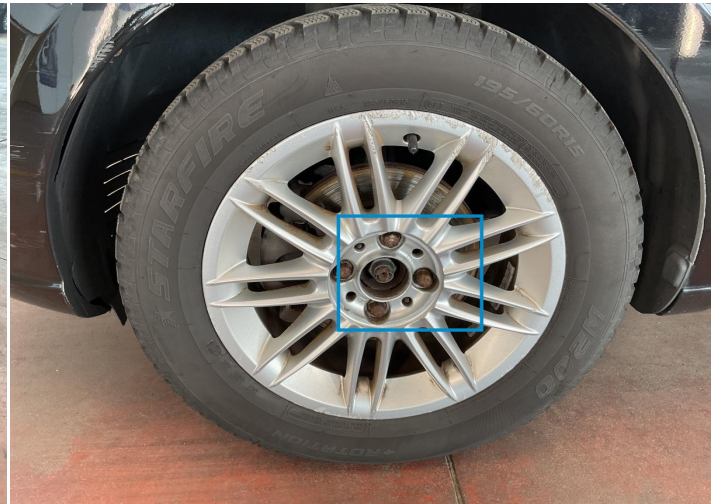
| 38 | Rim Brand Logo / Front Left | Missing Part |

38. Rim Brand Logo / Front Left  
Missing Part -

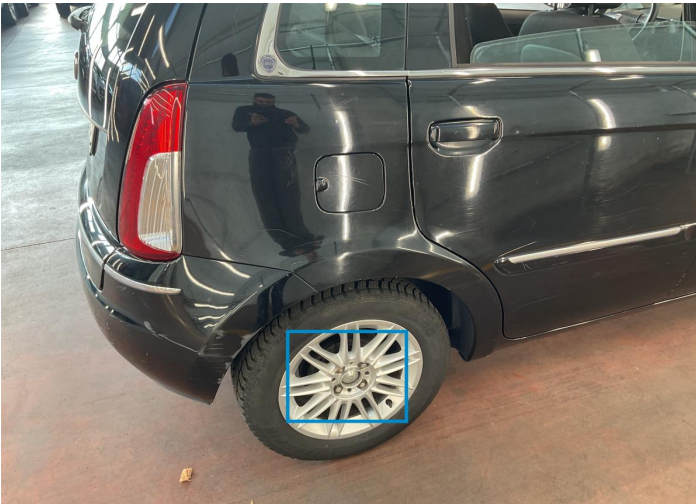
| 39 | Rim Brand Logo / Back Right | Missing Part |

39. Rim Brand Logo / Back Right  
Missing Part -

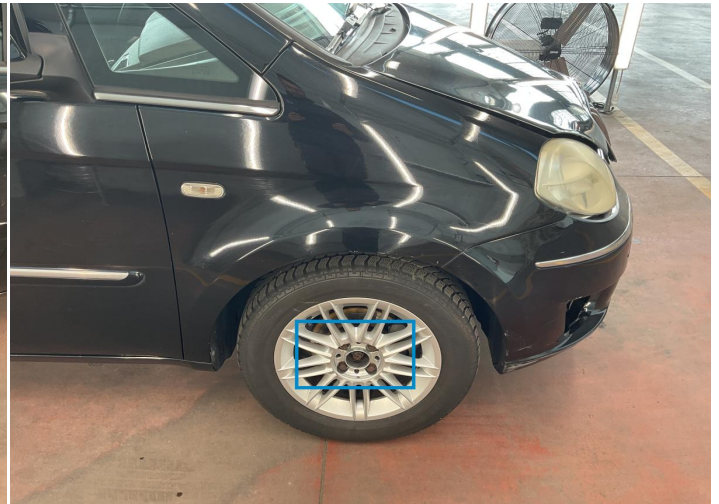
| 40 | Rim Brand Logo / Front Right | Missing Part |

40. Rim Brand Logo / Front Right  
Missing Part -
