Hüsge Gruppe®
Die Gutachter

status report

Maserati Levante

Vehicle identification number	ZN6TU61B00X253417	mileage read:	201366 km
..			
First Registration / construction year:	12.01.2018 / 2016	Visit Date / place of birth:	04.09.2025 Hoppegarten
Bodywork:	SUV	Re - import:	no
Body type:	hatchback	KBA no. :	4014//AAZ
Fuel / emission class:	diesel / € 6	transmission type:	automatic
Displacement / power:	2987 ccm / 202 kW (275 PS)	Engine:	four-wheel
paint:	black	Number of previous owners:	2
Doors / seats:	5 / 5	number keys:	2
Next HU / AU:	- / -	cushion type:	leather
Service book available:	no	Interior Color:	black
smoking vehicle:	no	Last service km / on the:	- / -
Vehicle roadworthy:	yes	Vehicle roadworthy:	no
Submitted vehicle	Eg II (veh - letter)	state outside:	3 - Average
documents:			
visit condition:	-	condition inside:	3 - Average
state general:	3 - Average

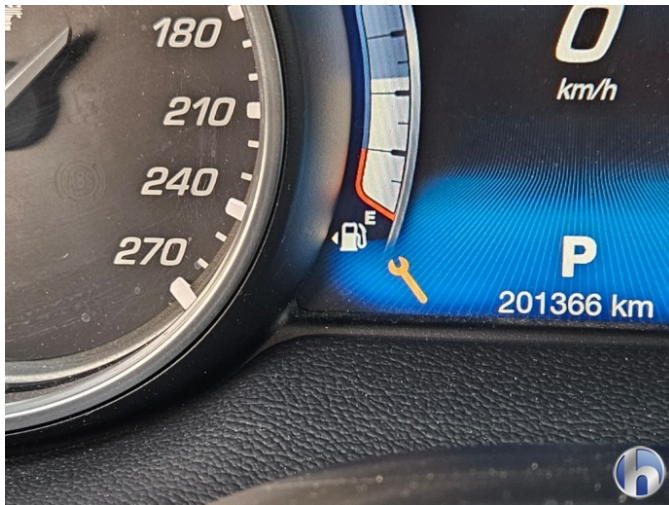
component	Damage	Rep kind
1. proof of maintenance	Missing	Replace
2. maintenance	Due	Replace
3. Sommerradsatz	Not available	Replace
4. Windshield	Chipping from stones	Replace
5. Door Rear - right	Scratch(es)	Smart repair
6. Front fender - right	Damaged	Paint
7. Front fender - left	Wear and tear	acceptable
8. Roof frame - left	Delle	Gentle refurbishing
9.	Damaged	Smart repair
10. Türeinstieg Vorne - Links	Scratch(es)	Paint

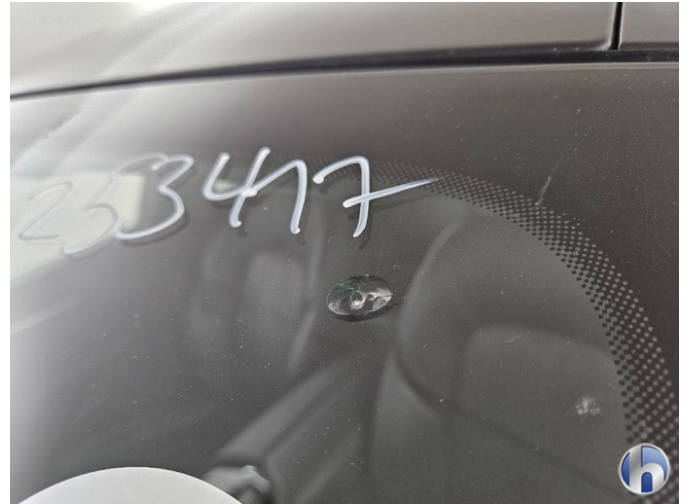
4. Windshield

Subfloor Inspection:	Conducted limited To investigate the vehicle (ä . Lift o .) Were not lifting means even a ramp or pit available. For this reason, a visit to the vehicle's underside was limited.
Mileage plausible:	not testable not testable
reference:	
Note Road Safe:	Steinschlag Frontscheibe
