# VOLKSWAGEN Polo IV

## Polo 1.2

VIN NO WVWZZZ9NZ9Y062797

### Inspection Report Summary

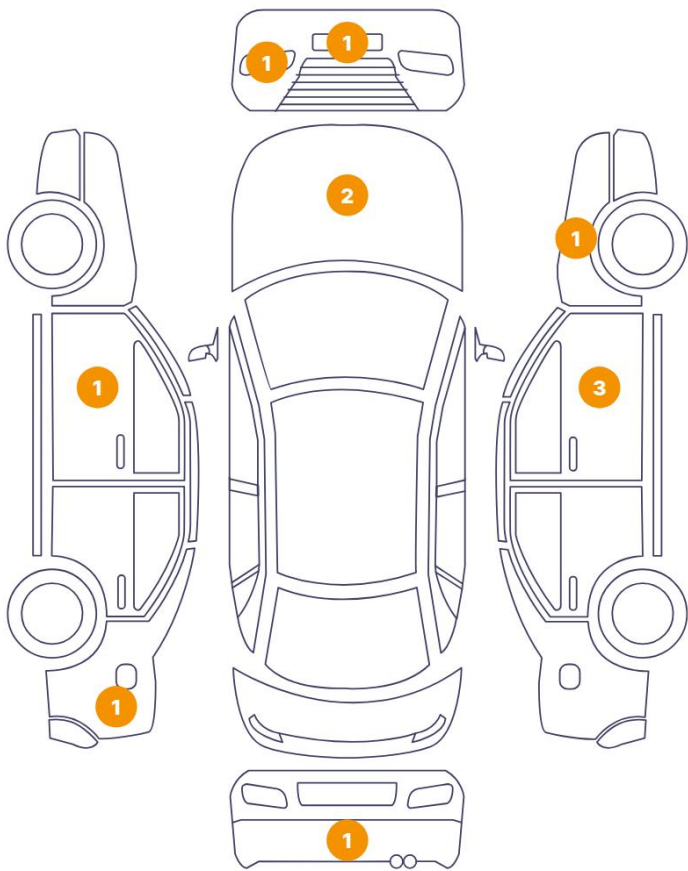
11 Schäden

Component	Damage	Comments
1	Hood	Paint / Scratch / Scuff	
2	Door / Front Left	Bodywork / Dent / Dent	
3	Side Panel / Back Left	Bodywork / Dent / Dent	
4	Door / Front Right	Paint / Scratch / Scuff	
5	Door / Front Right	Bodywork / Dent / Dent	
6	Door / Front Right	Bodywork / Dent / Dent	
7	Fender / Front Right	Bodywork / Dent / Dent	
8	Bumper / Front	Paint / Scratch / Scuff	
9	Hood	Paint / Corrosion	
10	Front Light / Front Left	Glass Break	
11	Bumper / Back	Paint / Scratch / Scuff

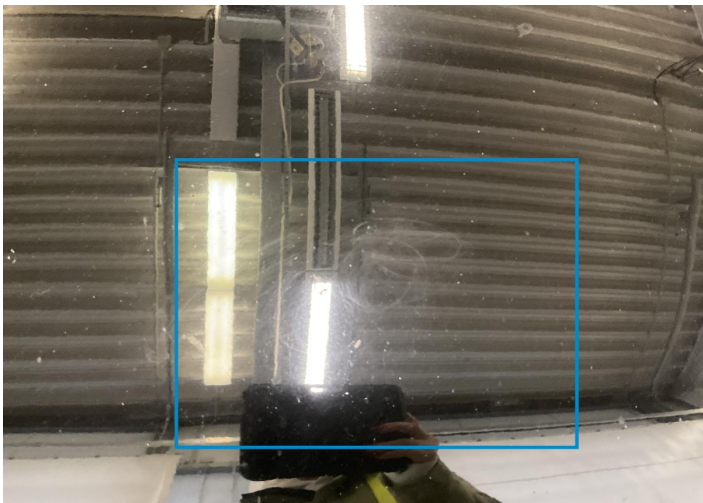
1. Hood  
Paint / Scratch / Scuff -

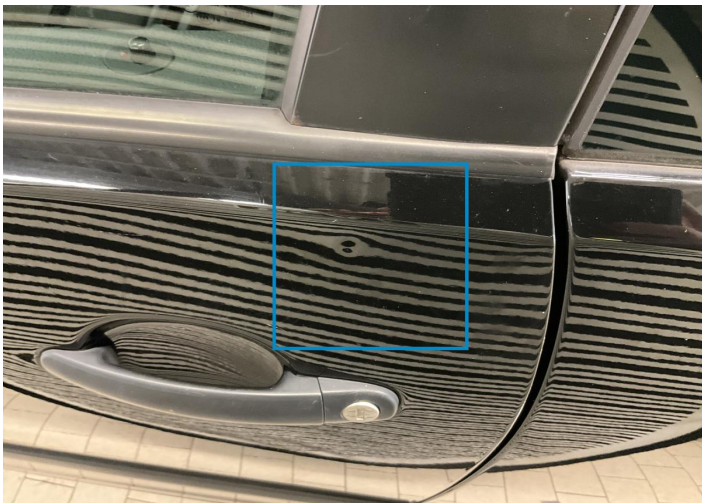
2. Door / Front Left  
Bodywork / Dent / Dent -

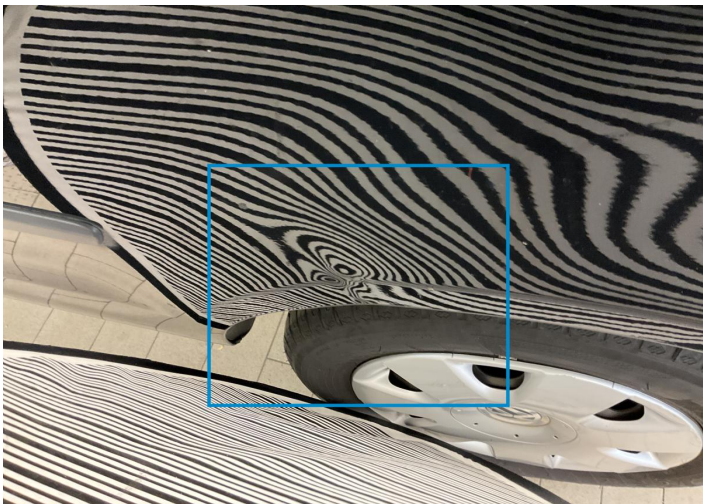
3. Side Panel / Back Left  
Bodywork / Dent / Dent -

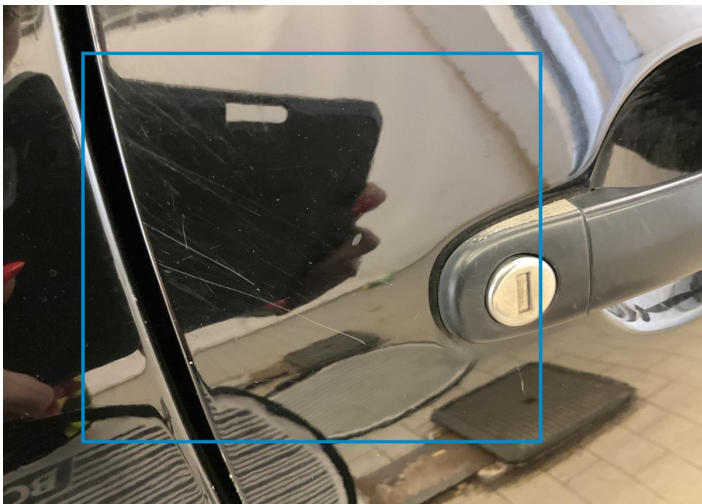
4. Door / Front Right  
Paint / Scratch / Scuff -

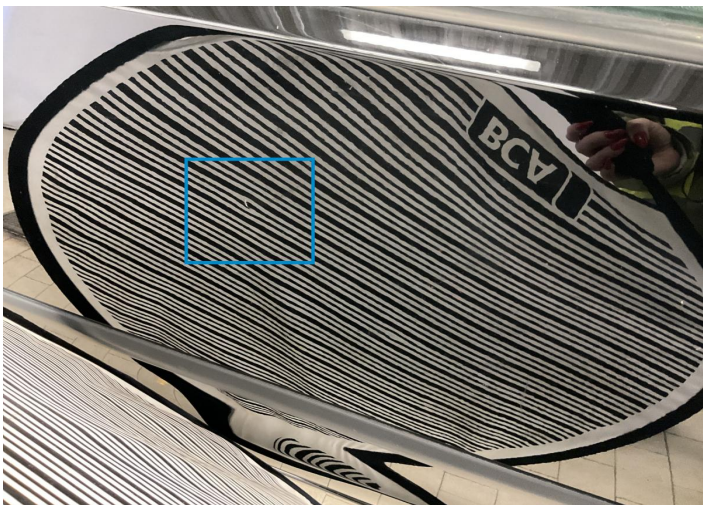
5. Door / Front Right  
Bodywork / Dent / Dent -

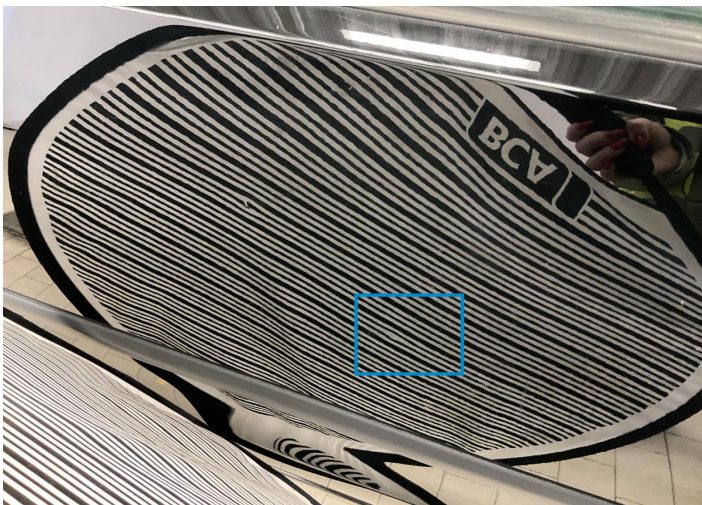
6. Door / Front Right  
Bodywork / Dent / Dent -

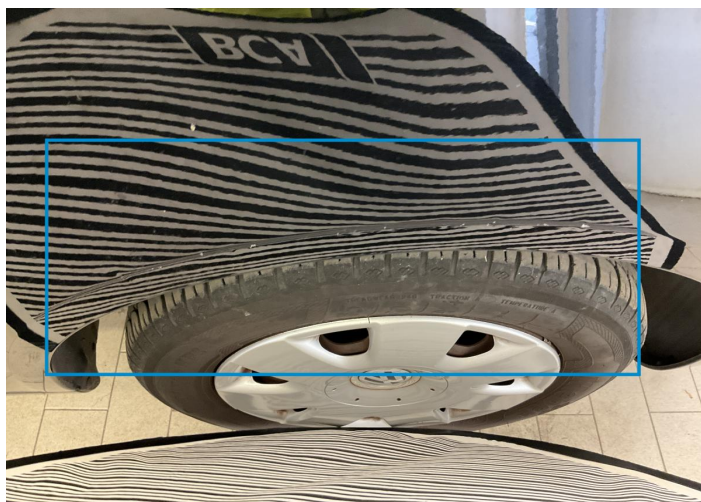
7. Fender / Front Right  
Bodywork / Dent / Dent -

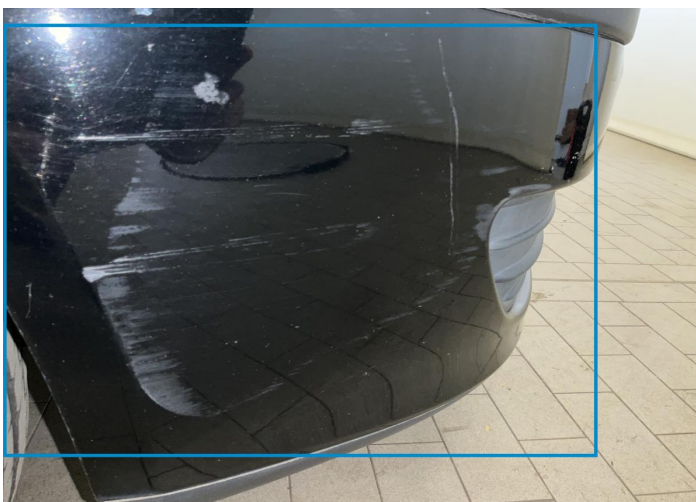
8. Bumper / Front  
Paint / Scratch / Scuff -

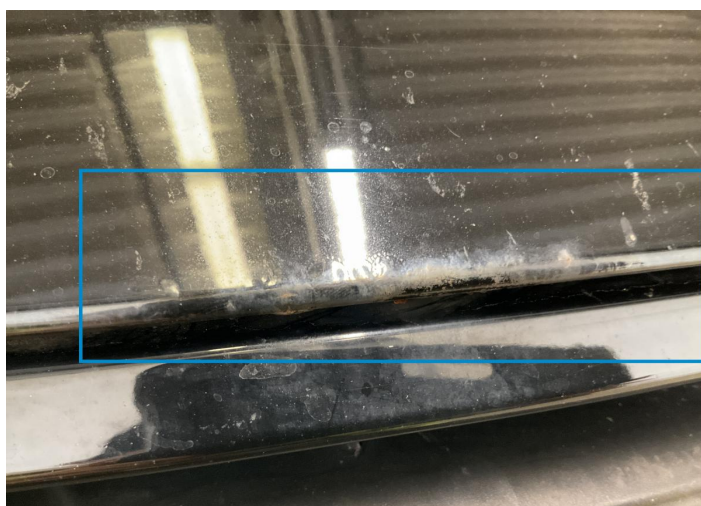
9. Hood  
Paint / Corrosion -

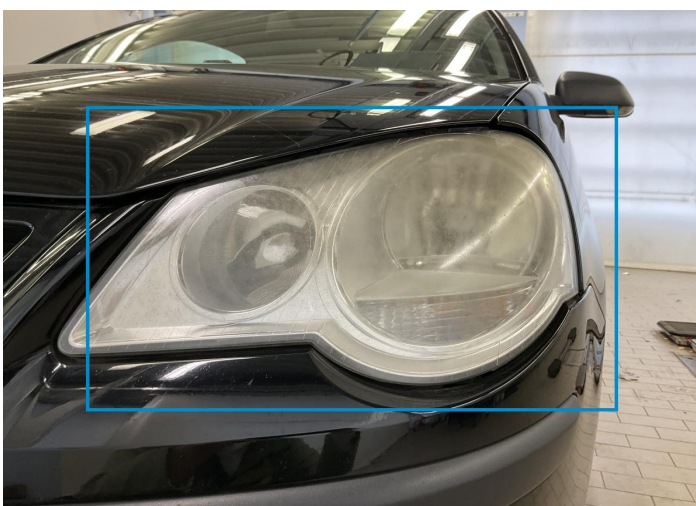
10. Front Light / Front Left  
Glass Break -

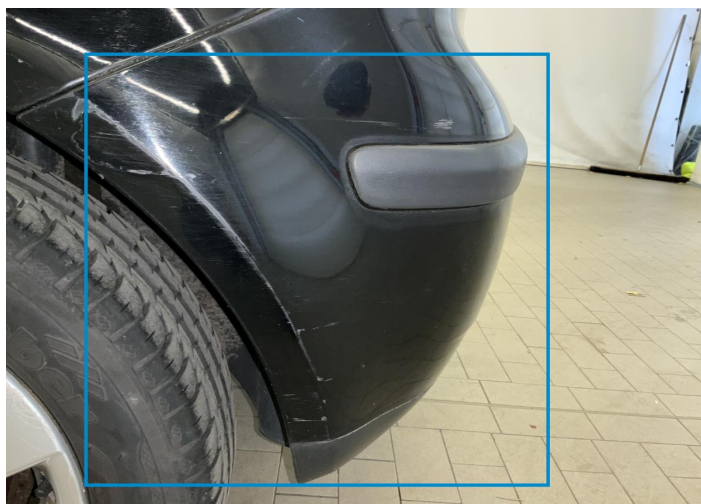
11. Bumper / Back  
Paint / Scratch / Scuff -
