Expertise

Protocol number: 41288940
Order No. / Reference: 25142005
Inspection date: 28 Aug 2025

Manufacturer: Volvo	Model: XC60 T6 AWD Recharge Geartronic R-Design
VIN: LYVUZH1UDNB028617

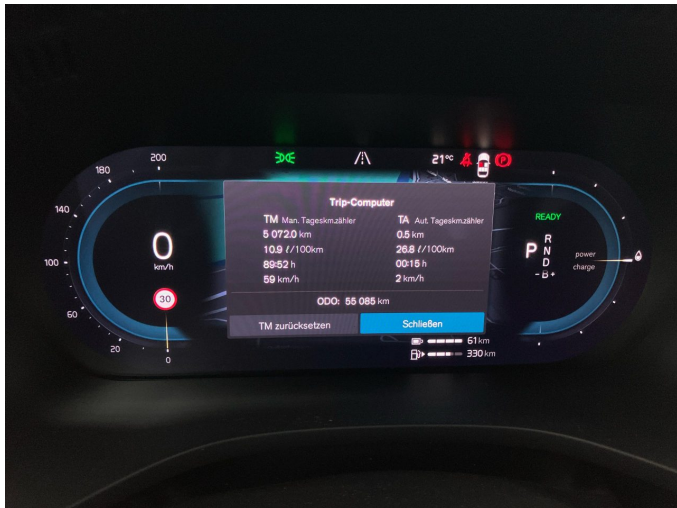
Vehicle details	
Manufacturer / Type / Model / Equipment	
Volvo XC60 T6 AWD Recharge Geartronic R-Design	
Vehicle Identification number	LYVUZH1UDNB028617
Mileage (Read)	55,085 km
First registration	10 Jun 2022
Number of holders	1
Next periodical technical inspection	06/2027
(Report on hand)	
Power / Engine displacement	186 kw / 1,969 ccm
Fuel type / Cylinder	Hybr.B/E ext. edition / 4
Gearbox / Number of gears	Automatic / 8
Type of drive	All-wheel drive
Type of vehicle	SUV
Colour / colour code	Crystal Weiß-Perleffekt
Doors / Seats	5 / 5
Upholstery type	Cloth / leather combination
Colour of upholstery	Black-Grey
Re/Import	no
Driving readiness	Roadworthy

Figure 7: Instrument cluster

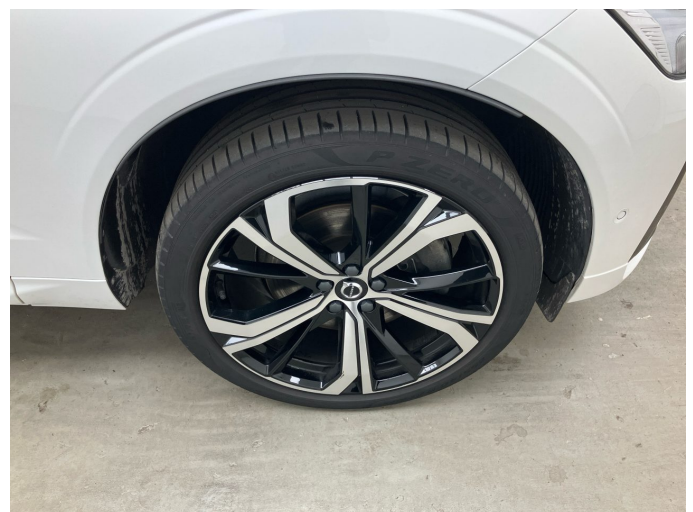
#	Tyre size	Type of tyre	Manufacturer	Tread depth
1)	255/40 R21 102V	Summer tyres on Light alloy	Pirelli	4mm / 4mm
2)	255/40 R21 102V	Summer tyres on Light alloy	Pirelli	4mm / 4mm

Figure 12: Mounted tyres

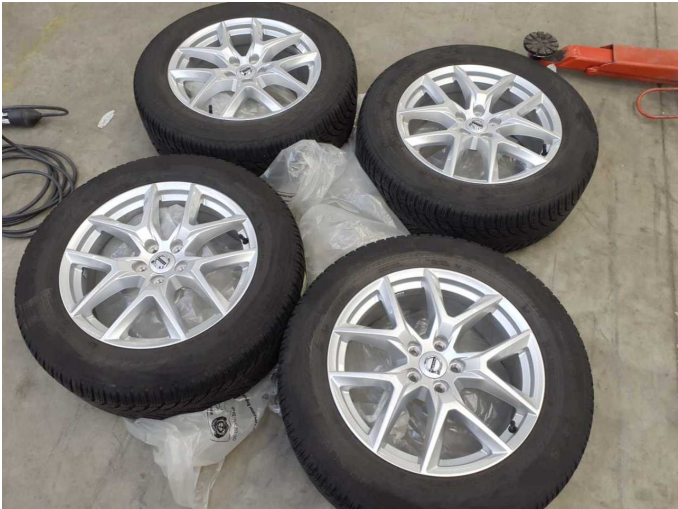
#	Tyre size	Type of tyre	Manufacturer	Tread depth
1)	235/60 R18 107V	Winter tyres on Light alloy	Nokian	5mm / 5mm
2)	235/60 R18 107V	Winter tyres on Light alloy	Nokian	5mm / 5mm

Figure 16: Additional tyres

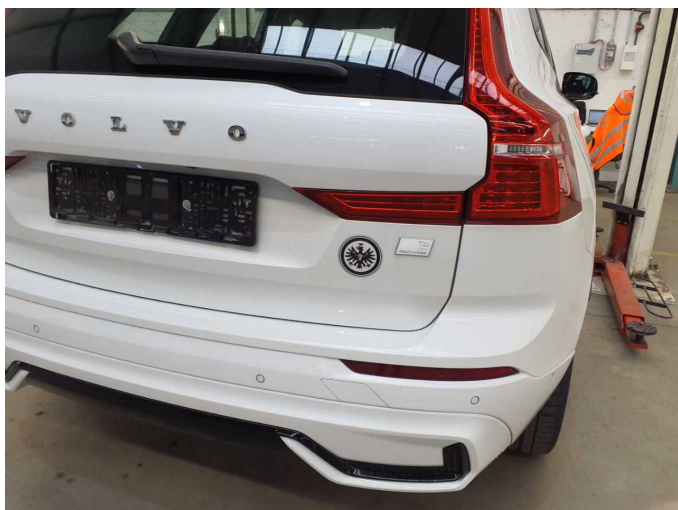
No.	Component group	Description
1	Body	Body - Glued / labelled - De-glue / neutralise
2	Wheel / tyres	Alloy rim - rear right side - Scratched - Loss in value

Damage 1: Body: Body - Glued / labelled - De-glue / neutralise

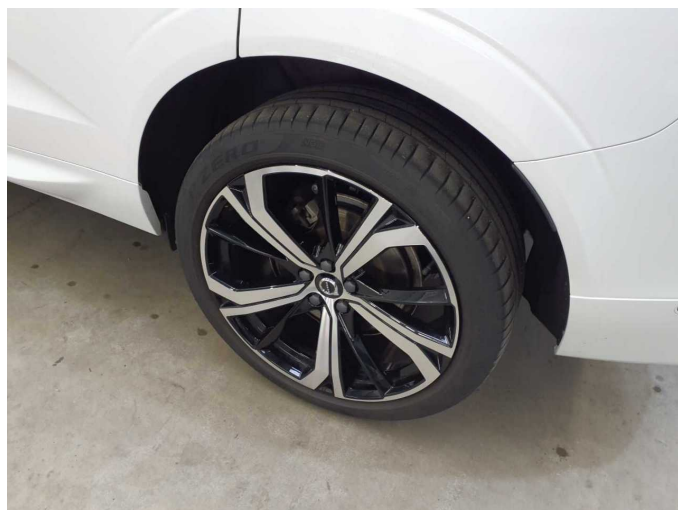
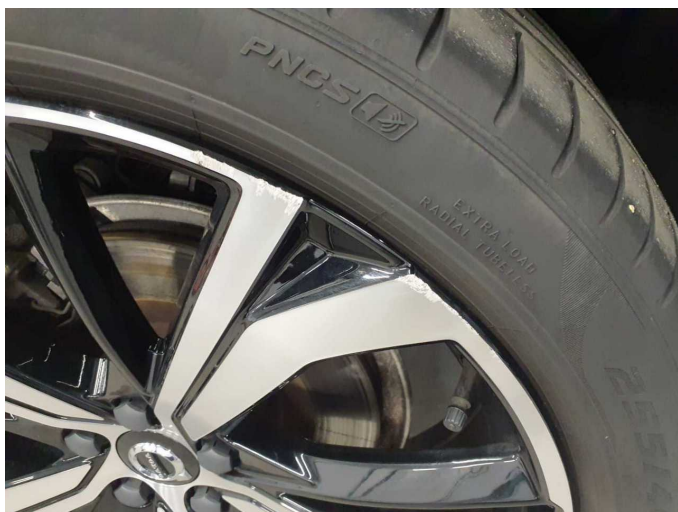
Damage 2: Wheel / tyres: Alloy rim - rear right side - Scratched - Loss in value
