Expertise

Protocol number: 41688844
Order No. / Reference: 25178418
Inspection date: 25 Sept 2025

Manufacturer: Volvo	Model: XC60 T6 AWD Recharge Geartronic Inscription
VIN: LYVUZH1VDNB062667

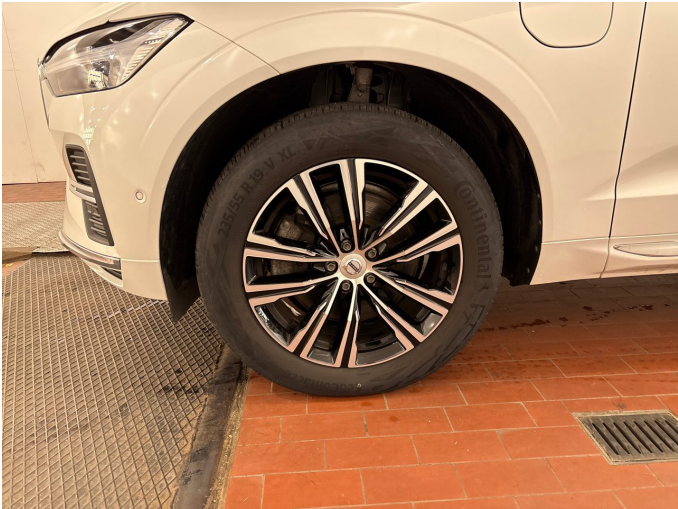
Figure 12: Mounted tyres

#	Tyre size	Type of tyre	Manufacturer	Tread depth
1)	235/55 R19 105V	Summer tyres on Light alloy	Continental	5mm / 5mm
2)	235/55 R19 105V	Summer tyres on Light alloy	Continental	5mm / 5mm

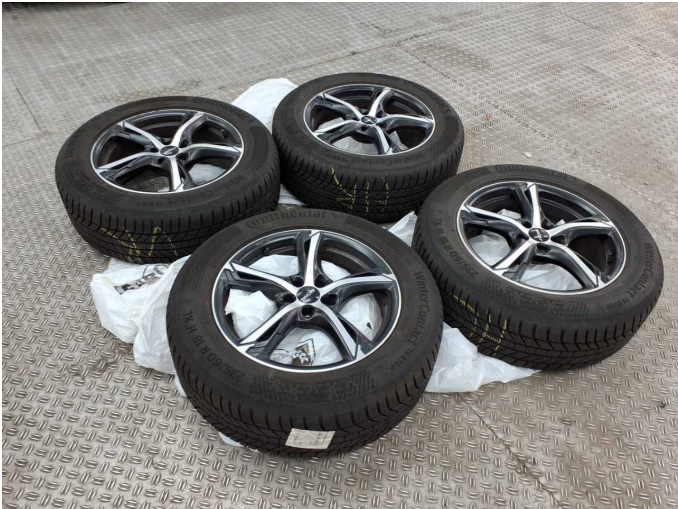
Figure 16: Additional tyres

#	Tyre size	Type of tyre	Manufacturer	Tread depth
1)	235/60 R18 107H	Winter tyres on Light alloy	Continental	6mm / 6mm
2)	235/60 R18 107H	Winter tyres on Light alloy	Continental	6mm / 6mm

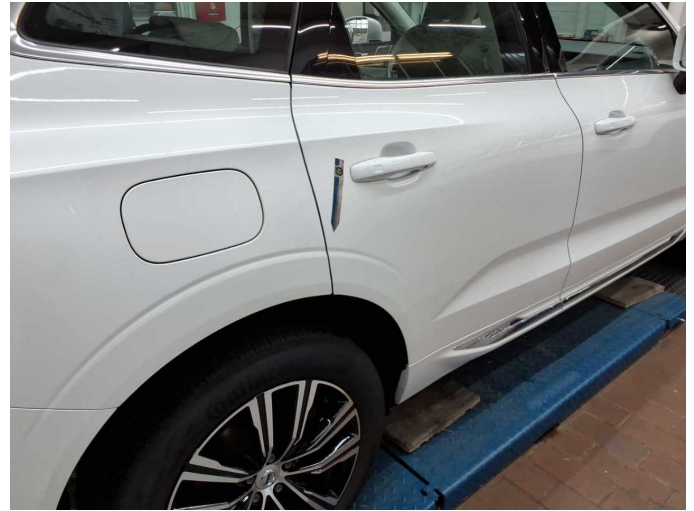
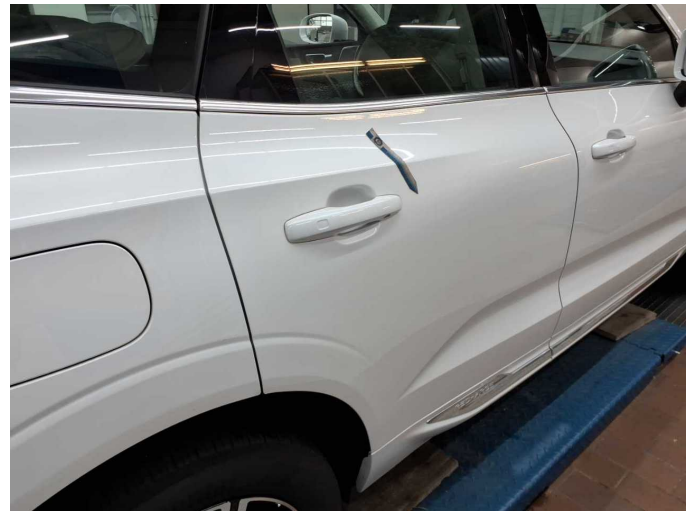
Damage 1: Door - rear right side: Door - dent(s) - Smart repair

No.	Component group	Description
1	Door - rear right side	Door - dent(s) - Smart repair
2	Door - rear left side	Door - dent(s) - Smart repair
3	Front bumper	Front bumper - Scratched - Smart repair
4	Side panel - rear right side	Side panel - dent(s) - Smart repair

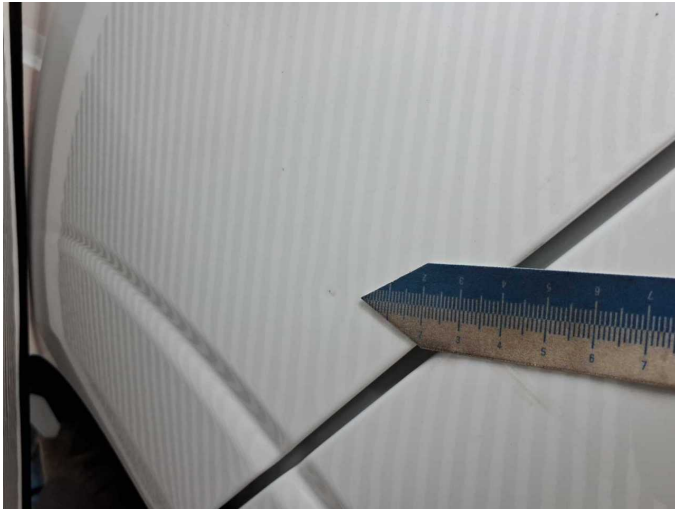
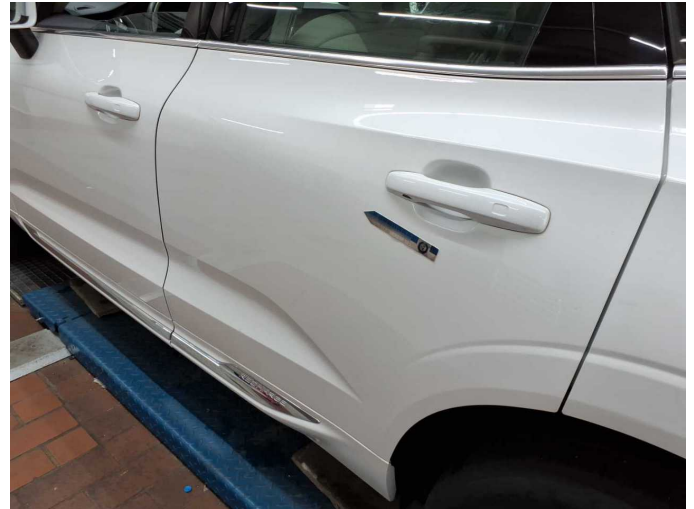
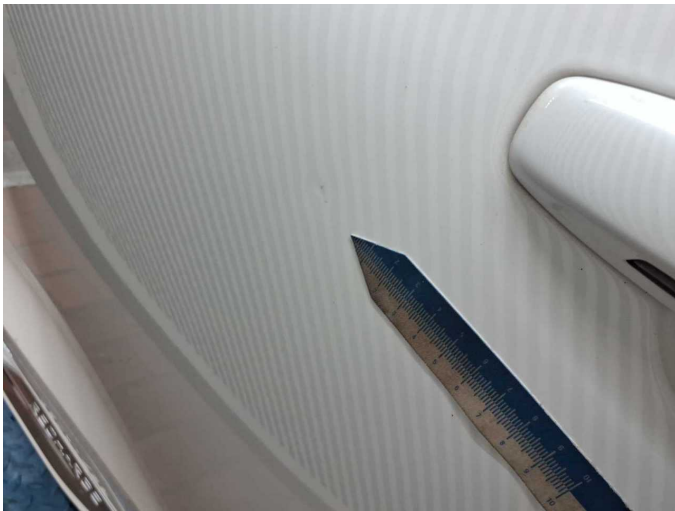
Damage 2: Door - rear left side: Door - dent(s) - Smart repair

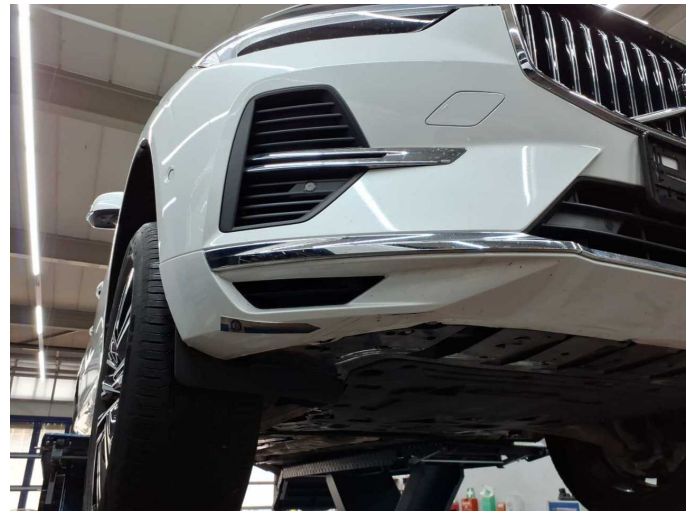
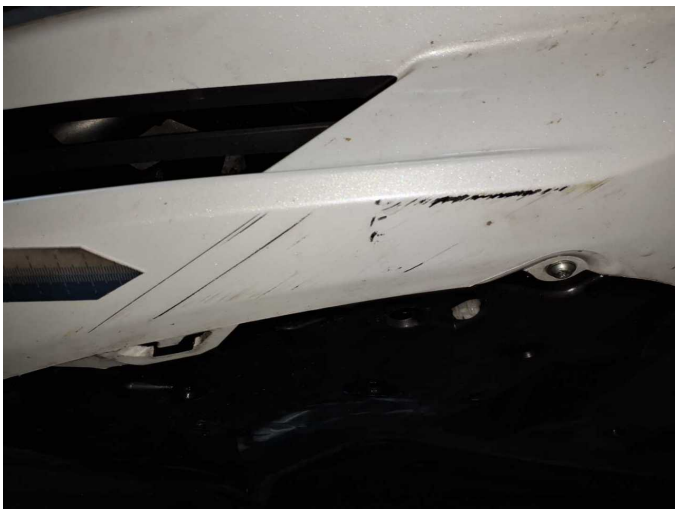
Damage 3: Front bumper: Front bumper - Scratched - Smart repair

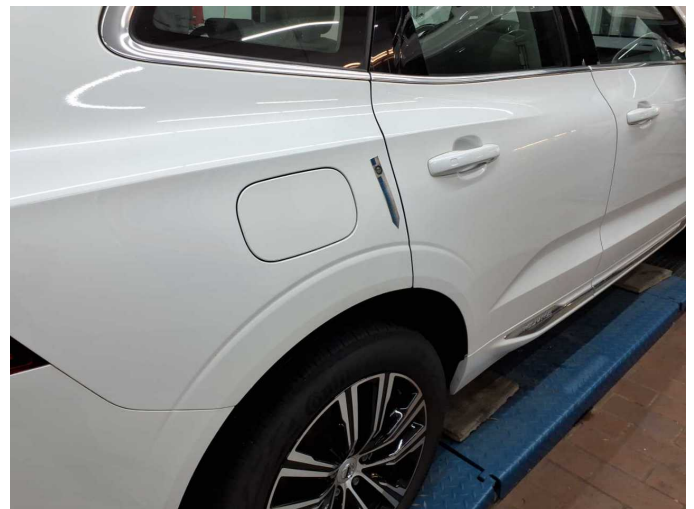
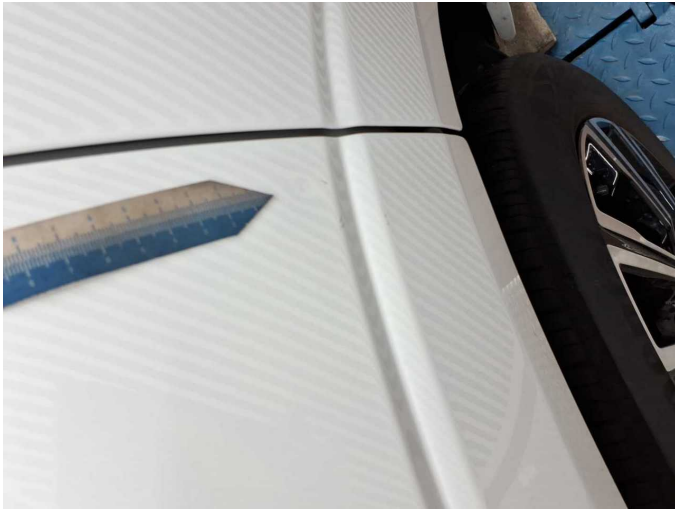
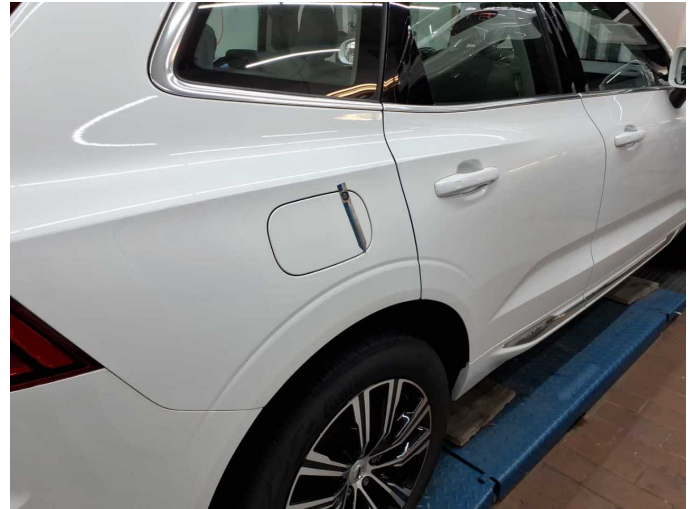
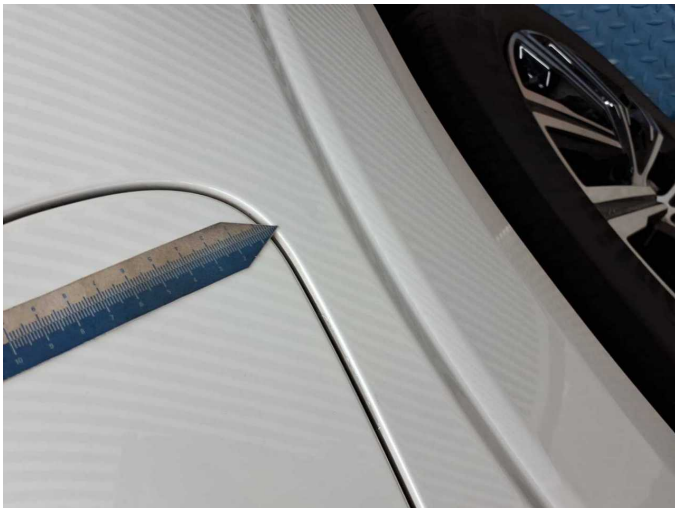
Damage 4: Side panel - rear right side: Side panel - dent(s) - Smart repair

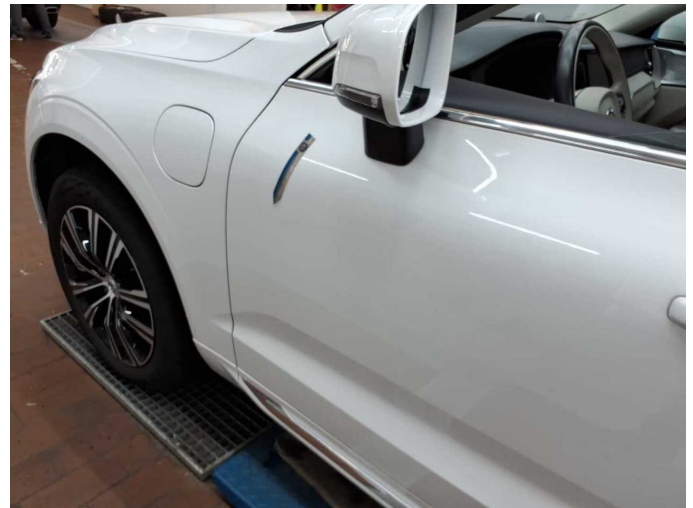
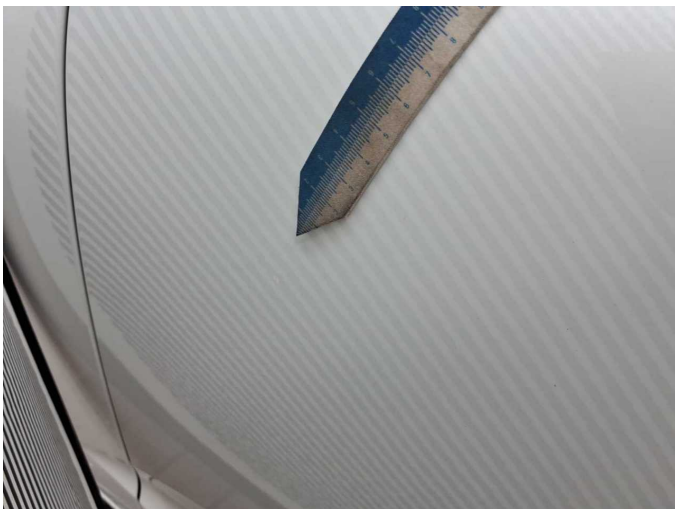
Wear and tear 3: Door - front left side: Door - dent(s) - No deduction

No.	Component group	Description
1	2nd wheel set	1 alloy rim - Scratched - No deduction
2	Vehicle glazing	Windscreen - Stone chips - No deduction
3	Door - front left side	Door - dent(s) - No deduction
