## status report

| Report number: | 0000000841933-EN968 | | |

#### Hyundai Kona (OS)(2017->) Edition 30+ Elektro 2WD

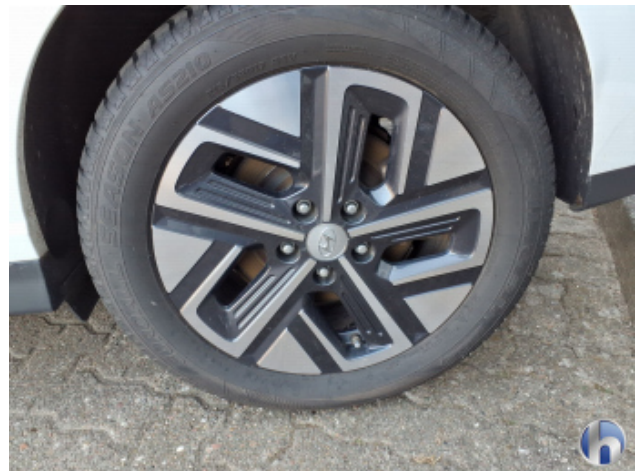
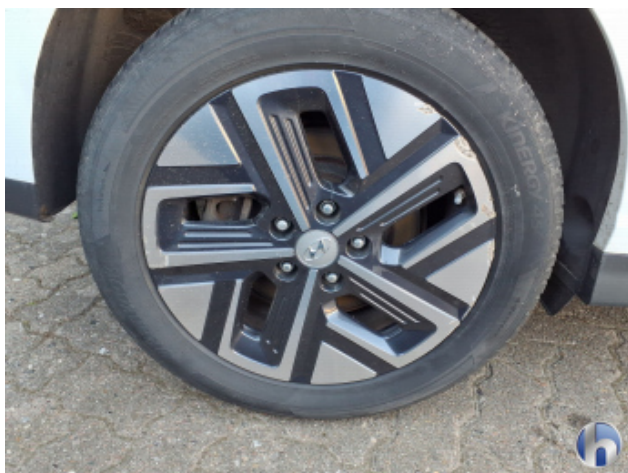
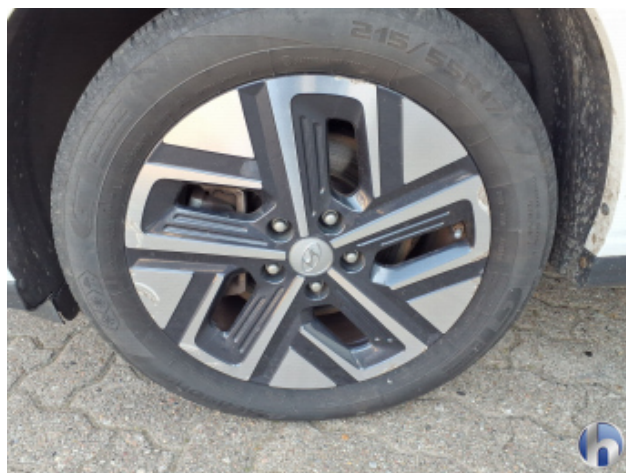
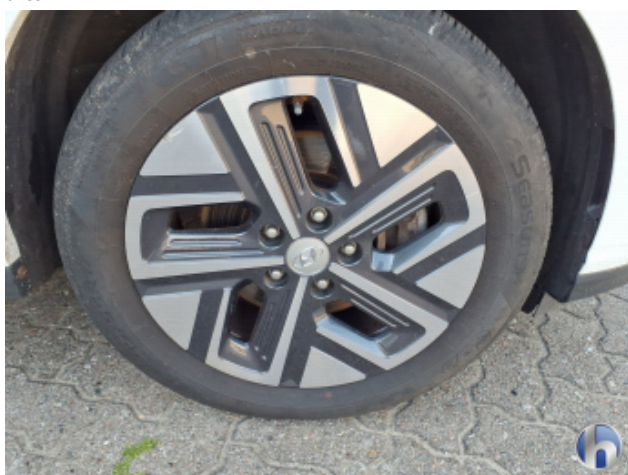
| | All weather tire | Aluminium original |
|---|---|---|
| 1st axis - Left / states . | - | 215/55/R17/-- 3 mm |
| 1st axis - right / states . | - | 215/55/R17/-- 3 mm |
| 2nd axis - Left / states . | - | 215/55/R17/-- 4 mm |
| 2nd axis - right / states . | - | 215/55/R17/-- 4 mm |
| Traffic Safety: | Not roadworthy | |

| 22. | 4 Reifen | Not safe for road traffic | Replace |

tires

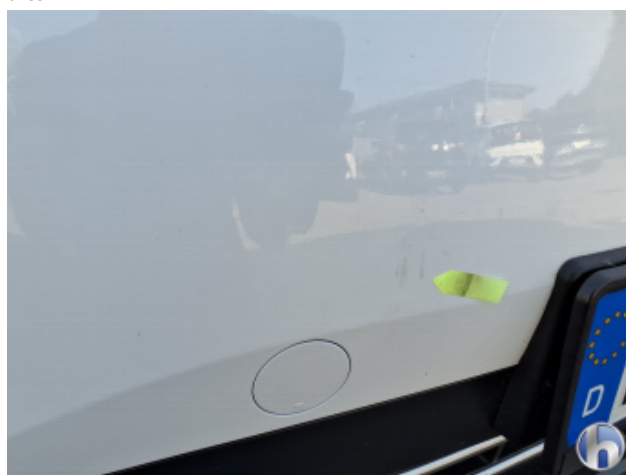
| | Component | Damage | Rep kind |
|---|---|---|---|
| 1. | Front bumper | Wear and tear | Without repair |

1. Front bumper  
Wear and tear - Without repair

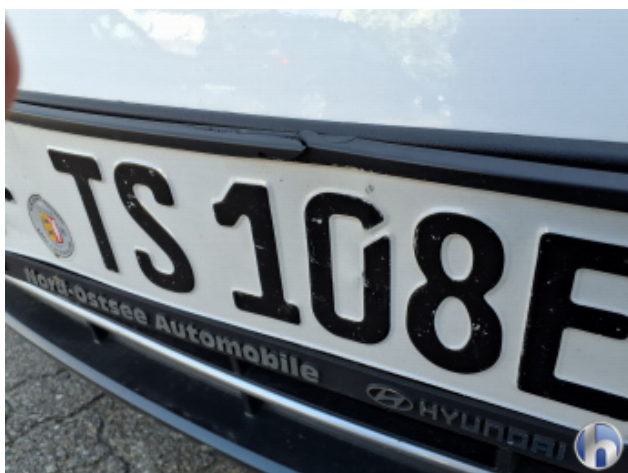
| | Component | Damage | Rep kind |
|---|---|---|---|
| 2. | Front bumper | Wear and tear | Without repair |

2. Front bumper  
Wear and tear - Without repair

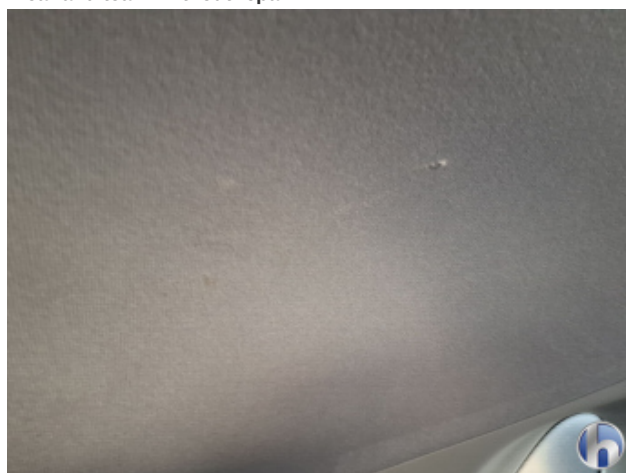
| | Component | Damage | Rep kind |
|---|---|---|---|
| 3. | Roof | Deep scratch | Smart repair |

3. Roof  
Deep scratch - Smart repair

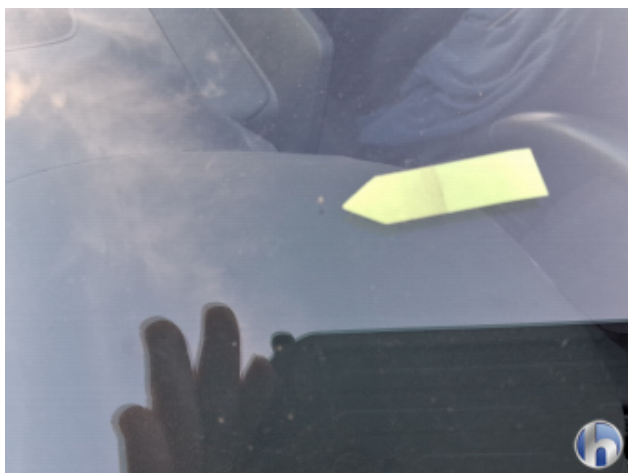
| | Component | Damage | Rep kind |
|---|---|---|---|
| 4. | Windshield | Wear and tear | Without repair |

4. Windshield  
Wear and tear - Without repair

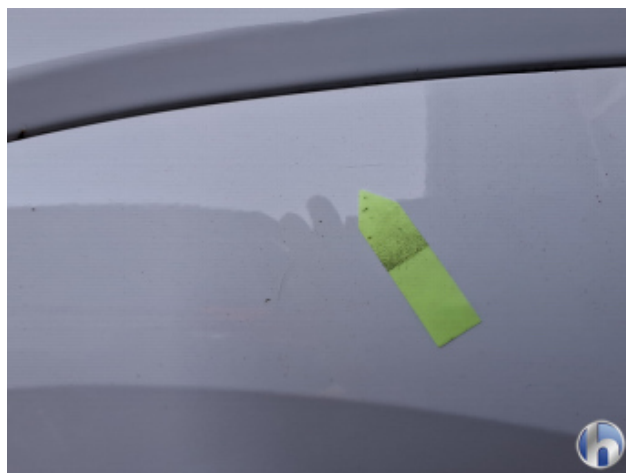
| | Component | Damage | Rep kind |
|---|---|---|---|
| 5. | Sidewall - Rear - Left | Deep scratch | Smart repair |

5. Sidewall - Rear - Left  
Deep scratch - Smart repair

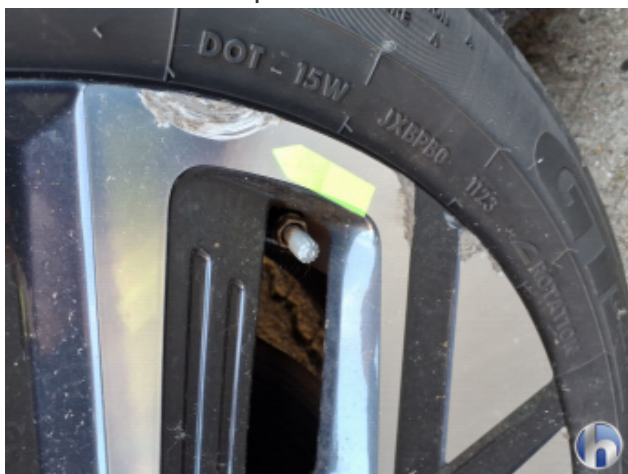
| | Component | Damage | Rep kind |
|---|---|---|---|
| 6. | Rim front - left | Damaged | Smart repair |

6. Rim front - left  
Damaged - Smart repair

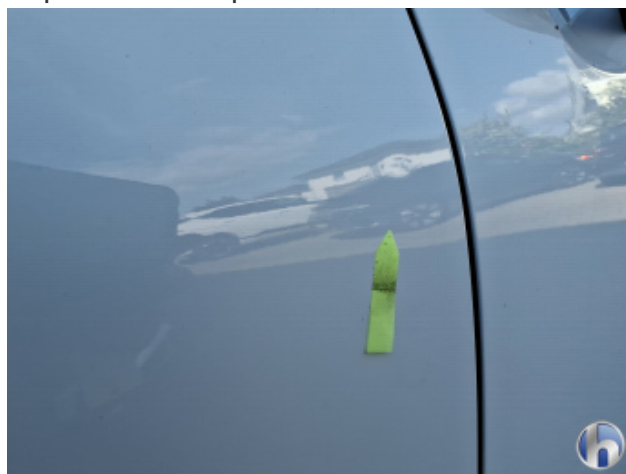
| | Component | Damage | Rep kind |
|---|---|---|---|
| 7. | Rear Door - Right | Dented | Gentle refurbishing |

7. Rear Door - Right  
Dented - Gentle refurbishing

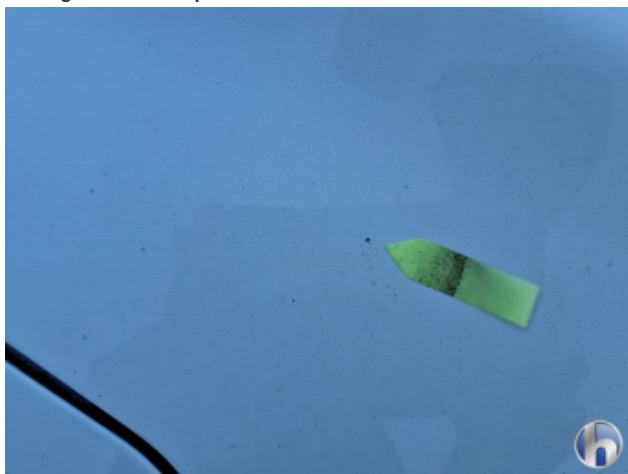
| | Component | Damage | Rep kind |
|---|---|---|---|
| 8. | Hood | Wear and tear | Without repair |

8. Hood  
Wear and tear - Without repair

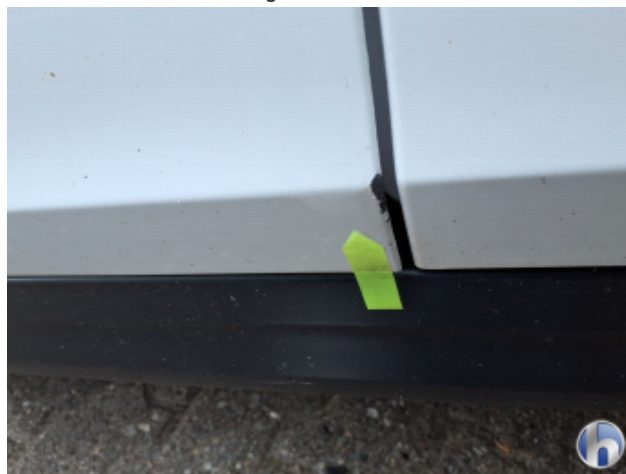
| | Component | Damage | Rep kind |
|---|---|---|---|
| 9. | Front door - left | Deep scratch | Smart repair |

9. Front door - left  
Deep scratch - Smart repair

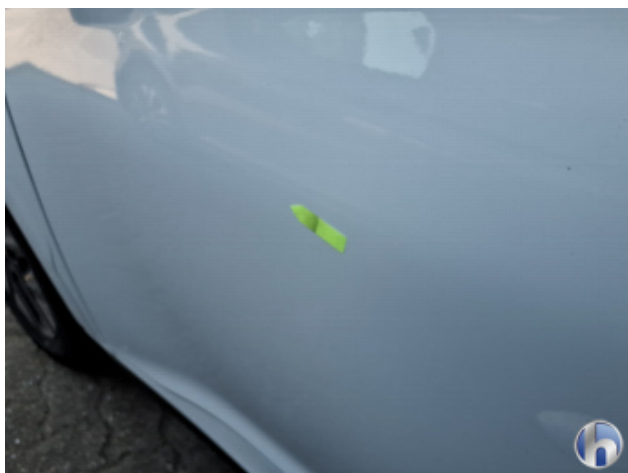
| | Component | Damage | Rep kind |
|---|---|---|---|
| 10. | Front door - left | Wear and tear | Without repair |

10. Front door - left  
Wear and tear - Without repair

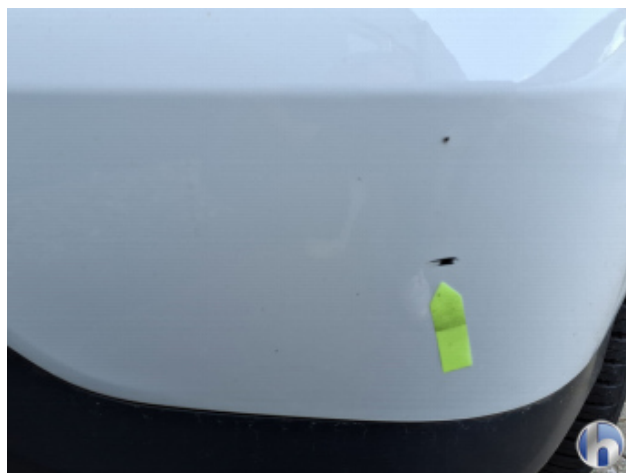
| | Component | Damage | Rep kind |
|---|---|---|---|
| 11. | Rear Bumper | Deep scratch | Smart repair |

11. Rear Bumper  
Deep scratch - Smart repair

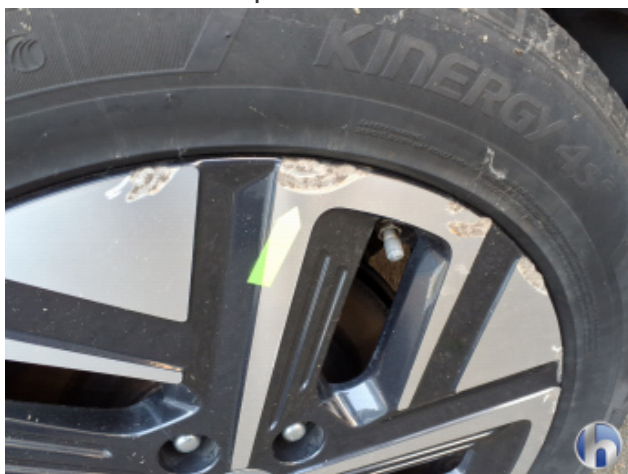
| | Component | Damage | Rep kind |
|---|---|---|---|
| 12. | Rim rear - right | Damaged | Smart repair |

12. Rim rear - right  
Damaged - Smart repair

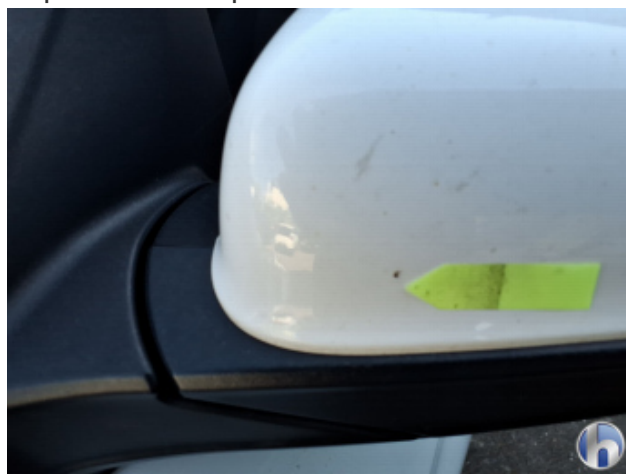
| | Component | Damage | Rep kind |
|---|---|---|---|
| 13. | Outside mirror - left | Chipping from stones | Smart repair |

13. Outside mirror - left  
Chipping from stones - Smart repair

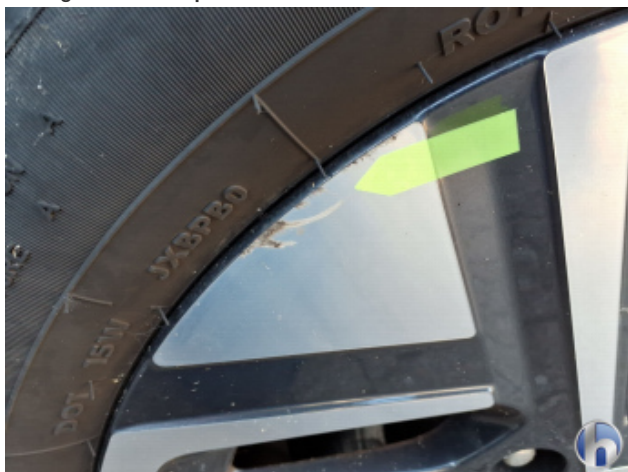
| | Component | Damage | Rep kind |
|---|---|---|---|
| 14. | Rim front - right | Damaged | Smart repair |

14. Rim front - right  
Damaged - Smart repair

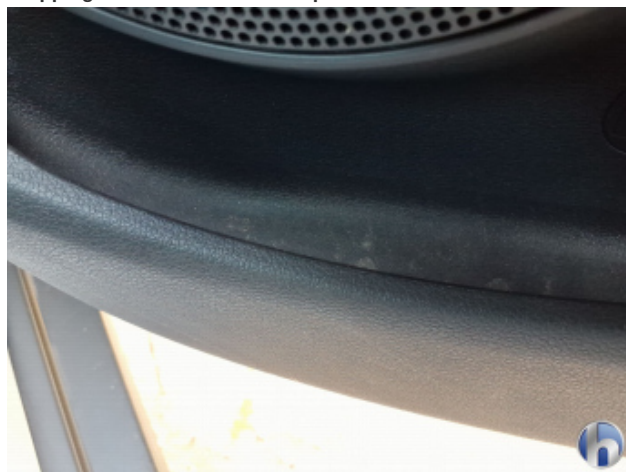
| | Component | Damage | Rep kind |
|---|---|---|---|
| 15. | covering | Wear and tear | Without repair |

15. covering  
Wear and tear - Without repair

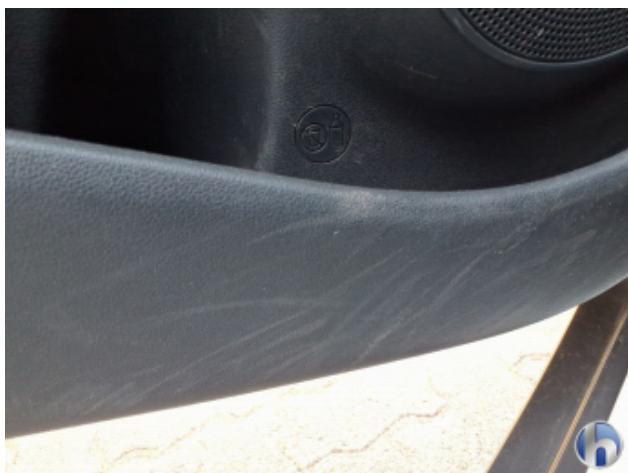
| | Component | Damage | Rep kind |
|---|---|---|---|
| 16. | covering | Wear and tear | Without repair |

16. covering  
Wear and tear - Without repair

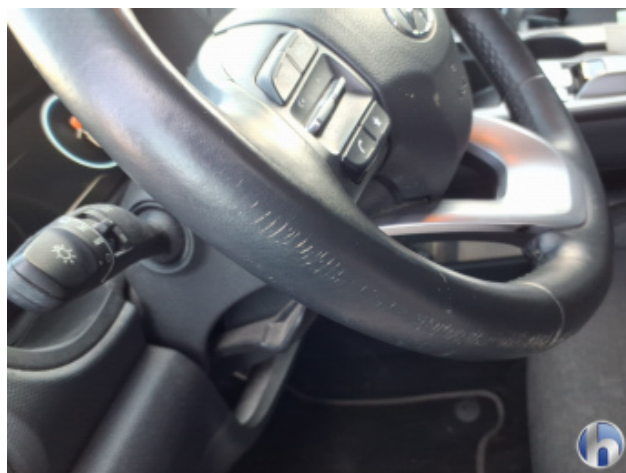
| | Component | Damage | Rep kind |
|---|---|---|---|
| 17. | Steering wheel (leather) | Deep scratch | Replace |

17. Steering wheel (leather)  
Deep scratch - Replace

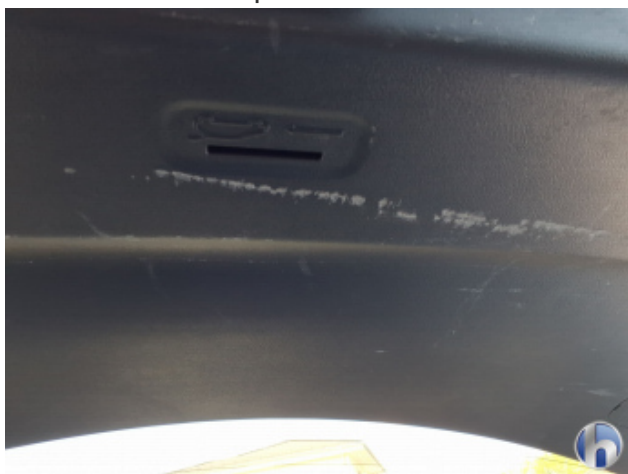
| | Component | Damage | Rep kind |
|---|---|---|---|
| 18. | tailgate trim | Damaged | Replace |

18. tailgate trim  
Damaged - Replace

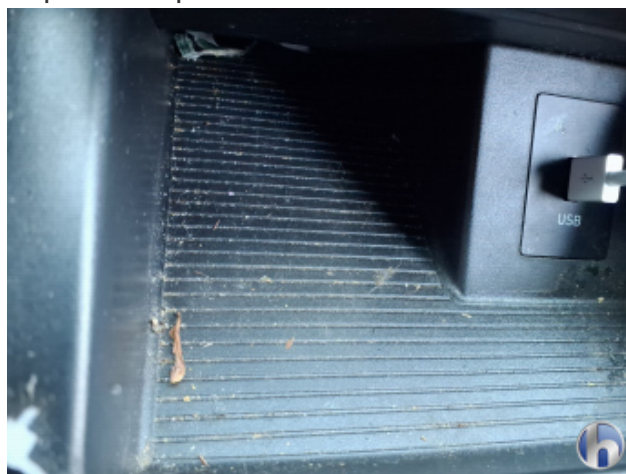
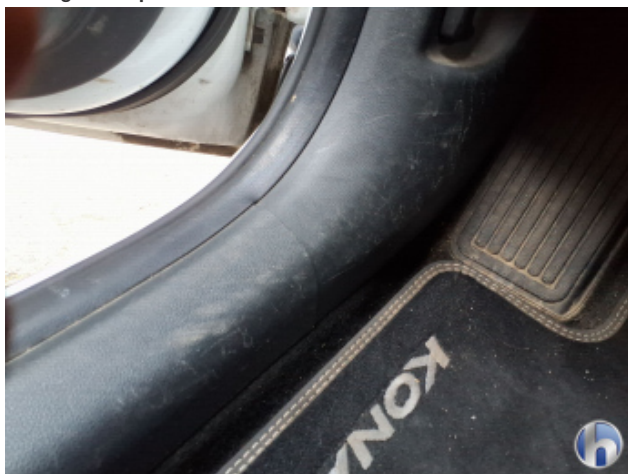
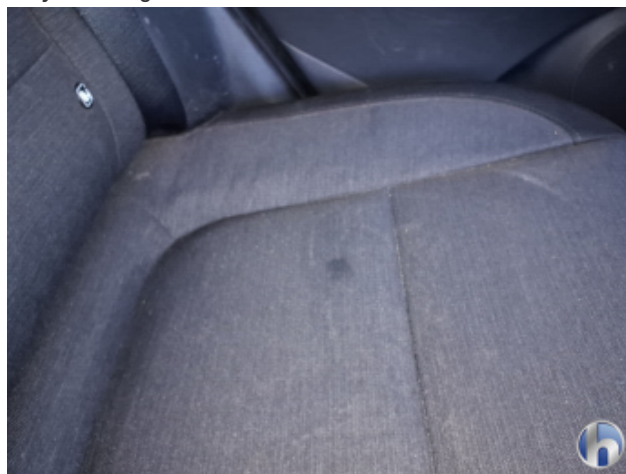
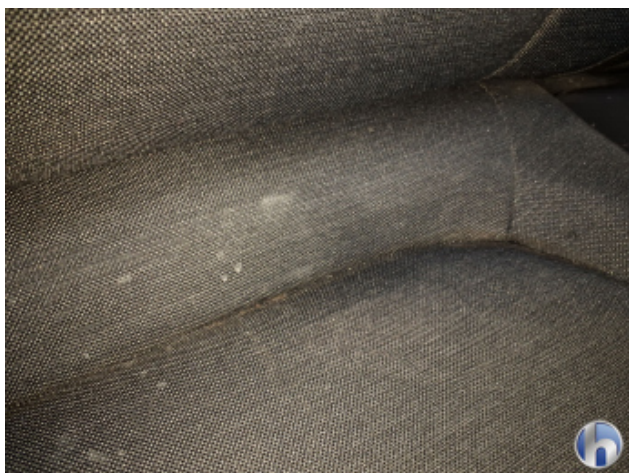
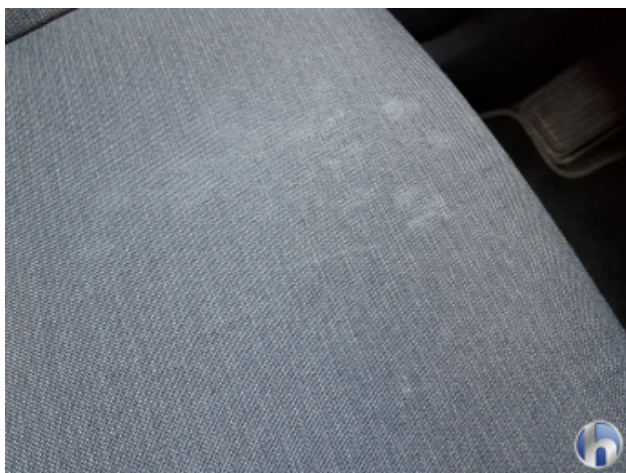
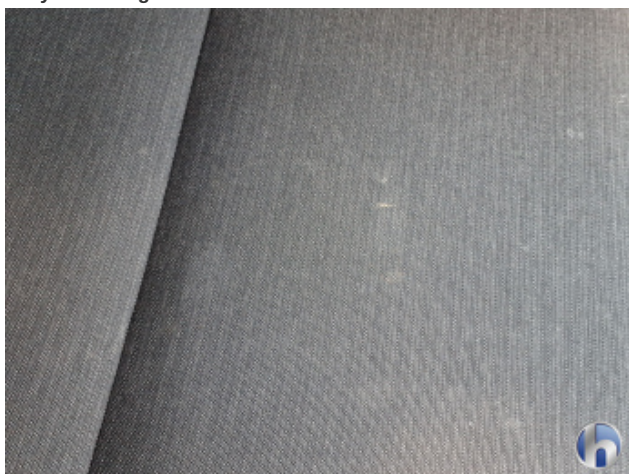
| 19. | Sitz Innenraum rechts vorne | Dirty | cleaning |

19. Sitz Innenraum rechts vorne  
Dirty - cleaning

19. Sitz Innenraum rechts vorne  
**Dirty - cleaning**
