## SKODA Fabia

### Fabia 1.0 MPI

### Inspection Report Summary

| Inspection Date / Place | 2025-09-25 / ARS Altmann<br>AG Riedstadt | Cosmetic Grade | 5 |

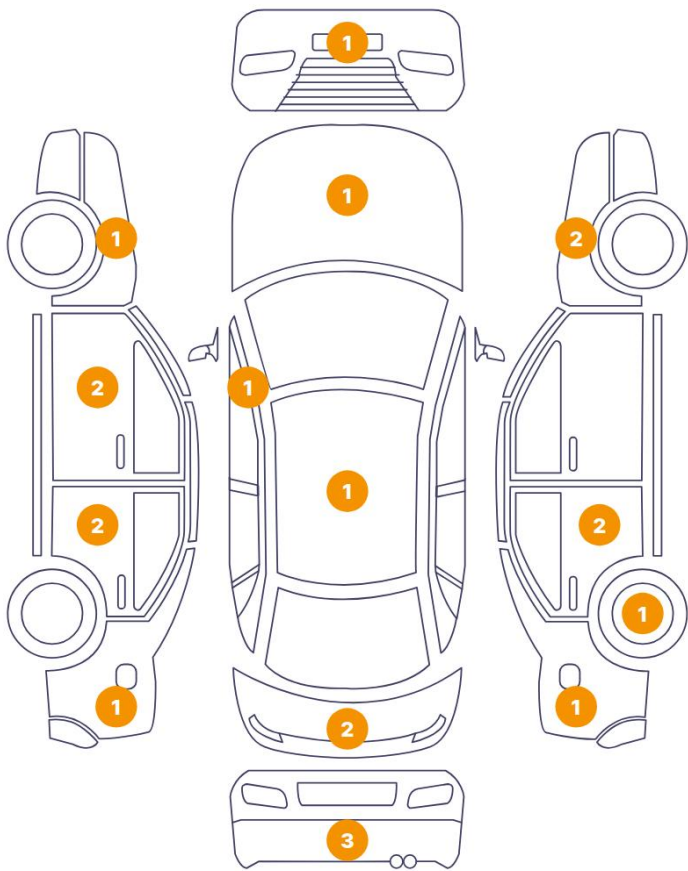
21 Schäden

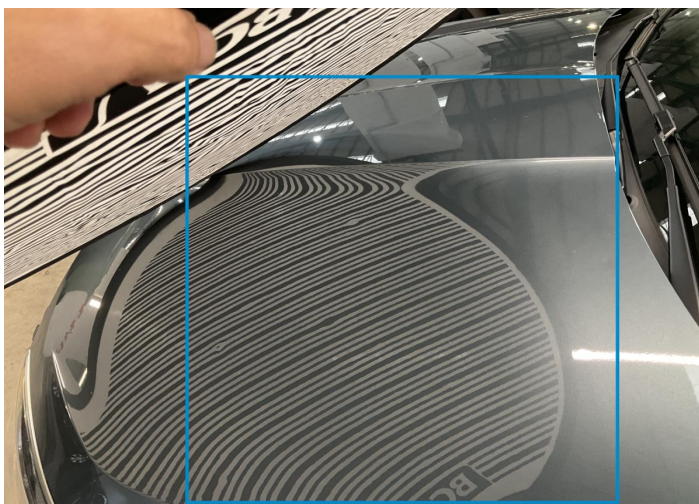
| Component | | Damage | Comments |
|---|---|---|---|
| 1 | Hood | Bodywork / Dent / Hail Area | |

1. Hood  
Bodywork / Dent / Hail Area -

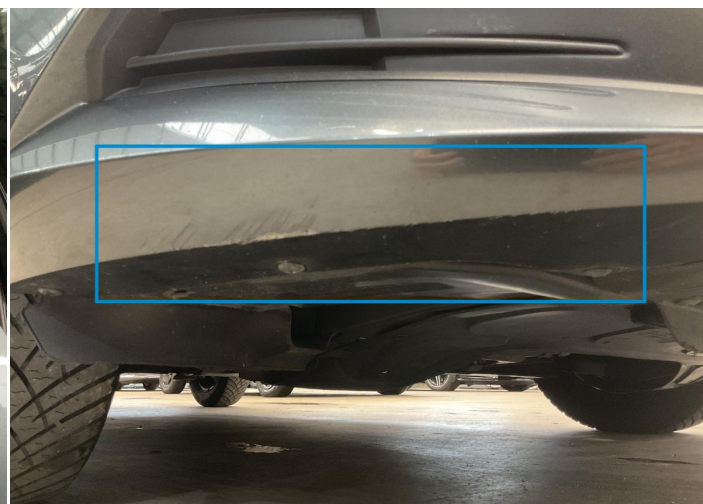
| Component | | Damage | Comments |
|---|---|---|---|
| 2 | Bumper / Front | Paint / Scratch / Scuff | |

2. Bumper / Front  
Paint / Scratch / Scuff -

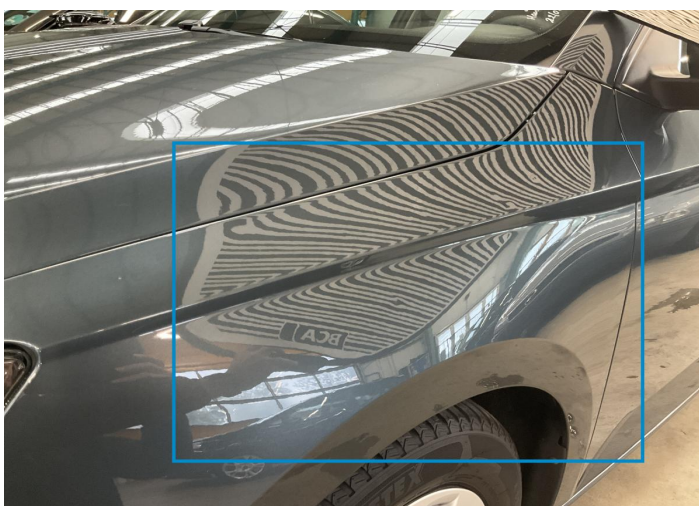
| Component | | Damage | Comments |
|---|---|---|---|
| 3 | Fender / Front Left | Bodywork / Dent / Hail Area | |

3. Fender / Front Left  
Bodywork / Dent / Hail Area -

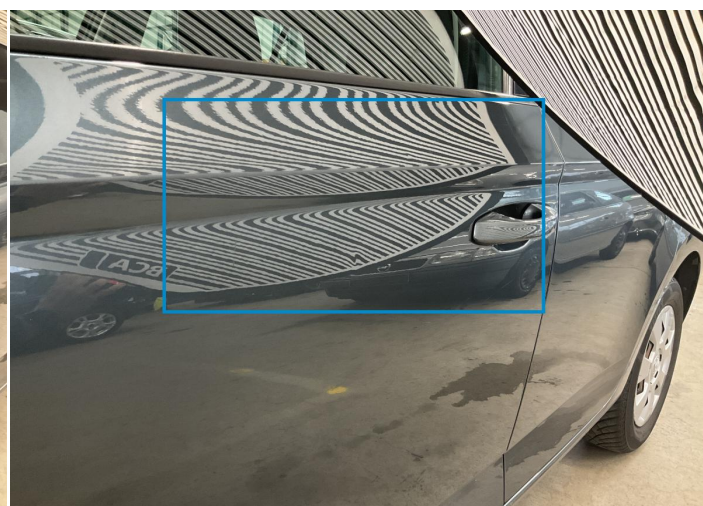
| Component | | Damage | Comments |
|---|---|---|---|
| 4 | Door / Front Left | Bodywork / Dent / Hail Area | |

4. Door / Front Left  
Bodywork / Dent / Hail Area -

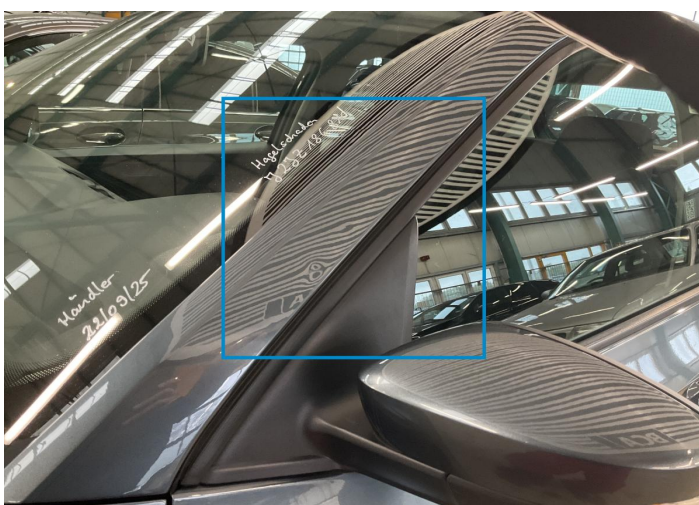
| Component | | Damage | Comments |
|---|---|---|---|
| 5 | Deflector / Front Left | Bodywork / Dent | |

5. Deflector / Front Left  
Bodywork / Dent -

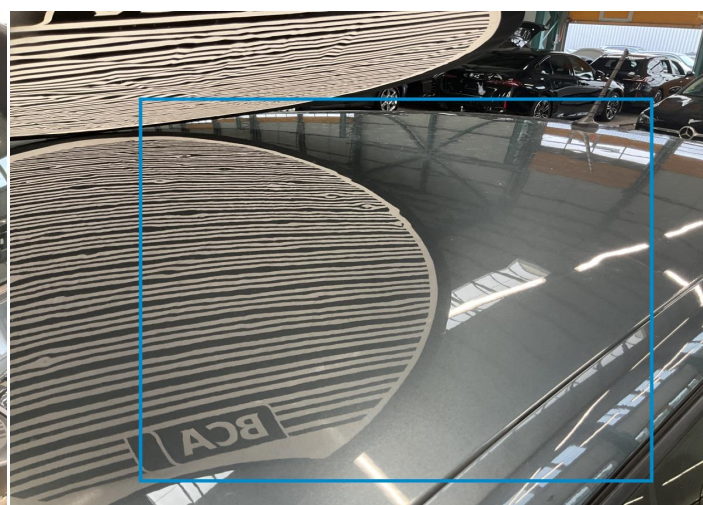
| Component | | Damage | Comments |
|---|---|---|---|
| 6 | Roof | Bodywork / Dent / Hail Area | |

6. Roof  
Bodywork / Dent / Hail Area -

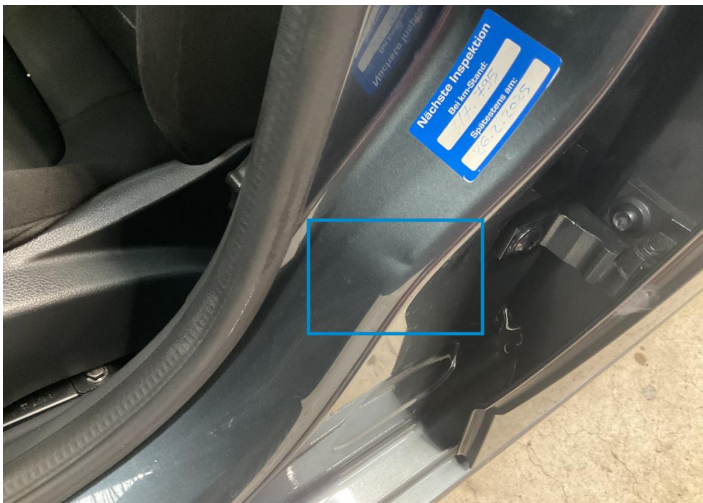
| Component | | Damage | Comments |
|---|---|---|---|
| 7 | Pillar / Front Left | Bodywork / Dent / Dent | |

7. Pillar / Front Left  
Bodywork / Dent / Dent -

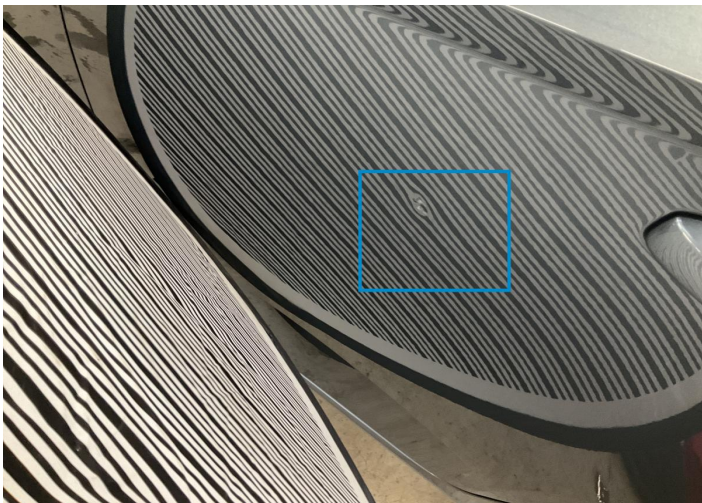
| Component | | Damage | Comments |
|---|---|---|---|
| 8 | Door / Back Left | Bodywork / Dent / Dent | |

8. Door / Back Left  
Bodywork / Dent / Dent -

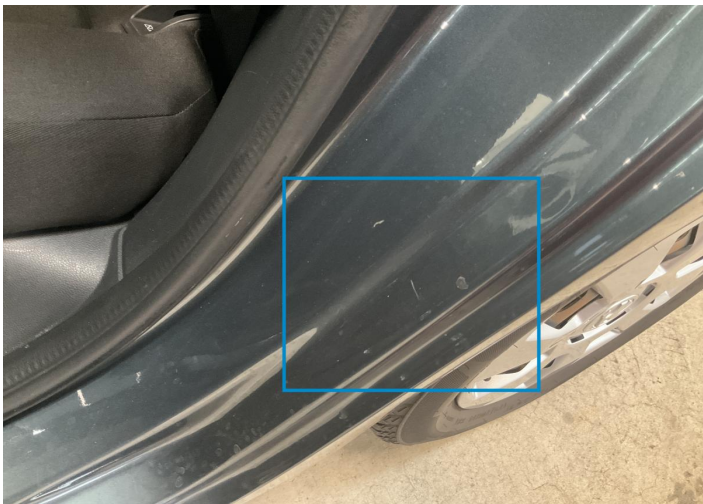
| Component | | Damage | Comments |
|---|---|---|---|
| 9 | Pillar / Back Left | Bodywork / Dent / Dent | |

9. Pillar / Back Left  
Bodywork / Dent / Dent -

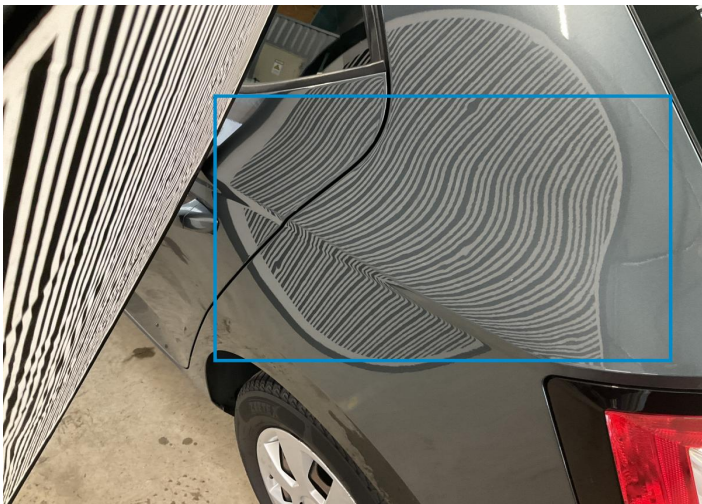
| Component | | Damage | Comments |
|---|---|---|---|
| 10 | Side Panel / Back Left | Bodywork / Dent / Hail Area | |

10. Side Panel / Back Left  
Bodywork / Dent / Hail Area -

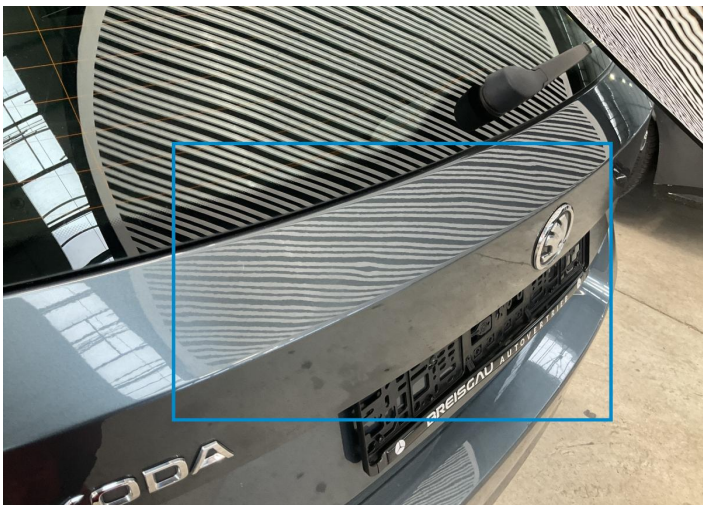
| Component | | Damage | Comments |
|---|---|---|---|
| 11 | Tailgate | Bodywork / Dent / Hail Area | |

11. Tailgate  
Bodywork / Dent / Hail Area -

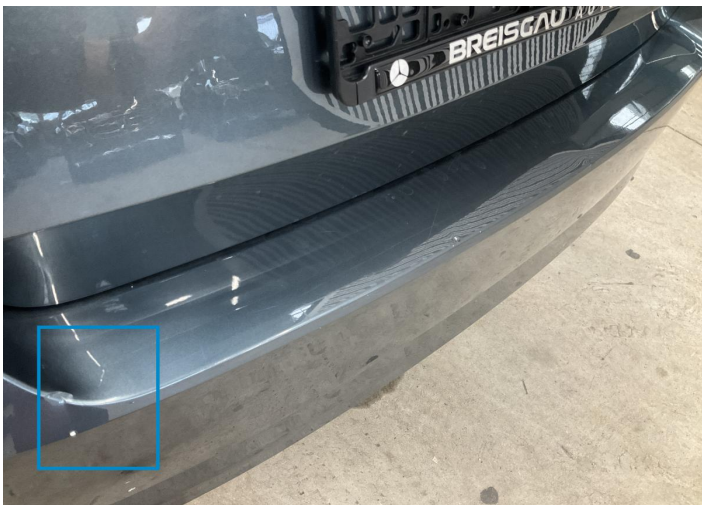
| Component | | Damage | Comments |
|---|---|---|---|
| 12 | Bumper / Back | Bodywork / Dent / Dent | |

12. Bumper / Back  
Bodywork / Dent / Dent -

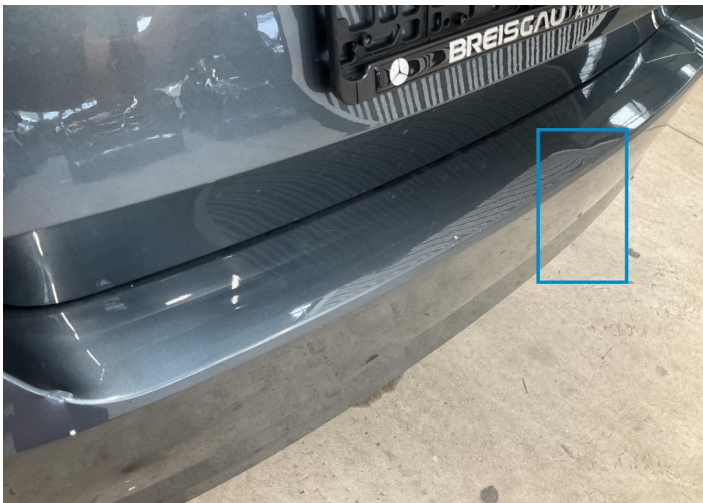
| 13 | Bumper / Back | Bodywork / Dent / Dent |

13. Bumper / Back  
Bodywork / Dent / Dent -

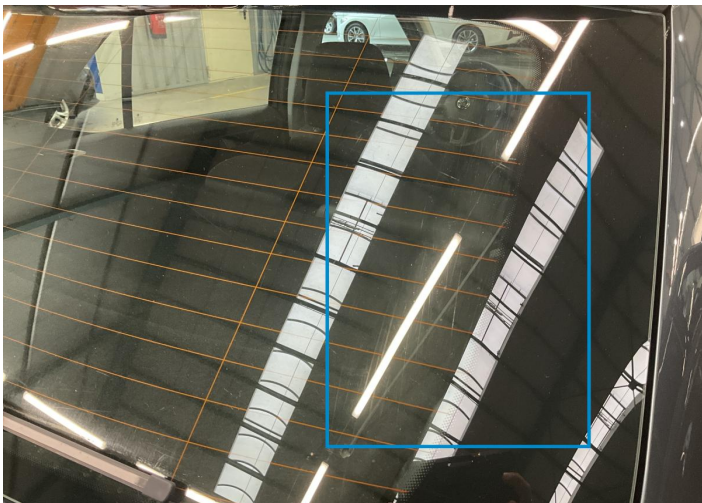
| 14 | Rear Window / Back | Glass Break / Scratch / Scratch |

14. Rear Window / Back  
Glass Break / Scratch / Scratch -

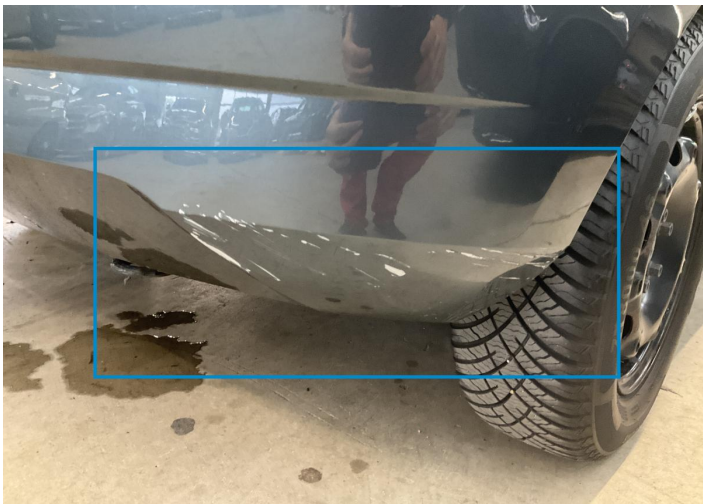
| 15 | Bumper / Back | Paint / Scratch / Scuff |

15. Bumper / Back  
Paint / Scratch / Scuff -

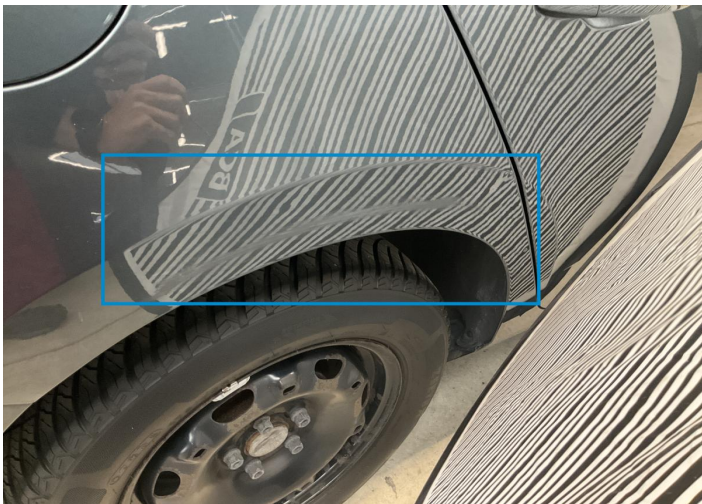
| 16 | Fender / Back Right | Bodywork / Dent / Dent |

16. Fender / Back Right  
Bodywork / Dent / Dent -

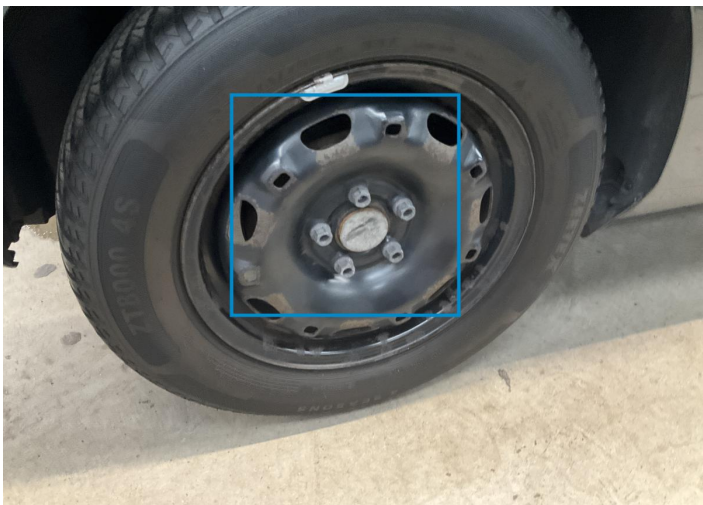
| 17 | Hubcap / Back Right | Missing element hubcap |

17. Hubcap / Back Right  
Missing element hubcap -

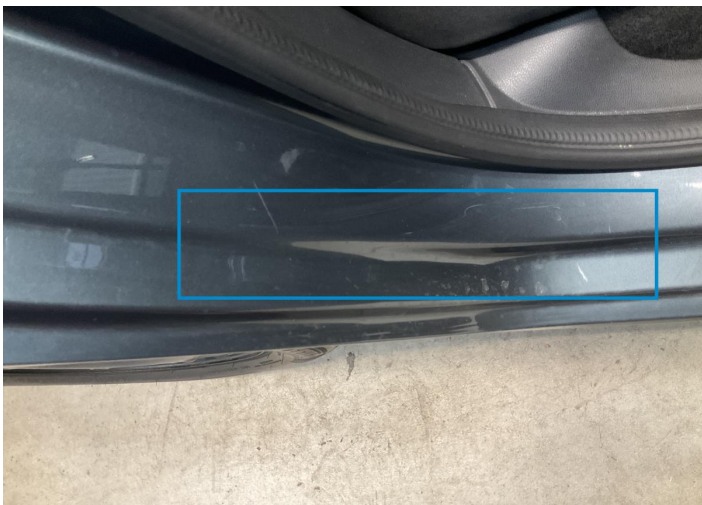
| 18 | Pillar / Back Right | Paint / Scratch / Scuff |

18. Pillar / Back Right  
Paint / Scratch / Scuff -

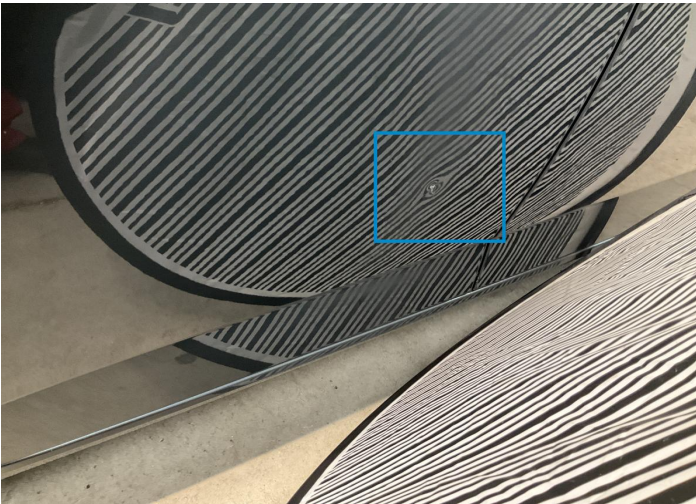
| 19 | Door / Back Right | Bodywork / Dent / Dent |

19. Door / Back Right  
Bodywork / Dent / Dent -

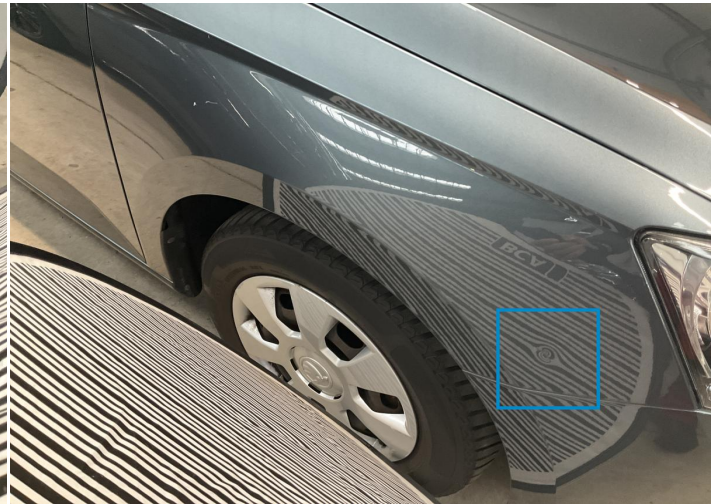
| 20 | Fender / Front Right | Bodywork / Dent / Dent |

20. Fender / Front Right  
Bodywork / Dent / Dent -

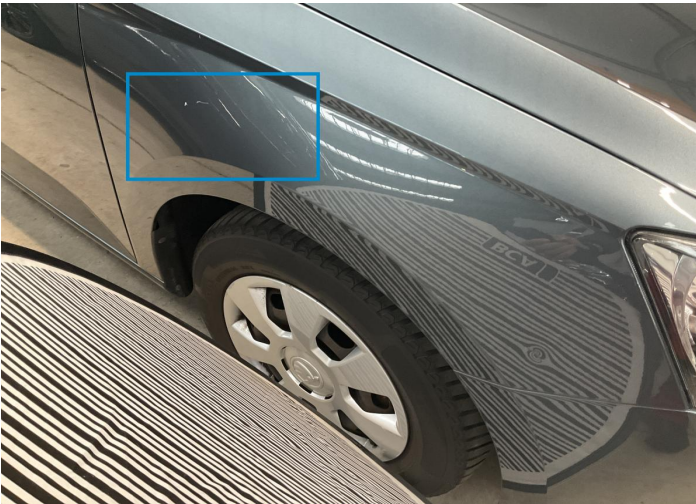
| 21 | Fender / Front Right | Paint / Scratch / Scuff |

21. Fender / Front Right  
Paint / Scratch / Scuff -
