Expertise

Protocol number: 41017453  
Order No. / Reference: 25048700  
Inspection date: 12 Aug 2025

Manufacturer: Skoda  
VIN: TMBJH7NP7M7066067

Model: Superb Combi 2.0 TDI DSG Ambition

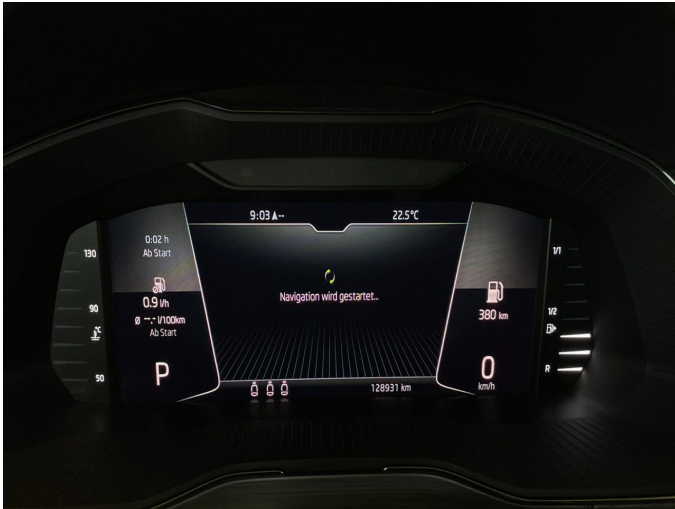
Figure 7: Instrument cluster

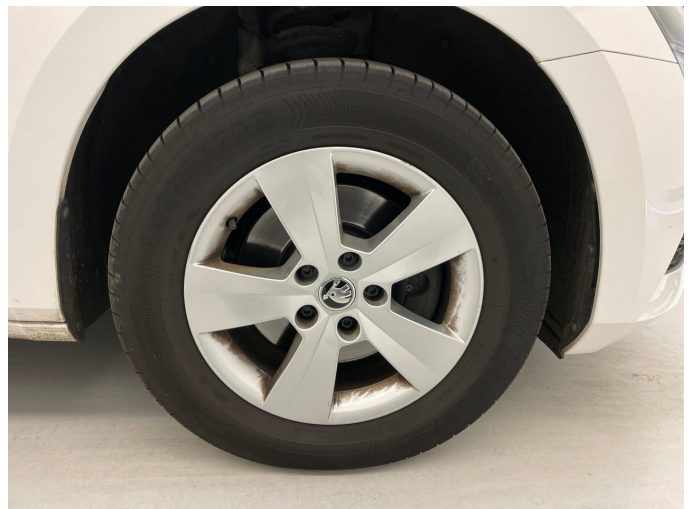
#	Tyre size	Type of tyre	Manufacturer	Tread depth
1)	215/60 R16 99V	Summer tyres on Light alloy	Goodyear	6mm / 6mm
2)	215/60 R16 99V	Summer tyres on Light alloy	Continental	5mm / 5mm

Figure 12: Mounted tyres

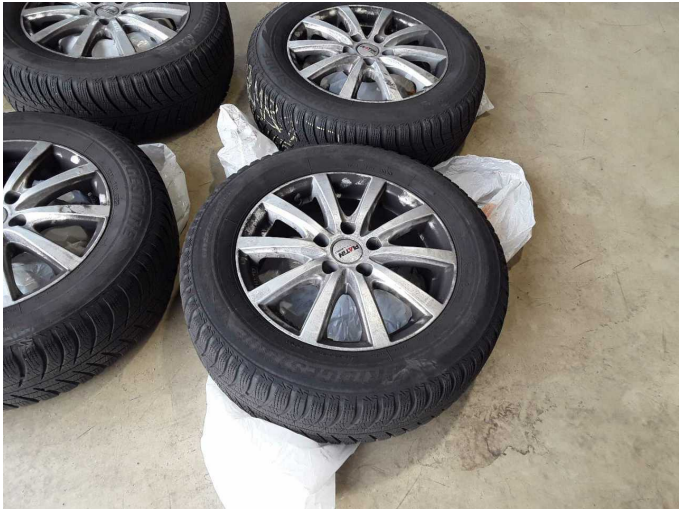
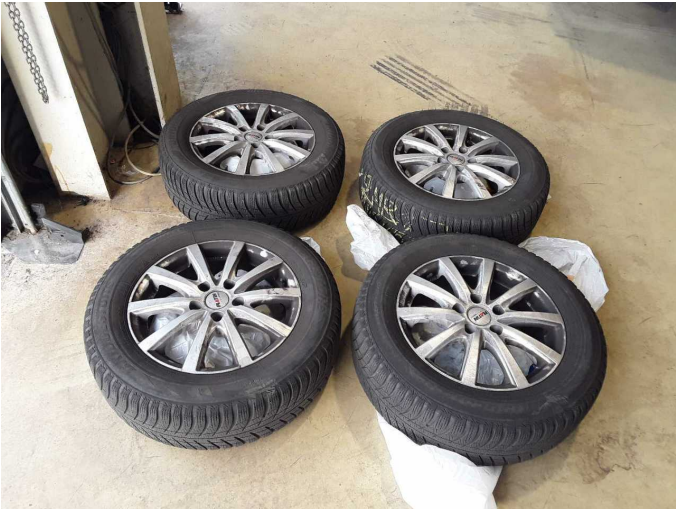
#	Tyre size	Type of tyre	Manufacturer	Tread depth
1)	215/60 R16 99H	Winter tyres on Light alloy	Bridgestone	5mm / 5mm
2)	215/60 R16 99H	Winter tyres on Light alloy	Bridgestone	5mm / 5mm

Figure 16: Additional tyres

Figure 17: Additional tyres

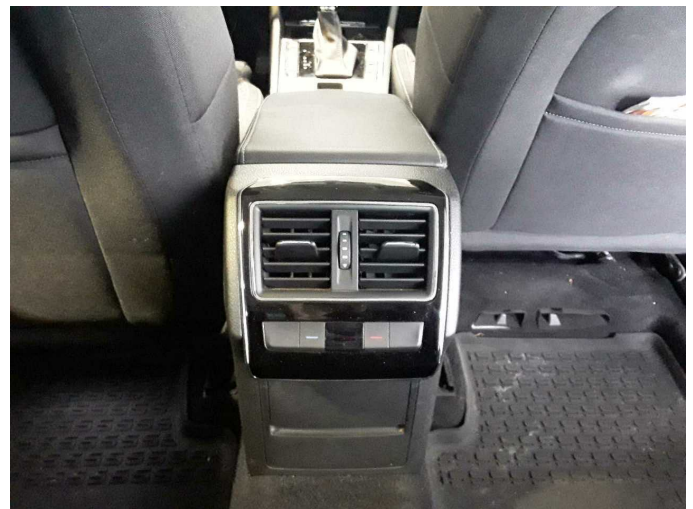
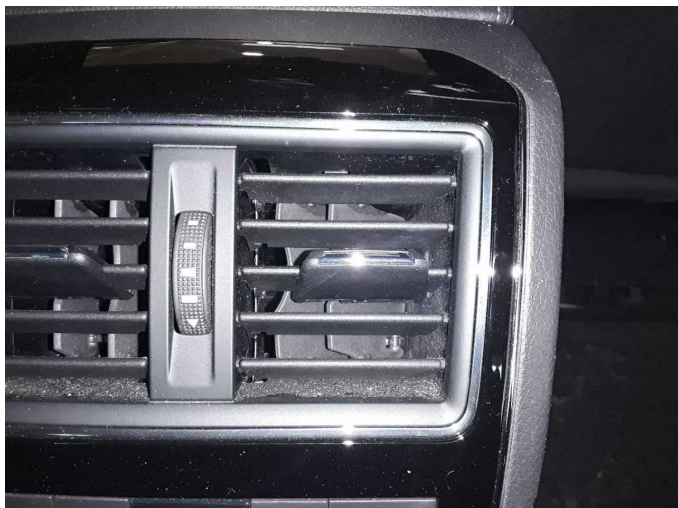
Damage 2: Instrument panel: Air nozzle - centre - Damaged - Replace

**Damage 2:** Instrument panel: Air nozzle - centre - Damaged - Replace

No.	Component group	Description
1	Equipment	Tirefit filler - Expired - Replace
2	Instrument panel	Air nozzle - centre - Damaged - Replace
3	Rear bumper	Rear bumper - Scratched - Paint

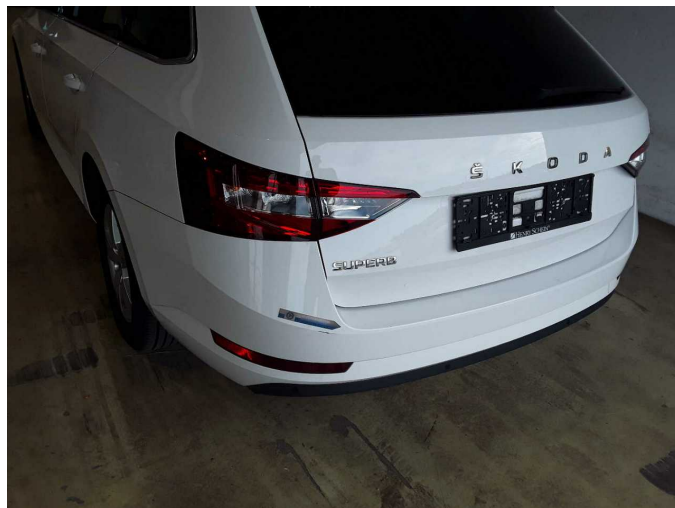
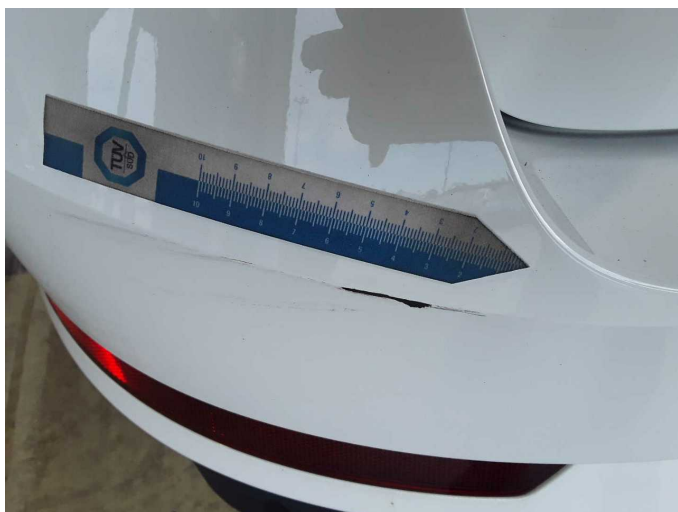
**Damage 3:** Rear bumper: Rear bumper - Scratched - Paint
