Expertise

Protocol number: 39817741
Order No. / Reference: 24731294
Inspection date: 21 May 2025

Manufacturer: Skoda
VIN: TMBJH7NPXL7043669

Model: Superb Combi 2.0 TDI DSG Style

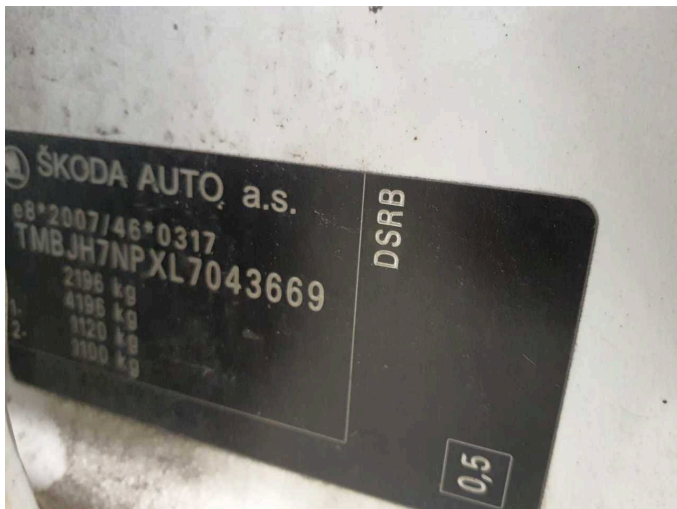
Figure 11: VIN

Documents submitted	At the time of the inspection, the registration certificate part 2 (letter) was available, but the registration certificate part 1 (certificate) was not available. (Copy)
VIN comparison	The vehicle identification number (VIN) was read and the undersigned verified that it matched the documents submitted during the inspection.
Inspection	The inspection conditions were sufficient for the assessment of the vehicle. Lifting equipment and a pit were available for examining the vehicle.
Test drive	No test drive/maneuvering was carried out during the inspection of the vehicle.
Engine function test	An engine test run was performed.

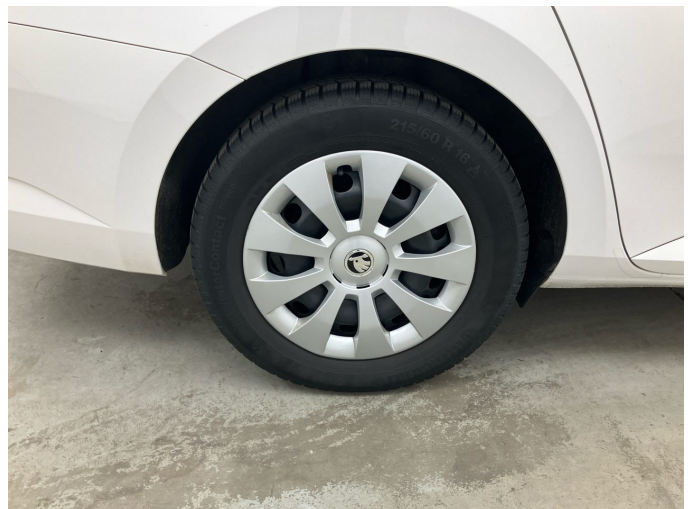
Figure 12: Mounted tyres

#	Tyre size	Type of tyre	Manufacturer	Tread depth
1)	215/60 R16 99H	Winter tyres on Steel rim with wheel cover	Continental	5mm / 5mm
2)	215/60 R16 99H	Winter tyres on Steel rim with wheel cover	Continental	5mm / 5mm

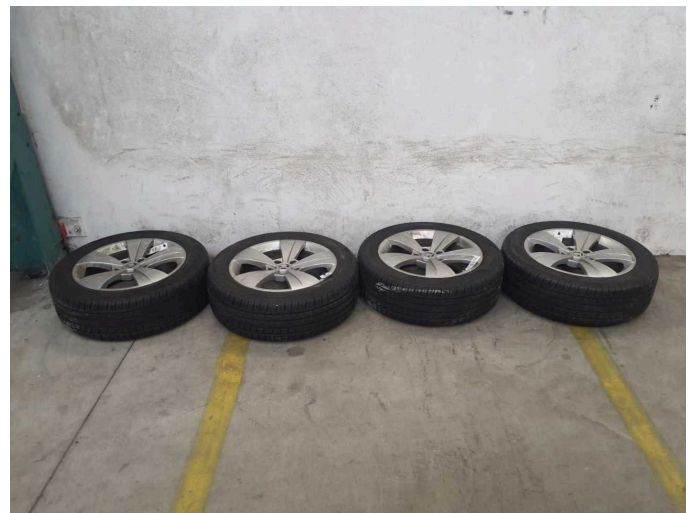
Figure 16: Additional tyres

#	Tyre size	Type of tyre	Manufacturer	Tread depth
1)	215/55 R17 94W	Summer tyres on Light alloy	Pirelli	6mm / 6mm
2)	215/55 R17 94W	Summer tyres on Light alloy	Pirelli	6mm / 6mm

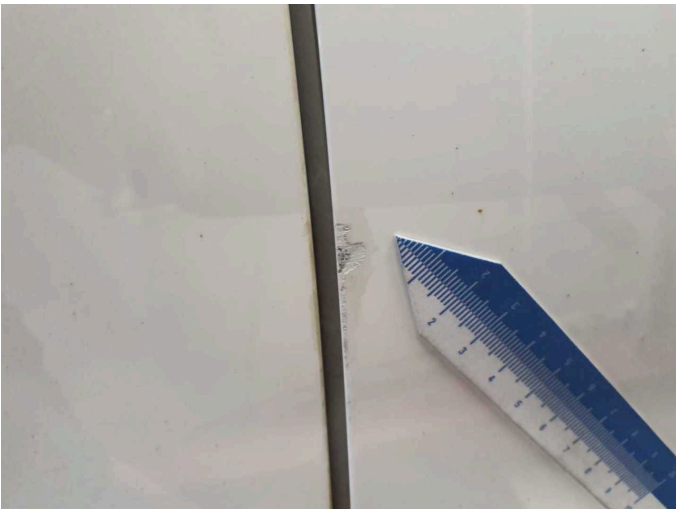
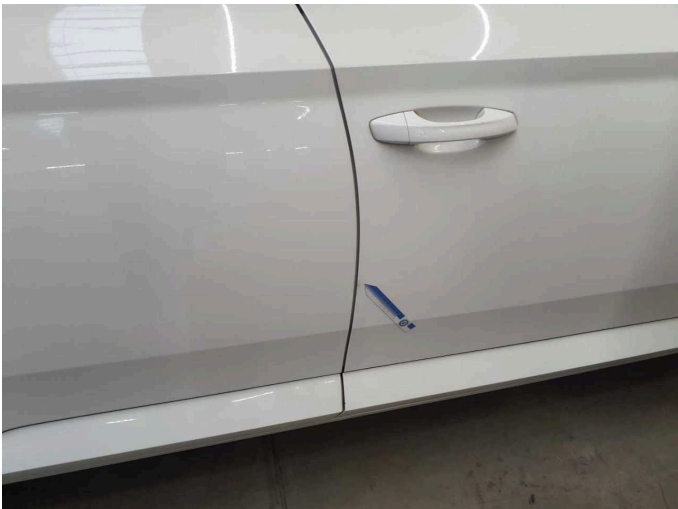
No.	Component group	Description
1	Door - front right side	Door edge - Scratch(es) - Smart repair
2	2nd wheel set	1 alloy rim - Scratched - Loss in value

Damage 1: Door - front right side: Door edge - Scratch(es) - Smart repair

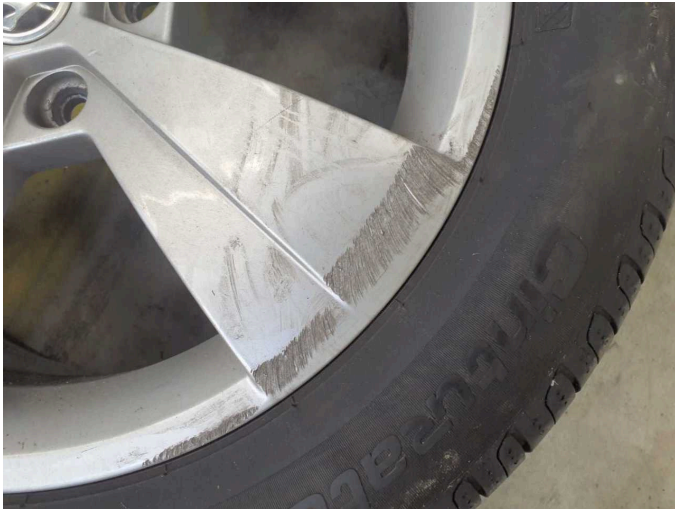
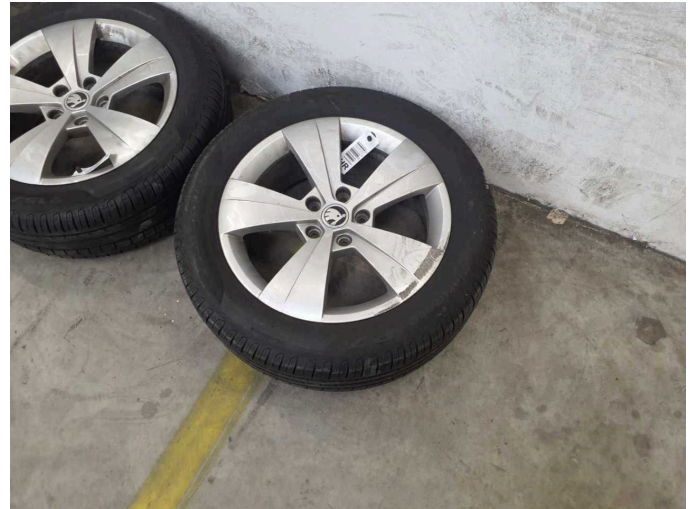
Damage 2: 2nd wheel set: 1 alloy rim - Scratched - Loss in value

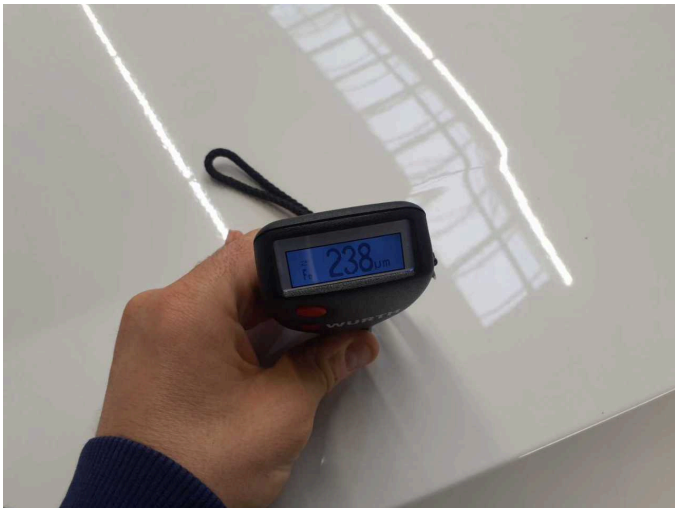
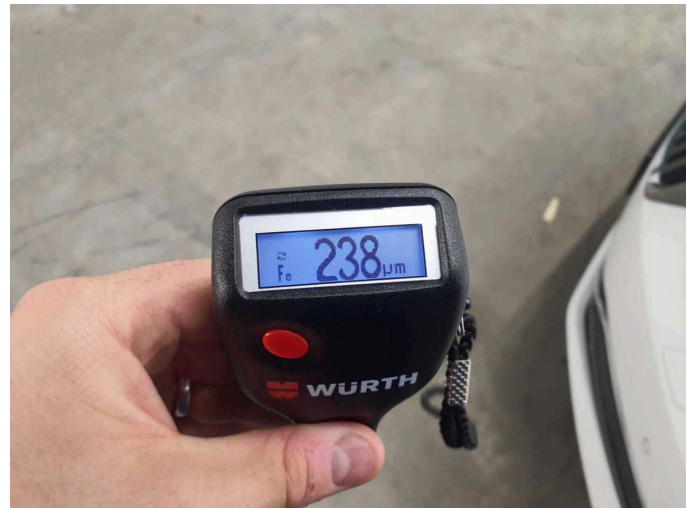
No.	Repainting
1	Bonnet, Professionally carried out, Invoice of repair done Non-existent
2	Side panel - rear left side, Professionally carried out, Invoice of repair done Non-existent

Bonnet	238 µm	Side panel - rear left side	192 µm
--------	--------	-----------------------------	--------

Repainting 1: Bonnet

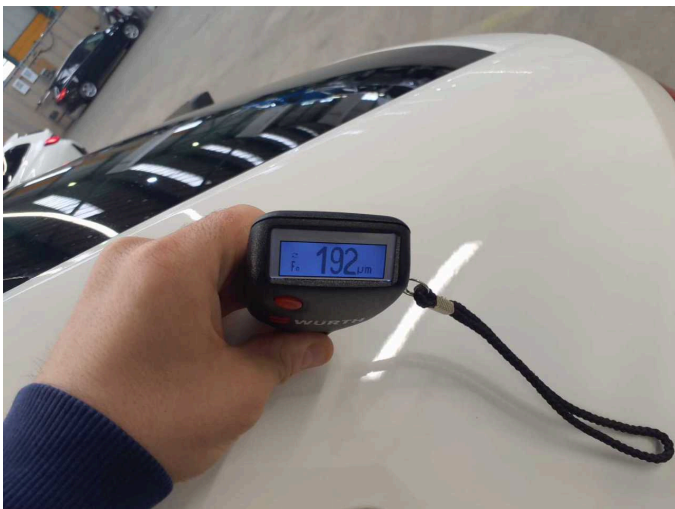
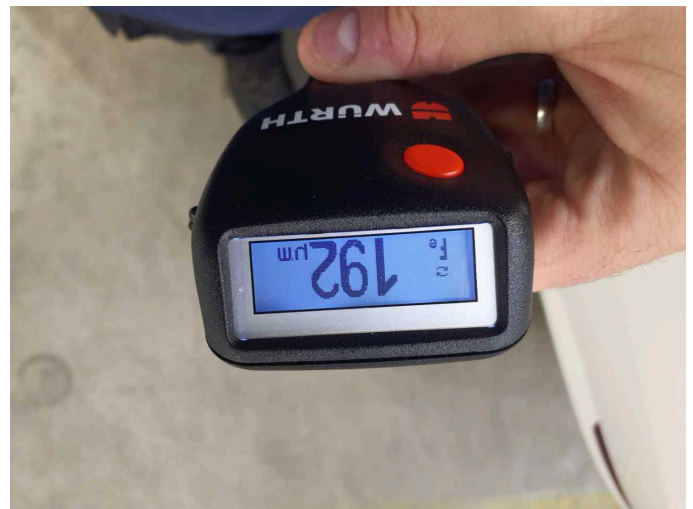
Repainting 2: Side panel - rear left side
