Expertise

Protocol number: 41174049
Order No. / Reference: 25113494
Inspection date: 22 Aug 2025

Manufacturer: Skoda
VIN: TMBJH9NP0P7007829

Model: Superb Combi 2.0 TDI DSG Premium Edition

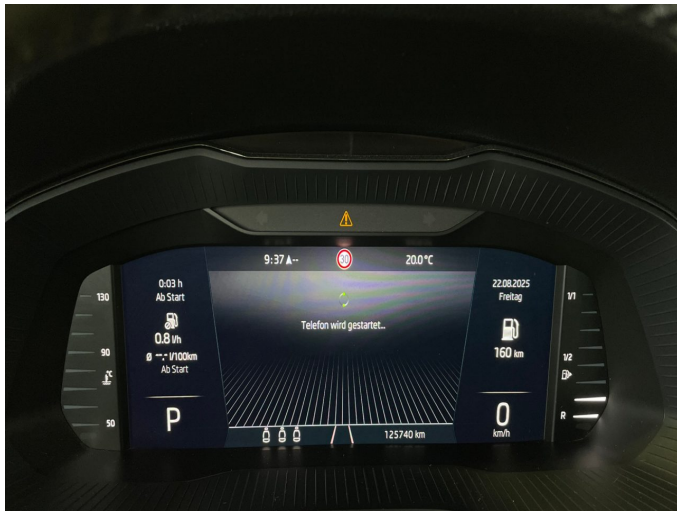
Figure 7: Instrument cluster

Maintenance booklet / proof	digital proof / complete	Next maintenance in	17,500 km
Last maintenance on / at	05/2025 at 115,982 km		
Key is / should be	2 / 2	FZG documents	ZB#2 (B) was available (copy), ZB#1 (S) was not available
		Letter No.	GJ950555
Previous damage / Accident	Detectable	Repainting	None detectable
Inspection conditions	sufficient	Lifting equipment / pit	yes
Test drive	Not performed	Engine function test	Performed
Manufacturer key number/ type code number	8004 / APL 01977		
Emission standard	EURO6;WLTP;AP;PI/CI; M, N1 I	Fine dust sticker	
Permitted total weight	2,196 kg	Empty weight

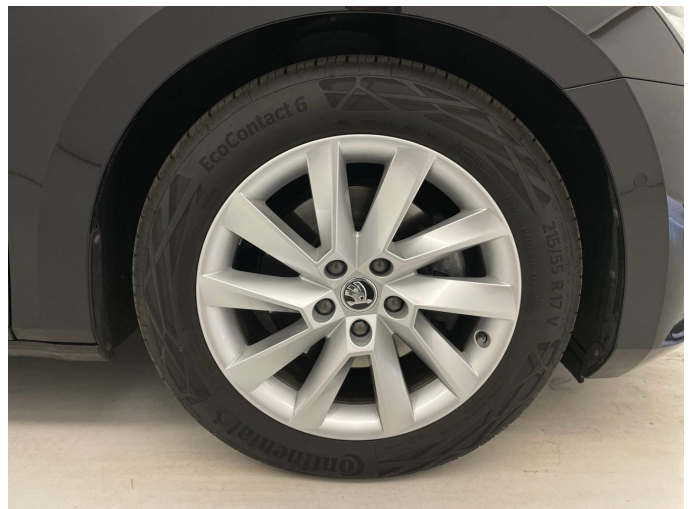
Figure 12: Mounted tyres

#	Tyre size	Type of tyre	Manufacturer	Tread depth
1)	215/55 R17 94V	Summer tires (with run-flat tires) on Light alloy	Continental	6mm / 6mm
2)	215/55 R17 94V	Summer tires (with run-flat tires) on Light alloy	Continental	6mm / 6mm

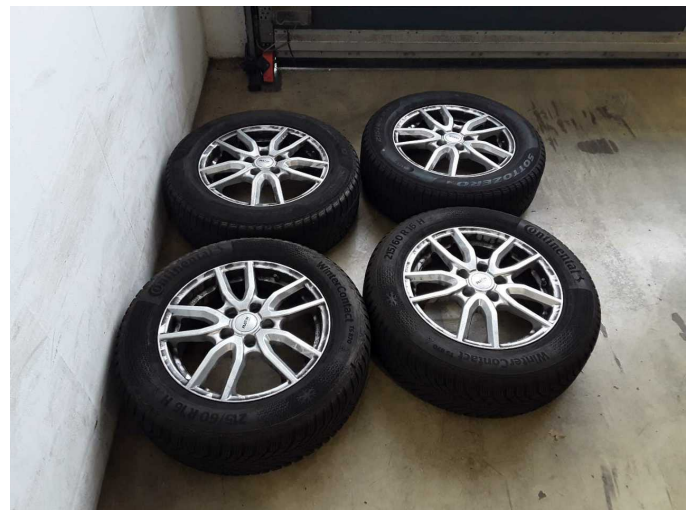
Figure 16: Additional tyres

#	Tyre size	Type of tyre	Manufacturer	Tread depth
1)	215/60 R16 95H	Winter tires (with run-flat tires) on Light alloy	Pirelli	5mm / 5mm
2)	215/60 R16 95H	Winter tyres on Light alloy	Continental	7mm / 7mm

Der Winterradsatz ist nicht Bestandteil der vorliegenden Fahrzeugausstattung.

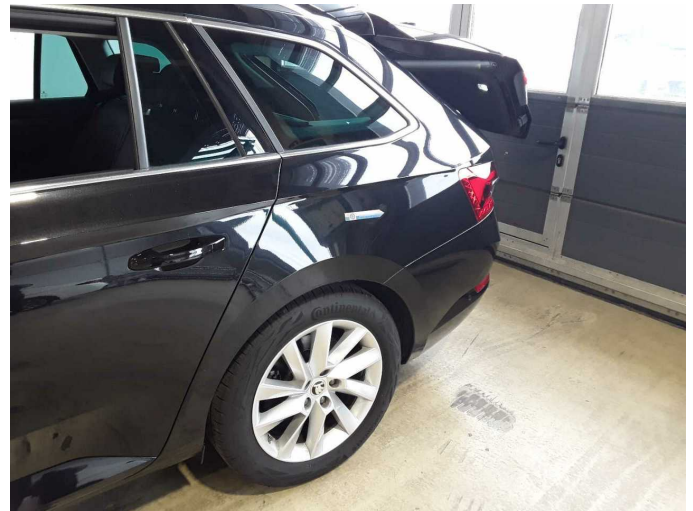
No.	Component group	Description
1	Door - rear right side	Door - Scratch(es) - Smart repair
2	Side panel - rear left side	Side panel - Scratch(es) - Paint

Damage 2: Side panel - rear left side: Side panel - Scratch(es) - Paint
