Expertise

Protocol number: 41653093
Order No. / Reference: 25193714
Inspection date: 23 Sept 2025

Manufacturer: Skoda	Model: Octavia Combi 2.0 TDI DSG First Edition
VIN: TMBJJ7NX9MY168484

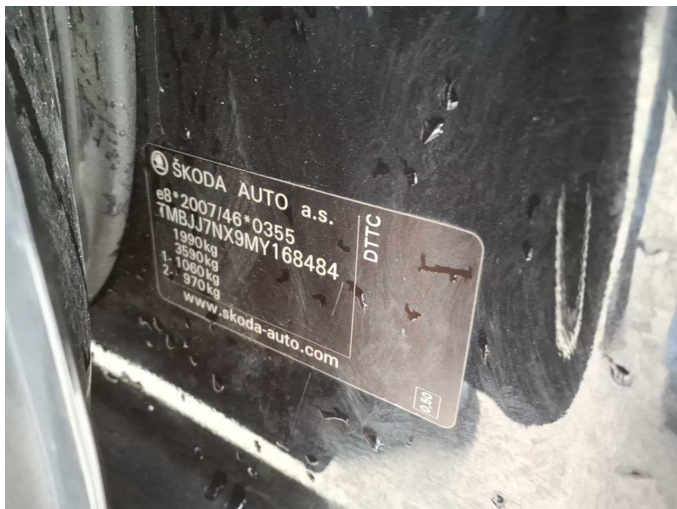
Documents submitted	At the time of the inspection, the registration certificate Part 2 (letter) was available, but the registration certificate Part 1 (certificate) was not. (Copy)
VIN comparison	The vehicle identification number (VIN) was read from the vehicle and its conformity with the submitted documents was verified during the inspection by the undersigned.
Inspection	The inspection conditions were sufficient for the assessment of the vehicle. Lifting equipment and a pit were available for examining the vehicle.
Test drive	No test drive/maneuvering was carried out during the inspection of the vehicle.
Engine function test	An engine test run was performed.

Figure 11: VIN

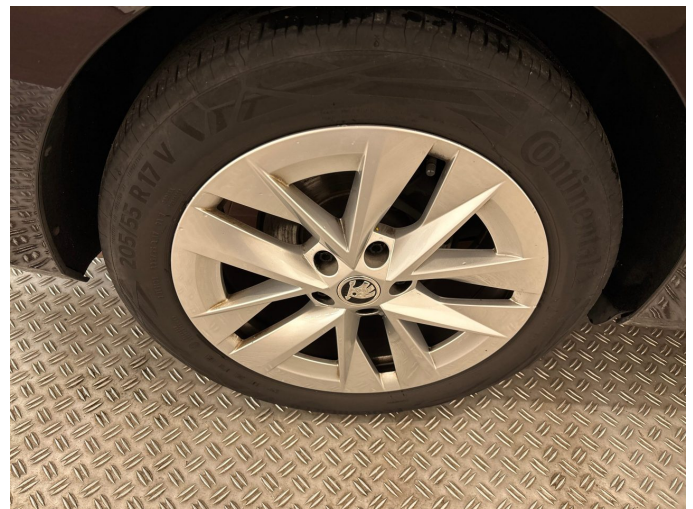
#	Tyre size	Type of tyre	Manufacturer	Tread depth
1)	205/55 R17 91V	Summer tyres on Light alloy	Continental	5mm / 5mm
2)	205/55 R17 91V	Summer tyres on Light alloy	Continental	4mm / 4mm

Figure 12: Mounted tyres

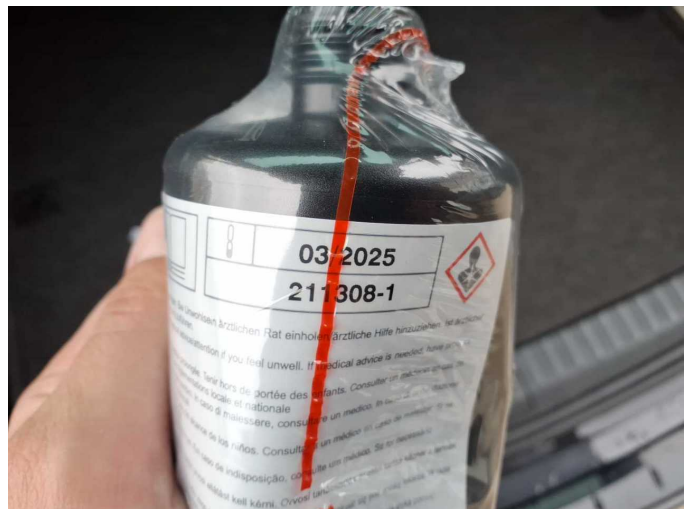
Damage 1: Equipment: Tirefit filler - Expired - Replace

No.	Component group	Description
1	Equipment	Tirefit filler - Expired - Replace
2	Side panel - rear left side	Side panel - Dent / paintcoat damage - Smart repair
3	Door - front left side	Door - Paint defect - Smart repair
4	Mudguard - left side	Mudguard - left side - Scratch(es) - Smart repair

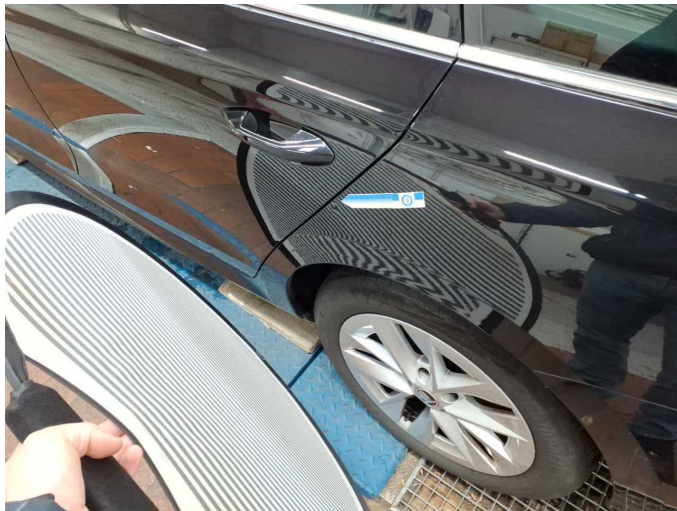
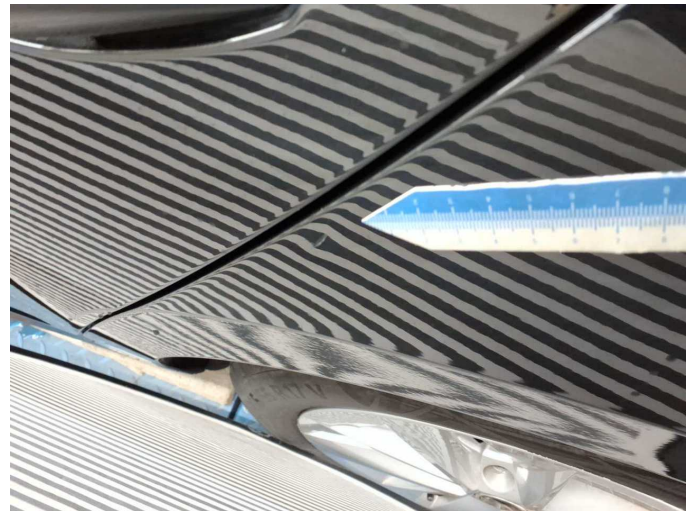
Damage 2: Side panel - rear left side: Side panel - Dent / paintcoat damage - Smart repair

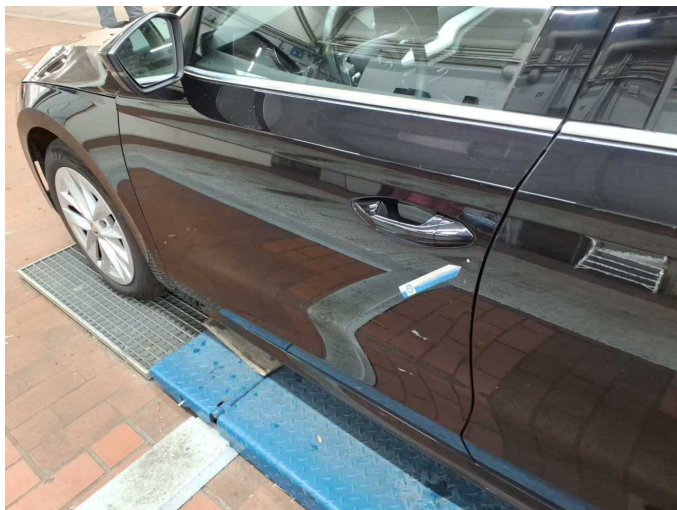
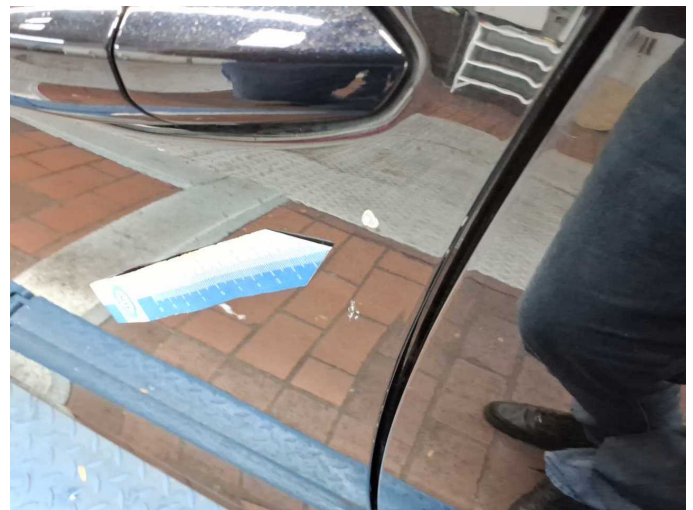
Damage 3: Door - front left side: Door - Paint defect - Smart repair

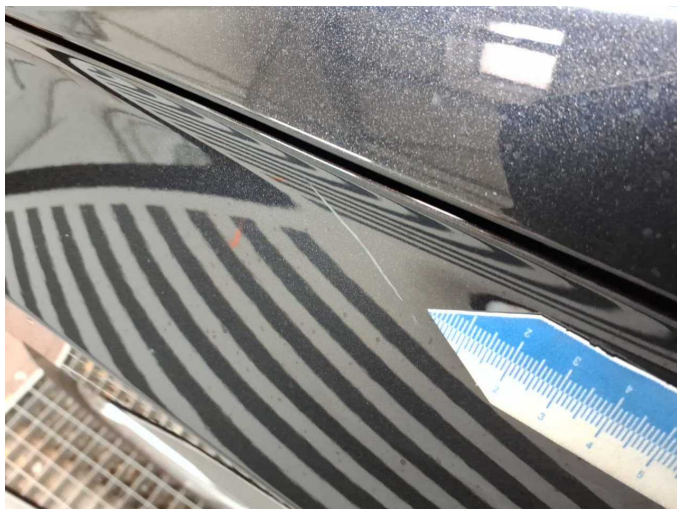
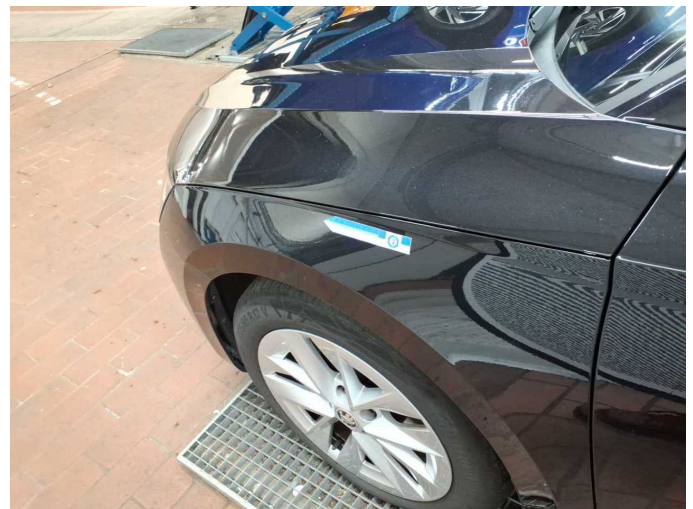
Damage 4: Mudguard - left side: Mudguard - left side - Scratch(es) - Smart repair

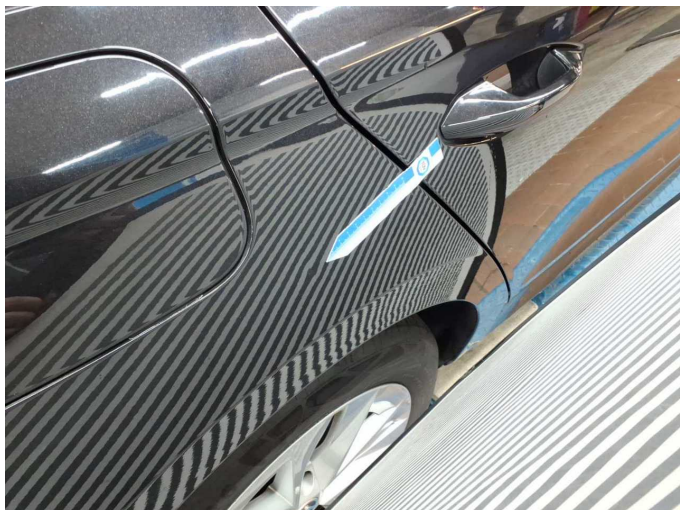
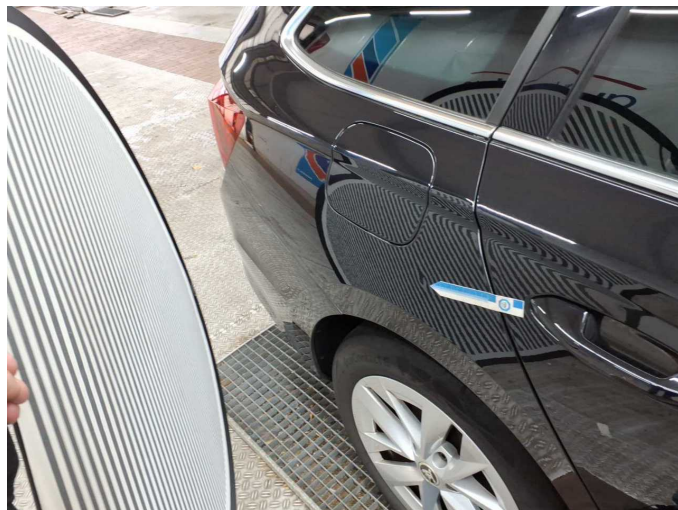
No.	Component group	Description
2	Body	Body - Stone chips - No deduction
3	Body	Body - Scratch(es) - No deduction
4	Vehicle glazing	Windscreen - Stone chips - No deduction
5	Side panel - rear right side	Side panel - dent(s) - No deduction

Wear and tear 5: Side panel - rear right side: Side panel - dent(s) - No deduction
