Expertise

Protocol number: 41598890
Order No. / Reference: 25241700
Inspection date: 17 Sept 2025

Manufacturer: Skoda	Model: Kodiahq 2.0 TDI DSG Ambition
VIN: TMBJJ9NS5L8066324

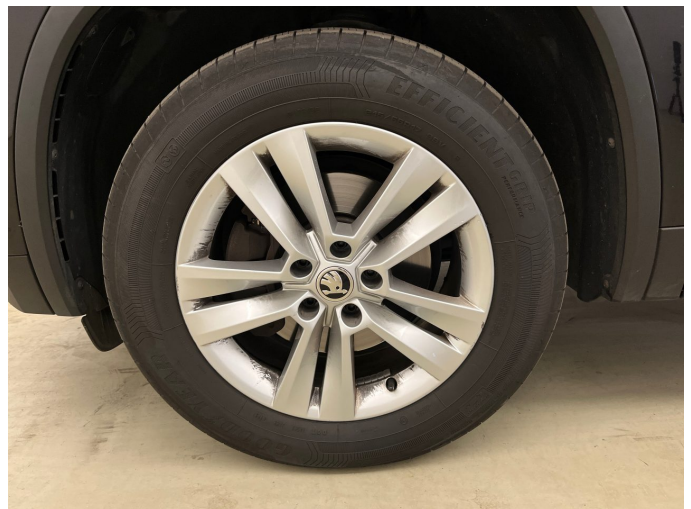
Figure 12: Mounted tyres

#	Tyre size	Type of tyre	Manufacturer	Tread depth
1)	215/65 R17 99V	Summer tyres on Light alloy	Goodyear	4mm / 4mm
2)	215/65 R17 99V	Summer tyres on Light alloy	Goodyear	5mm / 5mm

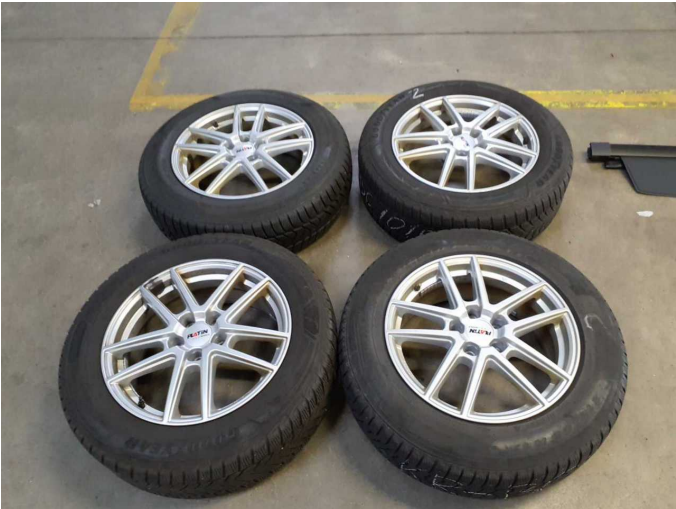
Figure 15: Additional tyres

#	Tyre size	Type of tyre	Manufacturer	Tread depth
1)	215/65 R17 99H	Winter tyres on Light alloy	Pirelli	4mm / 4mm
2)	215/65 R17 99V	Winter tyres on Light alloy	Goodyear	5mm / 5mm

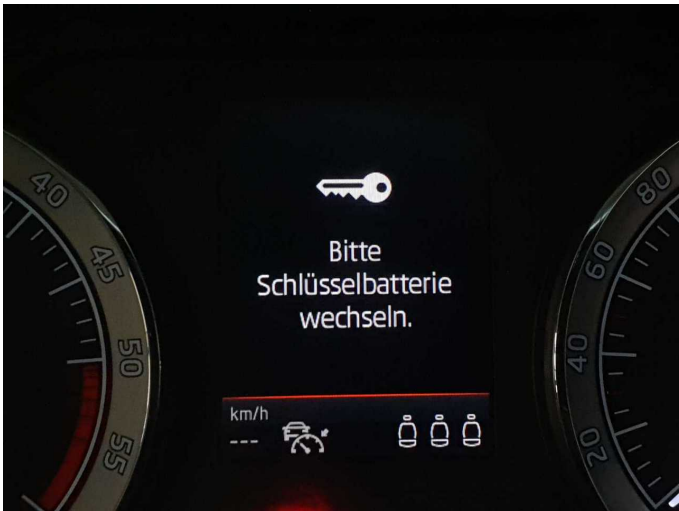
Damage 1: Equipment: Vehicle key (Batterie) - Empty - Replace

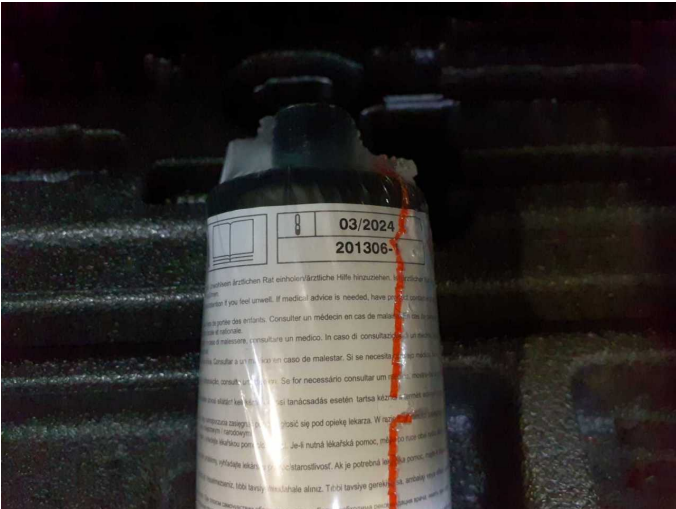
Damage 2: Equipment: Tirefit filler - Expired - Replace

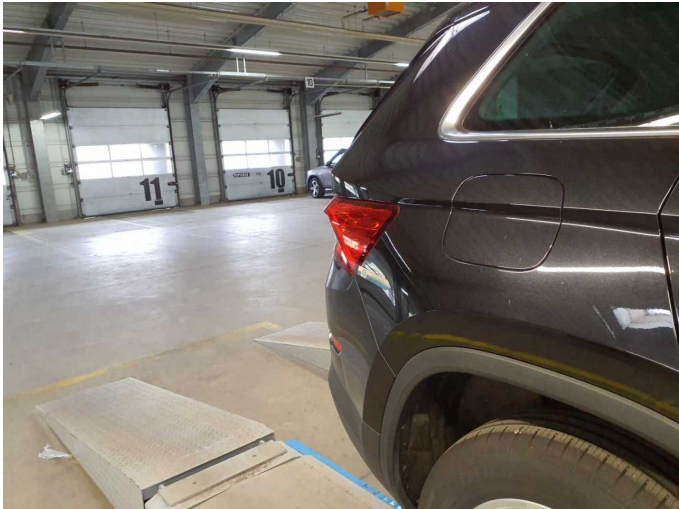
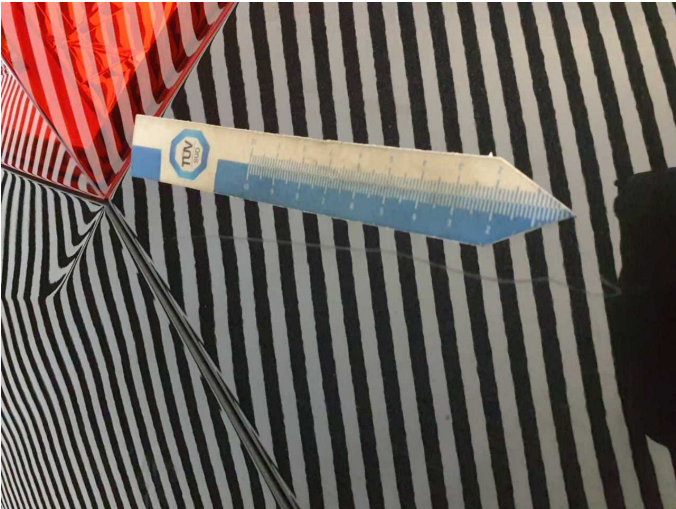
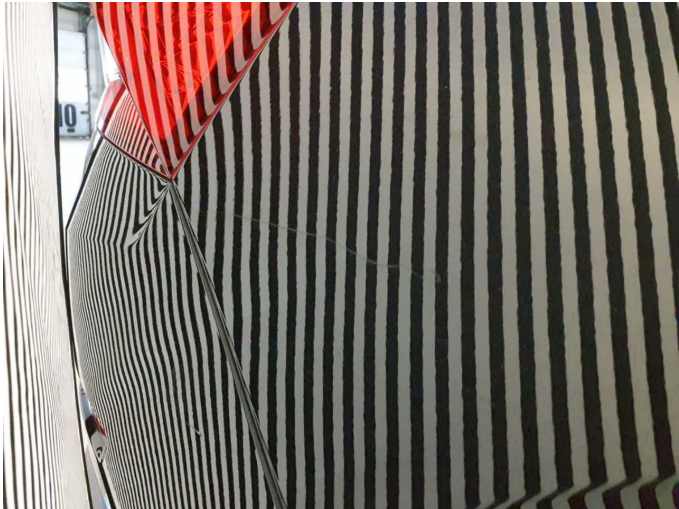
Damage 3: Side panel - rear right side: Side panel - Scratched - Paint

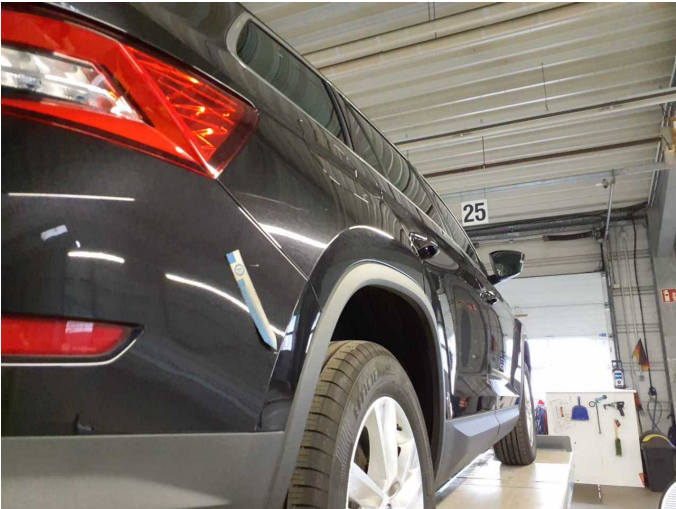
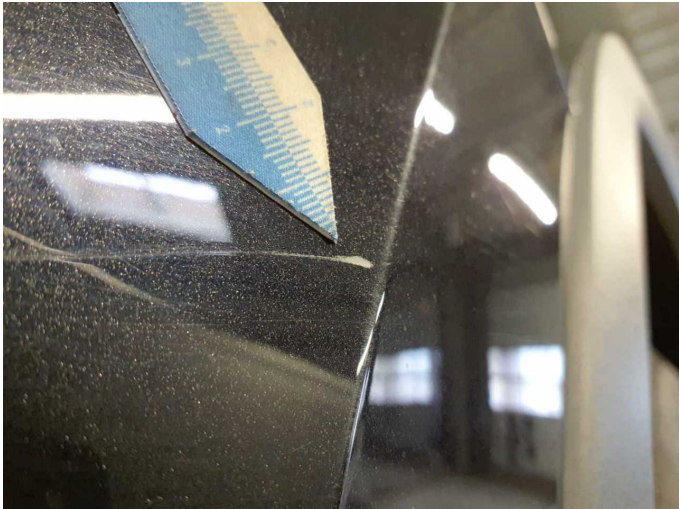
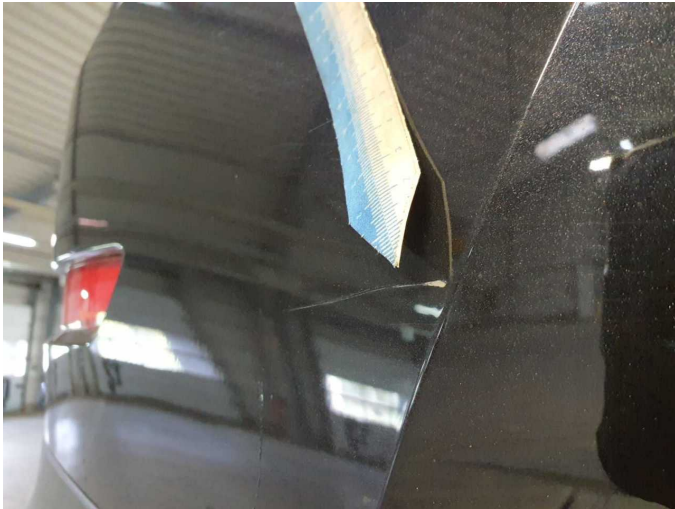
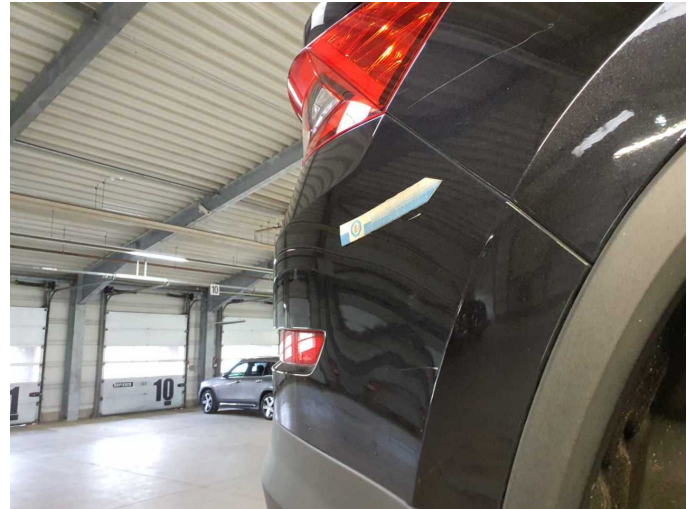
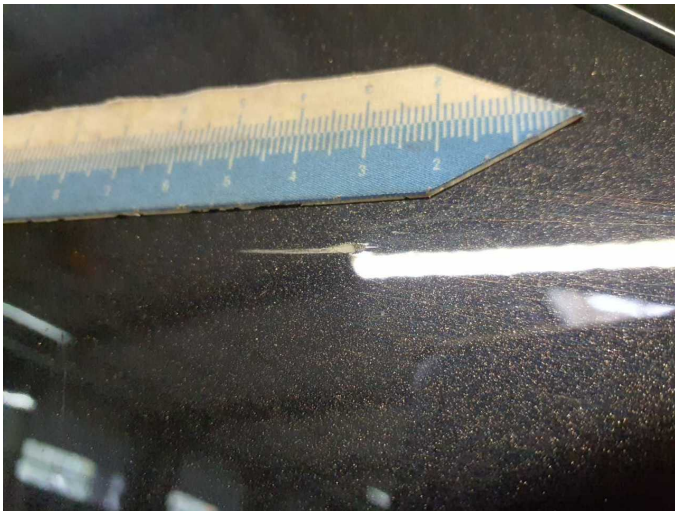
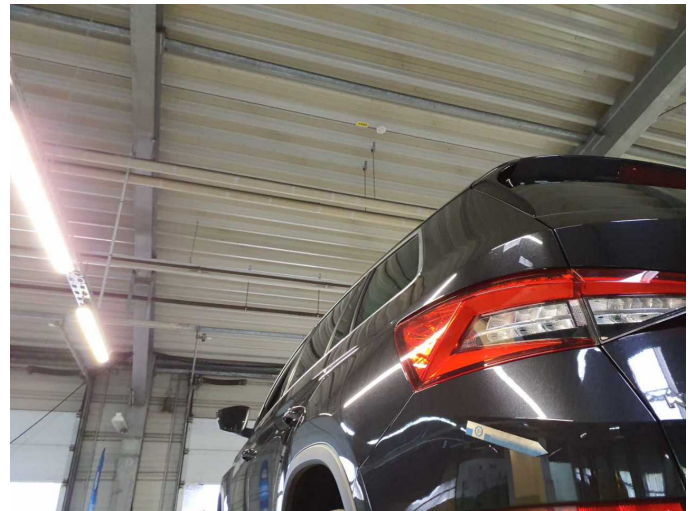
Damage 4: Rear bumper: Rear bumper - Scratched - Paint

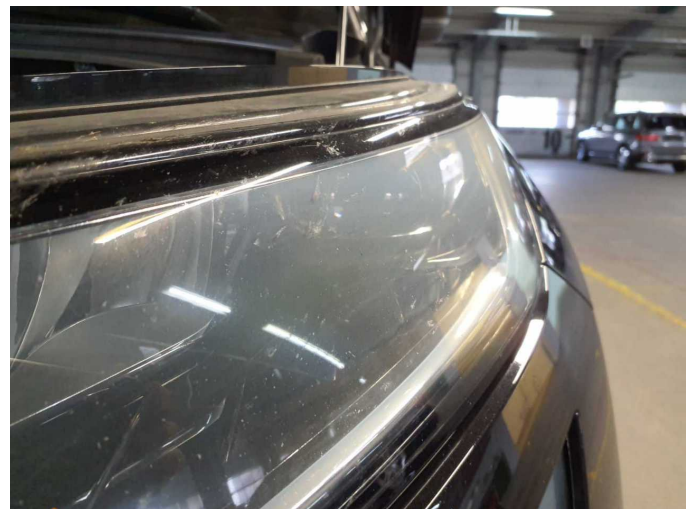
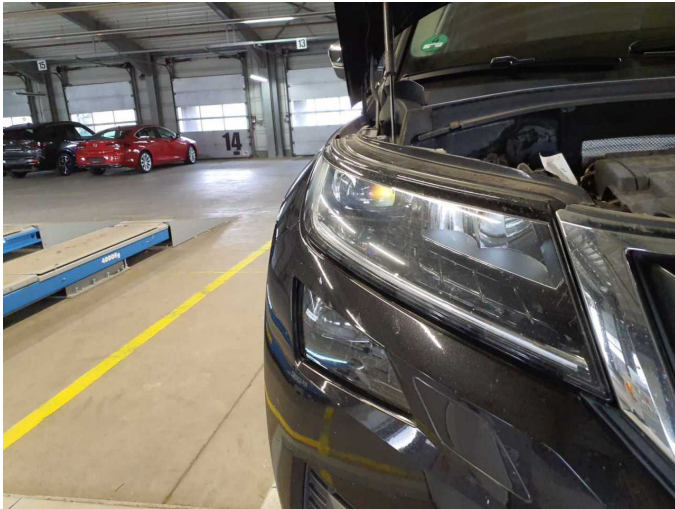
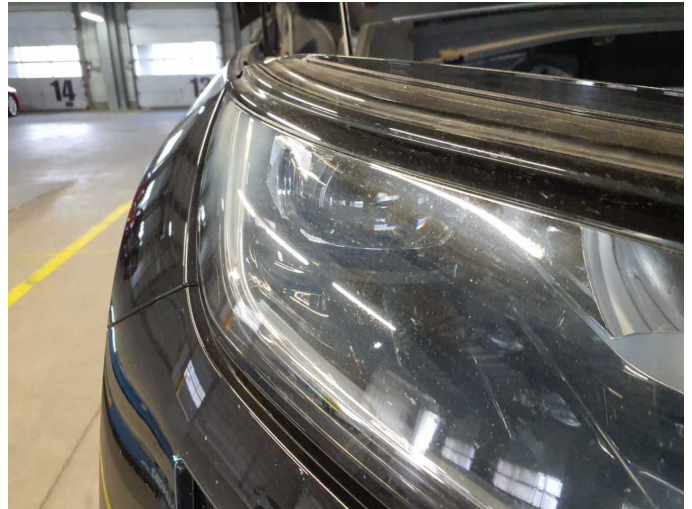
Damage 9: Headlight: Headlight - left side (Scheinwerfer blind/Milchig) - Damaged - Replace

Damage 10: Headlight: Headlight - right side (Scheinwerfer blind/Milchig)
- Damaged - Replace

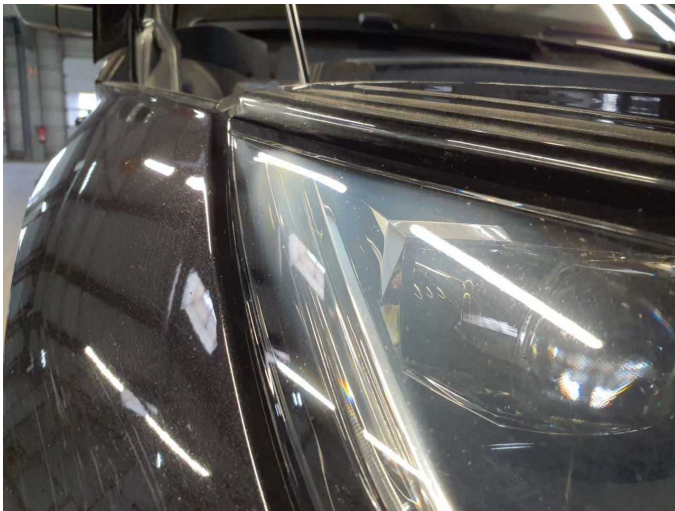
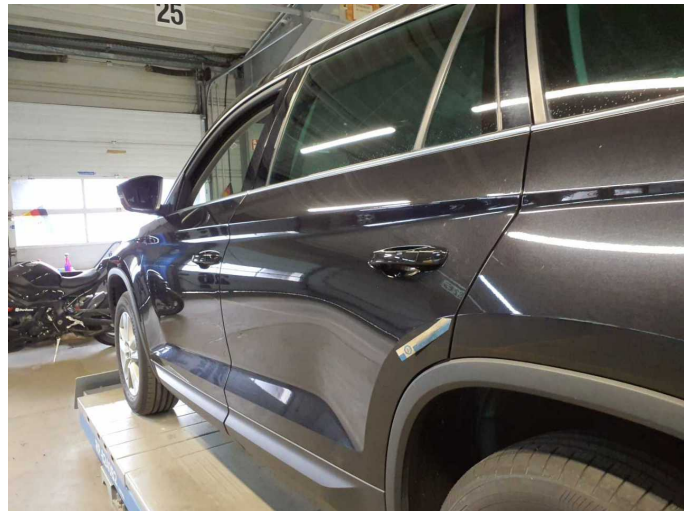
Damage 10: Headlight: Headlight - right side (Scheinwerfer blind/Milchig)
- Damaged - Replace

Wear and tear 7: Door - rear left side: Door - Scratched - Smart repair

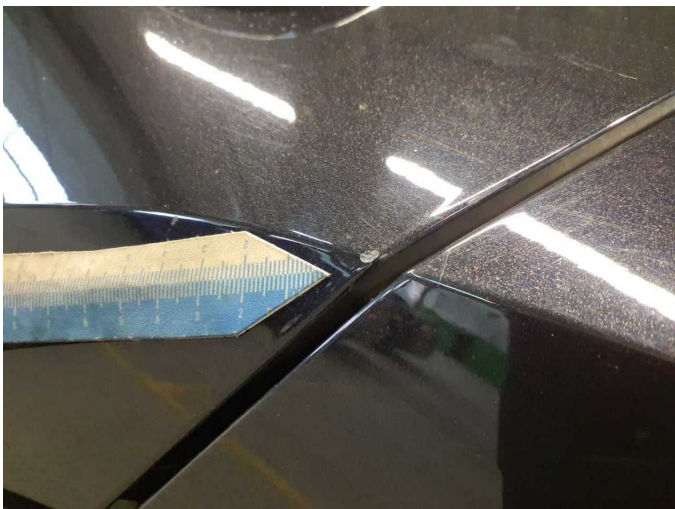
Wear and tear 7: Door - rear left side: Door - Scratched - Smart repair
