Expertise

Protocol number: 39730749  
Order No. / Reference: 24750610  
Inspection date: 14 May 2025

| Manufacturer: Skoda | Model: Octavia Combi 2.0 TDI DSG RS |

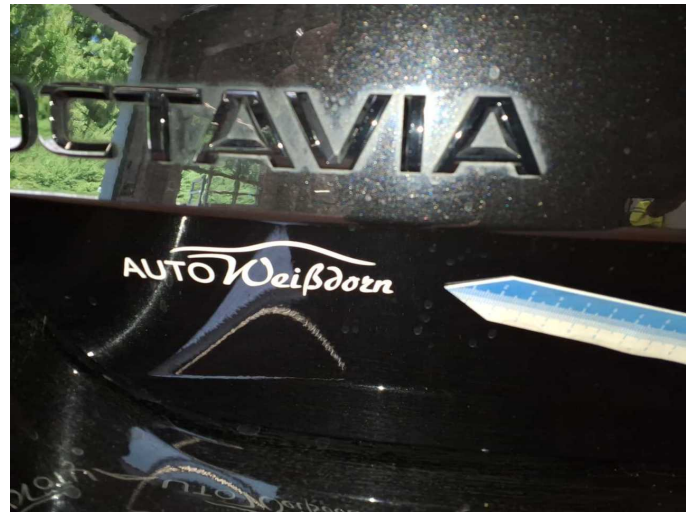
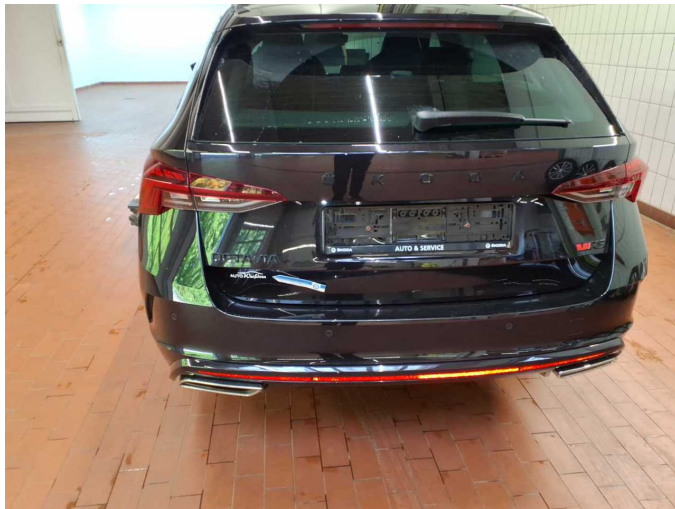
| No. | Component group | Description |
|---|---|---|
| 1 | Boot lid / rear door | Boot lid - Glued / labelled - Remove |

Damage 1: Boot lid / rear door: Boot lid - Glued / labelled - Remove

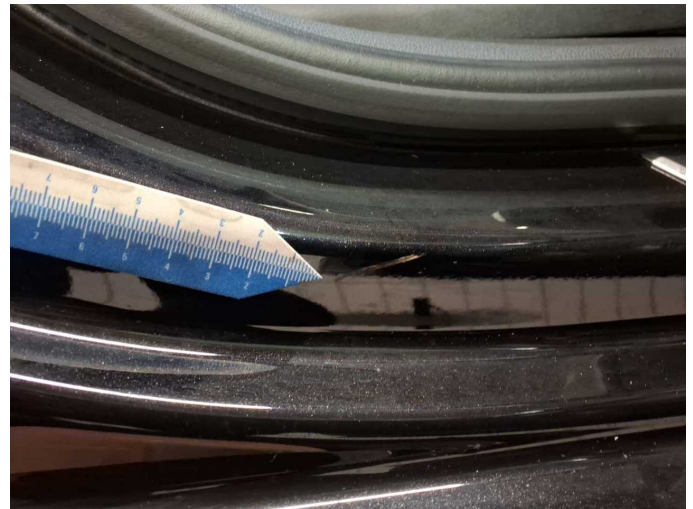
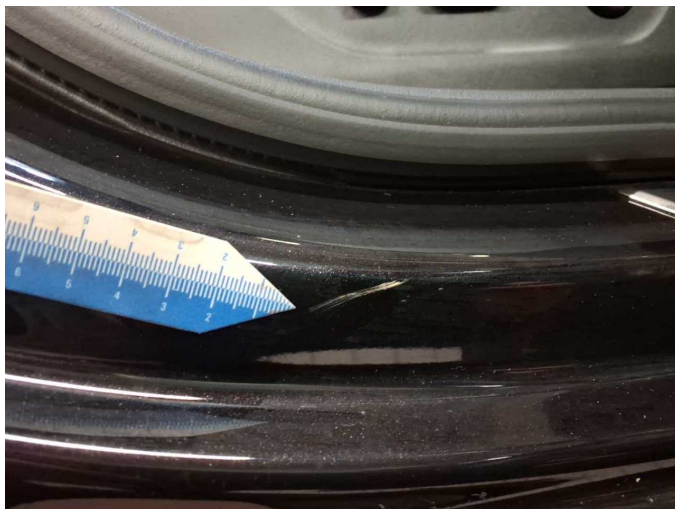
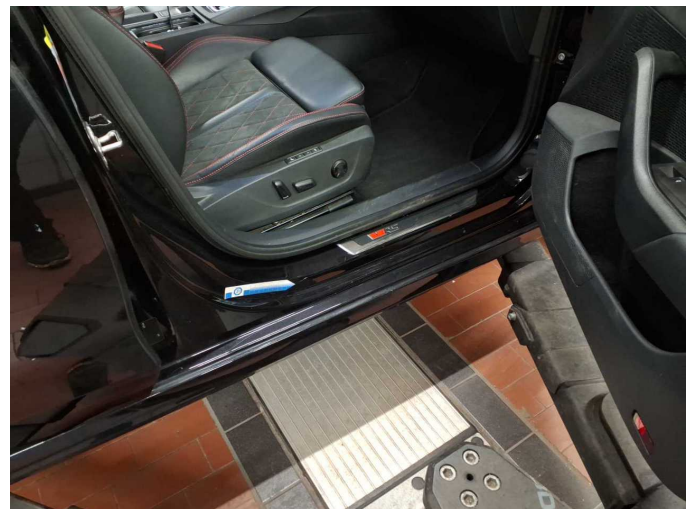
| No. | Component group | Description |
|---|---|---|
| 2 | Sill - right side | Sill - Scratch(es) - Smart repair |

Damage 2: Sill - right side: Sill - Scratch(es) - Smart repair

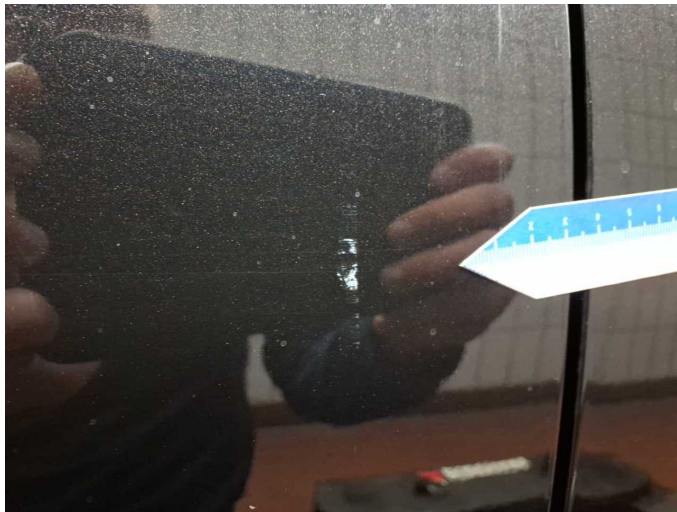
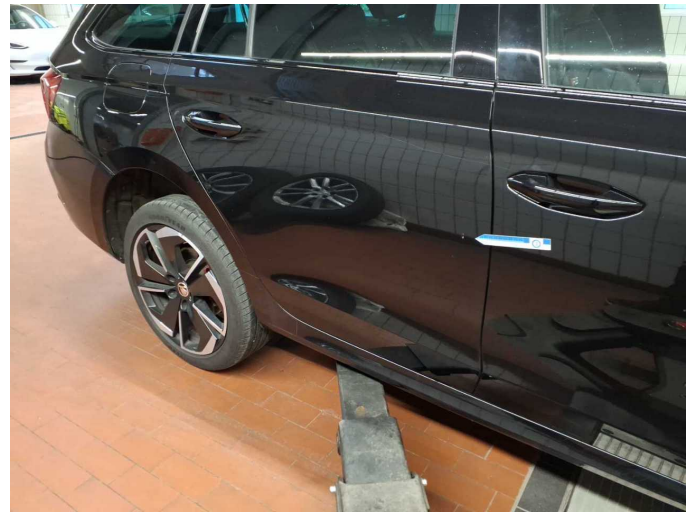
| No. | Component group | Description |
|---|---|---|
| 3 | Door - rear right side | Door - Scratched - Smart repair |

**Damage 3:** Door - rear right side: Door - Scratched - Smart repair

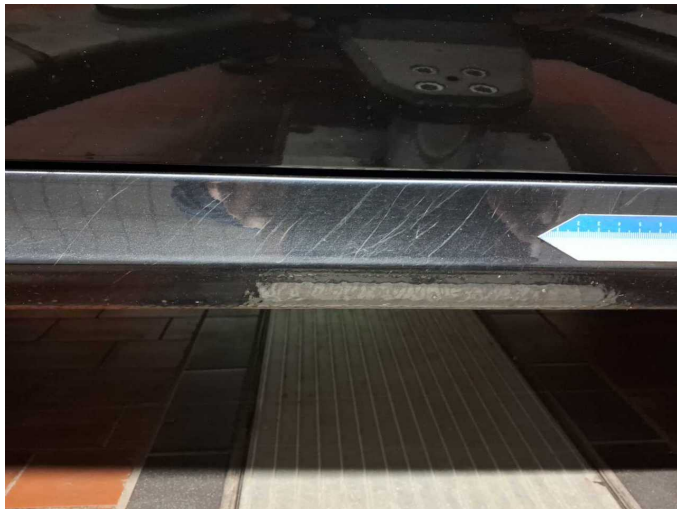
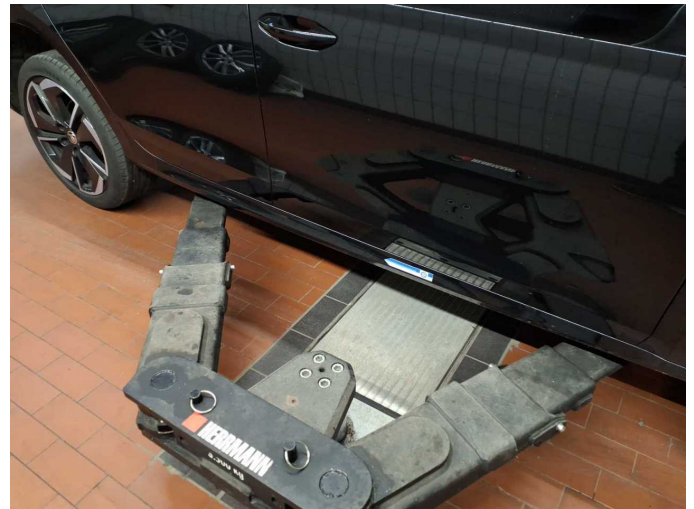
| No. | Component group | Description |
|---|---|---|
| 4 | Sill - right side | Sill - Scratch(es) - Smart repair |

**Damage 4:** Sill - right side: Sill - Scratch(es) - Smart repair

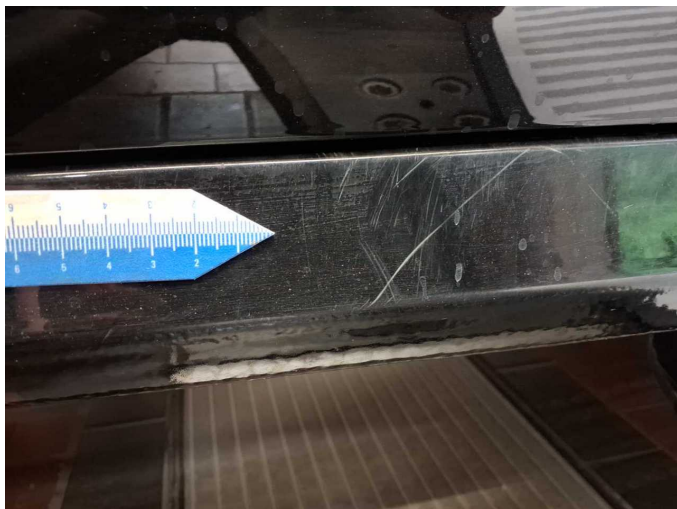
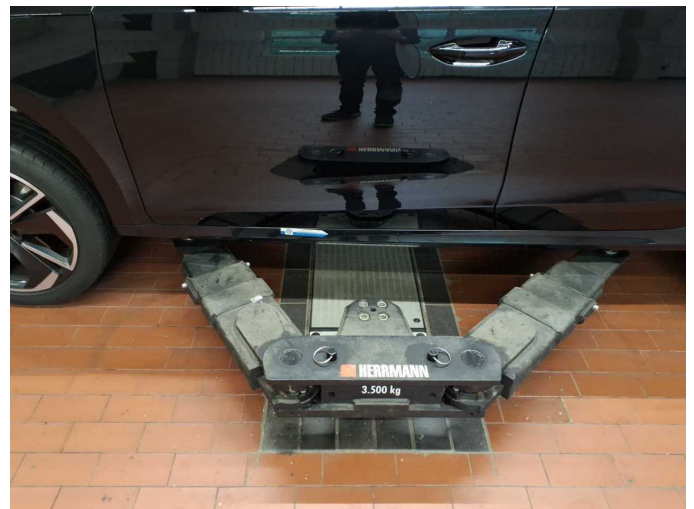
| No. | Component group | Description |
|---|---|---|
| 5 | Sill - left side | Sill - Scratch(es) - Smart repair |

**Damage 5:** Sill - left side: Sill - Scratch(es) - Smart repair

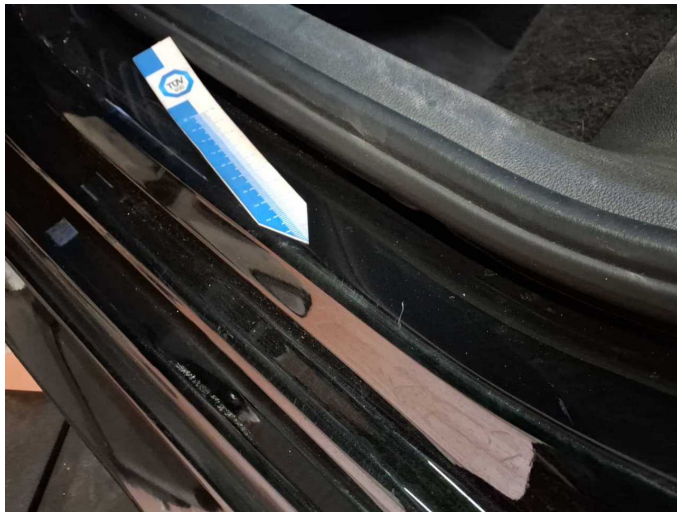
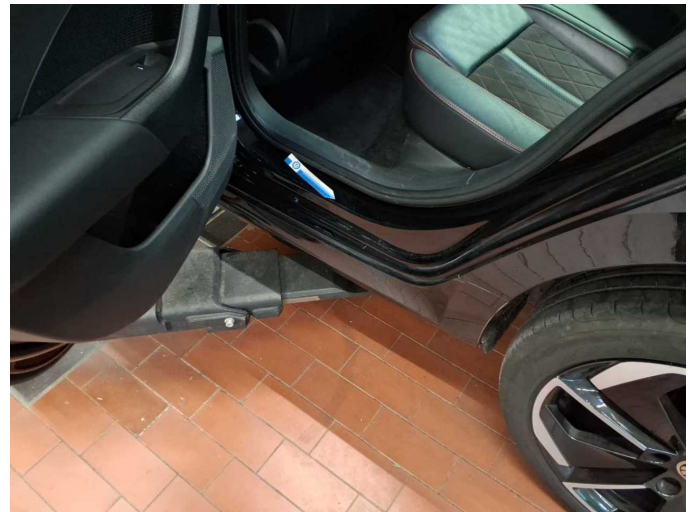
| No. | Component group | Description |
|---|---|---|
| 6 | Side panel - rear left side | Sill - Scratch(es) - Smart repair |

**Damage 6:** Side panel - rear left side: Sill - Scratch(es) - Smart repair

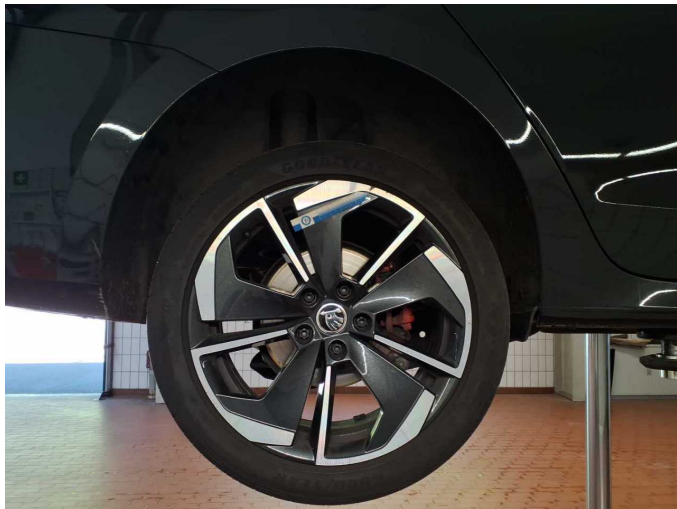
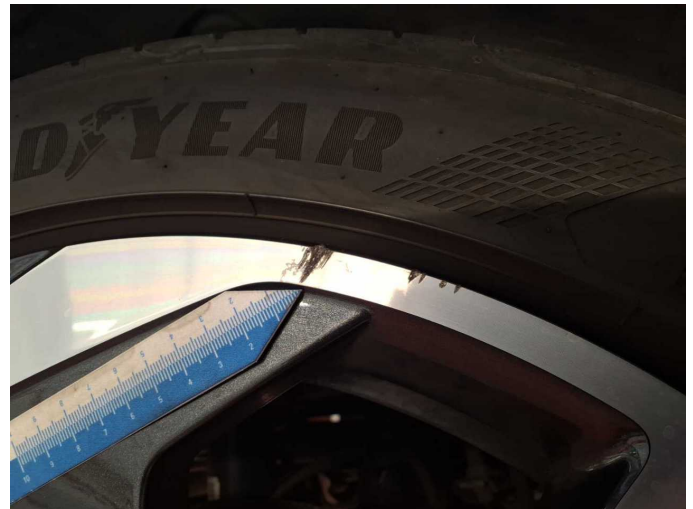
| No. | Component group | Description |
|---|---|---|
| 7 | Wheel / tyres | Alloy rim - rear right side - Scratched - Loss in value |

**Damage 7:** Wheel / tyres: Alloy rim - rear right side - Scratched - Loss in value

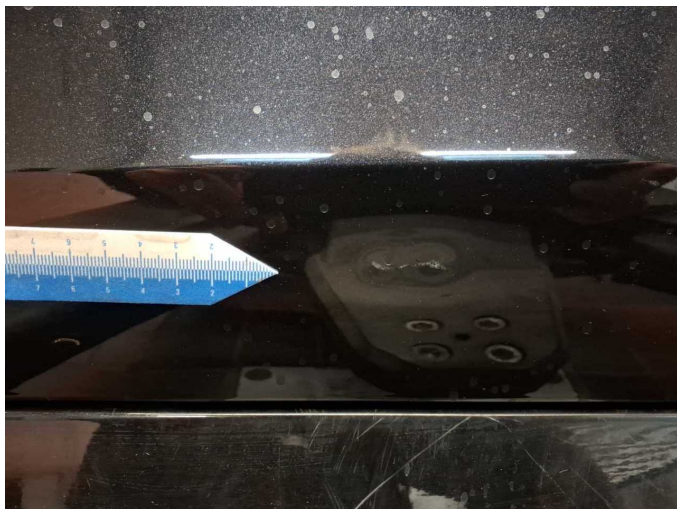
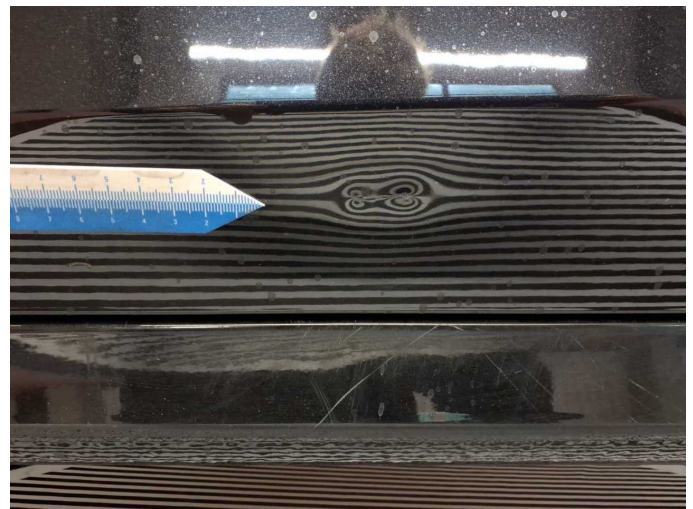
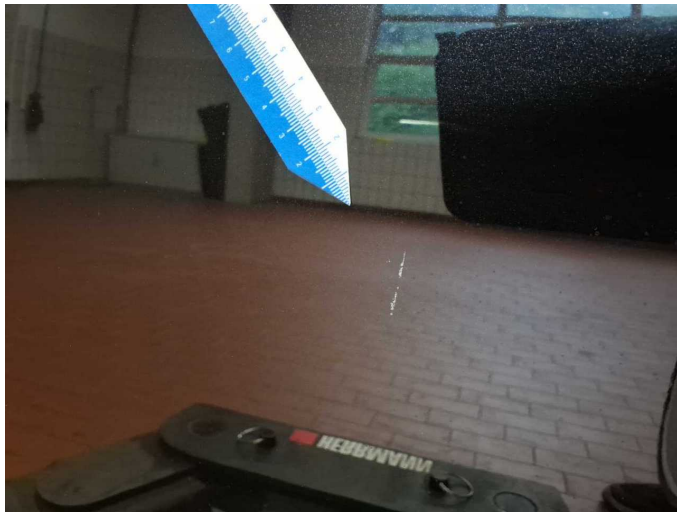
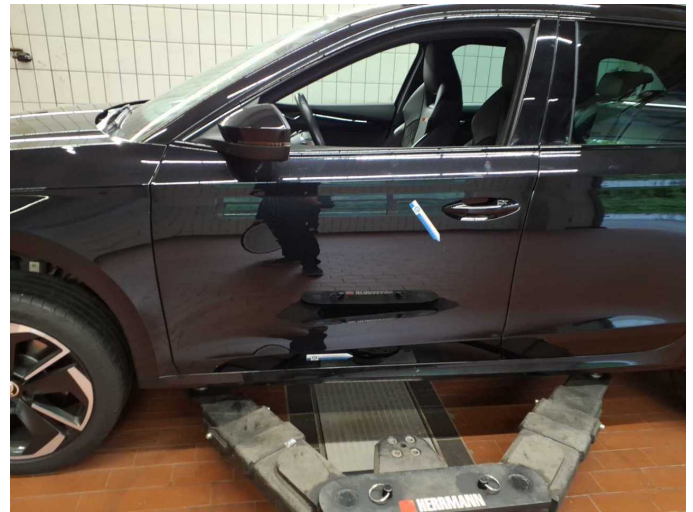
| No. | Component group | Description |
|---|---|---|
| 8 | Door - front left side | Door - Dent / paintcoat damage - Repair and paint |

**Damage 8:** Door - front left side: Door - Dent / paintcoat damage - Repair and paint

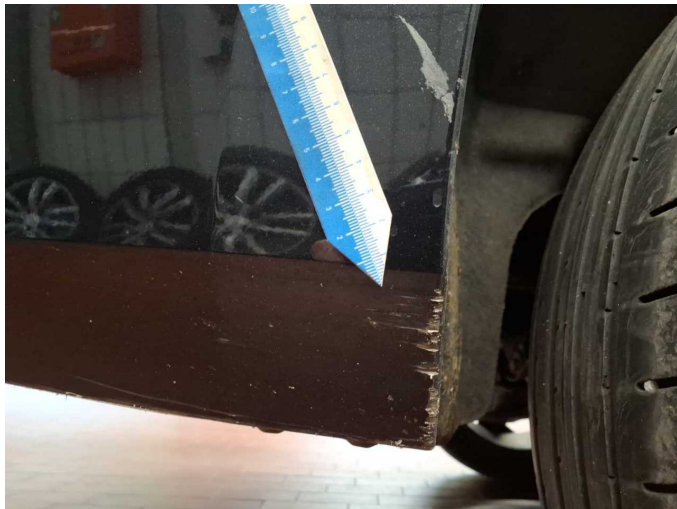
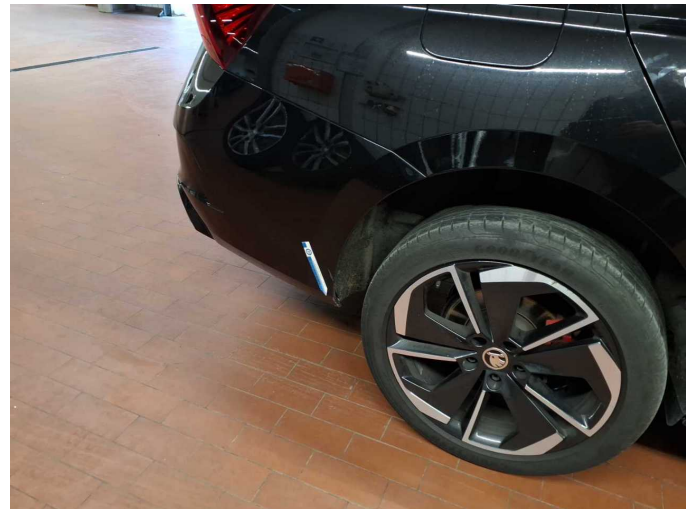
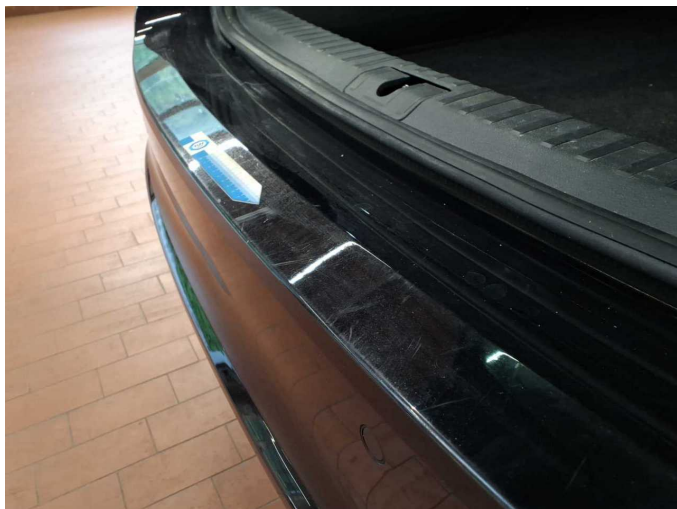
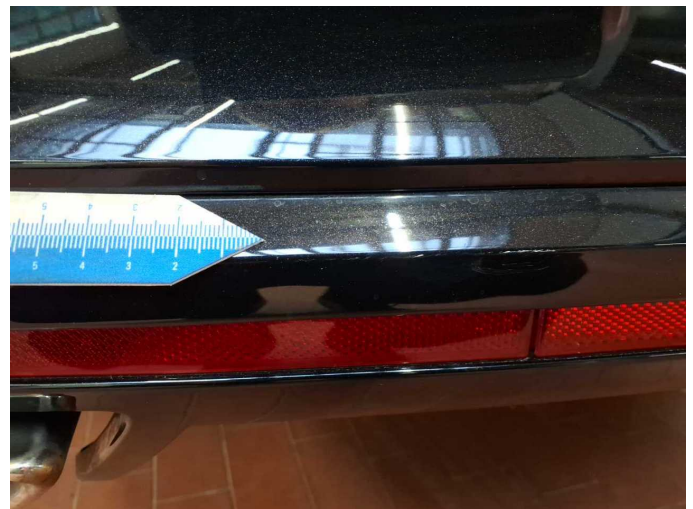
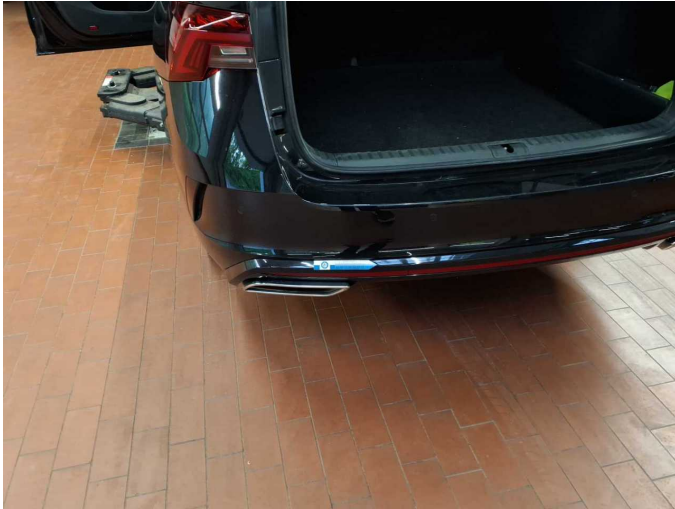
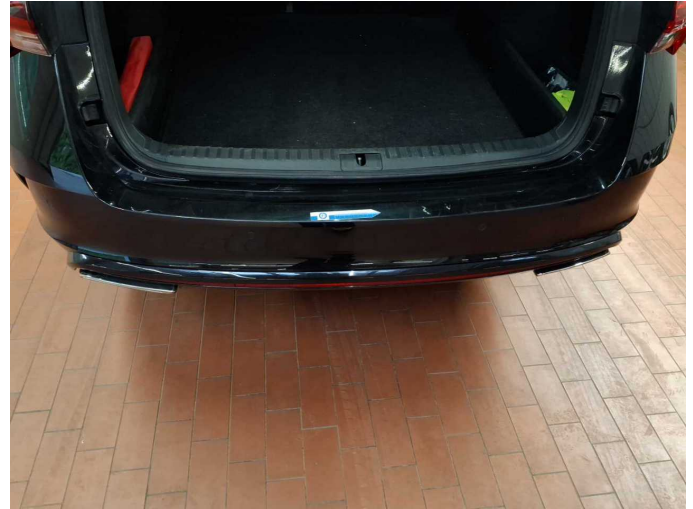
| No. | Component group | Description |
|---|---|---|
| 9 | Rear bumper | Rear bumper - Scratch(es) - Paint |

**Damage 9:** Rear bumper: Rear bumper - Scratch(es) - Paint

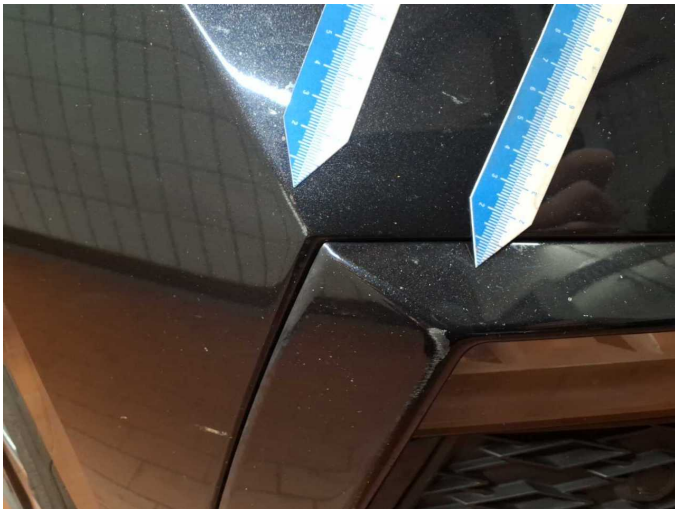
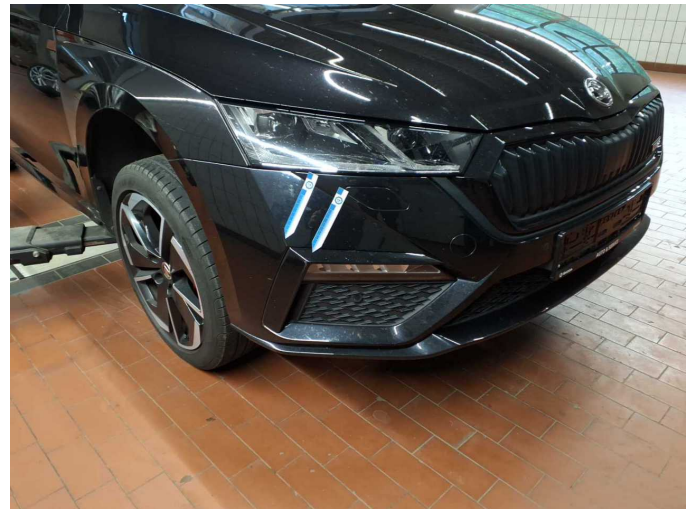
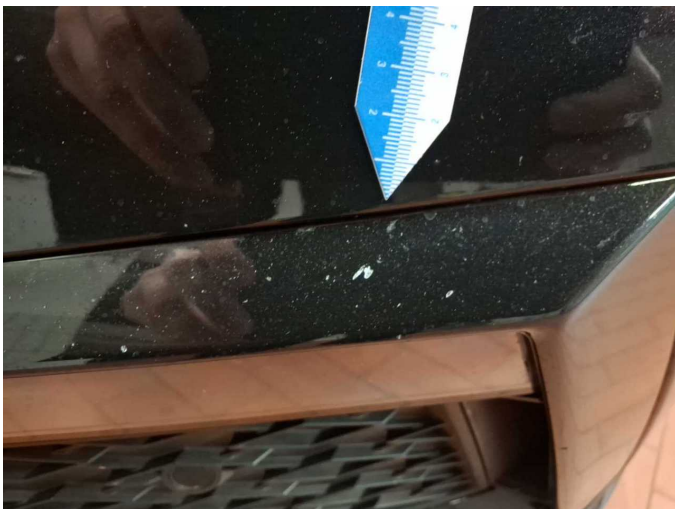
| No. | Component group | Description |
|---|---|---|
| 10 | Front bumper | Front bumper - Scratched - Paint |

**Damage 10:** Front bumper: Front bumper - Scratched - Paint

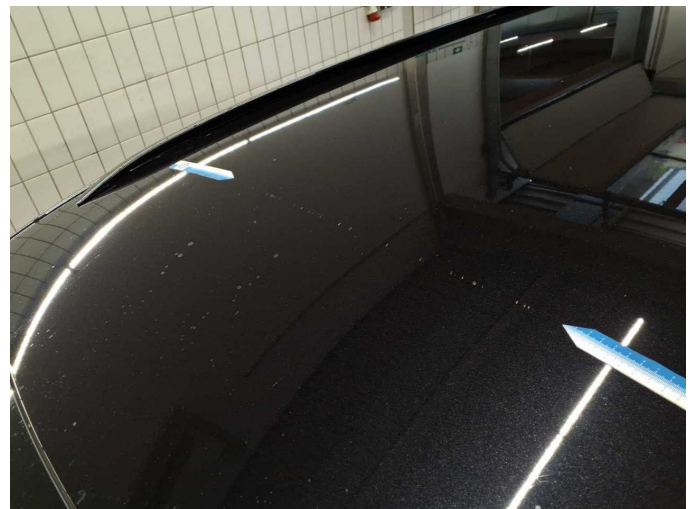
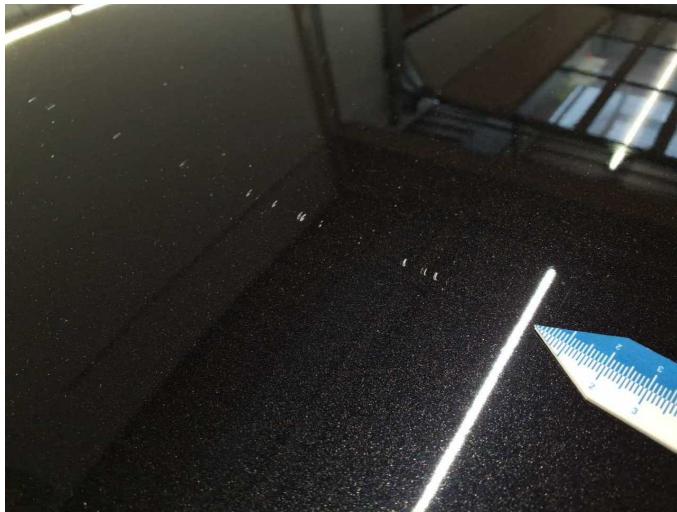
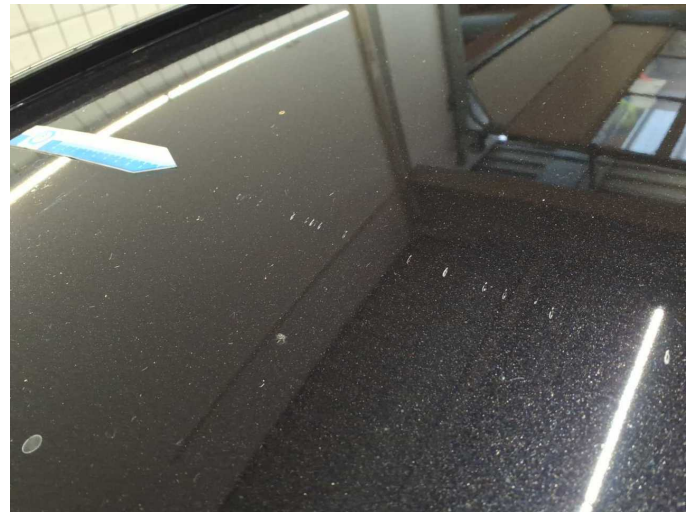
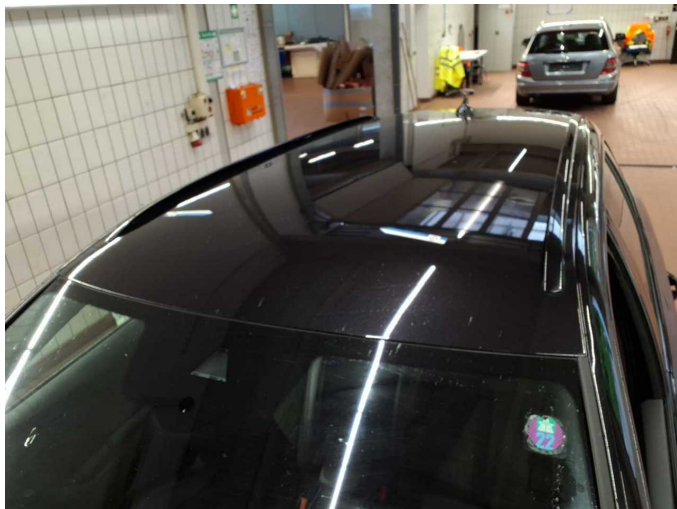
| No. | Component group | Description |
|---|---|---|
| 11 | Roof | Roof - Scratch(es) - Paint |

**Damage 11:** Roof: Roof - Scratch(es) - Paint

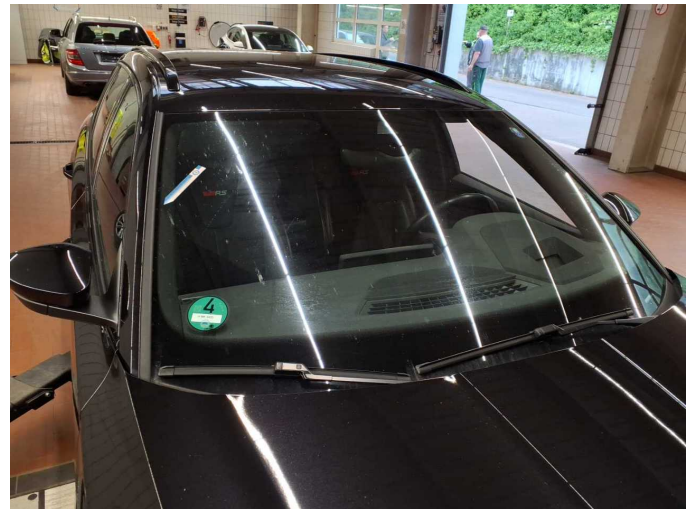
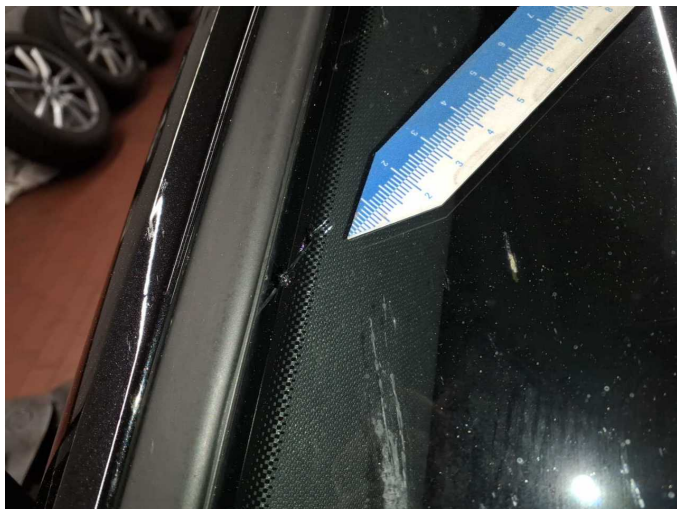
| No. | Component group | Description |
|---|---|---|
| 12 | Vehicle glazing | Windscreen - Broken / torn - repair according to calculation |

**Damage 12:** Vehicle glazing: Windscreen - Broken / torn - repair according to calculation

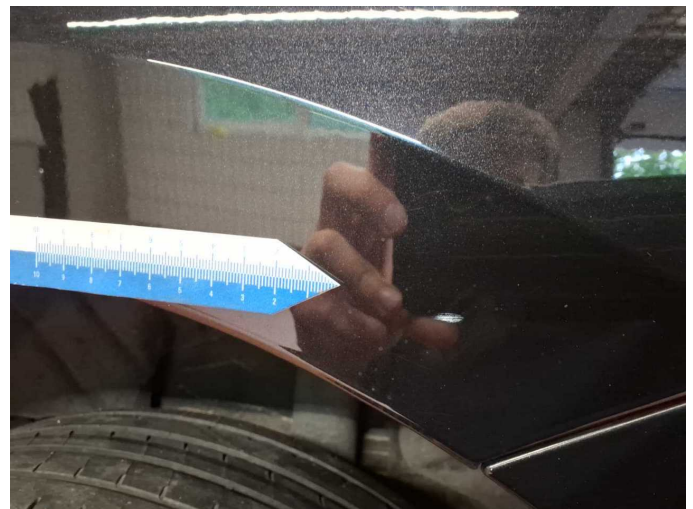
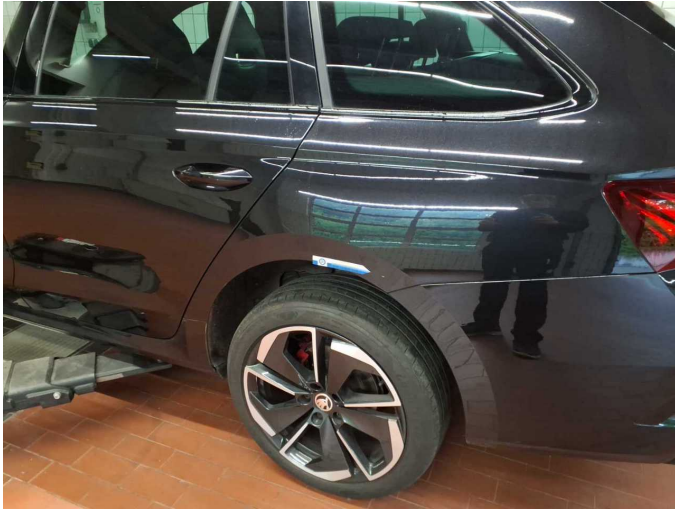
| No. | Component group | Description |
|---|---|---|
| 3 | Side panel - rear left side | Side panel - Scratch(es) - Cover / polish |

**Wear and tear 3:** Side panel - rear left side: Side panel - Scratch(es) - Cover / polish

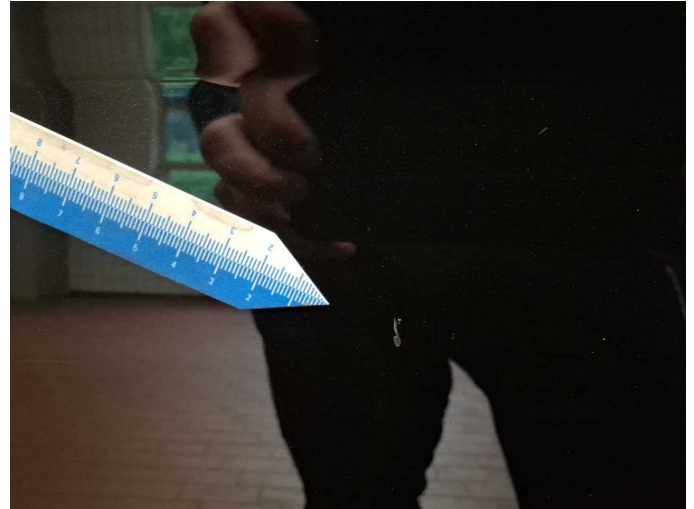
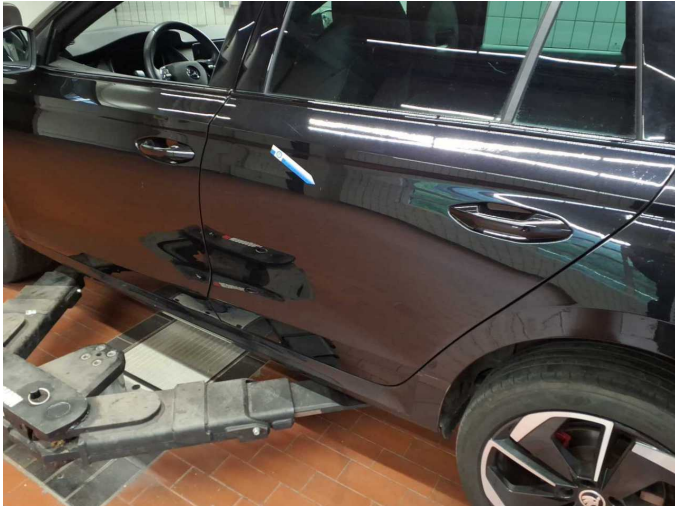
| No. | Component group | Description |
|---|---|---|
| 4 | Door - rear left side | Door - Scratch(es) - Cover / polish |

**Wear and tear 4:** Door - rear left side: Door - Scratch(es) - Cover / polish

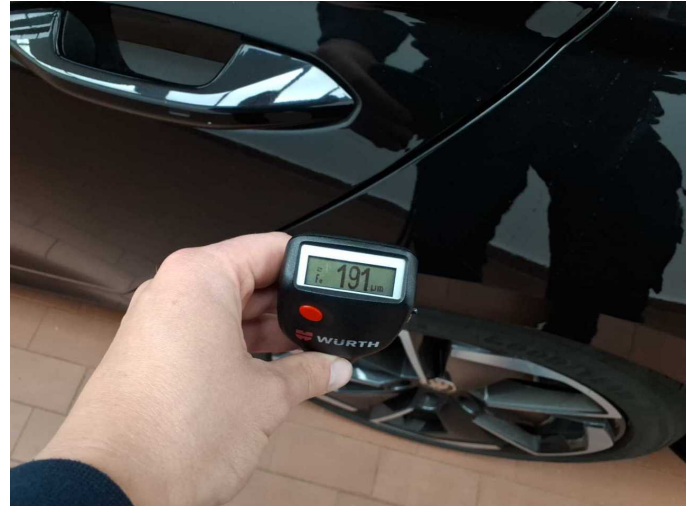
- Side panel - rear left side, Professionally carried out, Invoice of repair done Non-existent
- Door - rear left side, Professionally carried out, Invoice of repair done Non-existent
- Door - front left side, Professionally carried out, Invoice of repair done Non-existent

| Side panel - rear left side | 191 µm | Door - rear left side | 192 µm |

**Repainting 1:** Side panel - rear left side

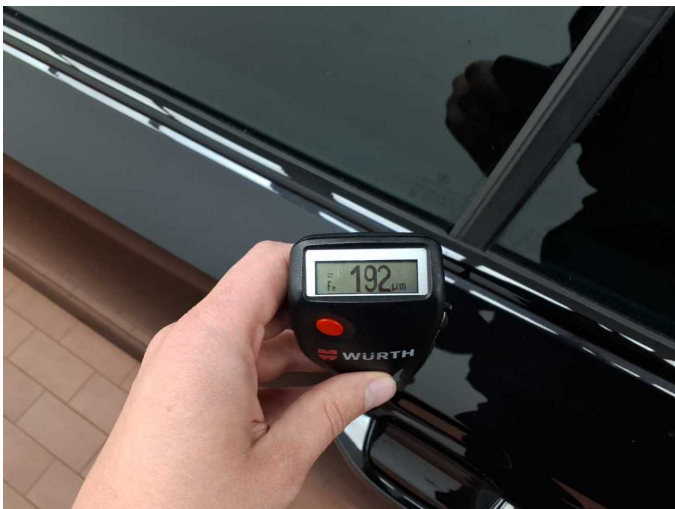
**Repainting 2:** Door - rear left side

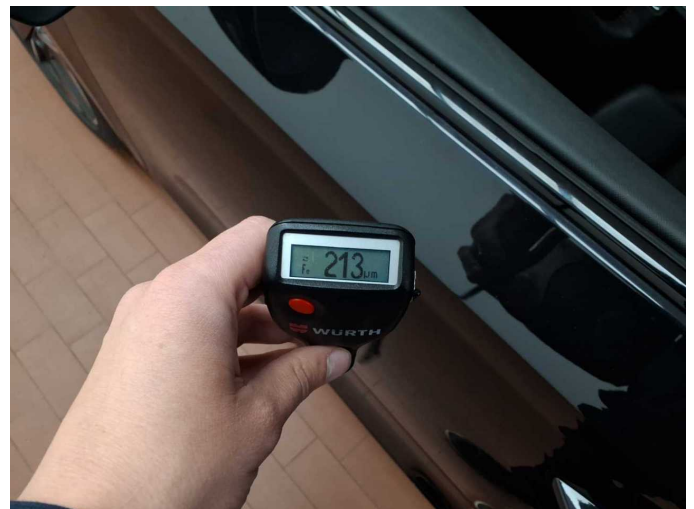
| Door - front left side | 213 µm | | |

**Repainting 3:** Door - front left side
