Expertise

Protocol number: 39876930  
Order No. / Reference: 24694561  
Inspection date: 23 May 2025

Manufacturer: Skoda  
VIN: TMBJR9NU4PC219269

Model: Karoq 1.5 TSI DSG Sportline

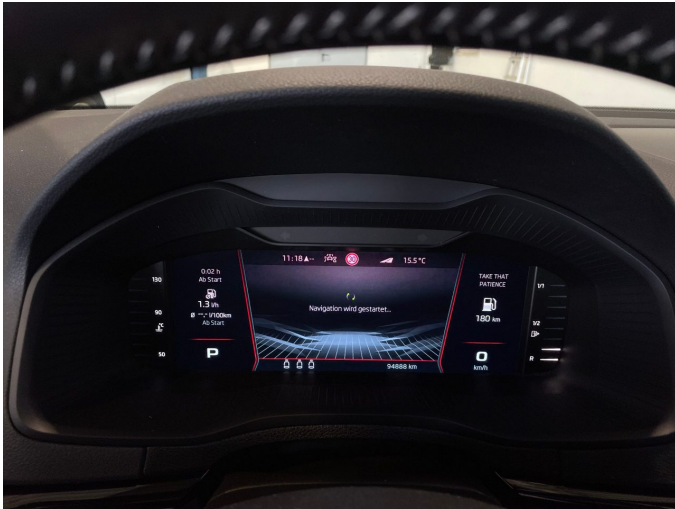
Figure 7: Instrument cluster

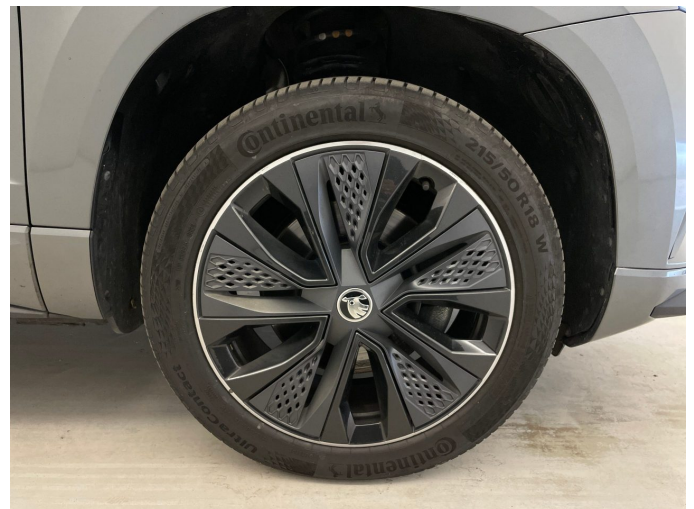
#	Tyre size	Type of tyre	Manufacturer	Tread depth
1)	215/50 R18 92W	Summer tyres on Light alloy	Continental	6mm / 6mm
2)	215/50 R18 92W	Summer tyres on Light alloy	Continental	5mm / 5mm

Figure 12: Mounted tyres

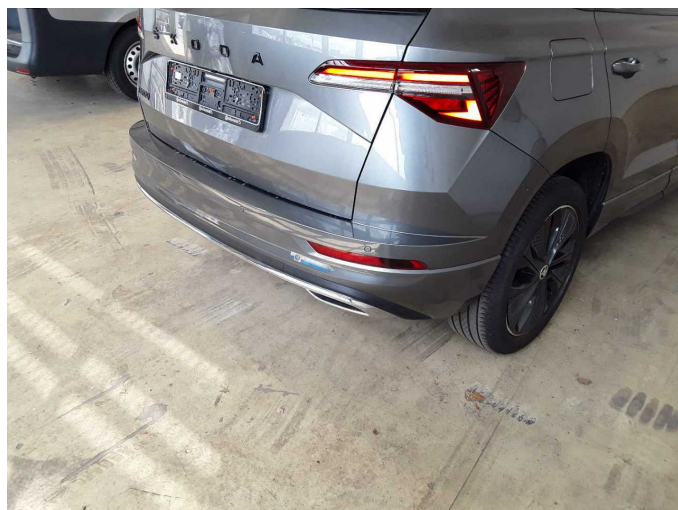
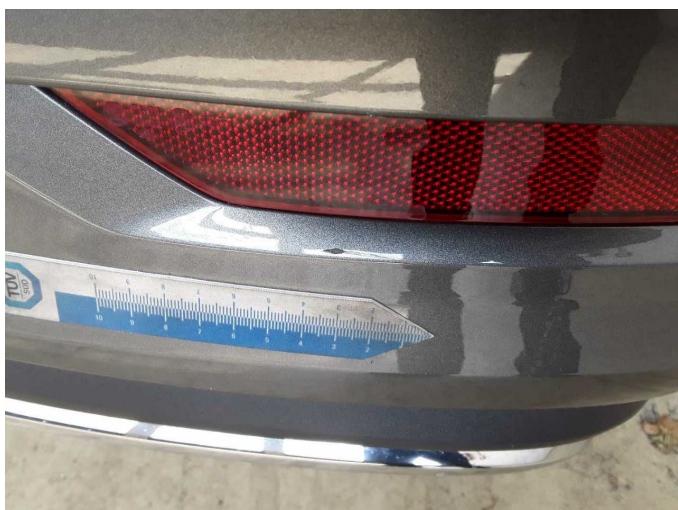
No.	Component group	Description
1	Rear bumper	Rear bumper - Scratch(es) - Smart repair
2	Boot lid / rear door	Boot lid - Dent / paintcoat damage - Smart repair
3	Wheel / tyres	Alloy rim - rear right side - Scratch(es) - Loss in value

Damage 1: Rear bumper: Rear bumper - Scratch(es) - Smart repair

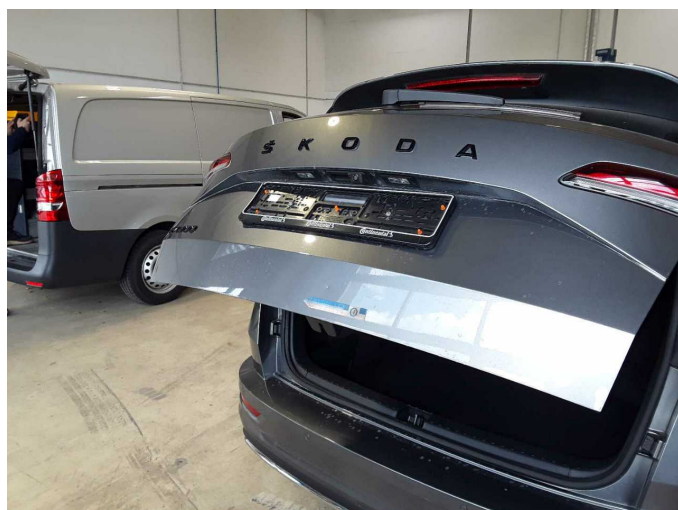
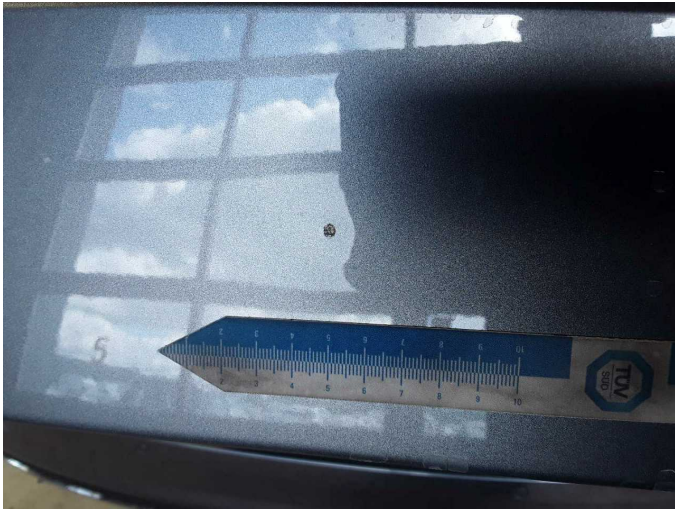
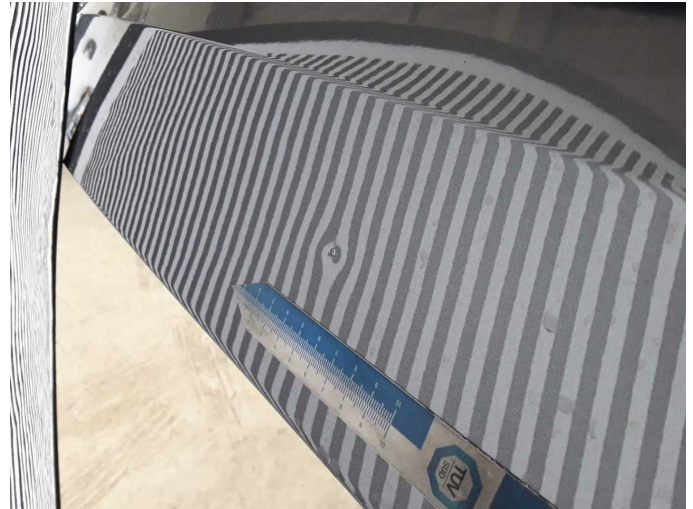
Damage 2: Boot lid / rear door: Boot lid - Dent / paintcoat damage - Smart repair

**Damage 2:** Boot lid / rear door: Boot lid - Dent / paintcoat damage - Smart repair

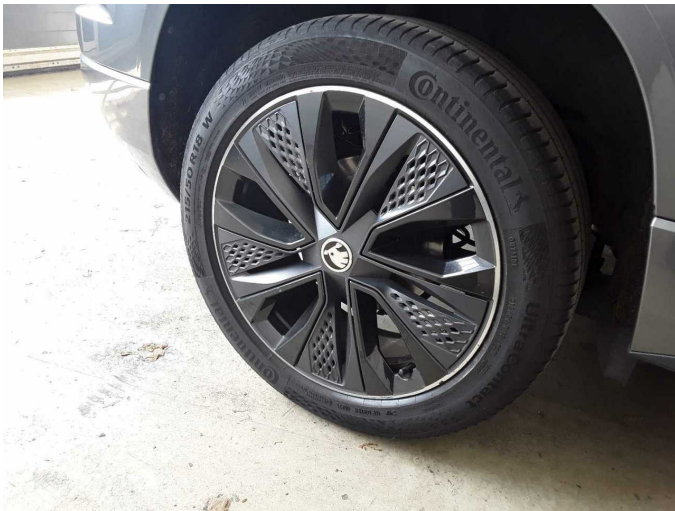
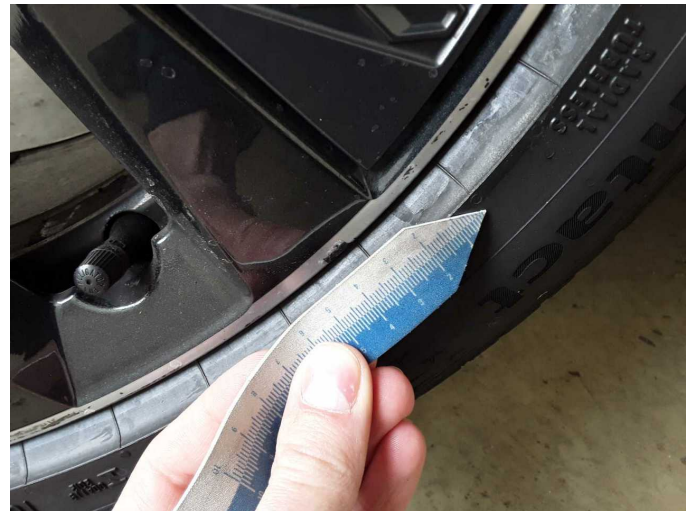
**Damage 3:** Wheel / tyres: Alloy rim - rear right side - Scratch(es) - Loss in value
