SKODA OCTAVIA COMBI IV

Vehicle information

Damages

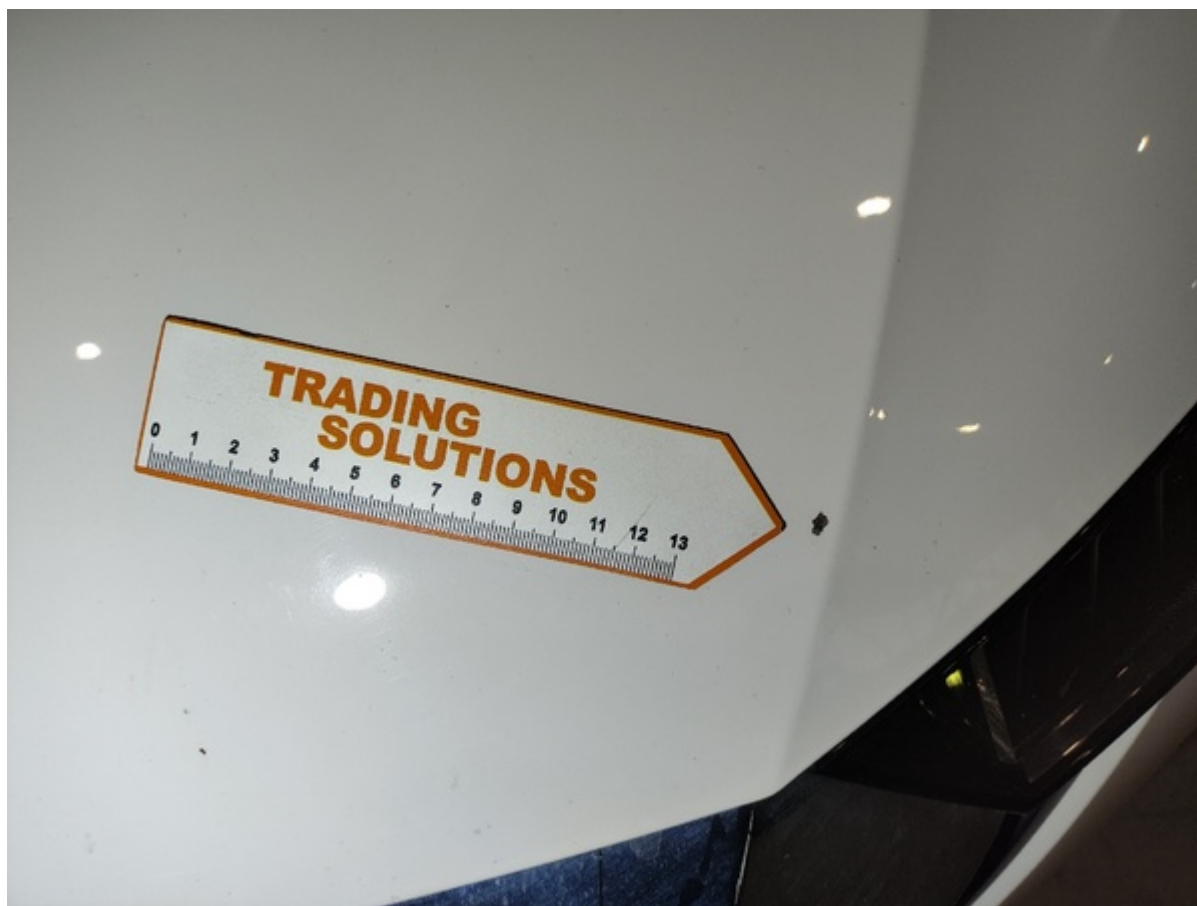
| Location | Damage | Comments | Costs excluding VAT |
|---|---|---|---|
| Bumper, Front | Chips, several | | 70 € |

Stötfångare Fram Stenskott flertal 800 kr

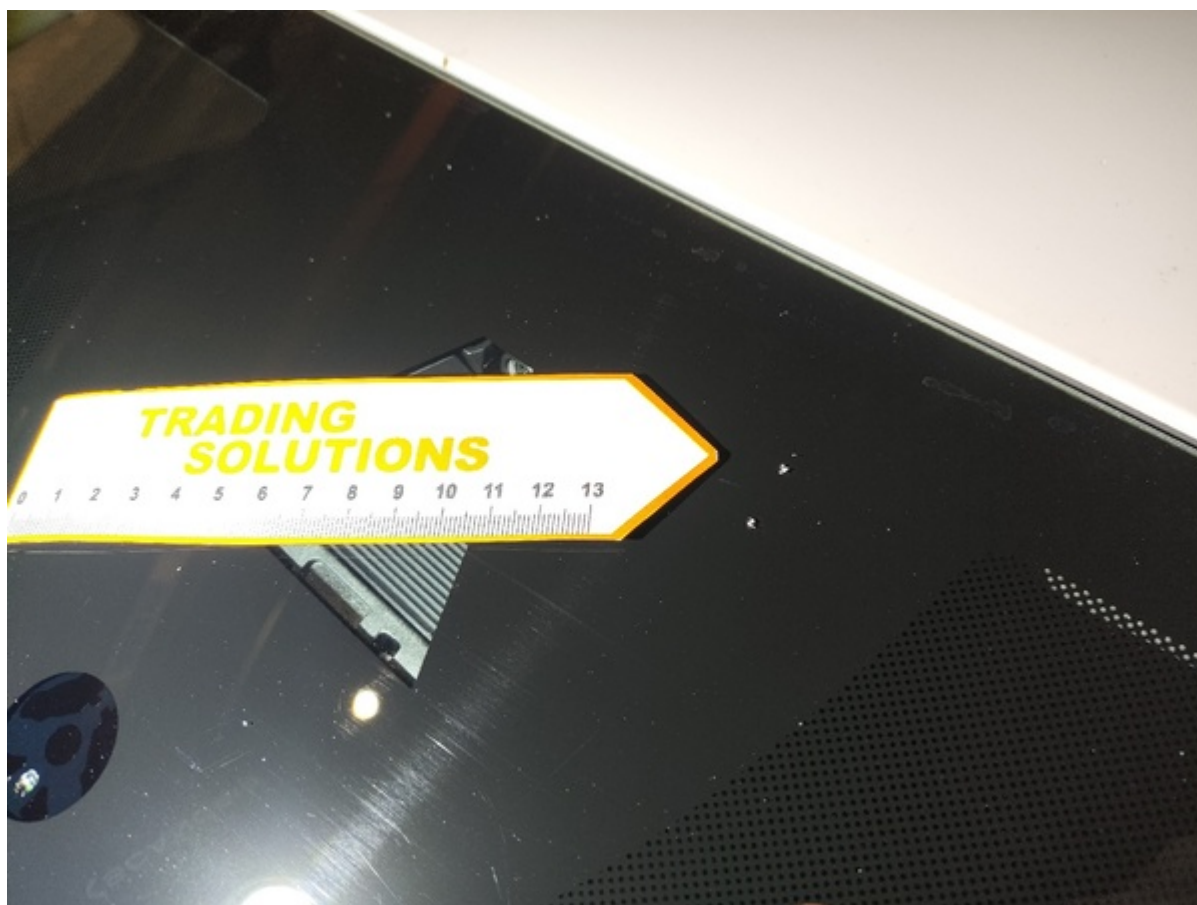
| Location | Damage | Comments | Costs excluding VAT |
|---|---|---|---|
| Bonnet | Chip | | 70 € |

Motorhuv Stenskott 800 kr
