Expertise

Protocol number: 39989444  
Order No. / Reference: 24806512  
Inspection date: 2 Jun 2025

| Manufacturer: Skoda | Model: Superb Combi 1.4 TSI iV DSG L&K |

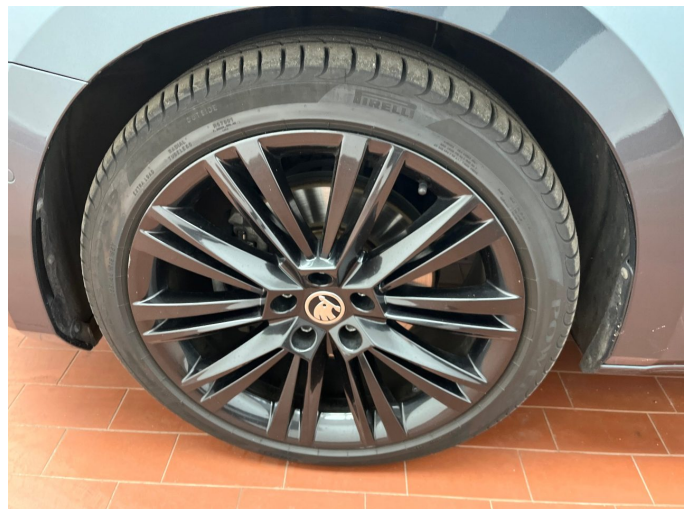
| # | Tyre size | Type of tyre | Manufacturer | Tread depth |
|---|---|---|---|---|
| 1) | 235/40 R19 96Y | Summer tyres on Light alloy | Pirelli | 6mm / 6mm |
| 2) | 235/40 R19 96Y | Summer tyres on Light alloy | Pirelli | 6mm / 6mm |

Figure 12: Mounted tyres

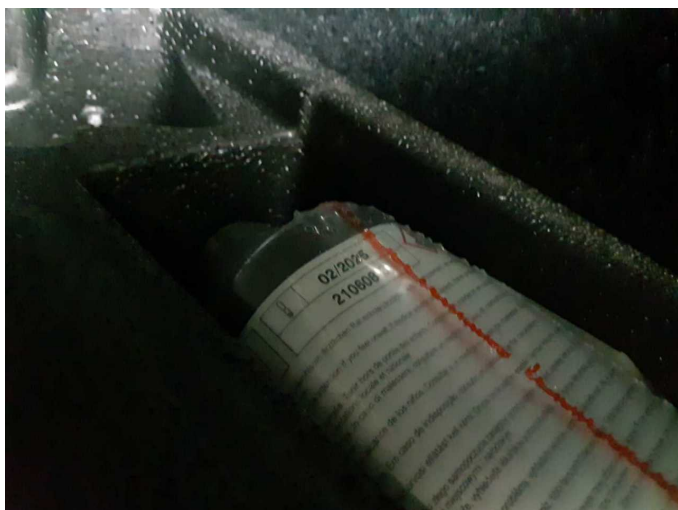
**Damage 1:** Equipment: Tirefit filler - Due - Replace

| No. | Component group | Description |
|---|---|---|
| 1 | Equipment | Tirefit filler - Due - Replace |

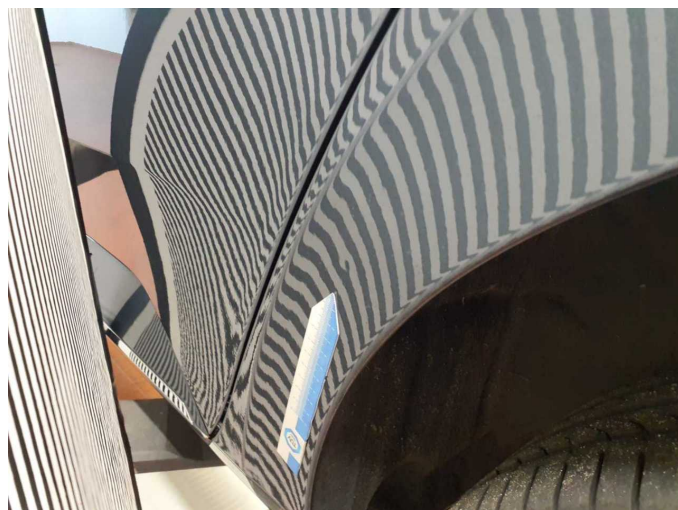
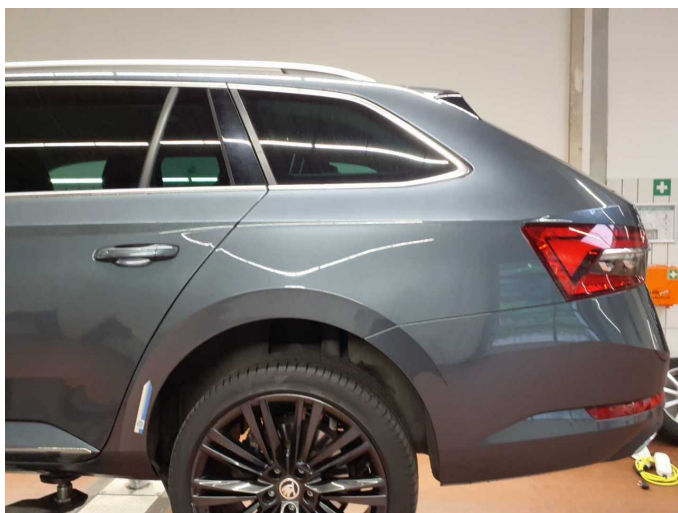
**Damage 2:** Side panel - rear left side: Side panel - dent(s) - Smart repair

| No. | Component group | Description |
|---|---|---|
| 2 | Side panel - rear left side | Side panel - dent(s) - Smart repair |

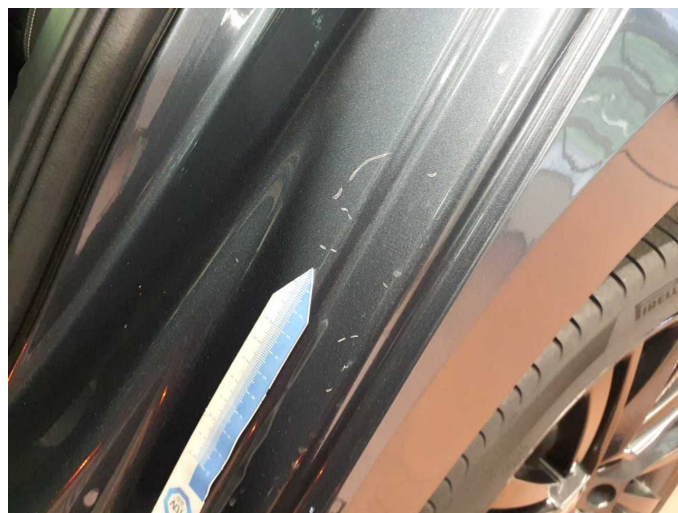
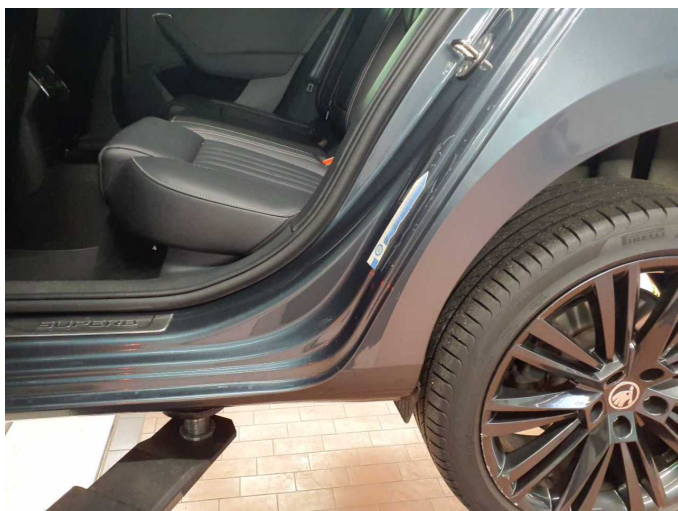
**Damage 3:** Side panel - rear left side: Sill - Scratched - Smart repair

| No. | Component group | Description |
|---|---|---|
| 3 | Side panel - rear left side | Sill - Scratched - Smart repair |

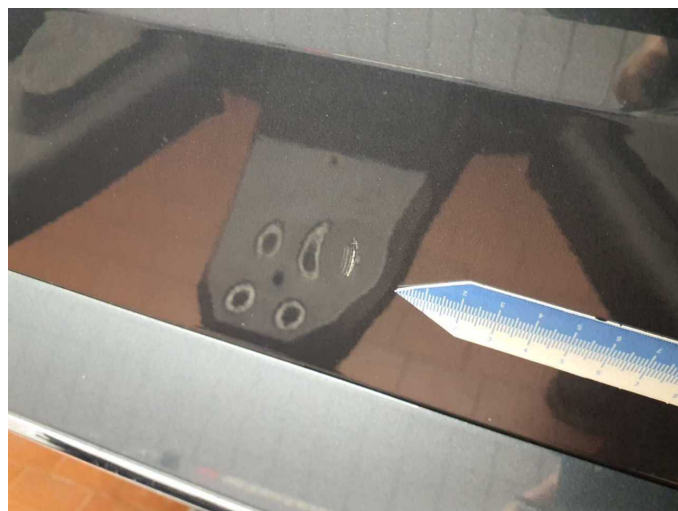
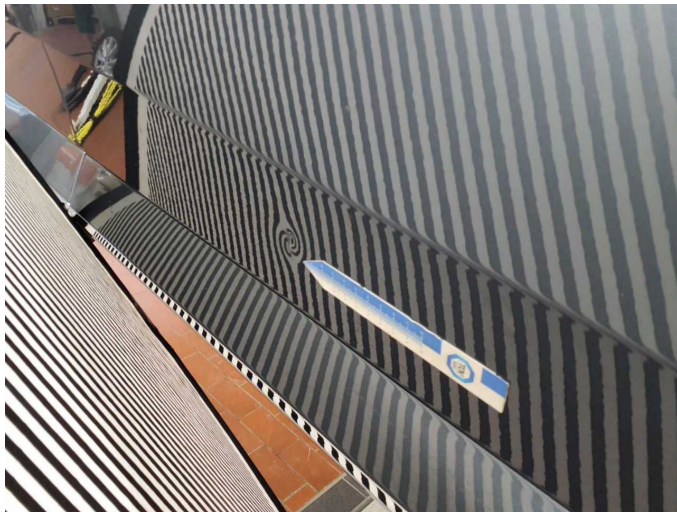
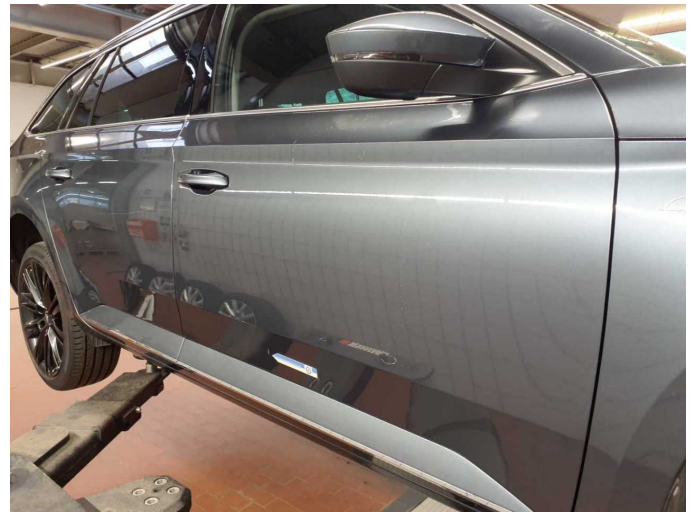
**Damage 4:** Door - front right side: Door - Dent / paintcoat damage - Smart repair

| No. | Component group | Description |
|---|---|---|
| 4 | Door - front right side | Door - Dent / paintcoat damage - Smart repair |

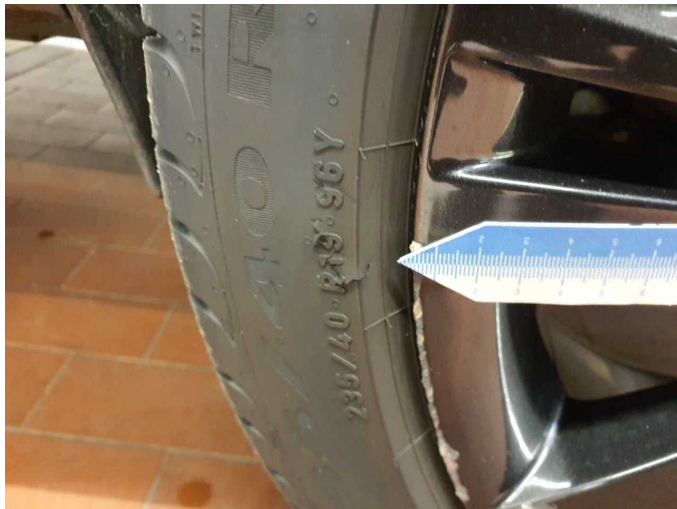
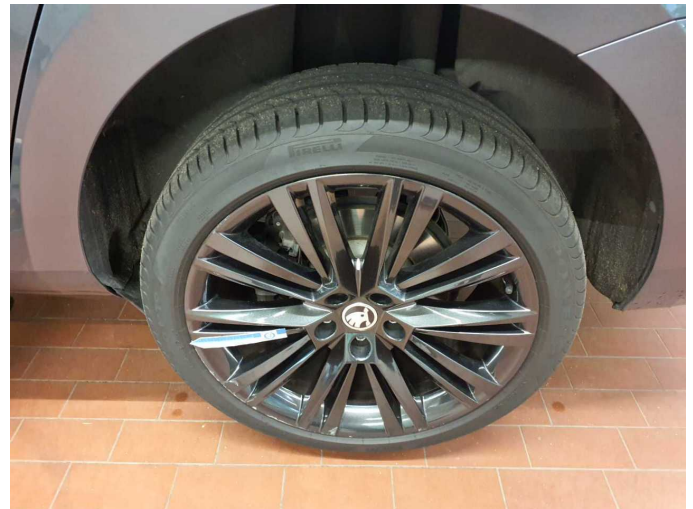
**Damage 5:** Wheel / tyres: Tyre - rear left side - Damaged - Replace

| No. | Component group | Description |
|---|---|---|
| 5 | Wheel / tyres | Tyre - rear left side - Damaged - Replace |

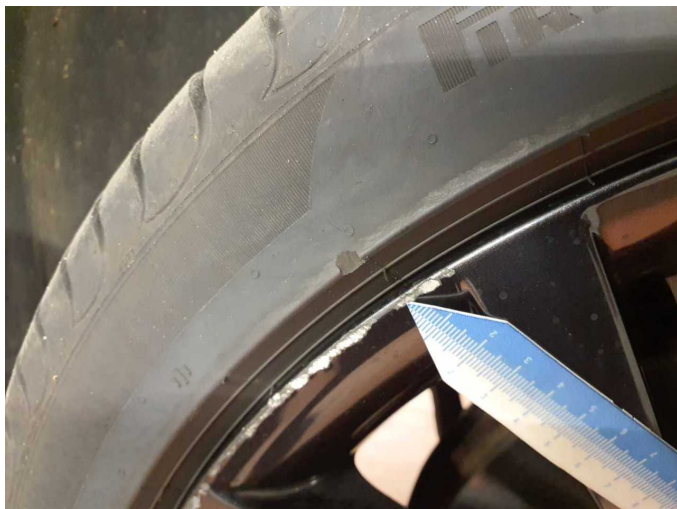
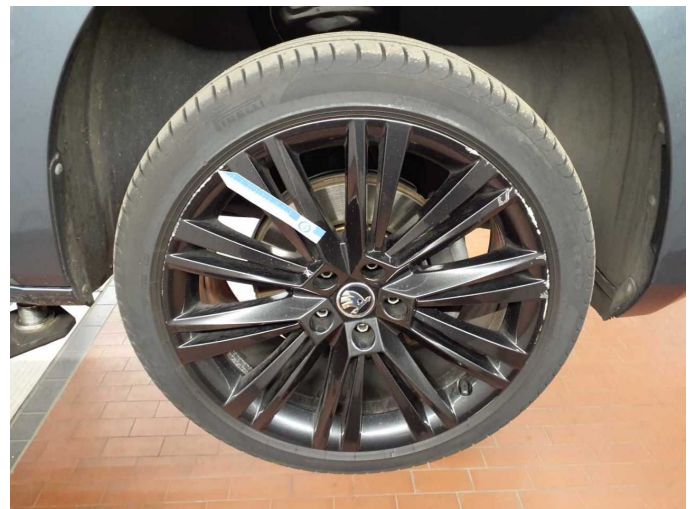
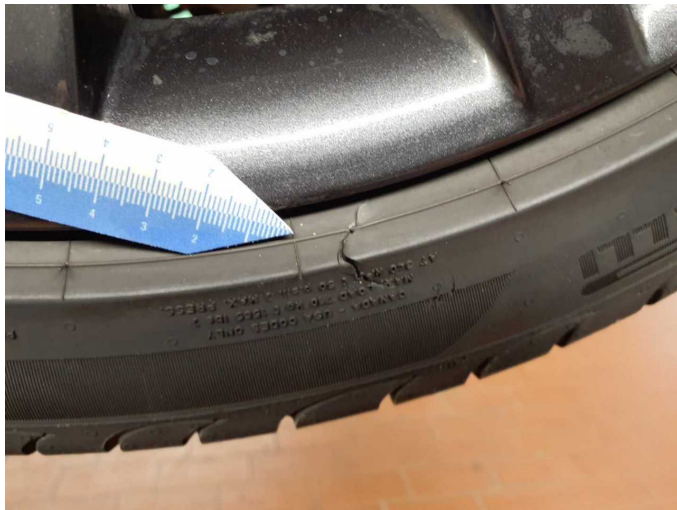
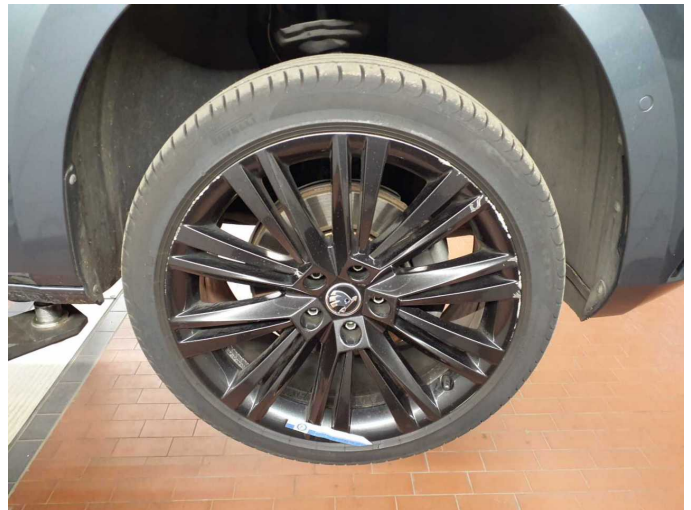
**Damage 6:** Wheel / tyres: Tyre - front right side - Damaged - Replace

| No. | Component group | Description |
|---|---|---|
| 6 | Wheel / tyres | Tyre - front right side - Damaged - Replace |

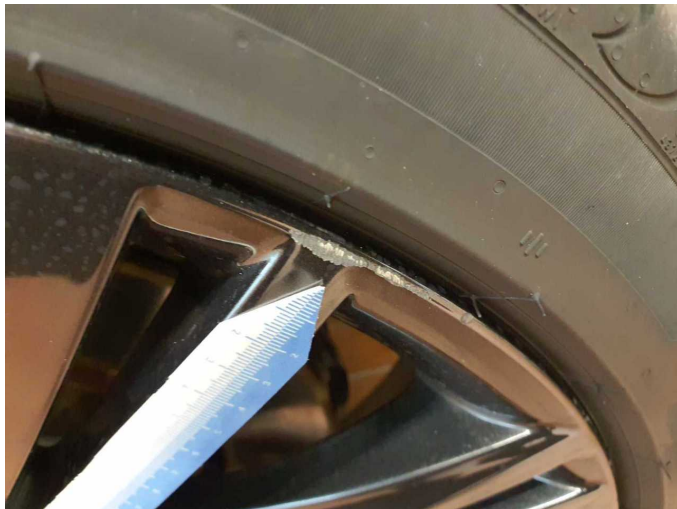
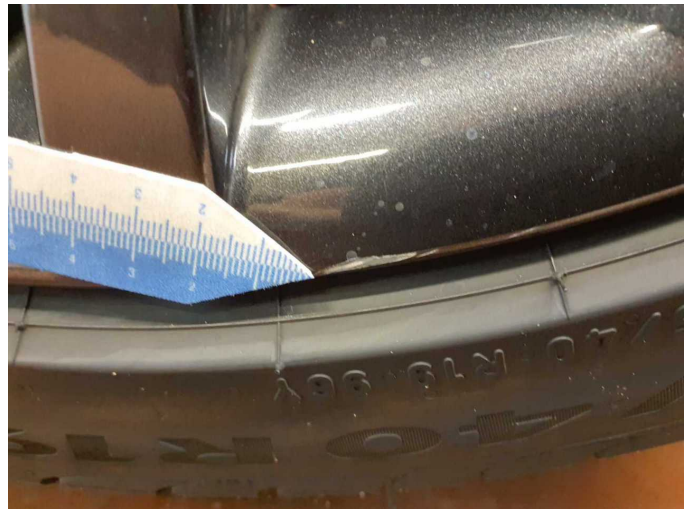
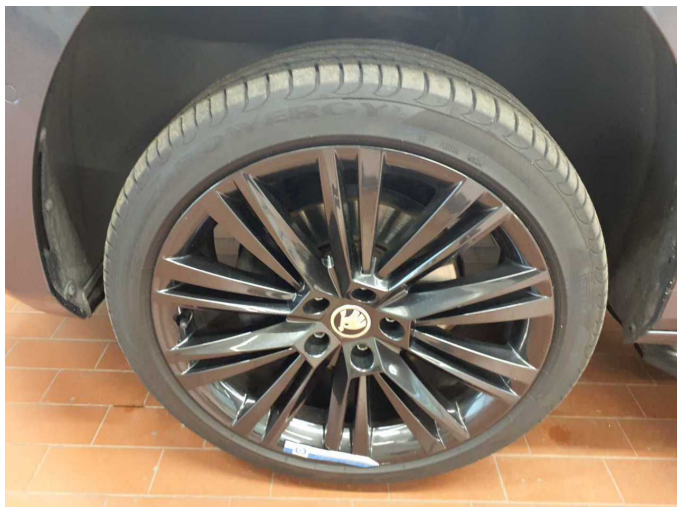
**Damage 7:** Wheel / tyres: Alloy rim - front left side - Scratch(es) - Loss in value

| No. | Component group | Description |
|---|---|---|
| 7 | Wheel / tyres | Alloy rim - front left side - Scratch(es) - Loss in value |

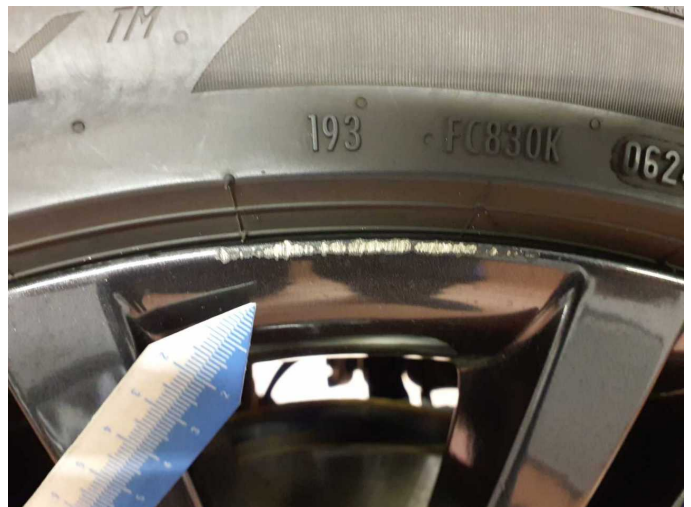
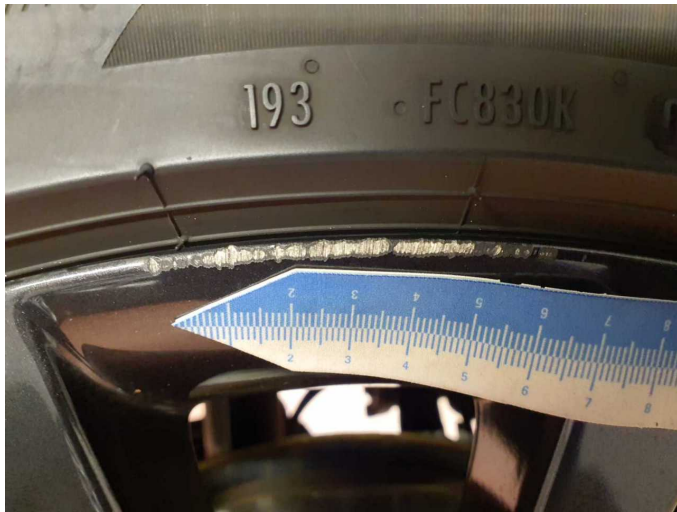
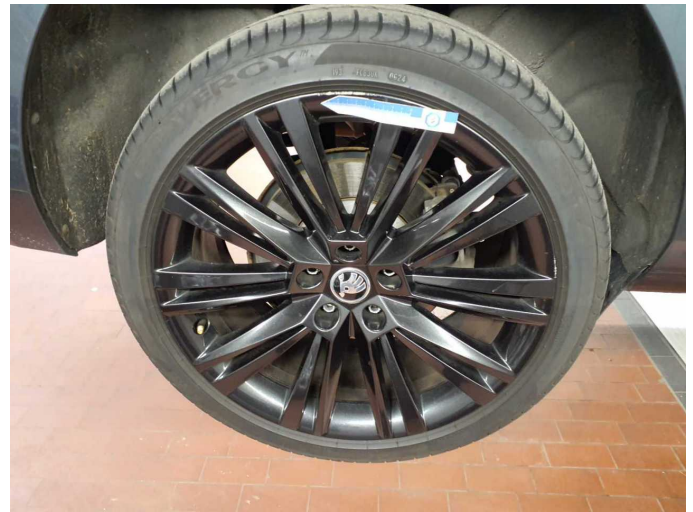
**Damage 8:** Wheel / tyres: Alloy rim - rear right side - Scratch(es) - Loss in value

| No. | Component group | Description |
|---|---|---|
| 8 | Wheel / tyres | Alloy rim - rear right side - Scratch(es) - Loss in value |

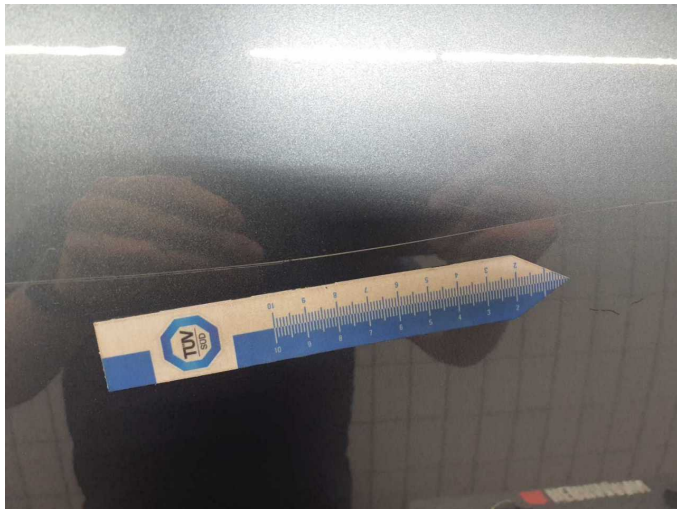
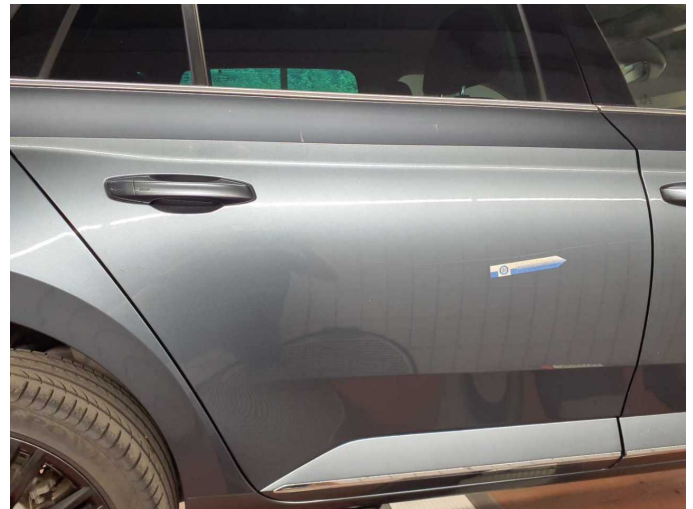
**Damage 9:** Door - rear right side: Door - Scratched - Paint

| No. | Component group | Description |
|---|---|---|
| 9 | Door - rear right side | Door - Scratched - Paint |

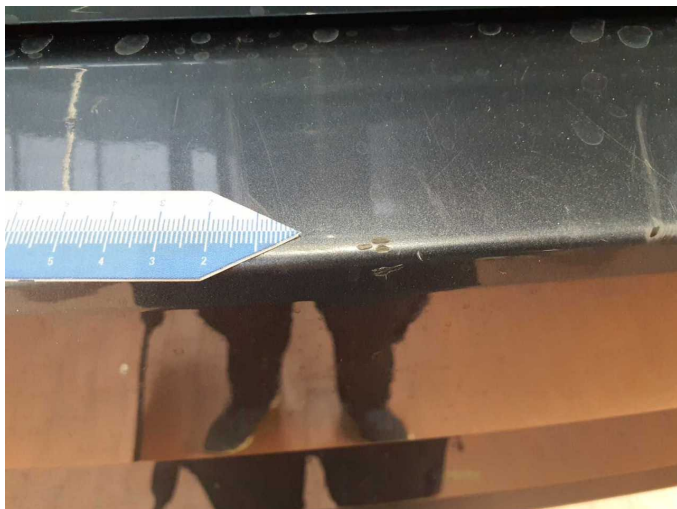
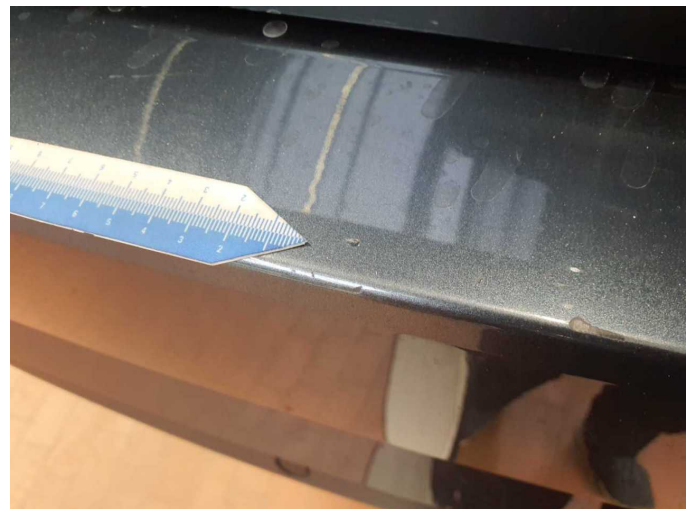
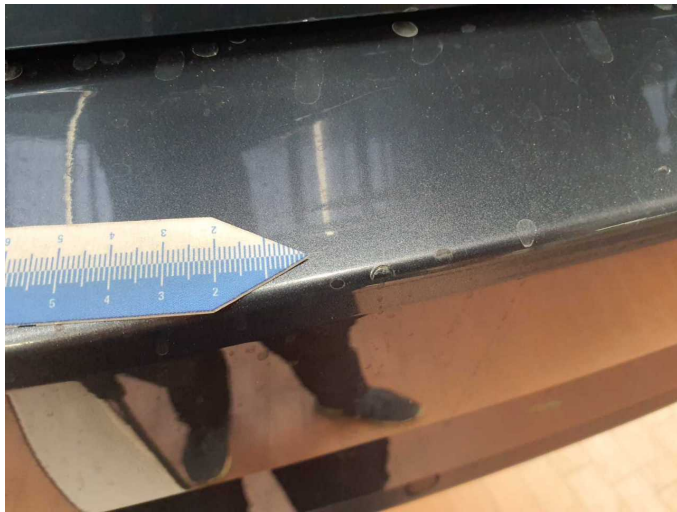
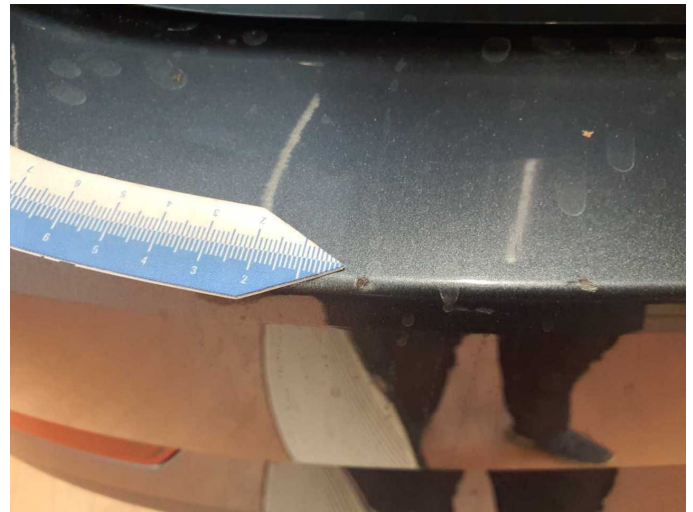
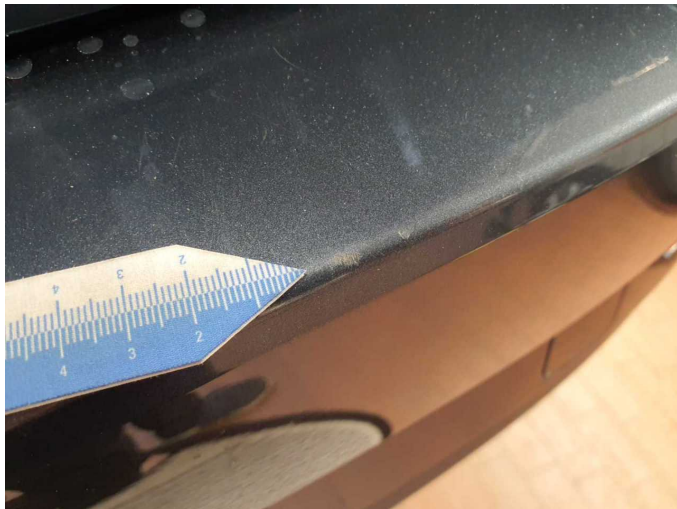
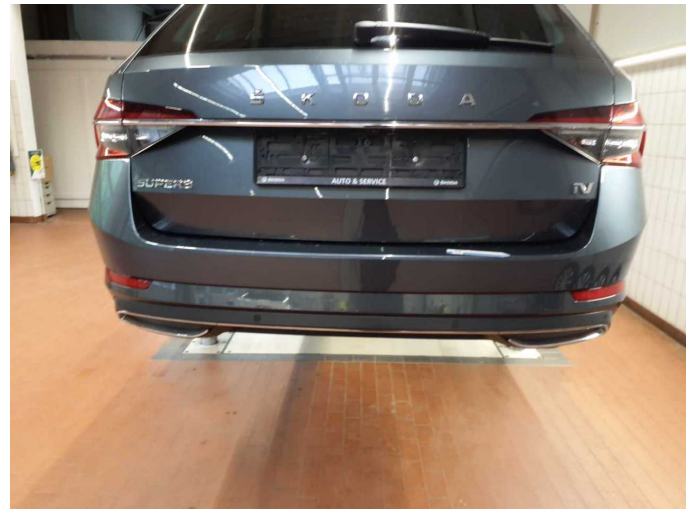
**Damage 10:** Rear bumper: Rear bumper - Scratched - Paint

| No. | Component group | Description |
|---|---|---|
| 10 | Rear bumper | Rear bumper - Scratched - Paint |

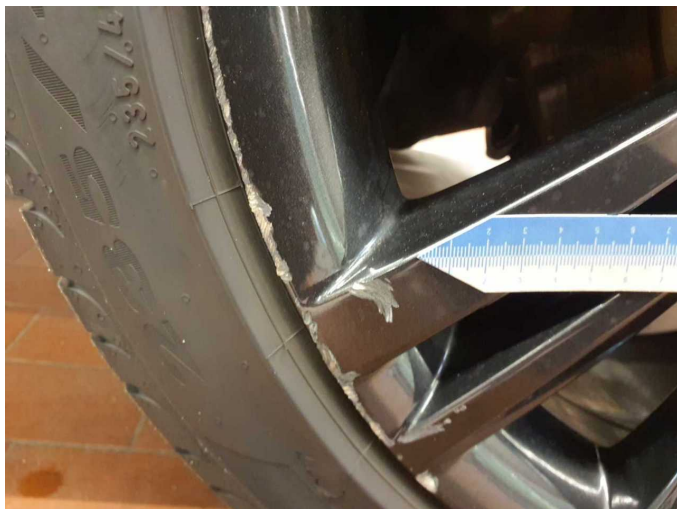
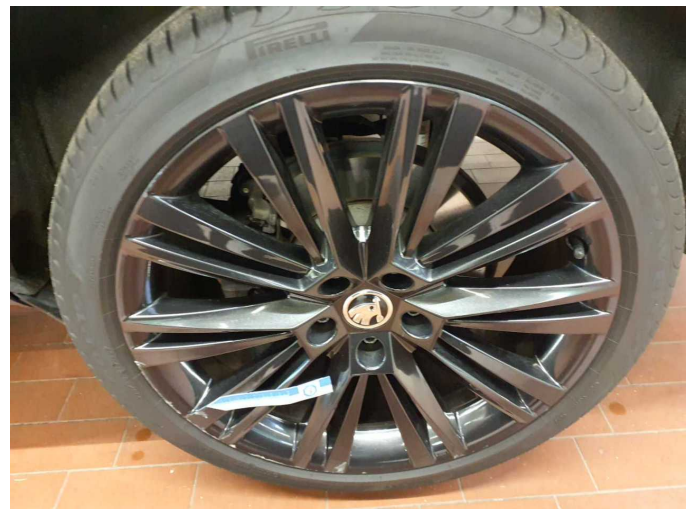
**Damage 11:** Wheel / tyres: Alloy rim - rear left side (Materialabtrag) - Scratched - Replace

| No. | Component group | Description |
|---|---|---|
| 11 | Wheel / tyres | Alloy rim - rear left side (Materialabtrag) - Scratched - Replace |

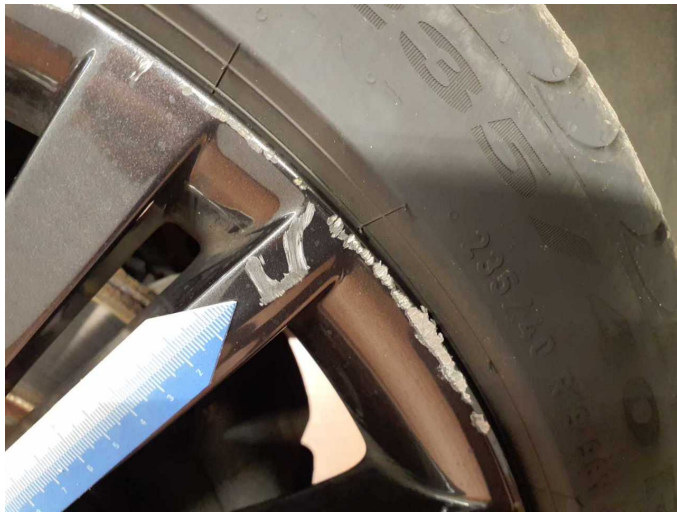
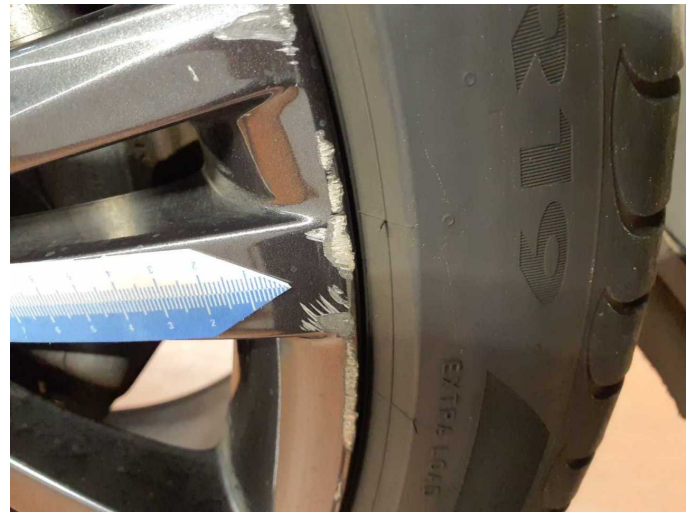
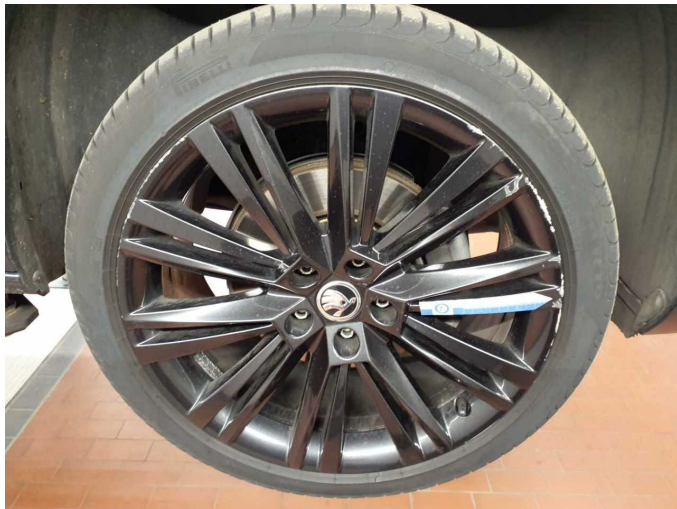
**Damage 12:** Wheel / tyres: Alloy rim - front right side (Materialabtrag) - Scratched - Replace

| No. | Component group | Description |
|---|---|---|
| 12 | Wheel / tyres | Alloy rim - front right side (Materialabtrag) - Scratched - Replace |

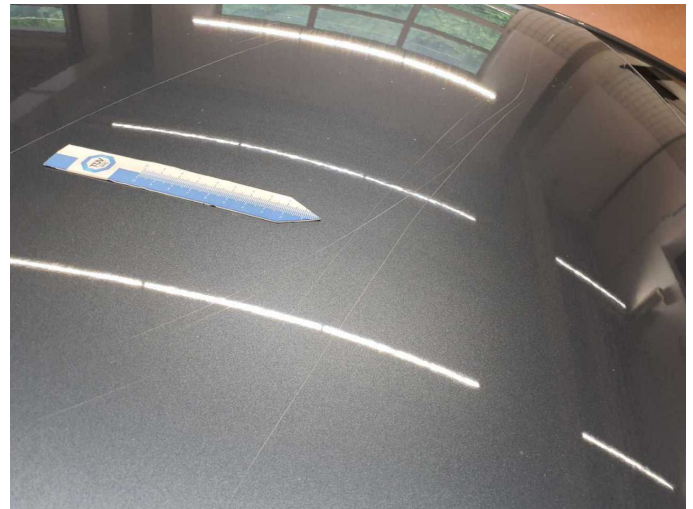
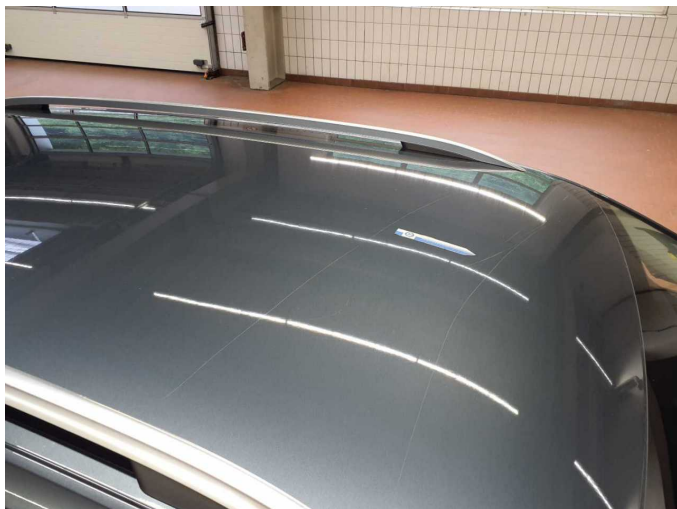
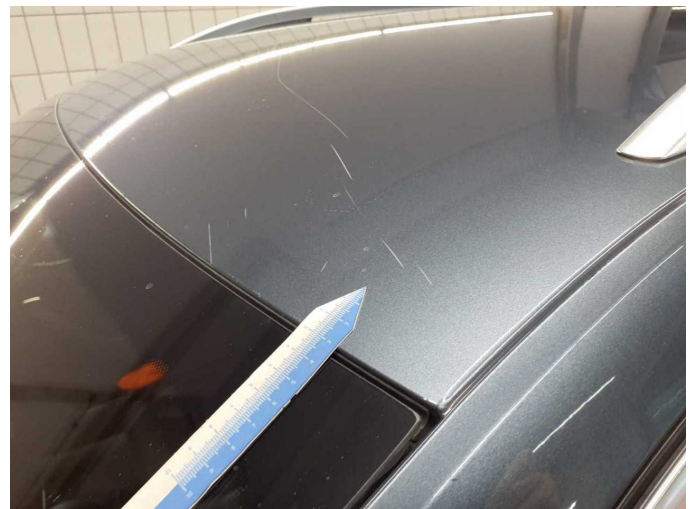
**Damage 13:** Roof: Roof - Scratched - Paint

| No. | Component group | Description |
|---|---|---|
| 13 | Roof | Roof - Scratched - Paint |

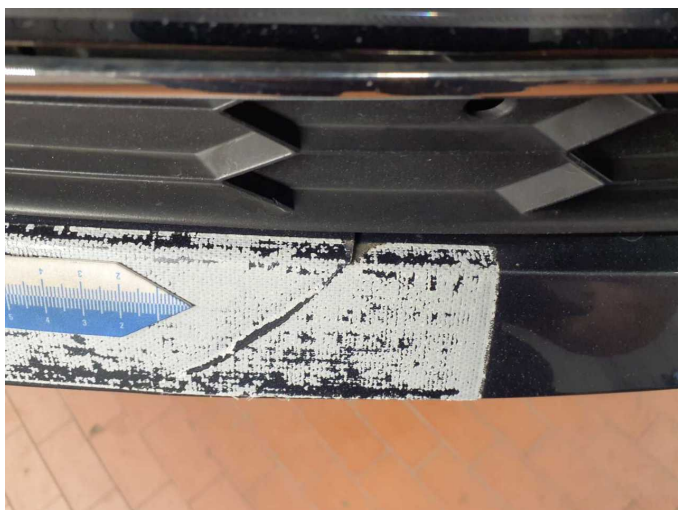
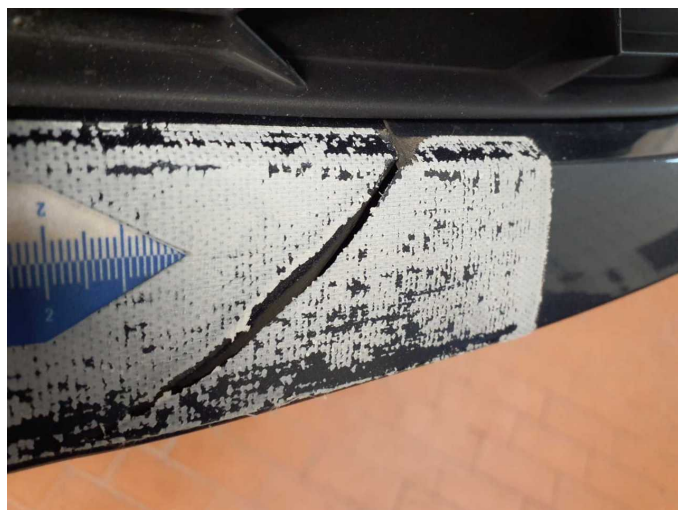
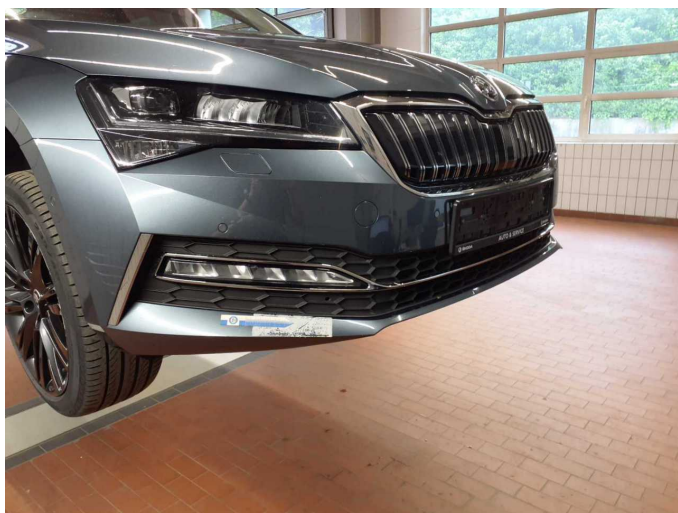
**Damage 14:** Front bumper: Front bumper - Broken / torn - Replace

| No. | Component group | Description |
|---|---|---|
| 14 | Front bumper | Front bumper - Broken / torn - Replace |

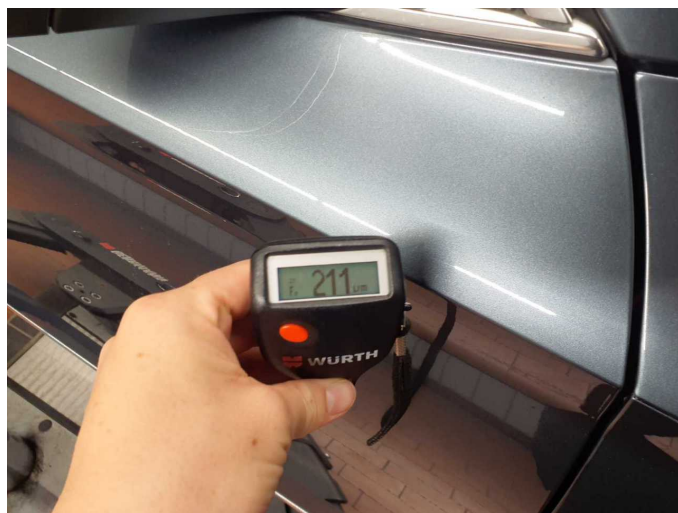
| No. | Repainting |
|---|---|
| 1 | Door - front right side, Professionally carried out, Invoice of repair done Non-existent |

| Door - front right side | 211 µm |

**Repainting 1:** Door - front right side
