Expertise

Protocol number: 41499933  
Order No. / Reference: 25196032  
Inspection date: 12 Sept 2025

Manufacturer: Skoda  
VIN: TMBJW9NPXM7031637

Model: Superb Combi 1.4 TSI iV DSG Ambition

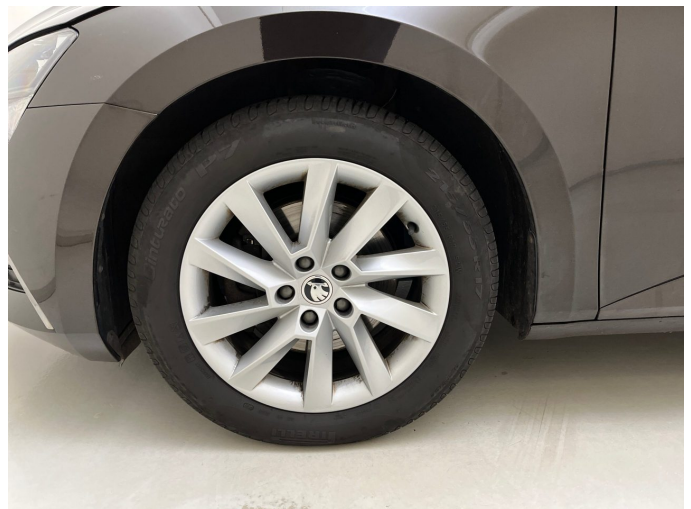
| Tyres | | | | |
|---|---|---|---|---|
| 1) | 215/55 R17 94W | Summer tyres on Light alloy | Pirelli | 4mm / 3mm |
| 2) | 215/55 R17 94W | Summer tyres on Light alloy | Pirelli | 7mm / 7mm |

Figure 12: Mounted tyres

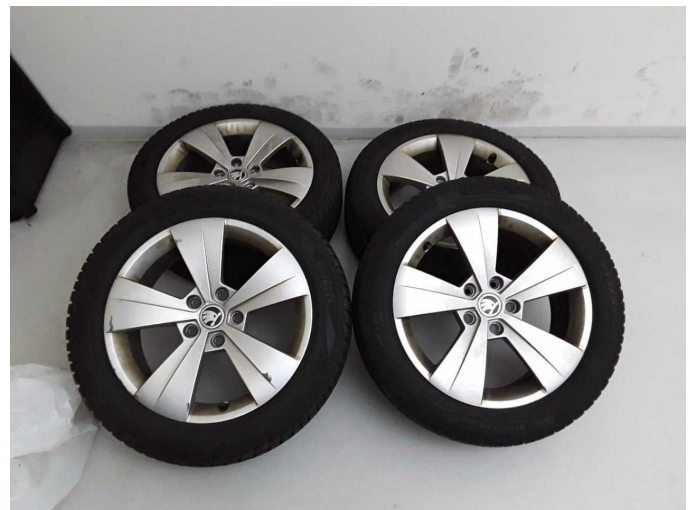
| Tyres | | | | |
|---|---|---|---|---|
| 1) | 215/55 R17 98H | Winter tyres on Light alloy | Pirelli | 0mm / 0mm |
| 2) | 215/55 R17 98H | Winter tyres on Light alloy | Pirelli | 8mm / 8mm |

Figure 16: Additional tyres

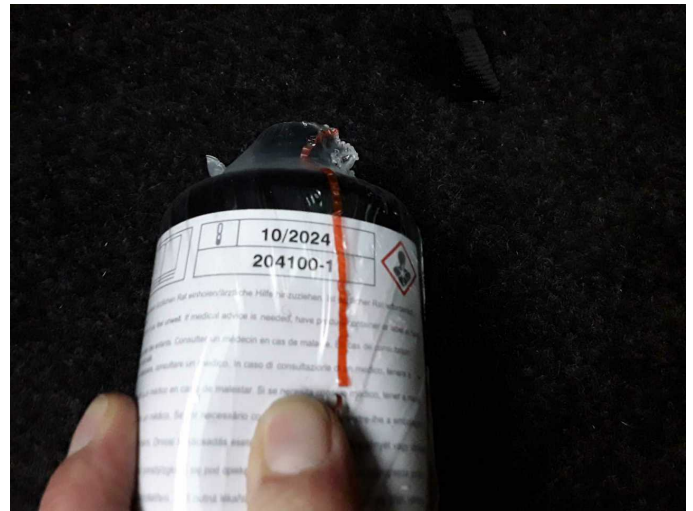
| No. | Component group | Description |
|---|---|---|
| 1 | Equipment | Tirefit filler - Expired - Replace |

Damage 1: Equipment: Tirefit filler - Expired - Replace

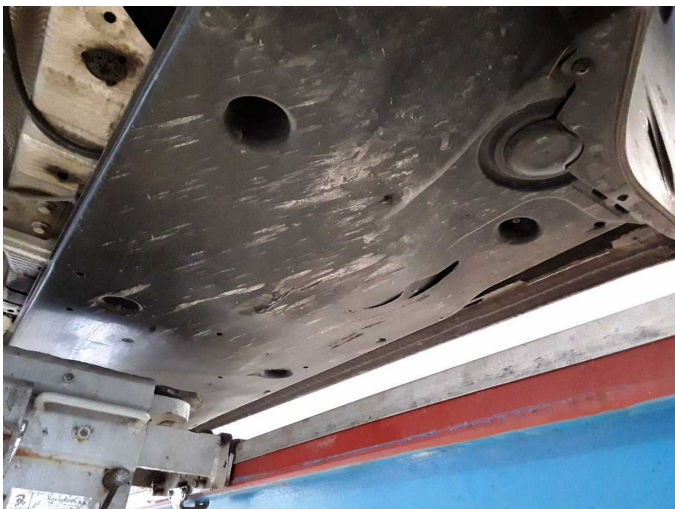
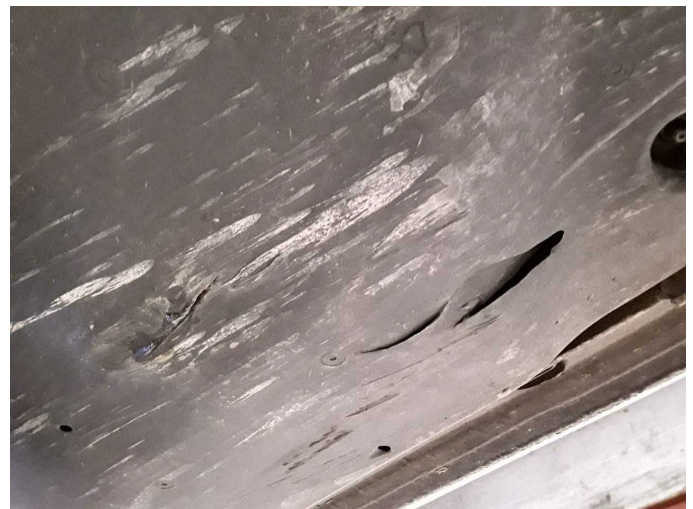
| No. | Component group | Description |
|---|---|---|
| 2 | Body | Underbody panelling (links) - Broken / torn - Replace |

Damage 2: Body: Underbody panelling (links) - Broken / torn - Replace

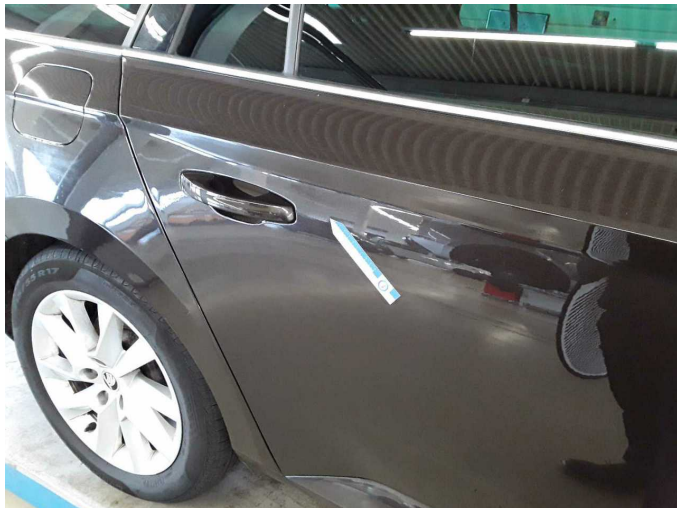
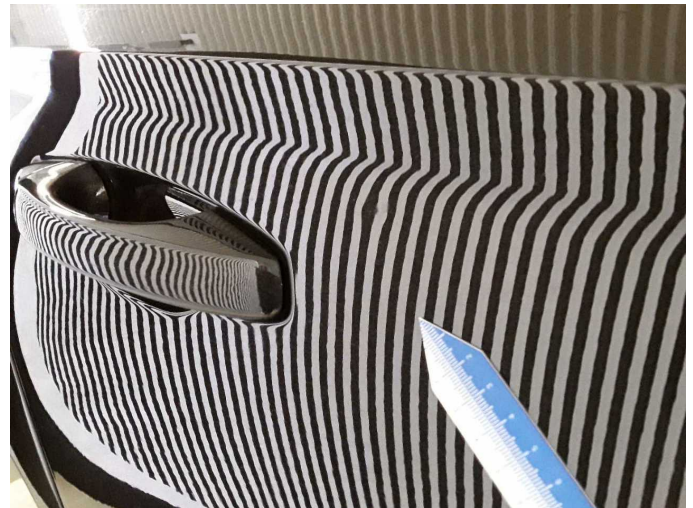
| No. | Component group | Description |
|---|---|---|
| 3 | Door - rear right side | Door - dent(s) - Smart repair |

**Damage 3:** Door - rear right side: Door - dent(s) - Smart repair

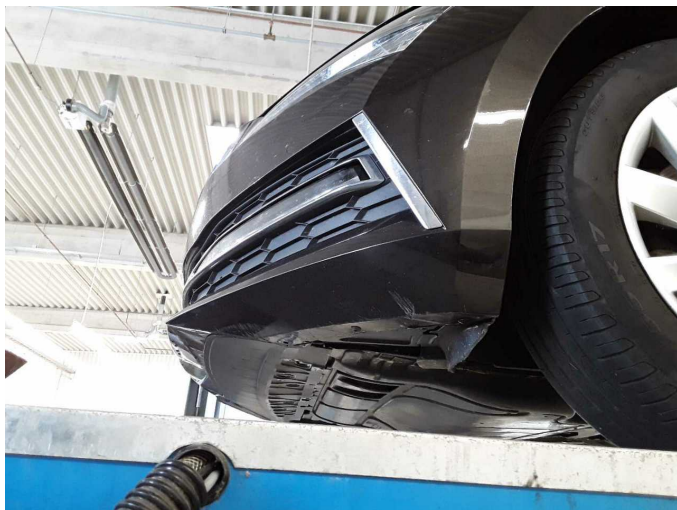
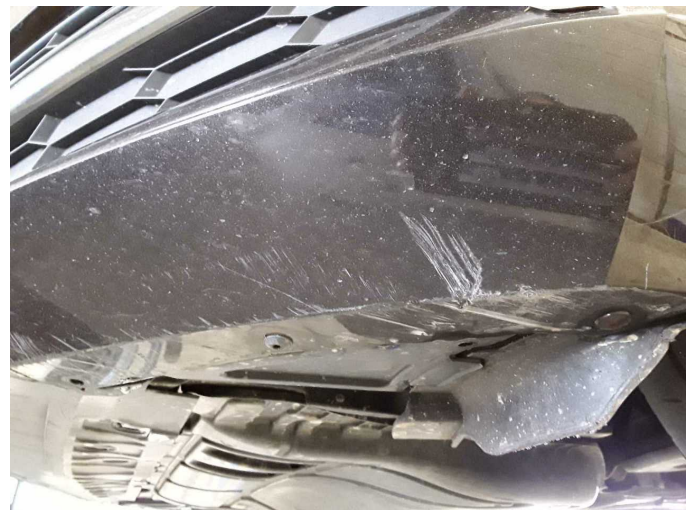
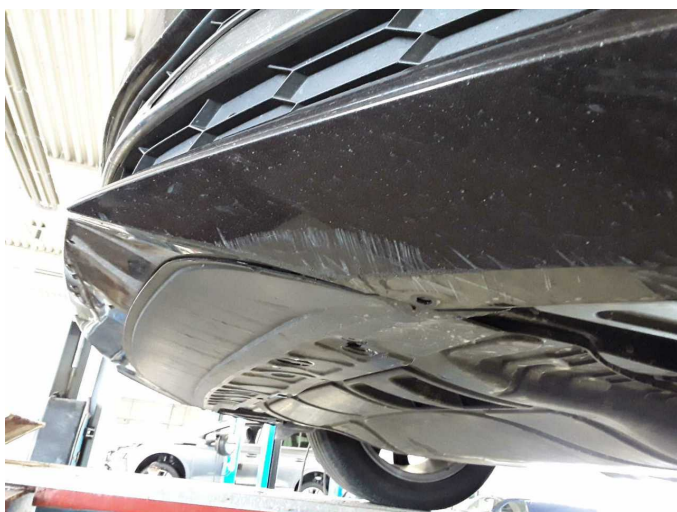
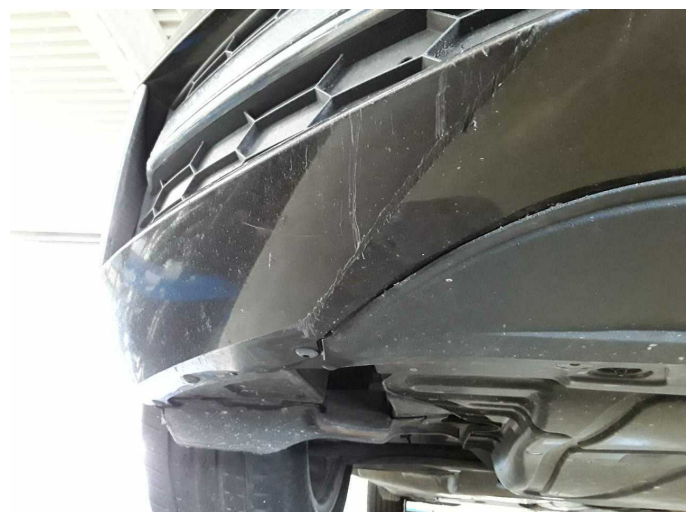
| No. | Component group | Description |
|---|---|---|
| 4 | Front bumper | Front bumper - Scratched - Paint |

**Damage 4:** Front bumper: Front bumper - Scratched - Paint

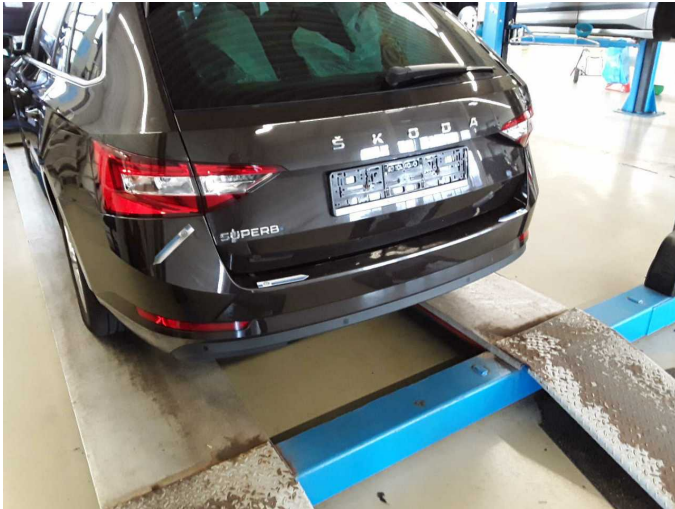
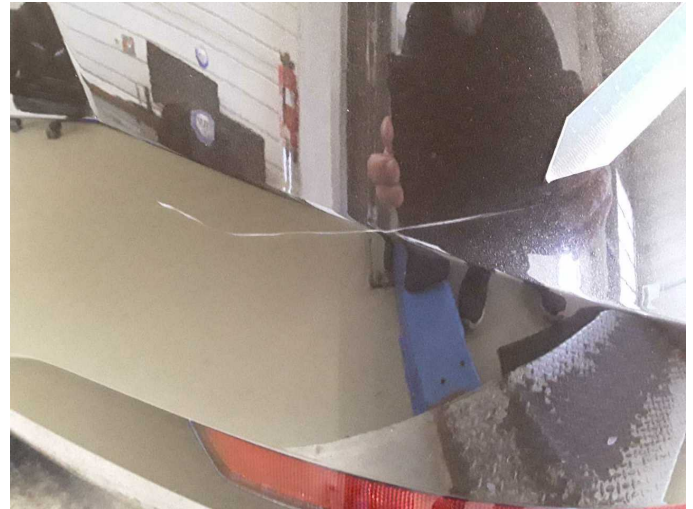
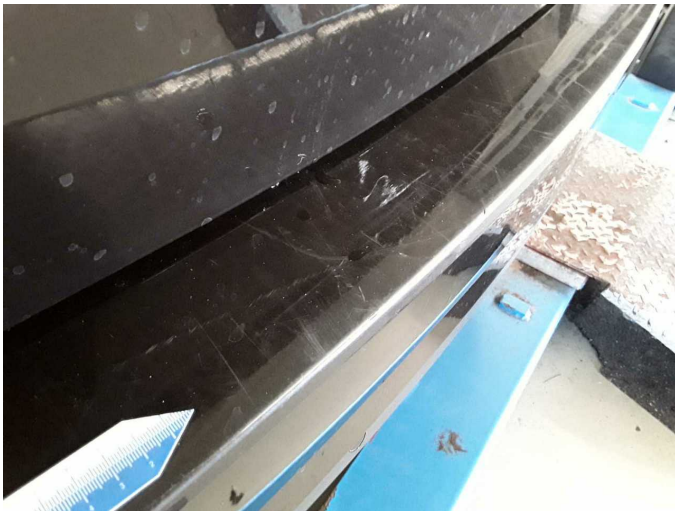
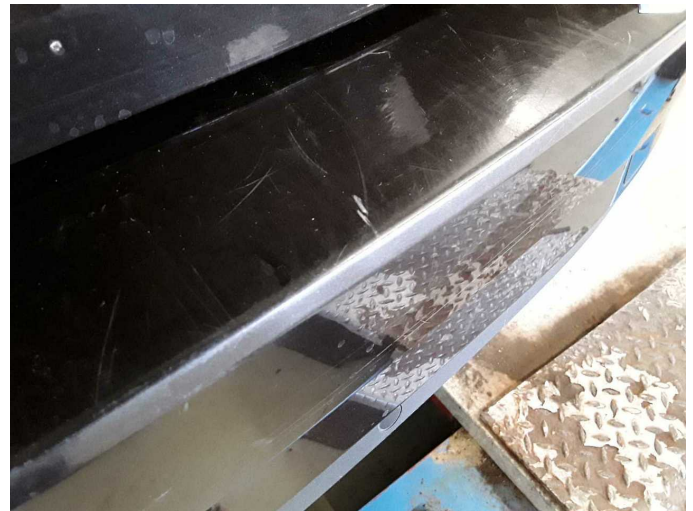
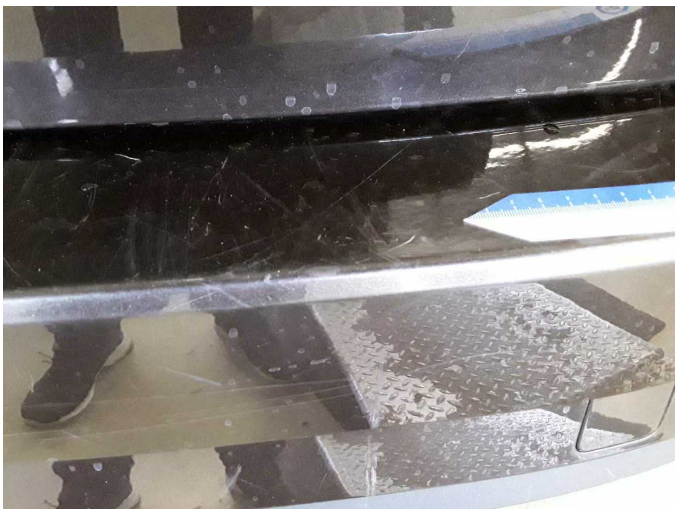
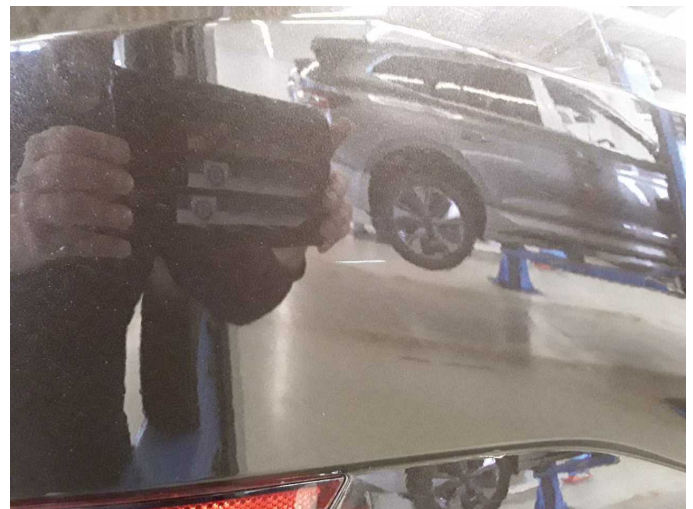
| No. | Component group | Description |
|---|---|---|
| 5 | Rear bumper | Rear bumper - Scratch(es) - Paint |

**Damage 5:** Rear bumper: Rear bumper - Scratch(es) - Paint

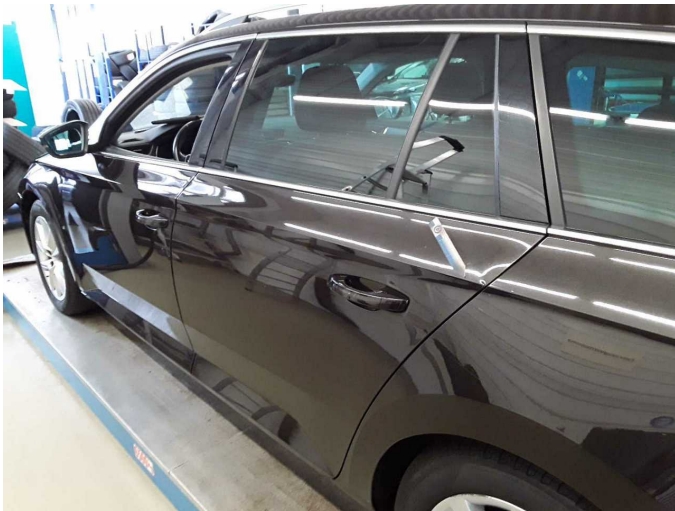
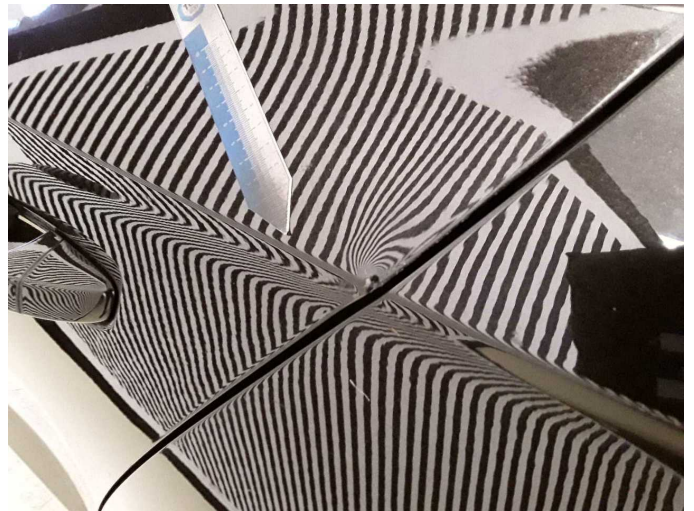
| No. | Component group | Description |
|---|---|---|
| 6 | Door - rear left side | Door - Dent / paintcoat damage - Repair and paint |

**Damage 6:** Door - rear left side: Door - Dent / paintcoat damage - Repair and paint

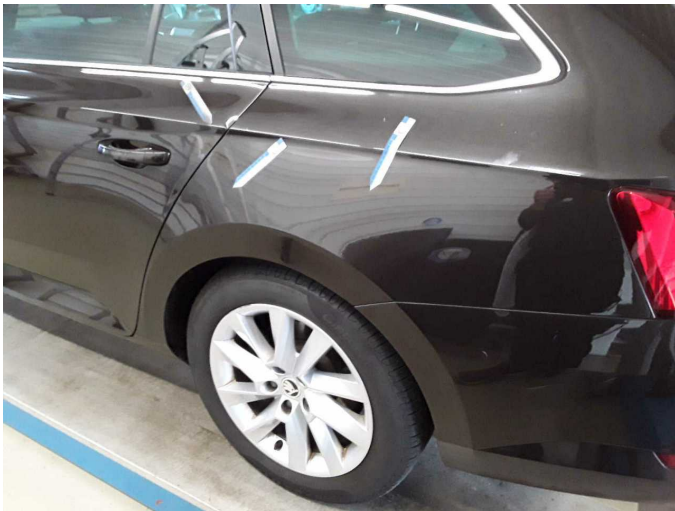
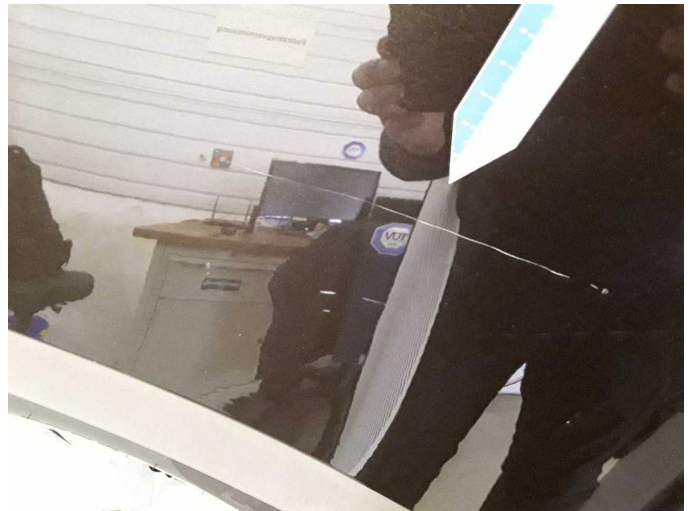
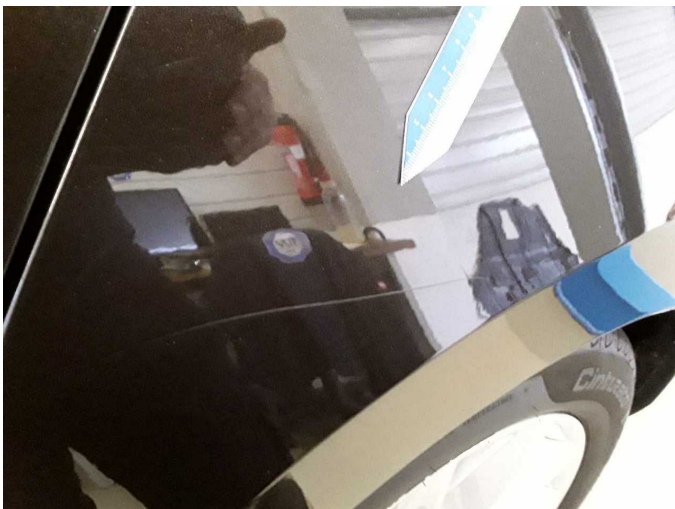
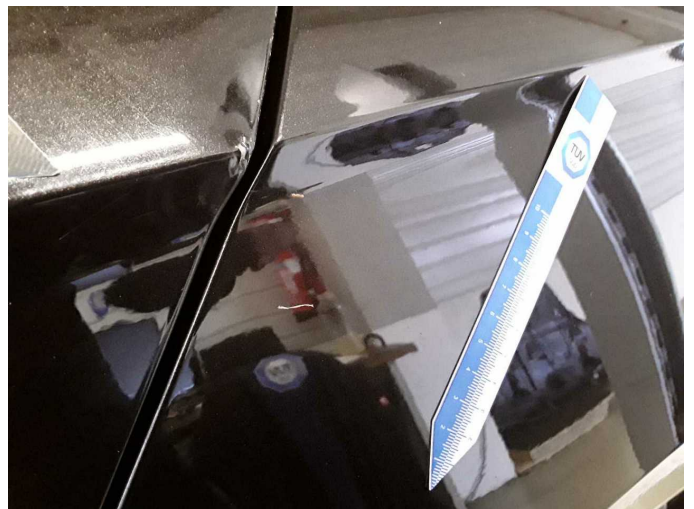
| No. | Component group | Description |
|---|---|---|
| 7 | Side panel - rear left side | Side panel - Scratch(es) - Paint |

**Damage 7:** Side panel - rear left side: Side panel - Scratch(es) - Paint

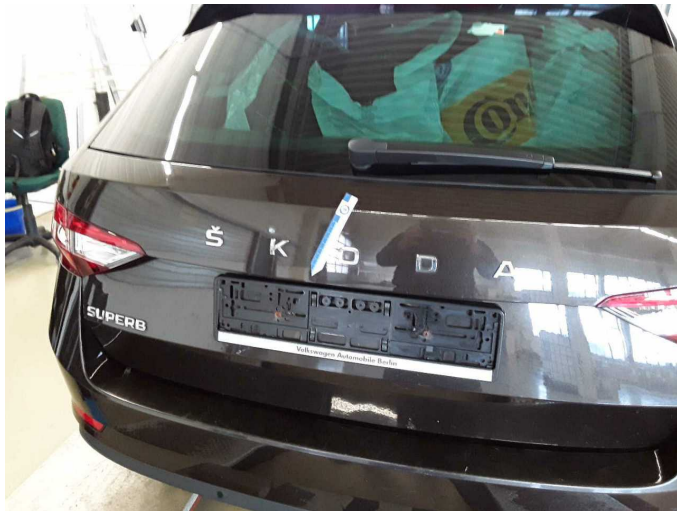
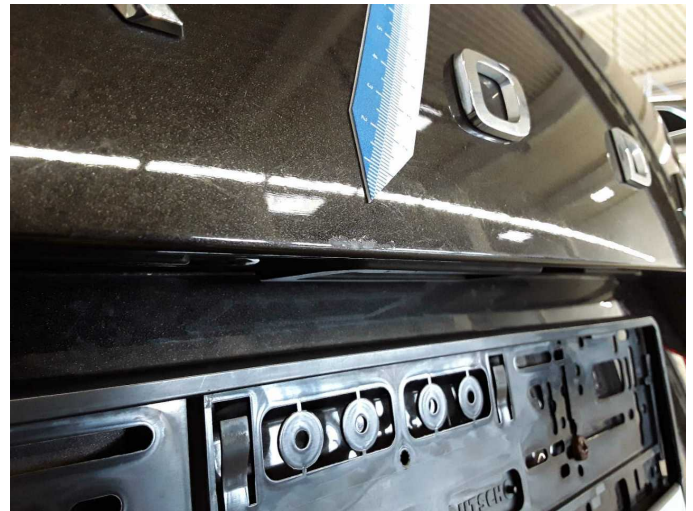
| No. | Component group | Description |
|---|---|---|
| 8 | Boot lid / rear door | Boot lid - Scratch(es) - Paint |

**Damage 8:** Boot lid / rear door: Boot lid - Scratch(es) - Paint

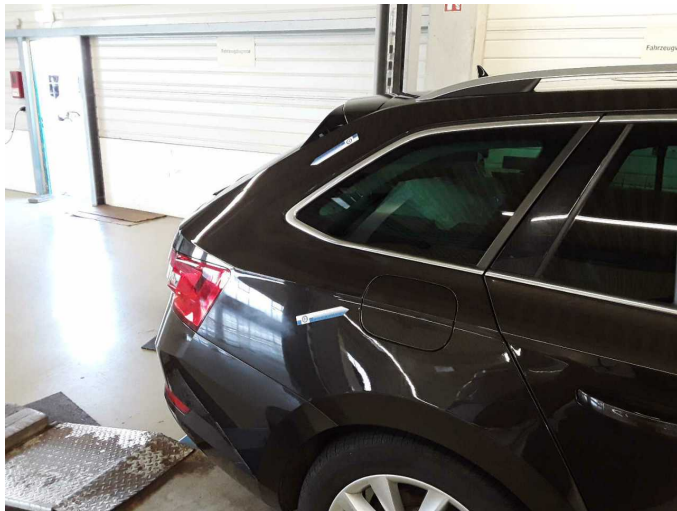
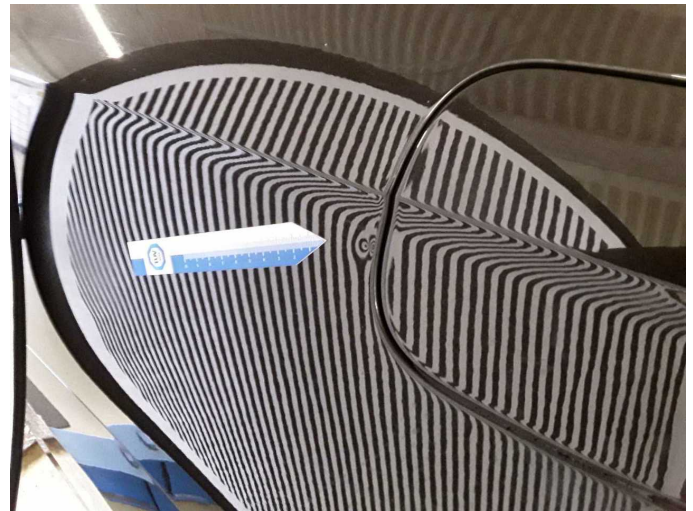
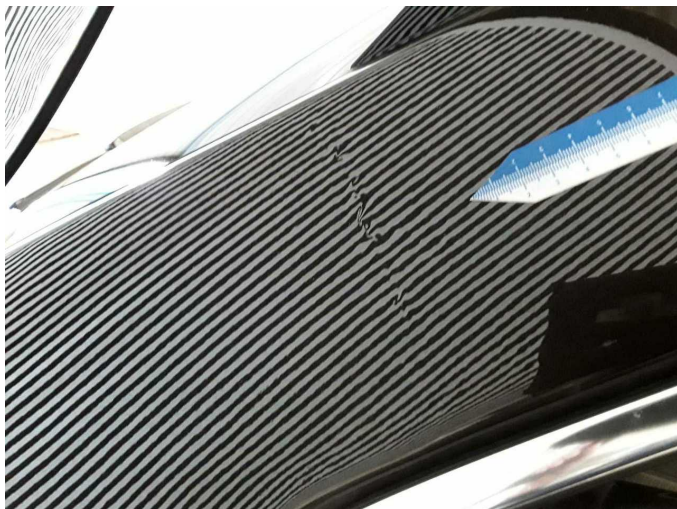
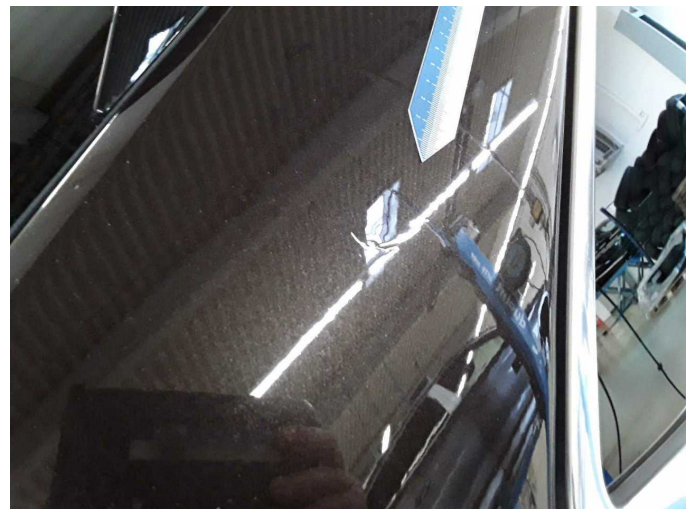
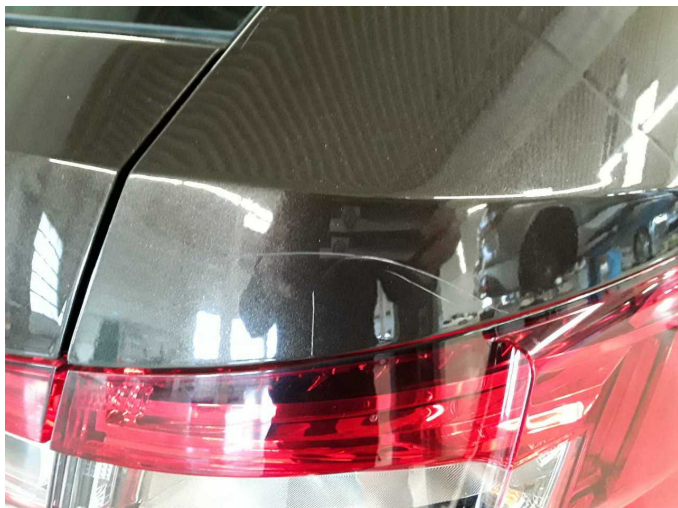
| No. | Component group | Description |
|---|---|---|
| 9 | Side panel - rear right side | Side panel (inkl. Schaden inst.) - Unprofessionally repaired - Repair and paint |

| No. | Repainting |
|---|---|
| 2 | Side panel - rear right side, Unprofessionally carried out |

**Damage 9:** Side panel - rear right side: Side panel (inkl. Schaden inst.) - Unprofessionally repaired - Repair and paint

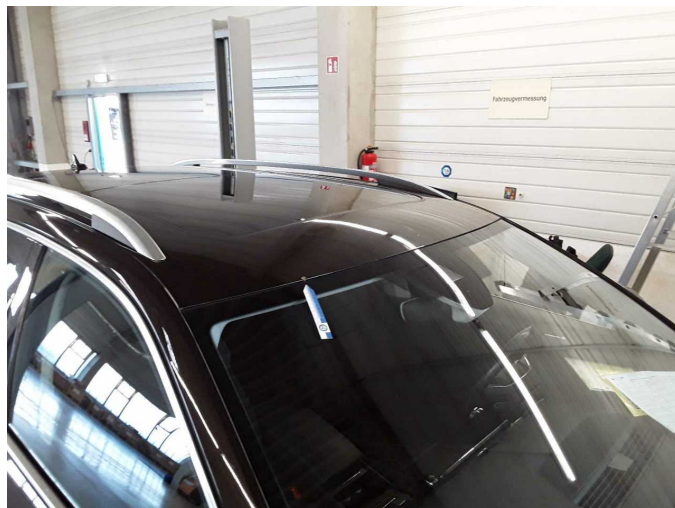
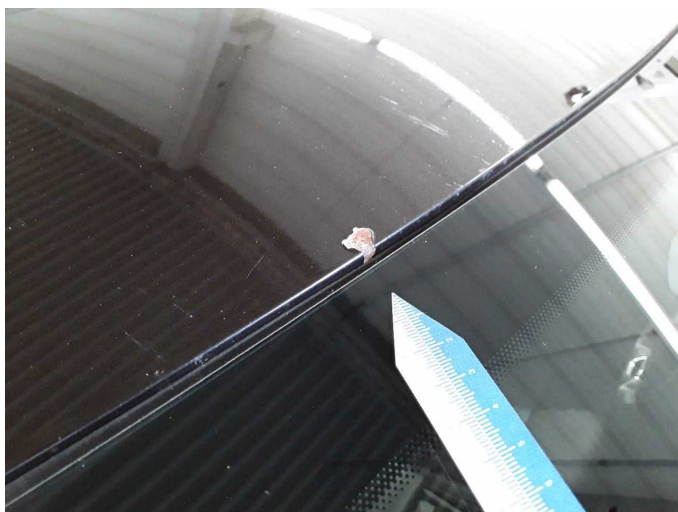
| No. | Component group | Description |
|---|---|---|
| 10 | Roof | Roof - Corrosion - Paint |

**Damage 10:** Roof: Roof - Corrosion - Paint

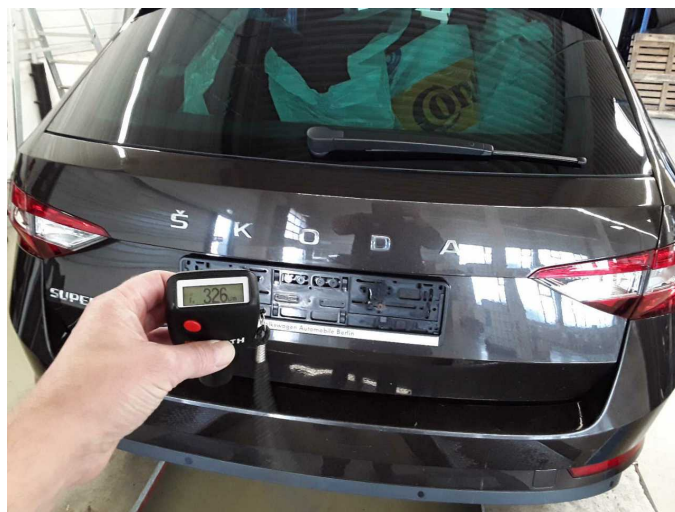
| Boot lid / rear door | 326 µm | Side panel - rear left side | 581 µm |

**Boot lid / rear door:** 326 µm

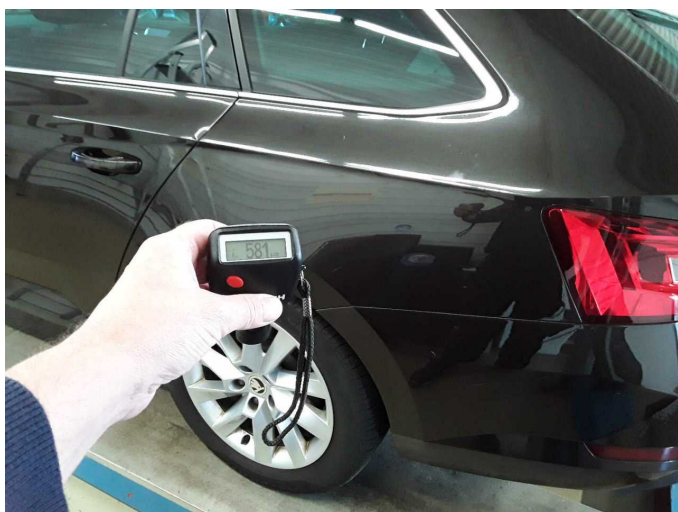
**Side panel - rear left side:** 581 µm

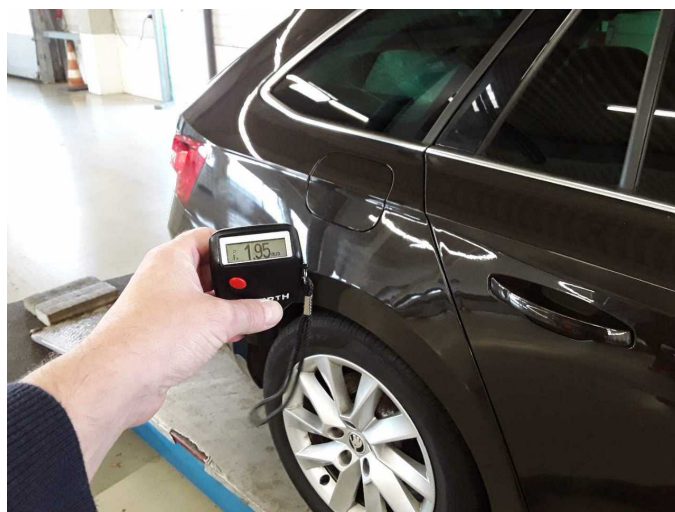
| Side panel - rear right side | 1,950 µm | Door - rear right side | 205 µm |

**Side panel - rear right side:** 1,950 µm

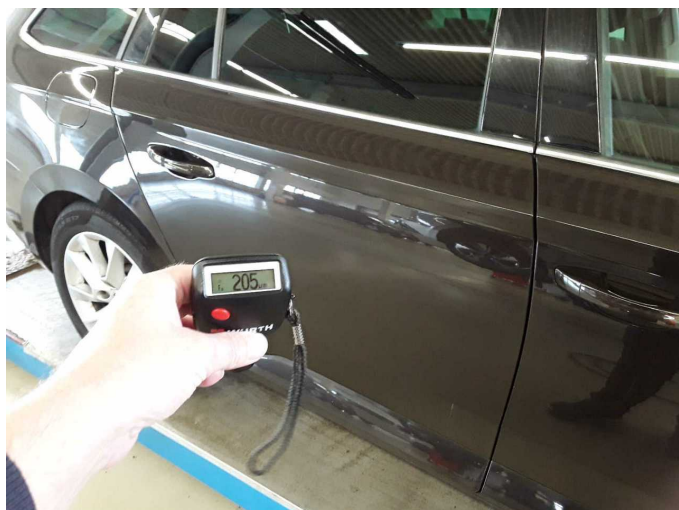
**Door - rear right side: 205  $\mu$ m**
