Expertise

Protocol number: 41513621  
Order No. / Reference: 25183472  
Inspection date: 12 Sept 2025

| Manufacturer: Skoda | Model: Kodiaq 2.0 TDI 4x4 DSG Drive 125 |

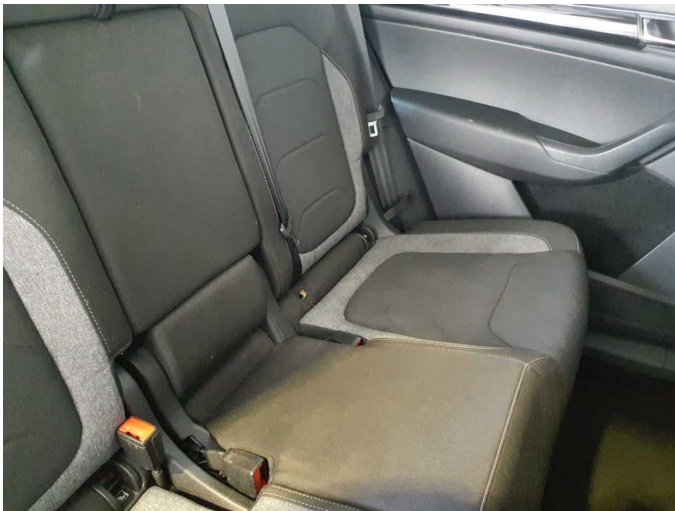
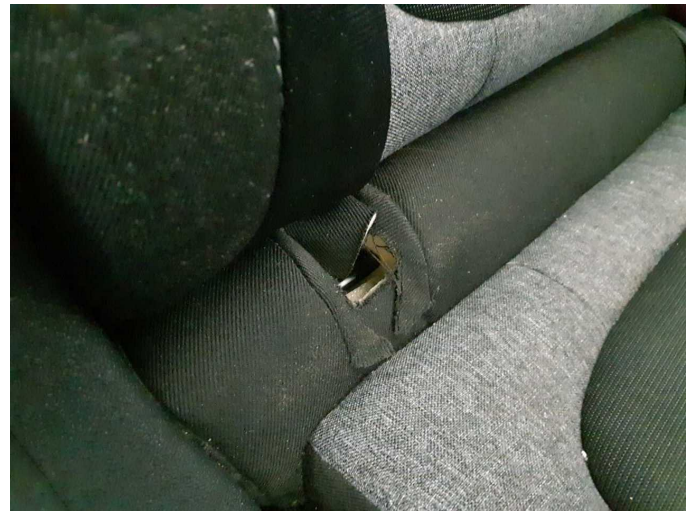
| No. | Component group | Description |
|---|---|---|
| 1 | Seat - rear | Back seat (Isofix Abdeckung) - Missing - Replace |

Damage 1: Seat - rear: Back seat (Isofix Abdeckung) - Missing - Replace

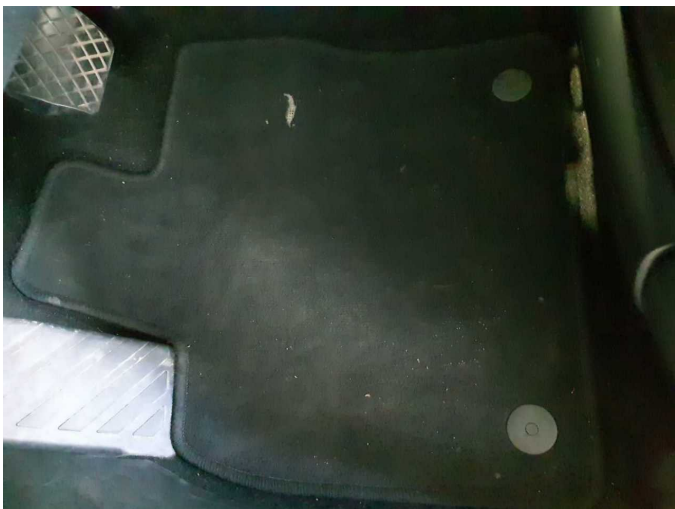
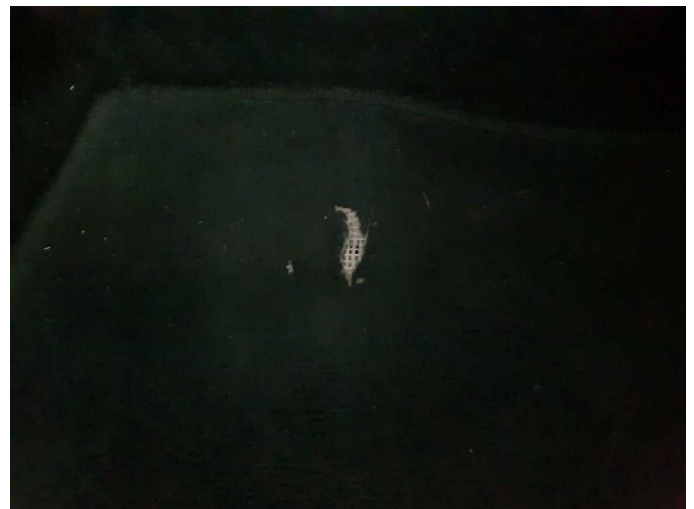
| No. | Component group | Description |
|---|---|---|
| 2 | Trim / covers | Floor mats (VL) - Damaged - Replace |

Damage 2: Trim / covers: Floor mats (VL) - Damaged - Replace

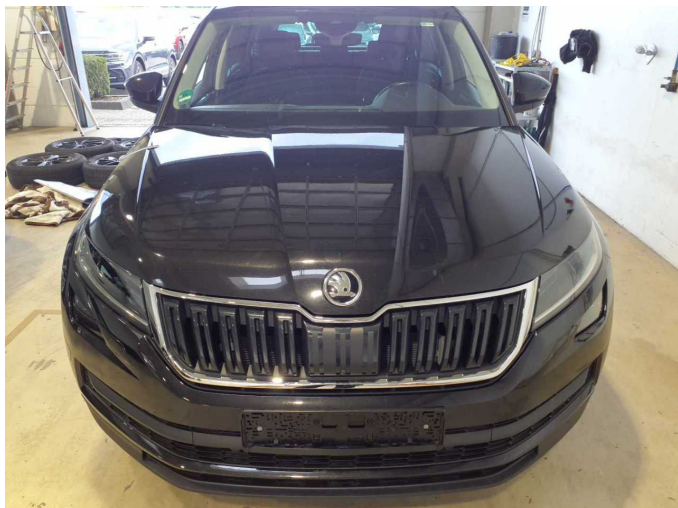
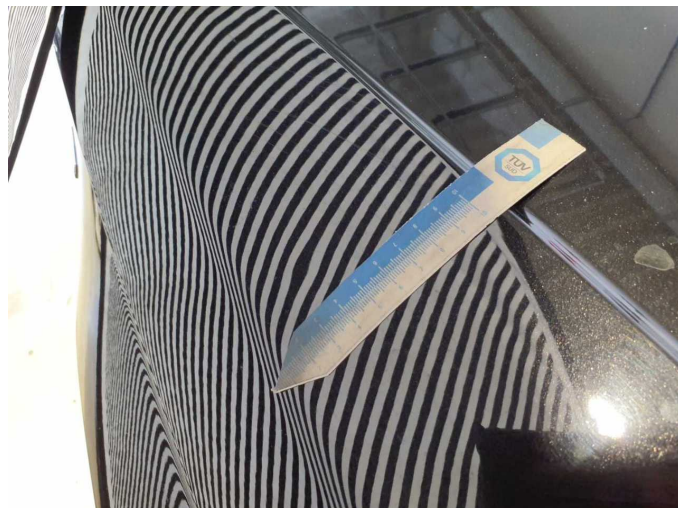
| No. | Component group | Description |
|---|---|---|
| 3 | Bonnet | Bonnet - dent(s) - Smooth repair work |

**Damage 3:** Bonnet: Bonnet - dent(s) - Smooth repair work

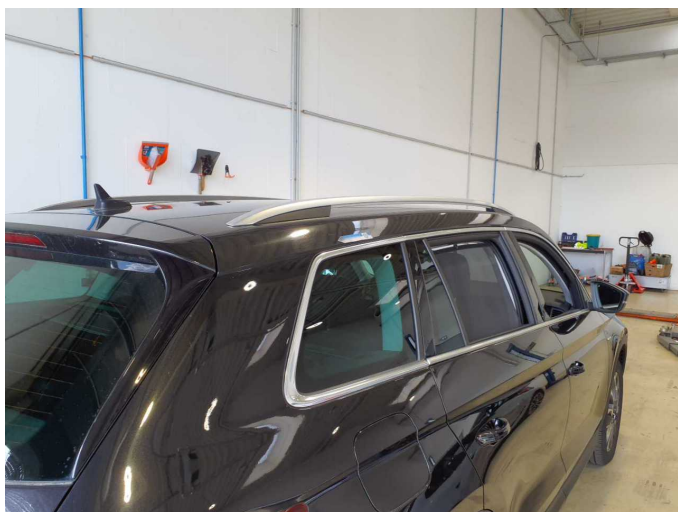
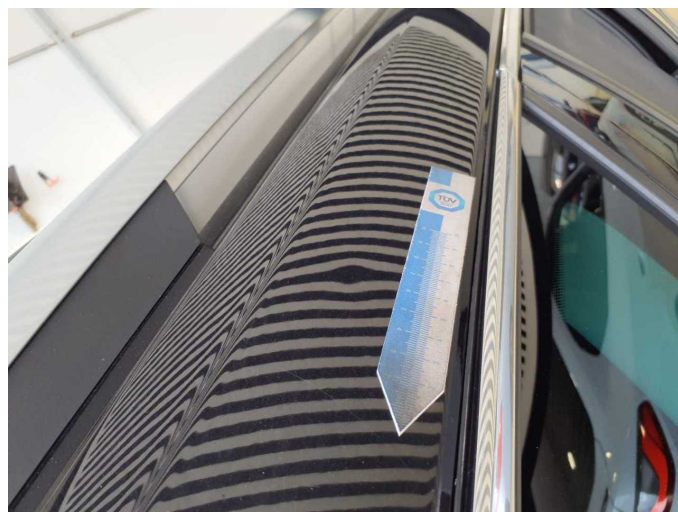
| No. | Component group | Description |
|---|---|---|
| 4 | Roof | Roof rail - right side - dent(s) - Smooth repair work |

**Damage 4:** Roof: Roof rail - right side - dent(s) - Smooth repair work

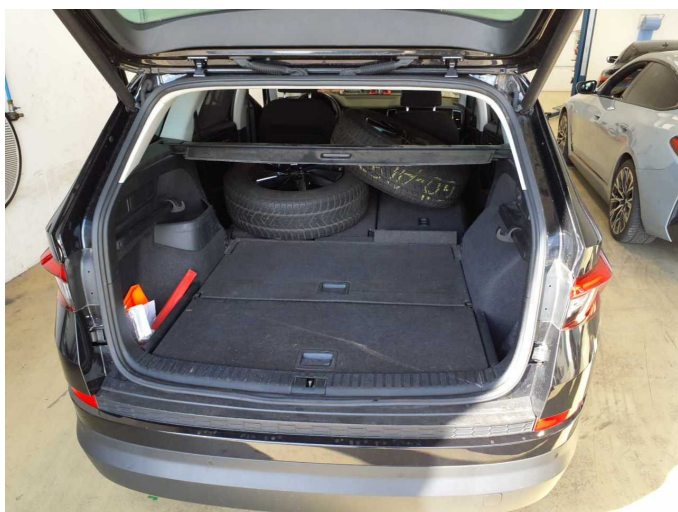
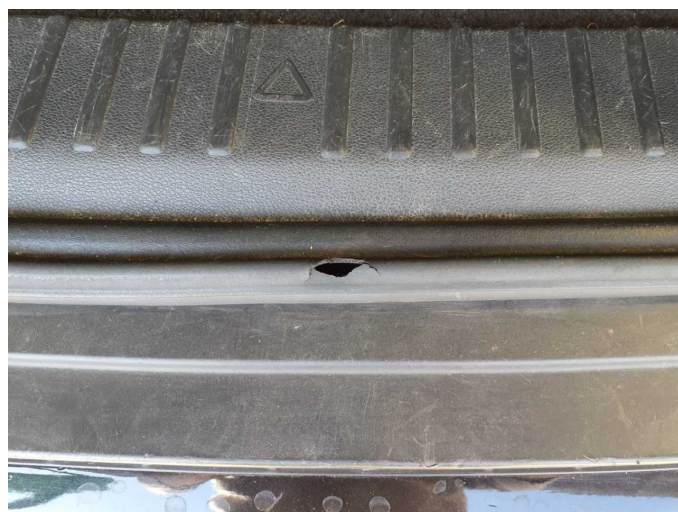
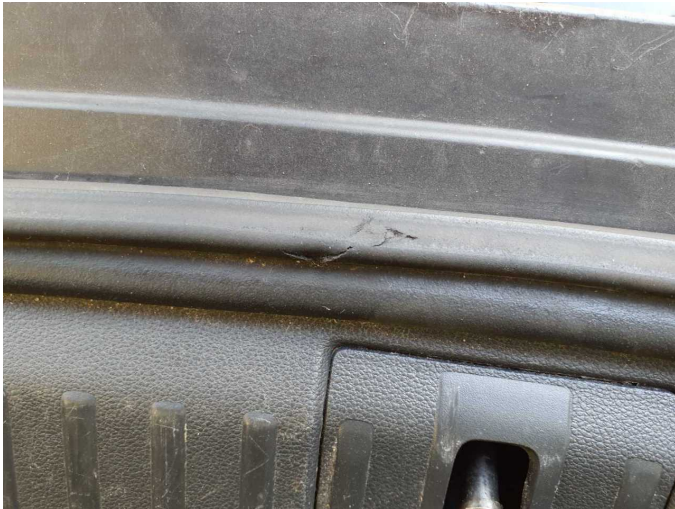
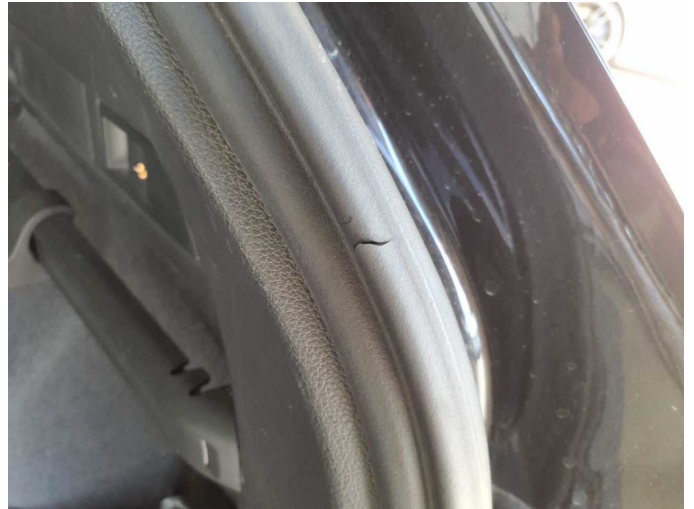
| No. | Component group | Description |
|---|---|---|
| 5 | Boot lid / rear door | Seal - Damaged - Replace |

**Damage 5:** Boot lid / rear door: Seal - Damaged - Replace

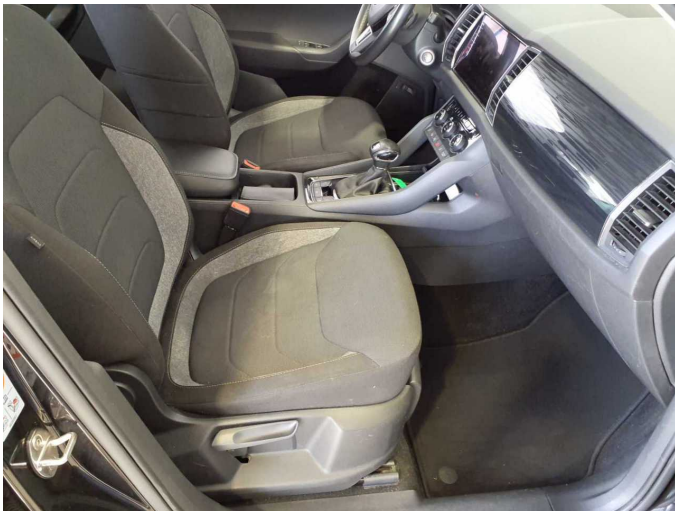
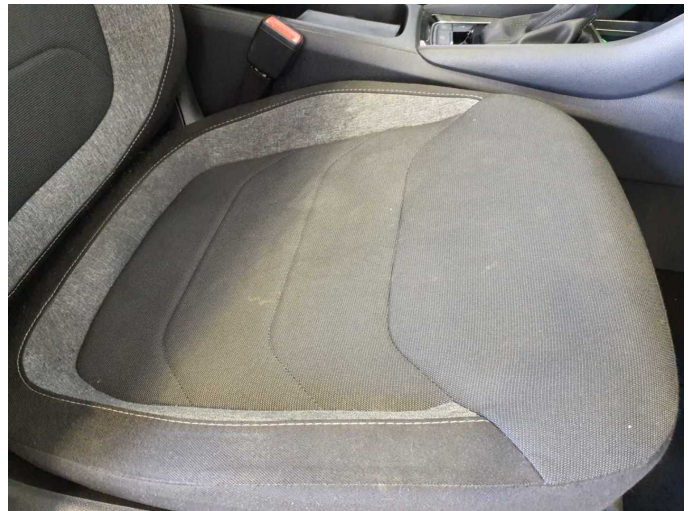
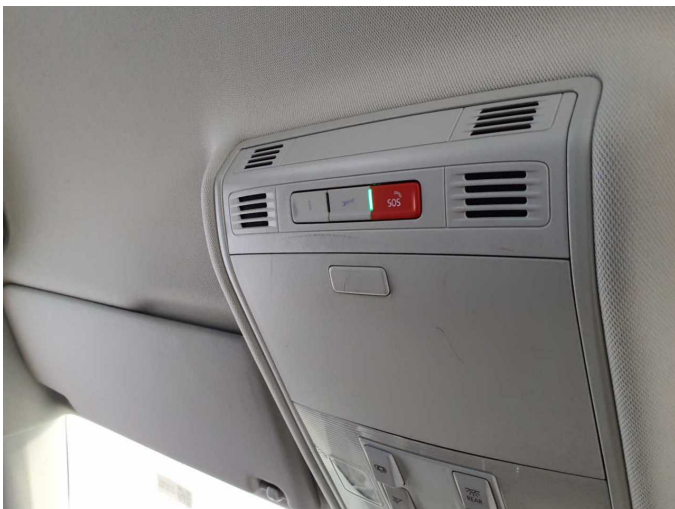
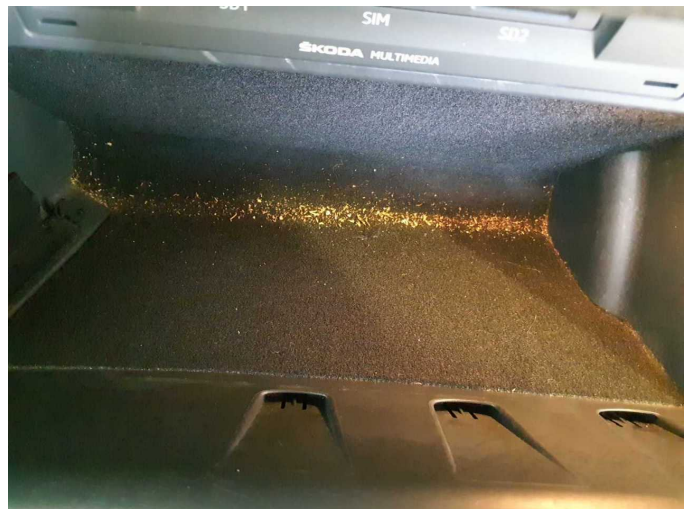
| No. | Component group | Description |
|---|---|---|
| 6 | Interior | Interior - Soiled - Clean |

**Damage 6:** Interior: Interior - Soiled - Clean

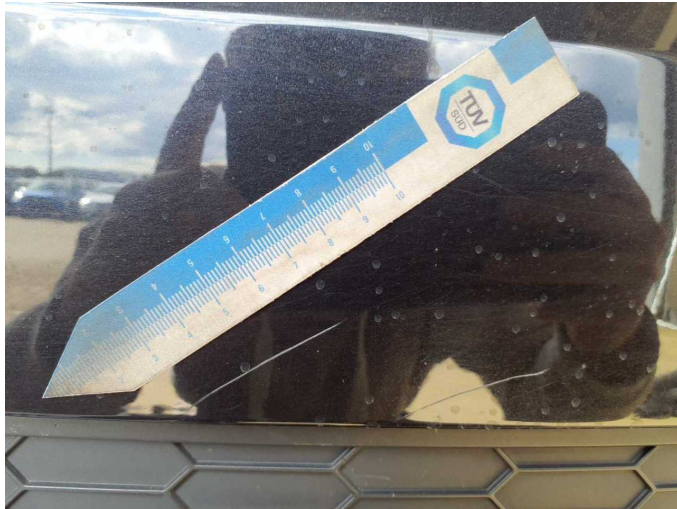
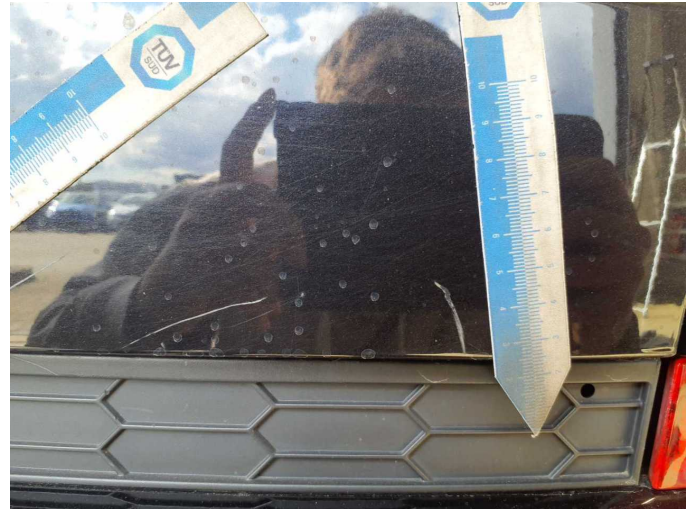
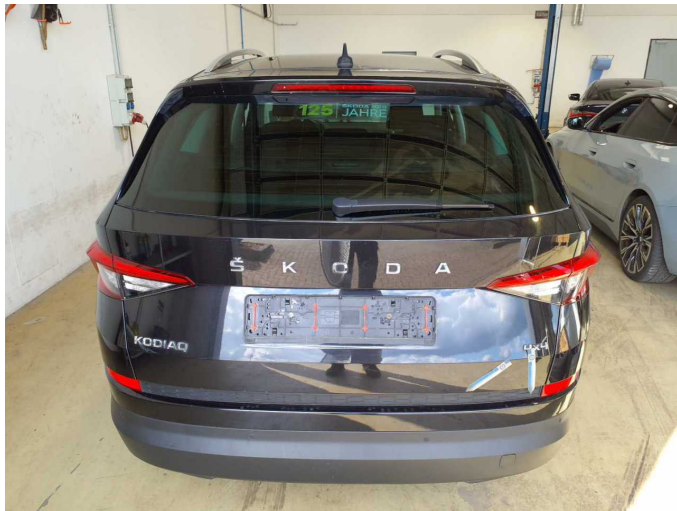
| No. | Component group | Description |
|---|---|---|
| 7 | Boot lid / rear door | Boot lid - Scratch(es) - Smart repair |

**Damage 7:** Boot lid / rear door: Boot lid - Scratch(es) - Smart repair

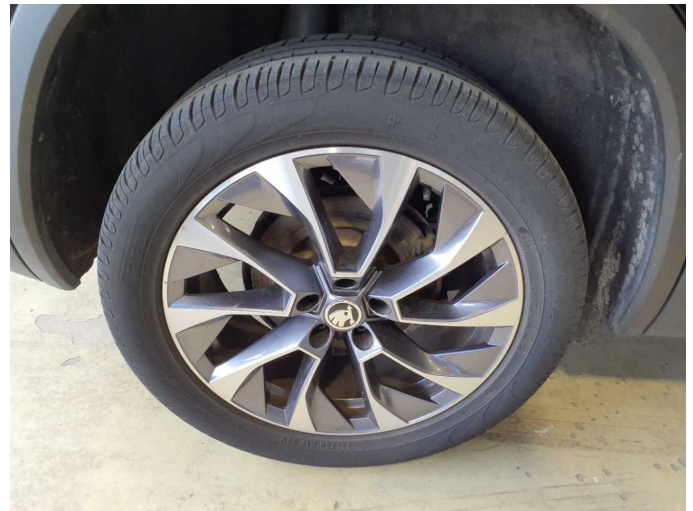
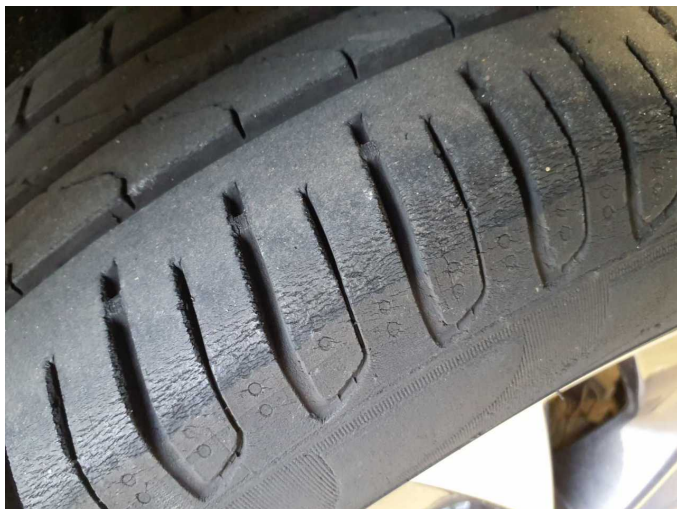
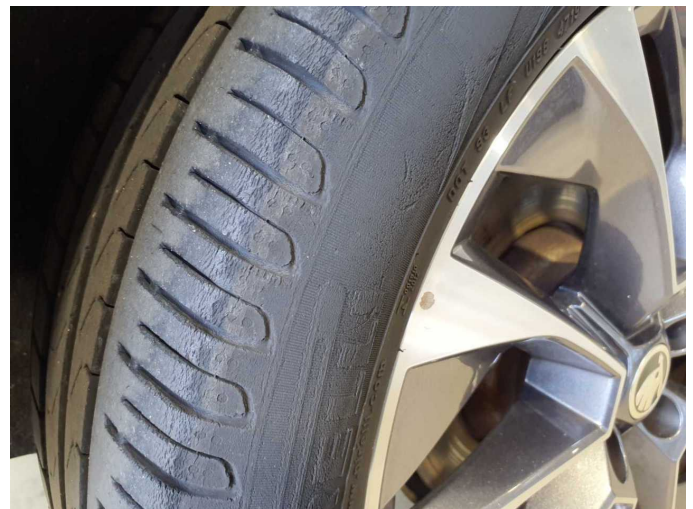
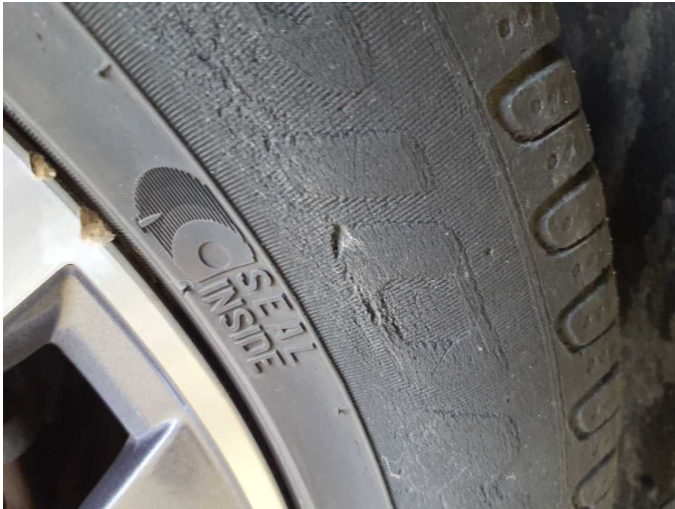
| No. | Component group | Description |
|---|---|---|
| 8 | Wheel / tyres | Tyre - rear right side - Porous / cracked - Replace |

**Damage 8:** Wheel / tyres: Tyre - rear right side - Porous / cracked - Replace

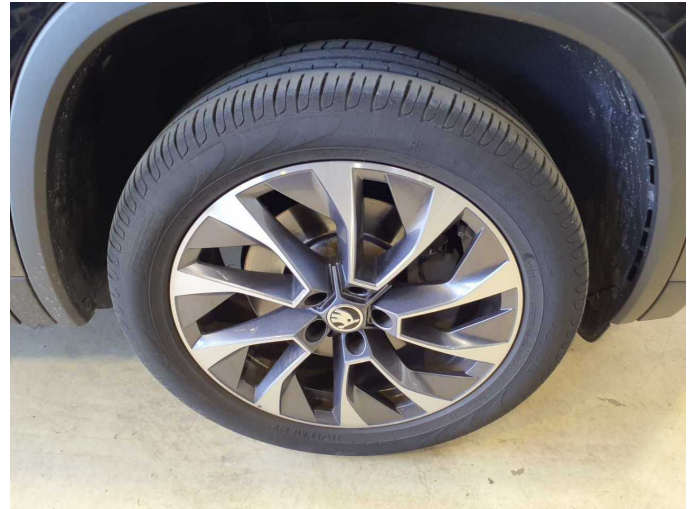
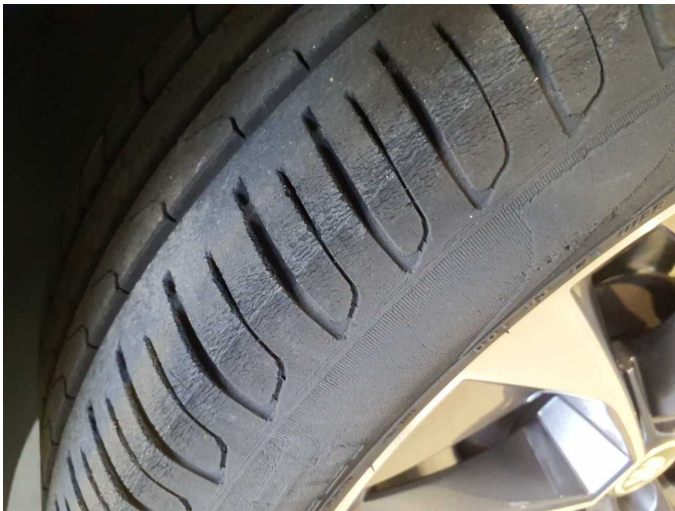
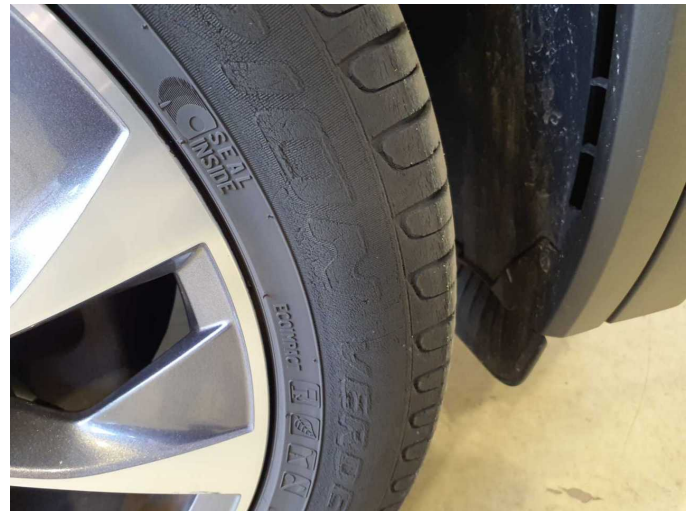
| No. | Component group | Description |
|---|---|---|
| 9 | Wheel / tyres | Tyre - front right side - Porous / cracked - Replace |

**Damage 9:** Wheel / tyres: Tyre - front right side - Porous / cracked - Replace

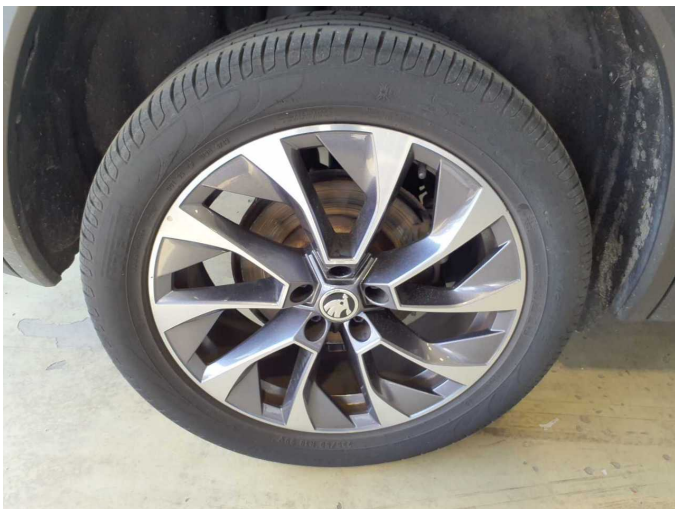
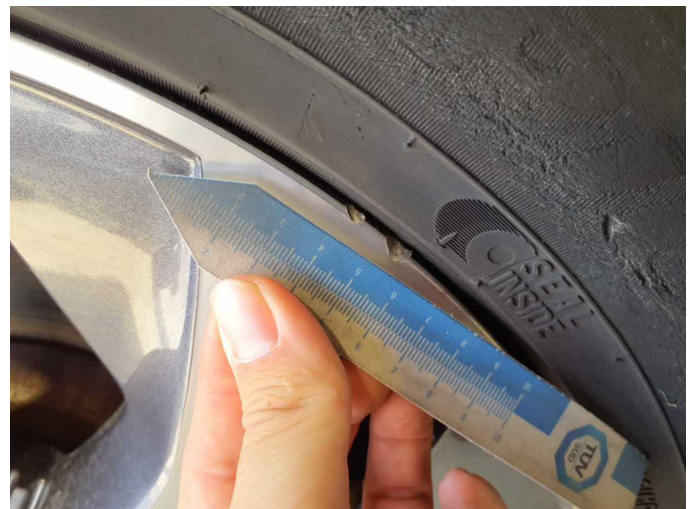
| No. | Component group | Description |
|---|---|---|
| 10 | Wheel / tyres | Alloy rim - rear right side (Materialabtrag) - Scratch(es) - Replace |

**Damage 10:** Wheel / tyres: Alloy rim - rear right side (Materialabtrag) - Scratch(es) - Replace

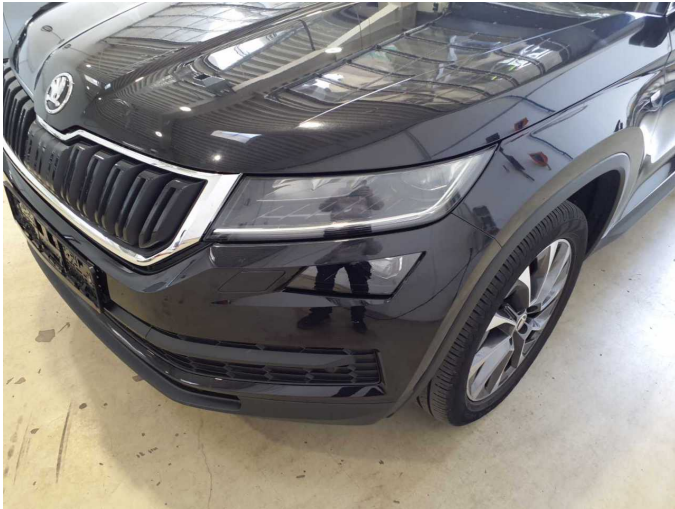
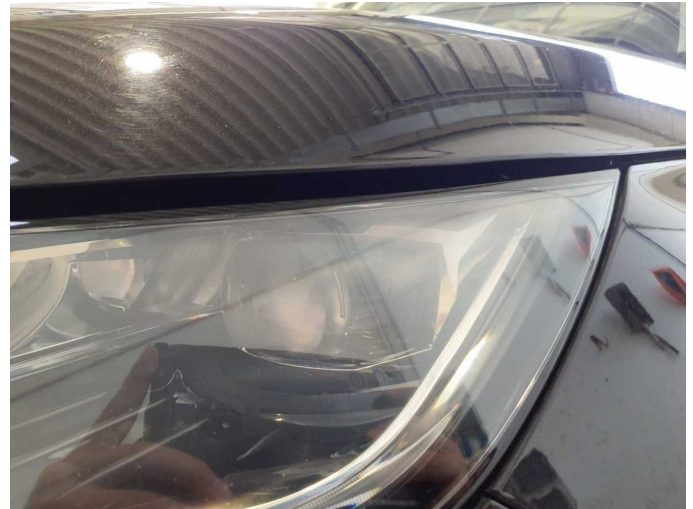
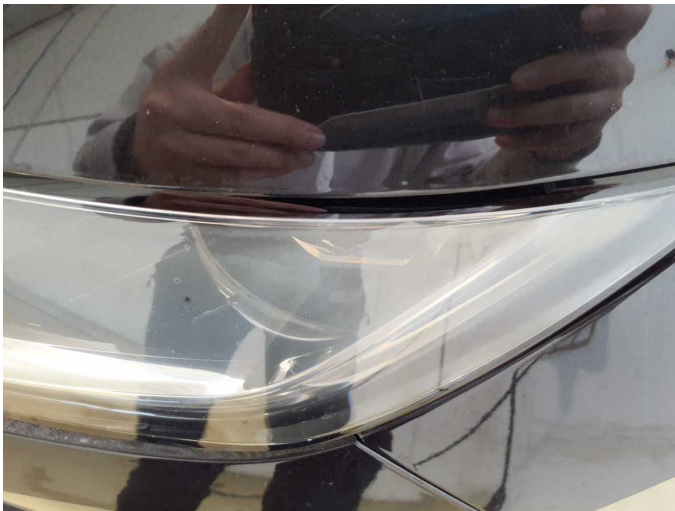
| No. | Component group | Description |
|---|---|---|
| 11 | Headlight | Headlight - left side (Milchig) - Damaged - Replace |

**Damage 11:** Headlight: Headlight - left side (Milchig) - Damaged - Replace

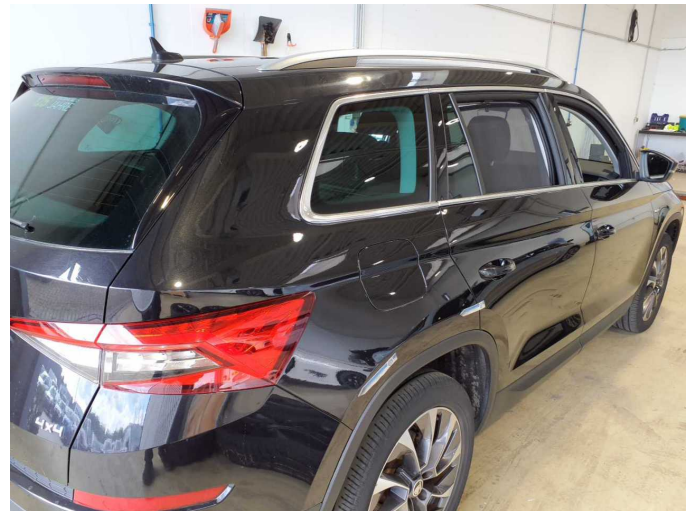
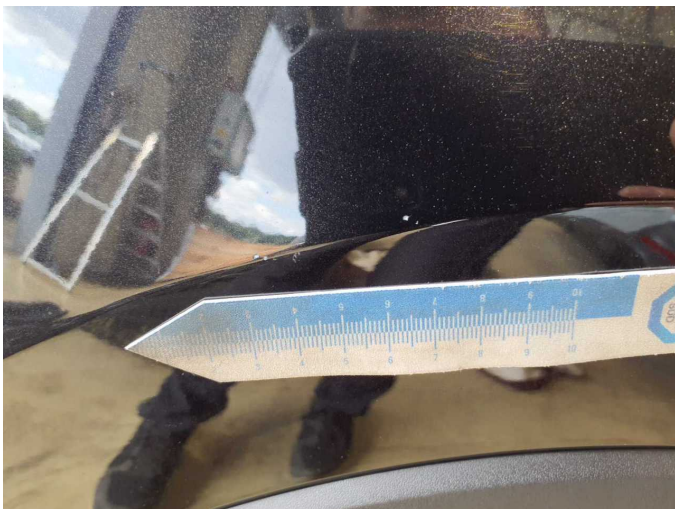
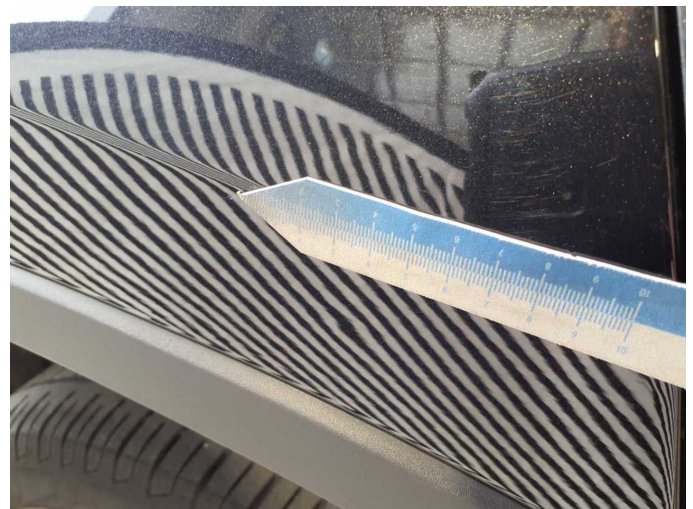
| No. | Component group | Description |
|---|---|---|
| 8 | Side panel - rear right side | Side panel - Dent / paintcoat damage - No deduction |

**Wear and tear 8:** Side panel - rear right side: Side panel - Dent / paintcoat damage - No deduction

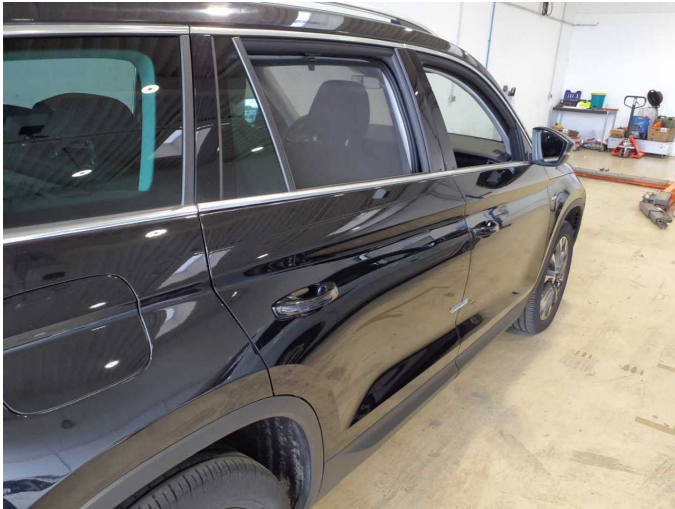
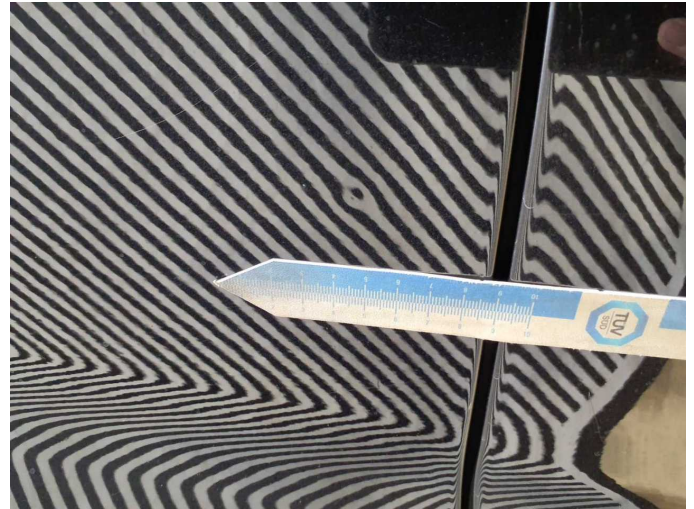
| No. | Component group | Description |
|---|---|---|
| 9 | Door - rear right side | Door - dent(s) - No deduction |

**Wear and tear 9:** Door - rear right side: Door - dent(s) - No deduction

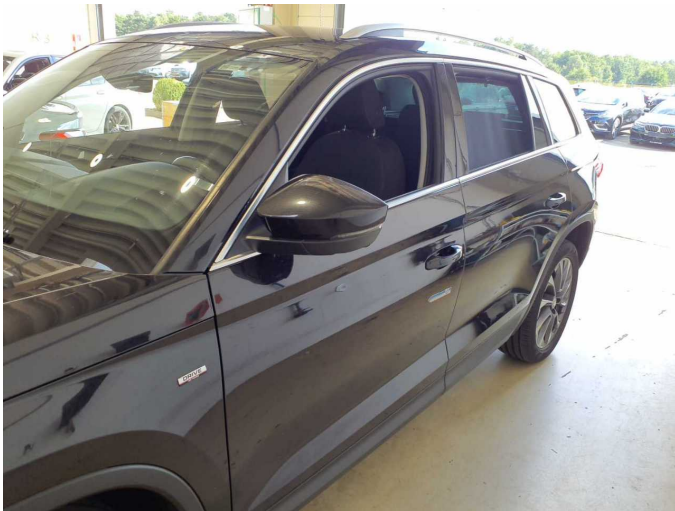
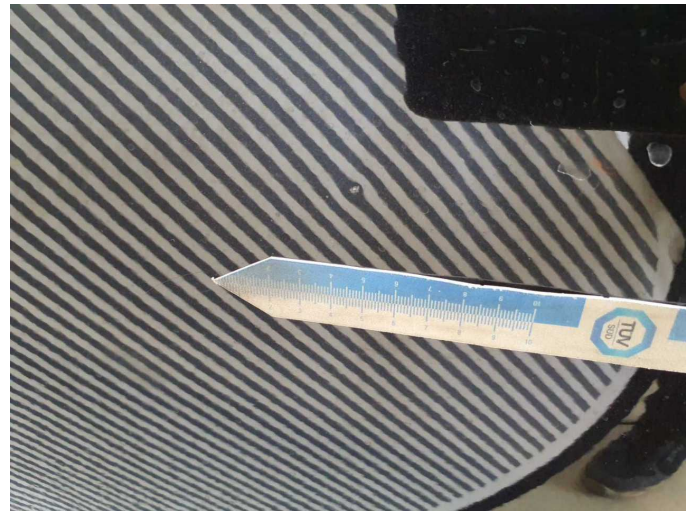
| No. | Component group | Description |
|---|---|---|
| 10 | Door - front left side | Door - dent(s) - No deduction |

**Wear and tear 10:** Door - front left side: Door - dent(s) - No deduction

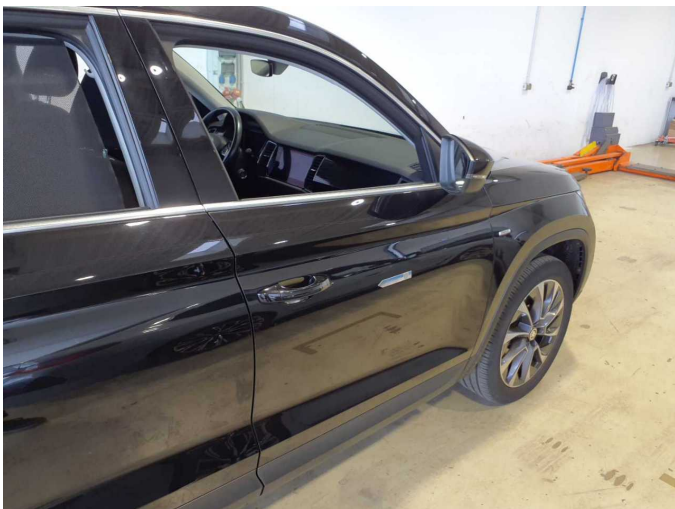
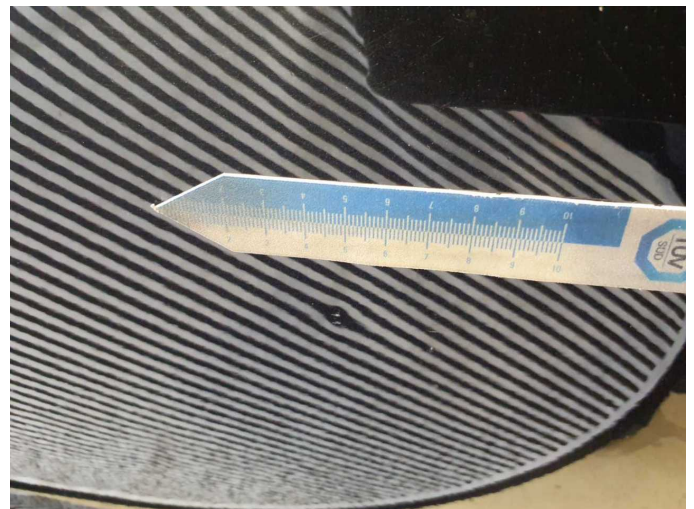
| No. | Component group | Description |
|---|---|---|
| 11 | Door - front right side | Door - Dent / paintcoat damage - No deduction |

**Wear and tear 11:** Door - front right side: Door - Dent / paintcoat damage  
- No deduction

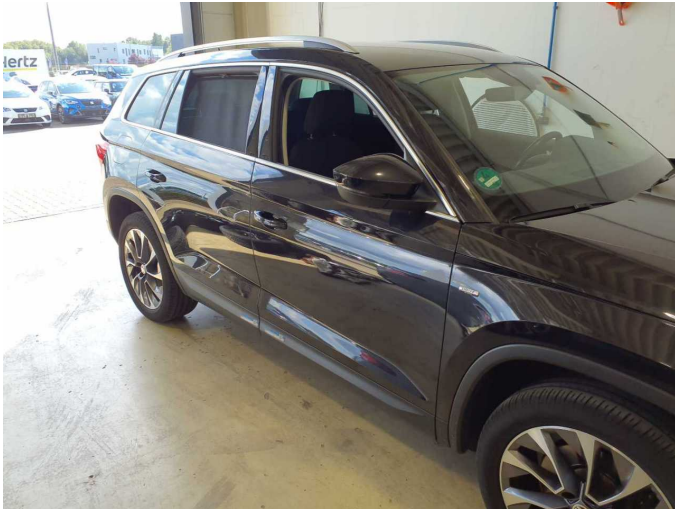
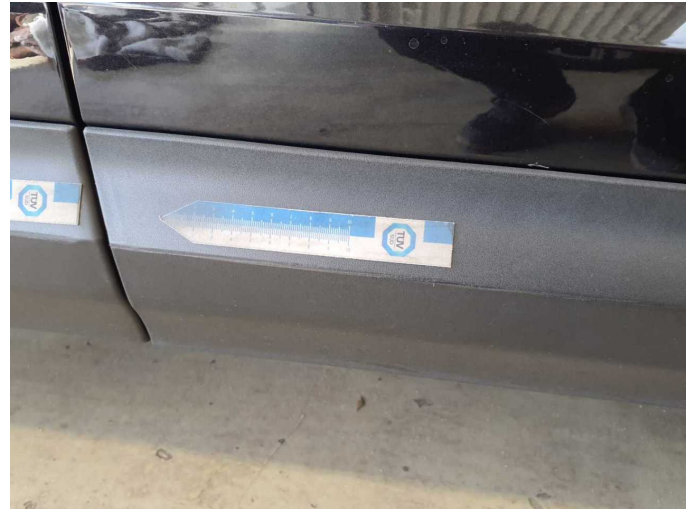
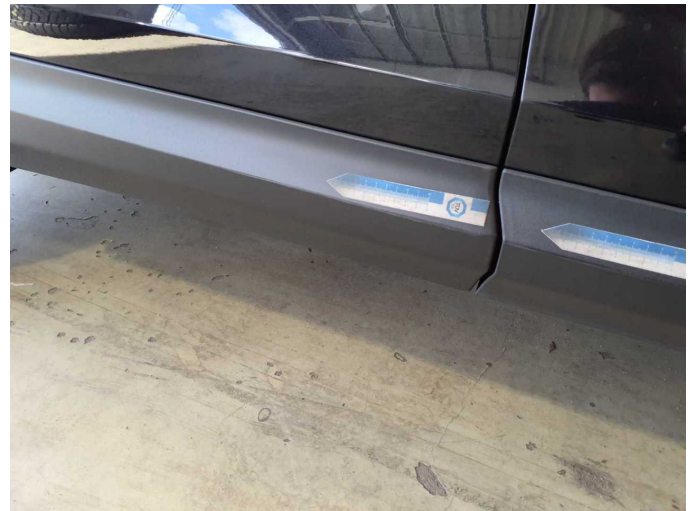
**Accident 1: Side right**

| No. | Previous damage | Extent of damage (Net) |
|---|---|---|
| 1 | Side right, Provided by user / customer, from 21 Aug 2023 | 7.960,51 € |

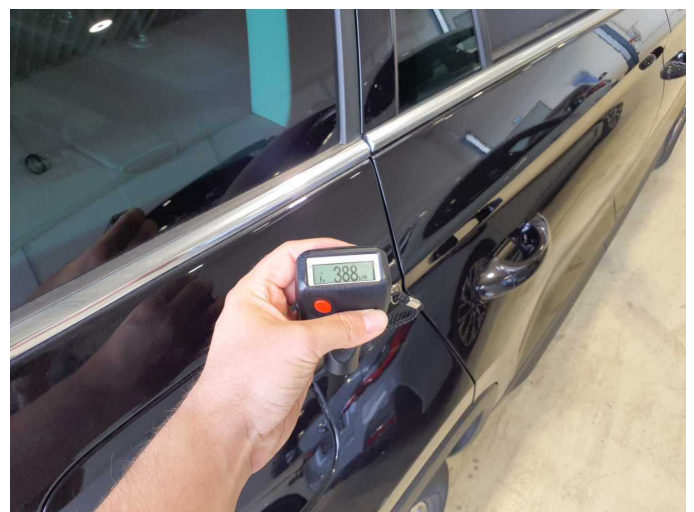
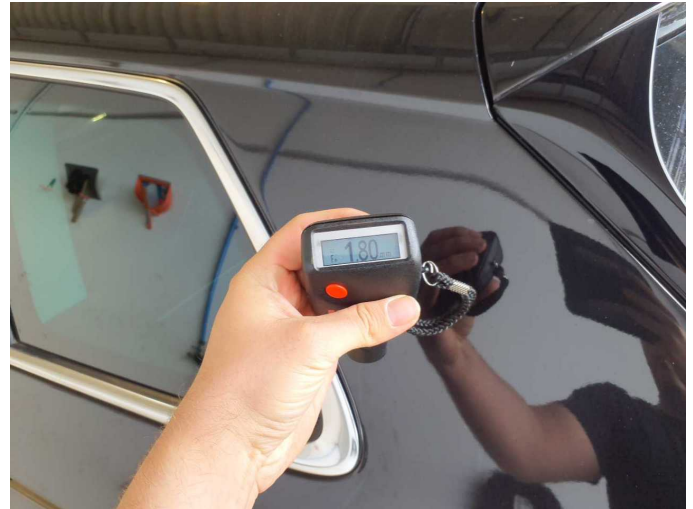
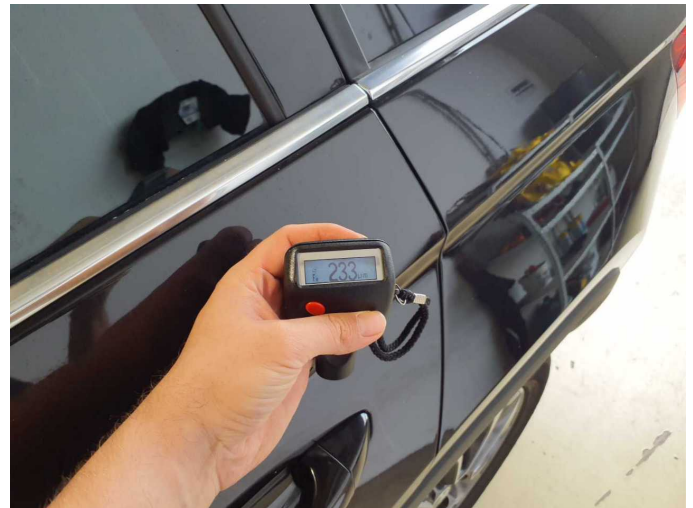
| No. | Repainting |
|---|---|
| 1 | Side panel - rear left side, Side panel - rear right side, Door - rear left side, Professionally carried out, Invoice of repair done Non-existent |

| Side panel - rear left side | 1,800<br>µm | Side panel - rear right side | 388 µm |
| Door - rear left side | 233 µm | | |

**Repainting 1: Side panel - rear left side, Side panel - rear right side,  
Door - rear left side**
