Expertise

Protocol number: 41520567
Order No. / Reference: 25218501
Inspection date: 15 Sept 2025

Manufacturer: Skoda
VIN: TMBLN9NS6M8038028

Model: Kodiah 2.0 TDI 4x4 DSG L&K

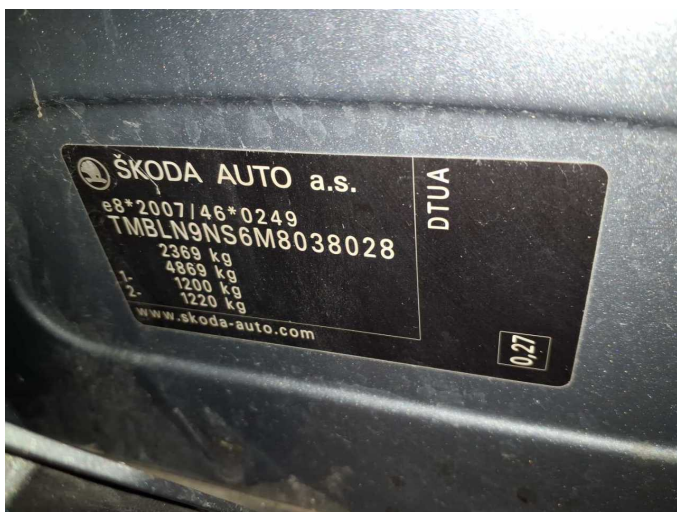
Figure 11: VIN

| VIN comparison | The vehicle identification number (VIN) was read from the vehicle and its conformity with the submitted documents was verified during the inspection by the undersigned. |

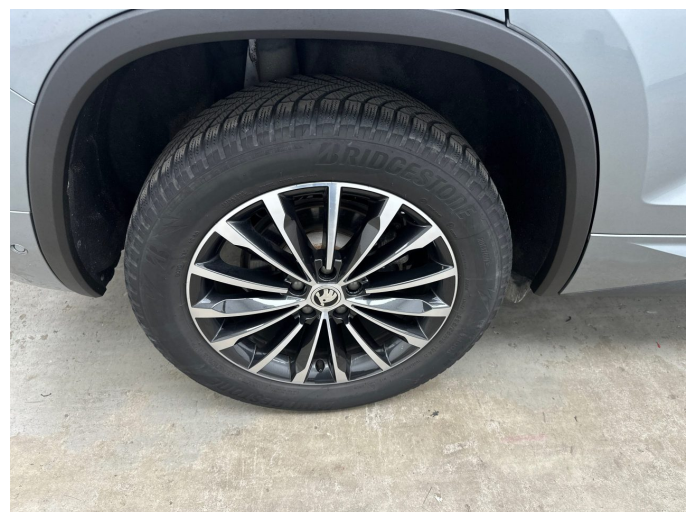
Figure 12: Mounted tyres

| # | Tyre size | Type of tyre | Manufacturer | Tread depth |
|---|---|---|---|---|
| 1) | 235/55 R18 104H | Winter tyres on Light alloy | Bridgestone | 2mm / 2mm |
| 2) | 235/55 R18 104H | Winter tyres on Light alloy | Bridgestone | 5mm / 5mm |

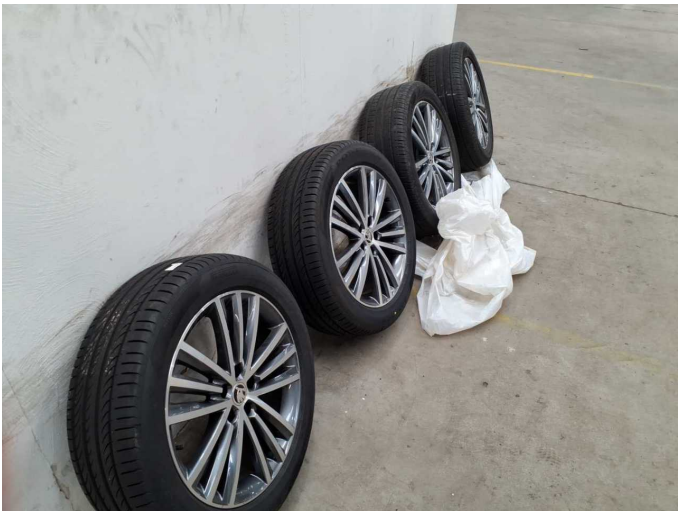
Figure 16: Additional tyres

| # | Tyre size | Type of tyre | Manufacturer | Tread depth |
|---|---|---|---|---|
| 1) | 235/50 R19 99V | Summer tires (with run-flat tires) on Light alloy | Pirelli | 5mm / 5mm |
| 2) | 235/50 R19 99V | Summer tires (with run-flat tires) on Light alloy | Pirelli | 7mm / 7mm |

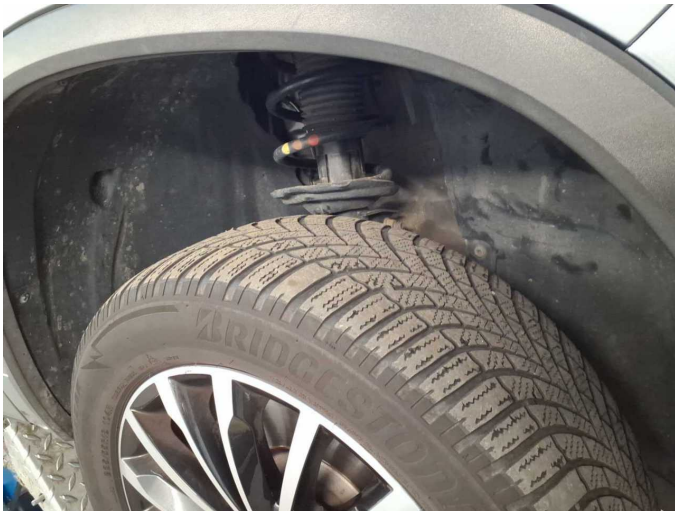
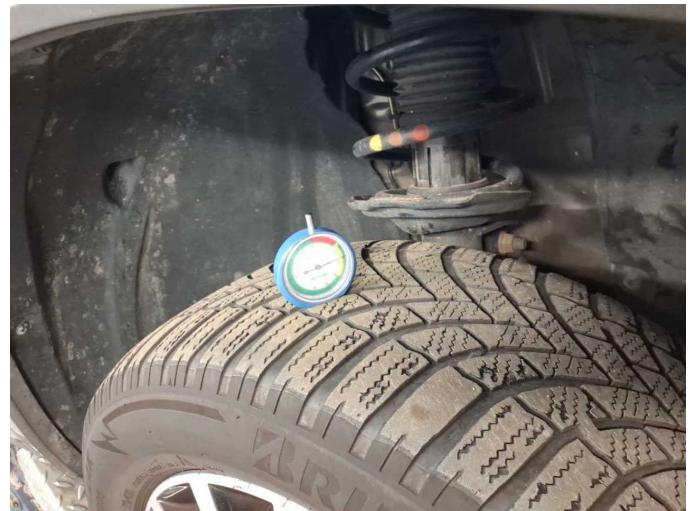
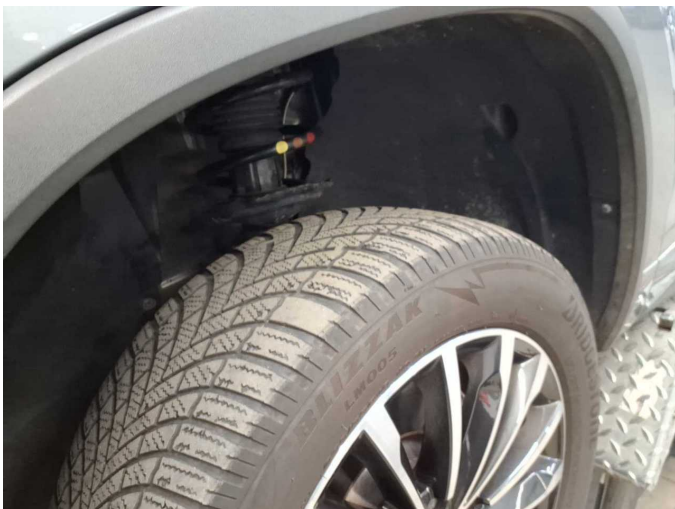
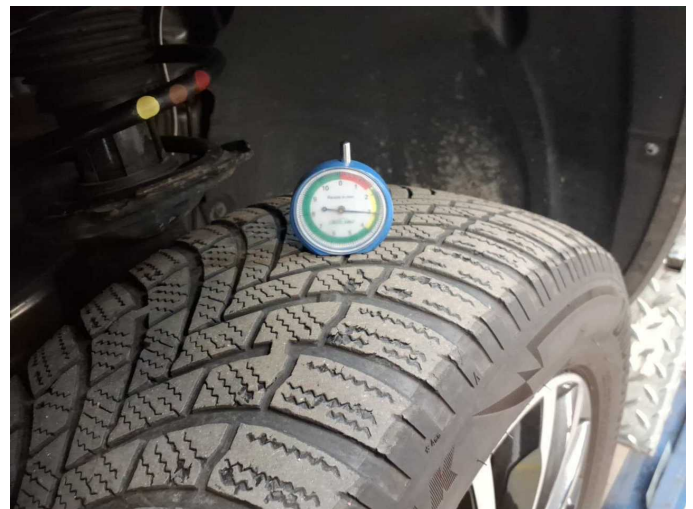
| No. | Component group | Description |
|---|---|---|
| 1 | Wheel / tyres | Tyre - front - Worn - No deduction |

Damage 1: Wheel / tyres: Tyre - front - Worn - No deduction

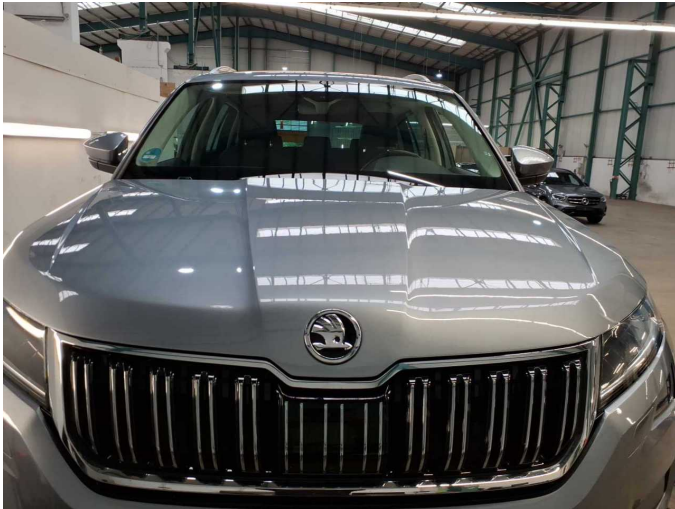
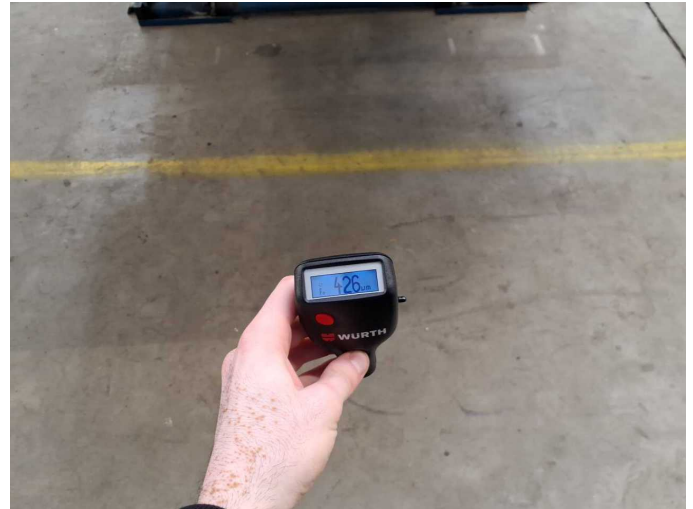
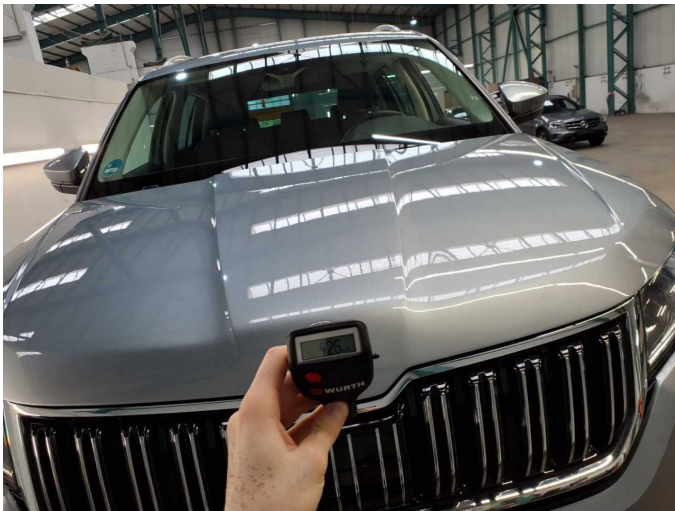
- 1 Bonnet, Side panel - rear right side
- 2 Side panel - rear right side

Repainting 1: Bonnet, Side panel - rear right side

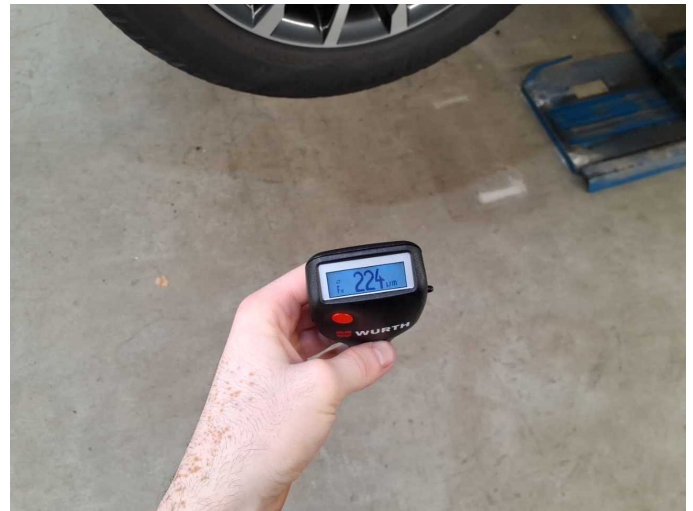
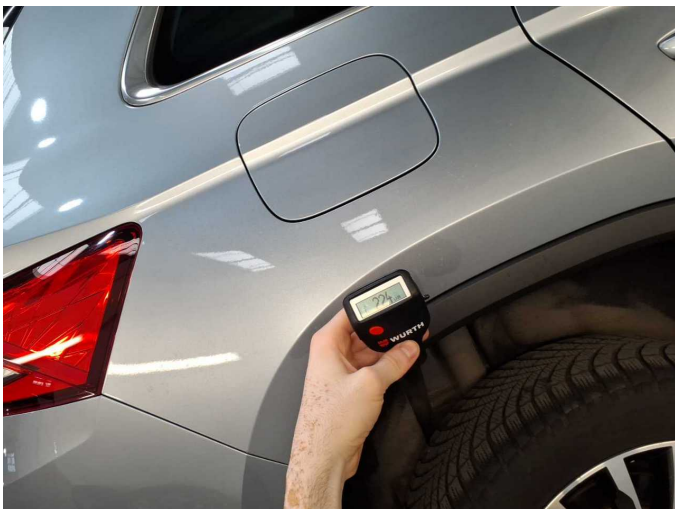
Repainting 2: Side panel - rear right side
