Expertise

Protocol number: 37910049
Order No. / Reference: 24265215
Inspection date: 14 Jan 2025

Manufacturer: Renault

Model: Twingo E-TECH 100% el. EQUILIB

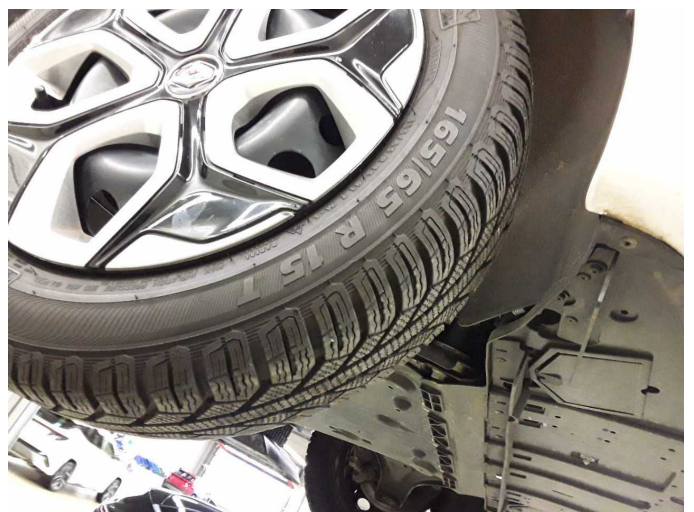
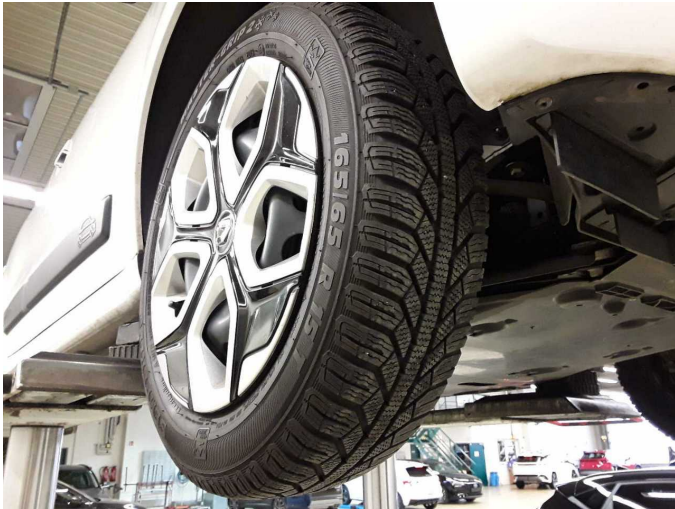
Damage 1: Wheel / tyres: Tyres - complete set (Winter statt Sommer) - Differs from the original configuration - No deduction

No.	Component group	Description
1	Wheel / tyres	Tyres - complete set (Winter statt Sommer) - Differs from the original configuration - No deduction

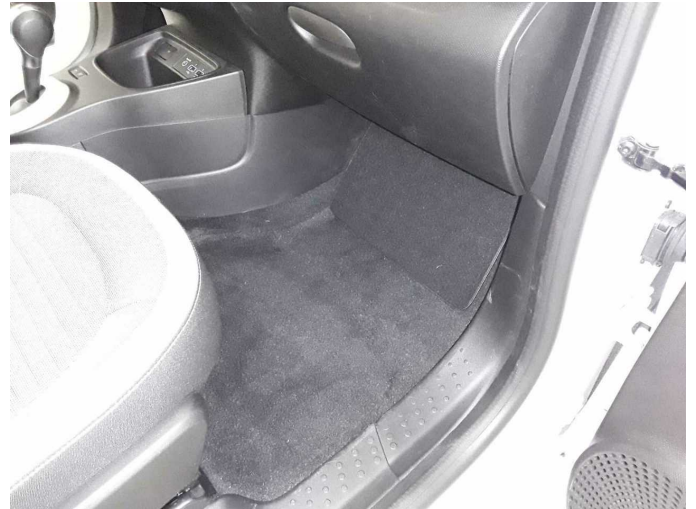
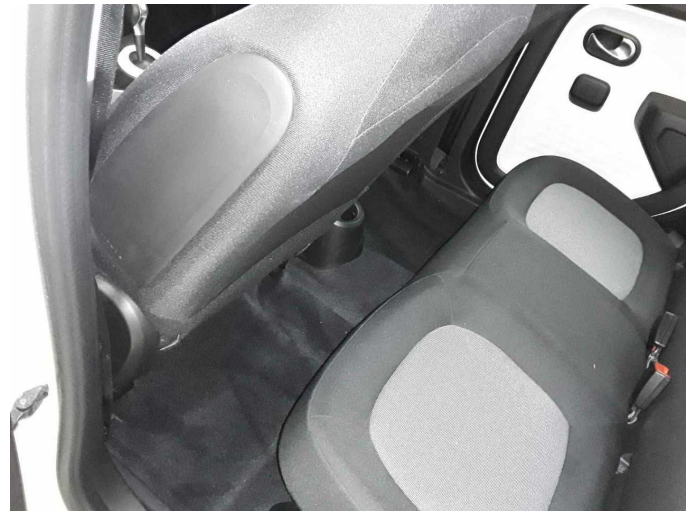
Missing part 1: Trim / covers: Floor mats - Missing - Replace

Trim / covers - Floor mats
