Expertise

Protocol number: 39888810  
Order No. / Reference: 24671012  
Inspection date: 23 May 2025

Manufacturer: Peugeot	Model: 3008 BlueHDi 130 Stop & Start EAT8 Allure Pack
VIN: VF3MCYHZUMS268813

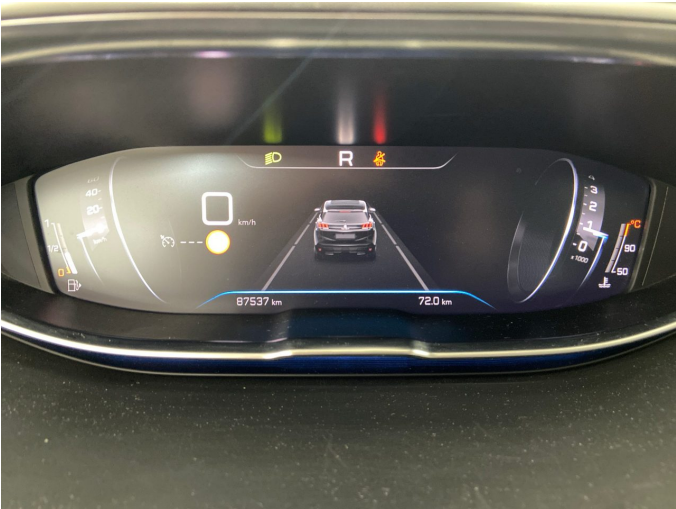
Figure 7: Instrument cluster

Vehicle details	
Manufacturer / Type / Model / Equipment	
Peugeot 3008 BlueHDi 130 Stop & Start EAT8 Allure Pack	
Vehicle Identification number	VF3MCYHZUMS268813
Mileage (Read)	87,537 km
First registration	15 Mar 2022
Number of holders	1
Power / Engine displacement	96 kw / 1,499 ccm
Fuel type / Cylinder	Diesel / 4
Gearbox / Number of gears	Automatic / 8
Type of drive	Front drive
Type of vehicle	SUV
Colour / colour code	Perlmutter Weiß Metallic
Doors / Seats	5 / 5
Upholstery type	Cloth / leather combination
Colour of upholstery	Black-Grey
Vehicle with smoke odor	no

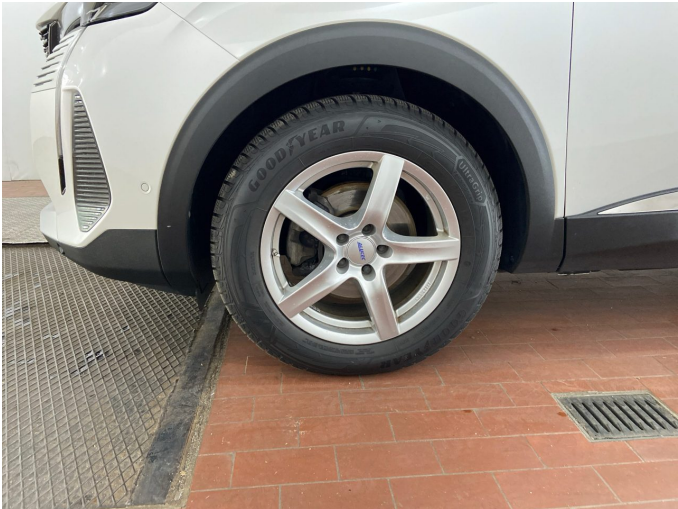
Figure 12: Mounted tyres

#	Tyre size	Type of tyre	Manufacturer	Tread depth
1)	215/65 R17 99V	Winter tyres on Light alloy	Goodyear	7mm / 7mm
2)	215/65 R17 99V	Winter tyres on Light alloy	Goodyear	7mm / 7mm

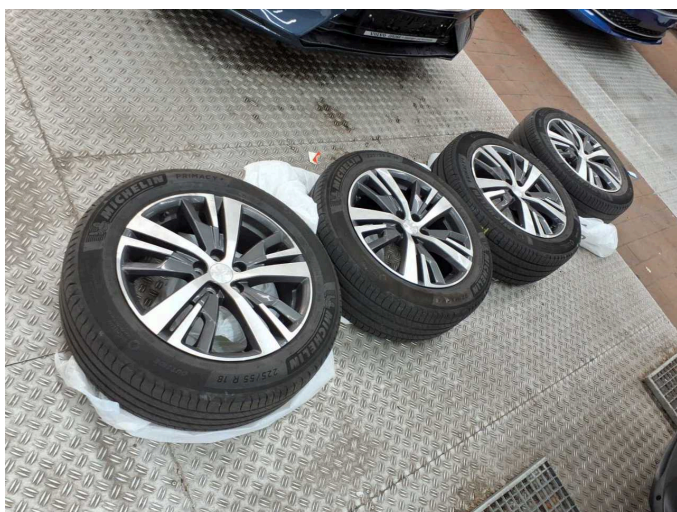
Figure 17: Additional tyres

#	Tyre size	Type of tyre	Manufacturer	Tread depth
1)	225/55 R18 102V	Summer tyres on Light alloy	Michelin	5mm / 5mm
2)	225/55 R18 102V	Summer tyres on Light alloy	Michelin	5mm / 5mm

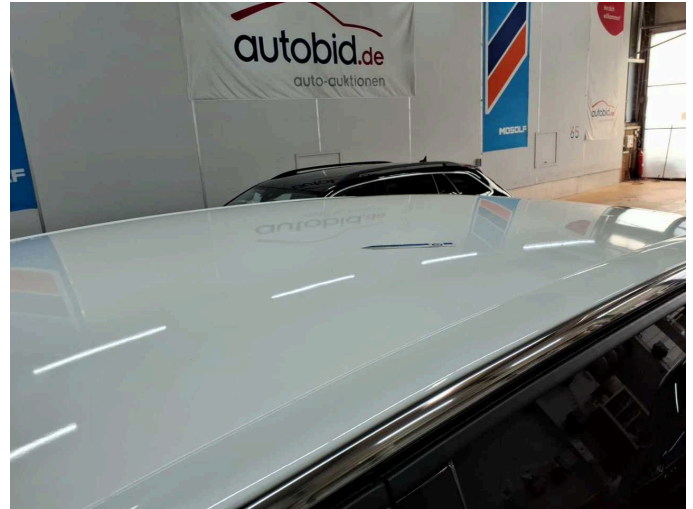
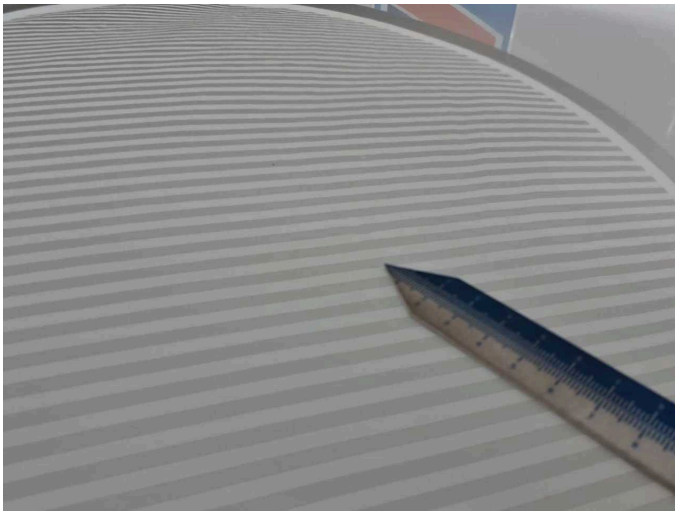
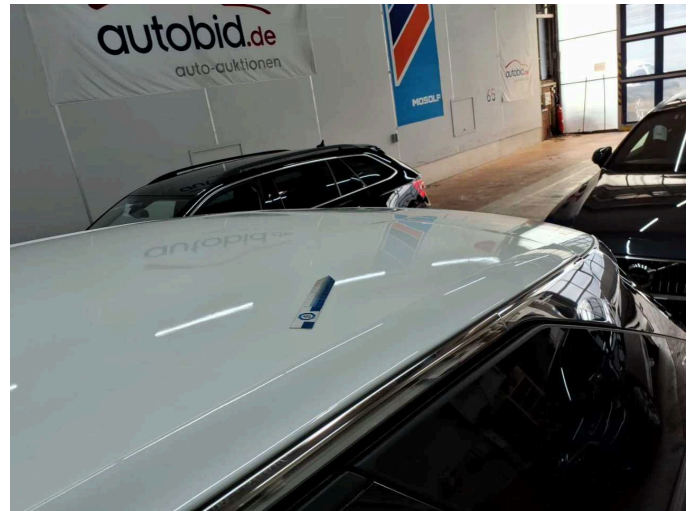
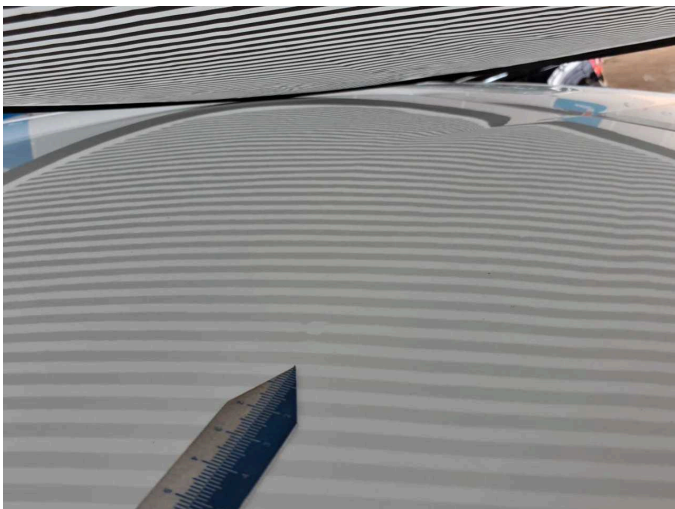
No.	Component group	Description
1	Roof	Roof - dent(s) - Smart repair

**Damage 1:** Roof: Roof - dent(s) - Smart repair

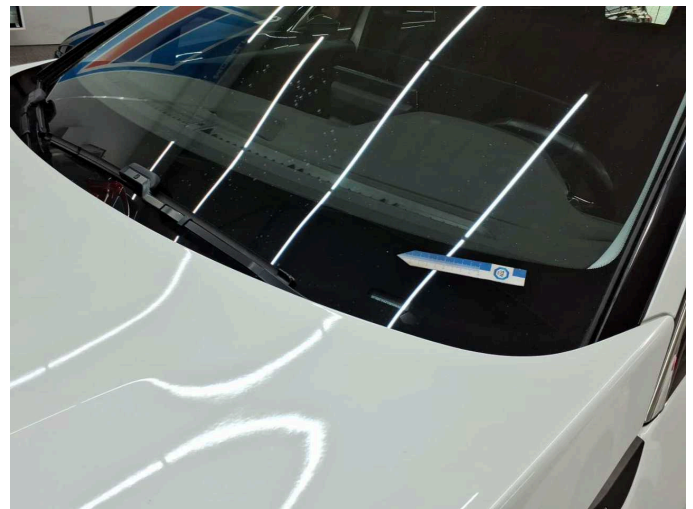
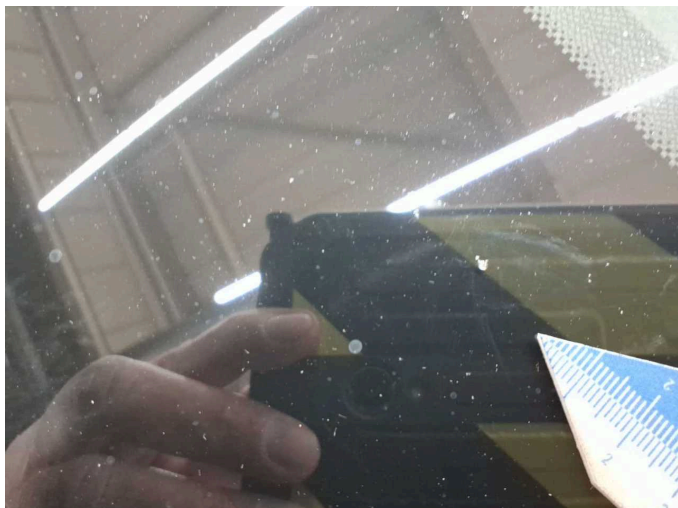
No.	Component group	Description
1	Wheel / tyres	Alloy rim - rear right side - Scratched - No deduction
2	Vehicle glazing	Windscreen (ohne Rissbildung) - Stone chips - No deduction

**Wear and tear 2:** Vehicle glazing: Windscreen (ohne Rissbildung) - Stone chips - No deduction

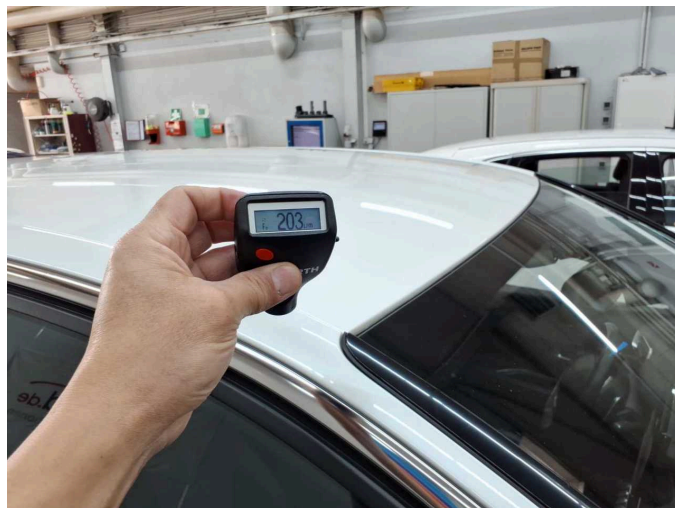
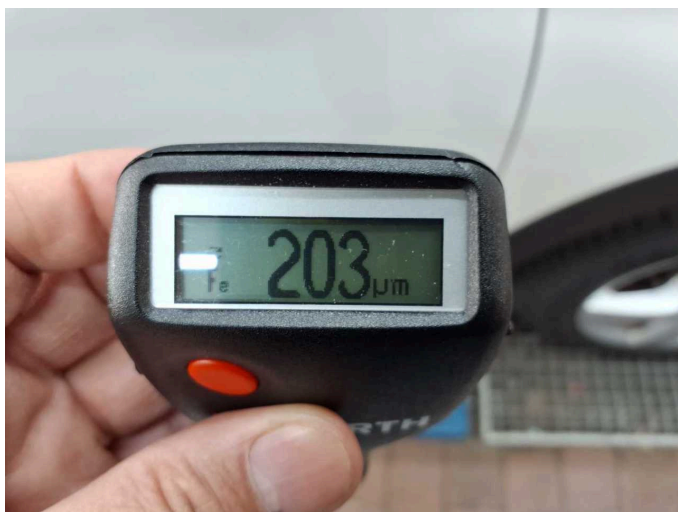
No.	Repainting
1	Roof, Professionally carried out, Invoice of repair done Non-existent

Roof	203 µm
------	--------

**Repainting 1:** Roof
