# SEAT Ibiza

## Ibiza 1.2 12V

VIN NO VSSZZZ6LZ5R055672  
Registration Number LZ5R055672

### Inspection Report Summary

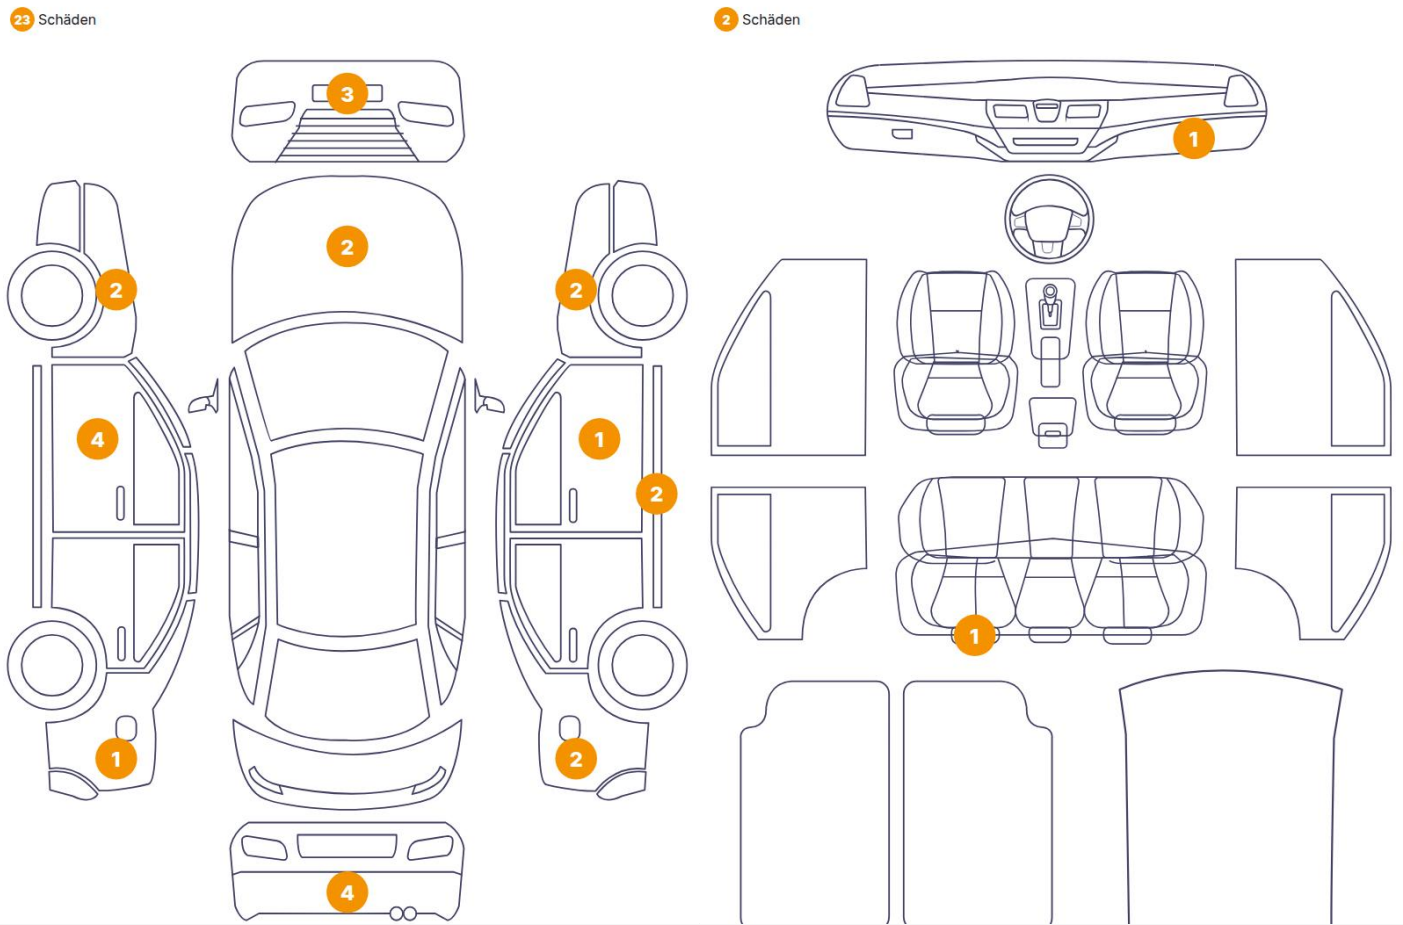
Cosmetic Damage

| Component | | Damage | Comments |

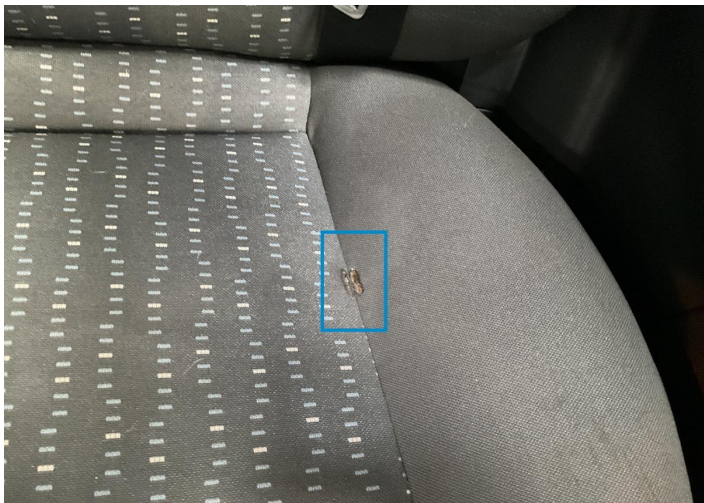
| Component | | Damage | Comments |
|---|---|---|---|
| 1 | Seat / Back Left | Interior / Holed | |

1. Seat / Back Left  
Interior / Holed -

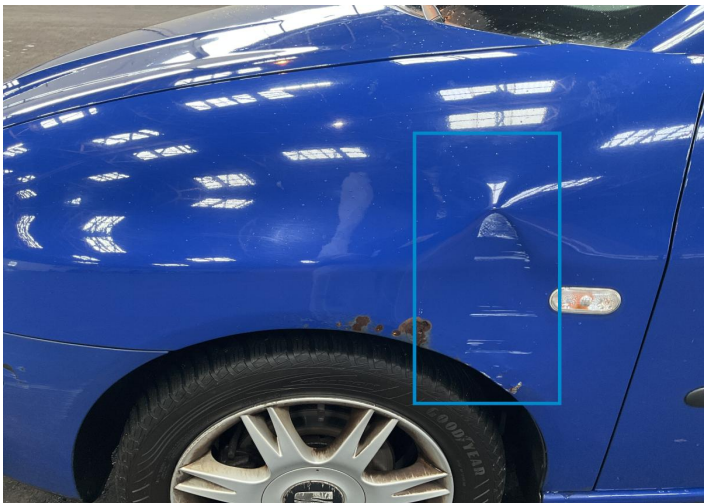
| Component | | Damage | Comments |
|---|---|---|---|
| 2 | Fender / Front Left | Bodywork / Dent / Dent | |

2. Fender / Front Left  
Bodywork / Dent / Dent -

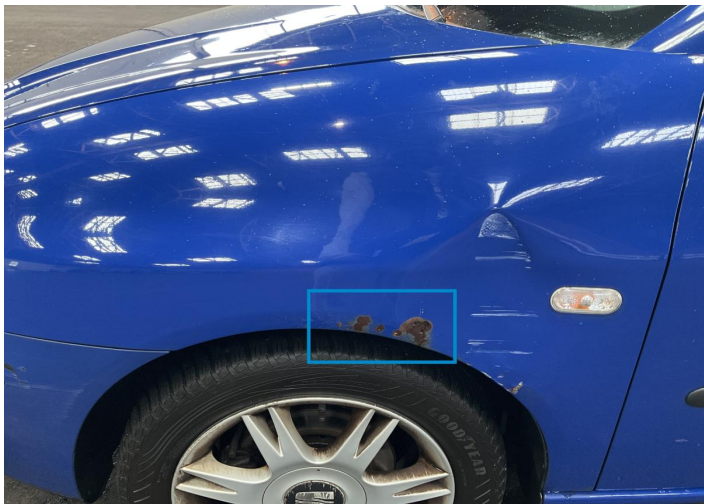
| Component | | Damage | Comments |
|---|---|---|---|
| 3 | Fender / Front Left | Paint / Corrosion | |

3. Fender / Front Left  
Paint / Corrosion -

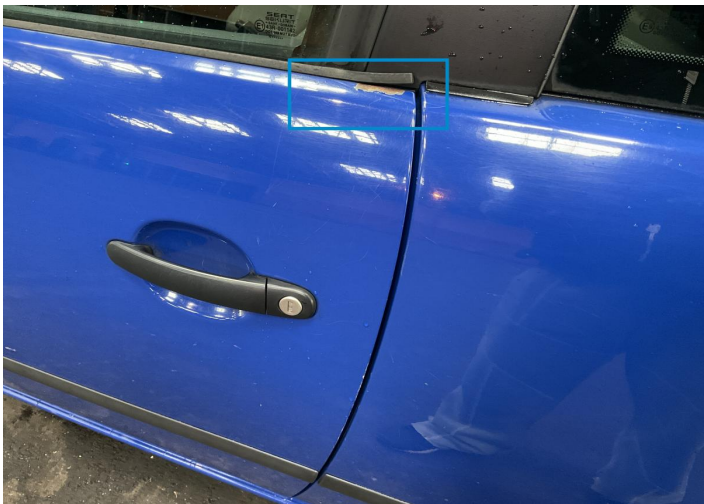
| Component | | Damage | Comments |
|---|---|---|---|
| 4 | Door / Front Left | Paint / Corrosion | |

4. Door / Front Left  
Paint / Corrosion -

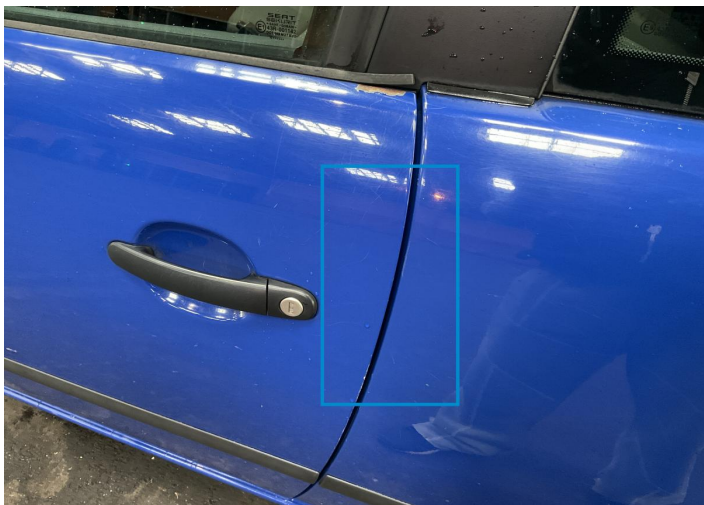
| Component | | Damage | Comments |
|---|---|---|---|
| 5 | Door / Front Left | Paint / Scratch / Scuff | |

5. Door / Front Left  
Paint / Scratch / Scuff -

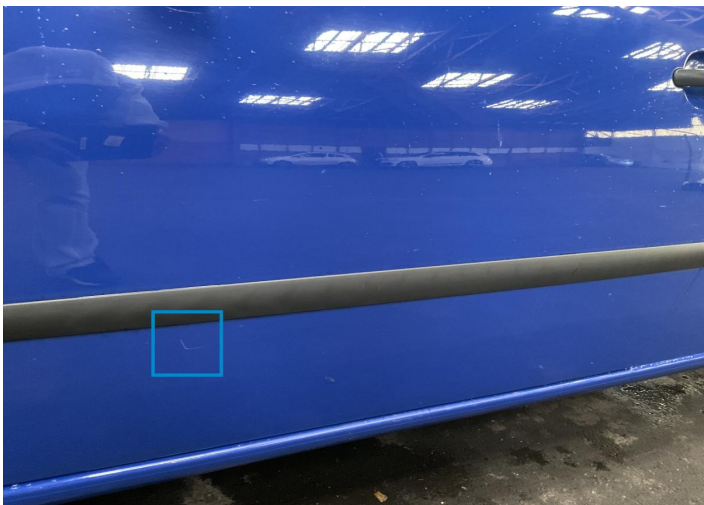
| Component | | Damage | Comments |
|---|---|---|---|
| 6 | Door / Front Left | Paint / Scratch / Scuff | |

6. Door / Front Left  
Paint / Scratch / Scuff -

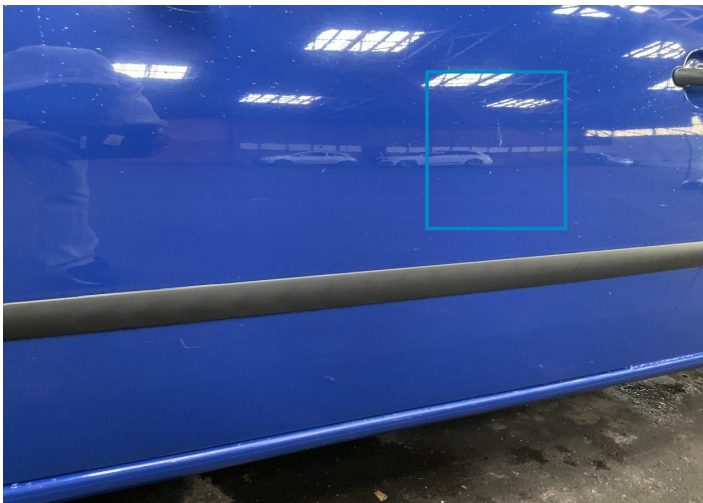
| Component | | Damage | Comments |
|---|---|---|---|
| 7 | Door / Front Left | Paint / Scratch / Scuff | |

7. Door / Front Left  
Paint / Scratch / Scuff -

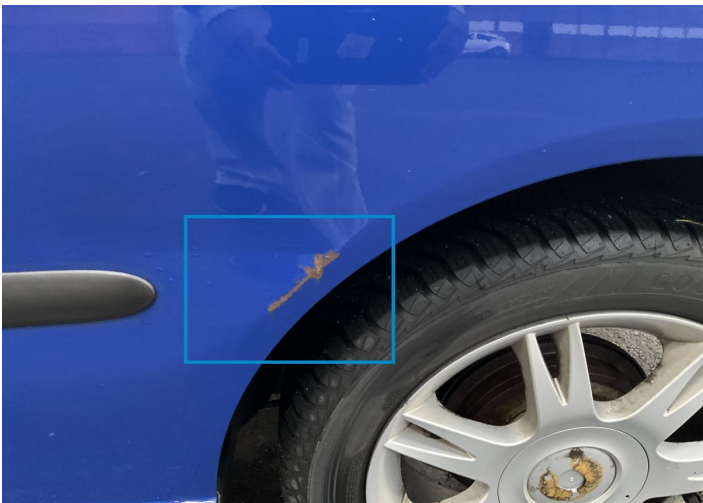
| Component | | Damage | Comments |
|---|---|---|---|
| 8 | Side Panel / Back Left | Paint / Corrosion | |

8. Side Panel / Back Left  
Paint / Corrosion -

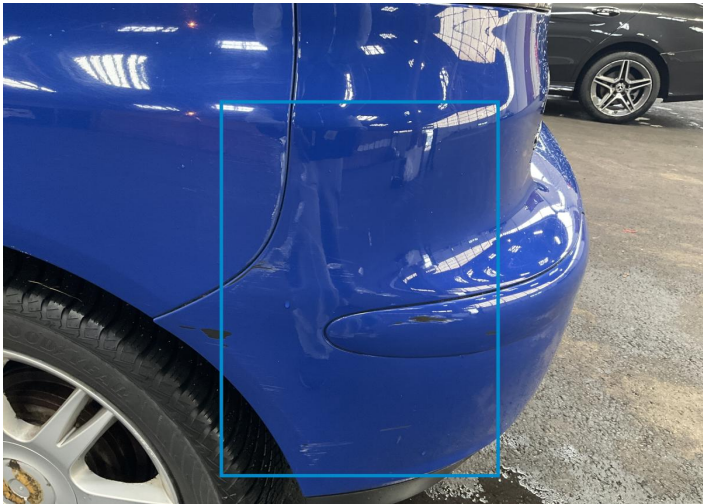
| Component | | Damage | Comments |
|---|---|---|---|
| 9 | Bumper / Back | Paint / Scratch / Scuff | |

9. Bumper / Back  
Paint / Scratch / Scuff -

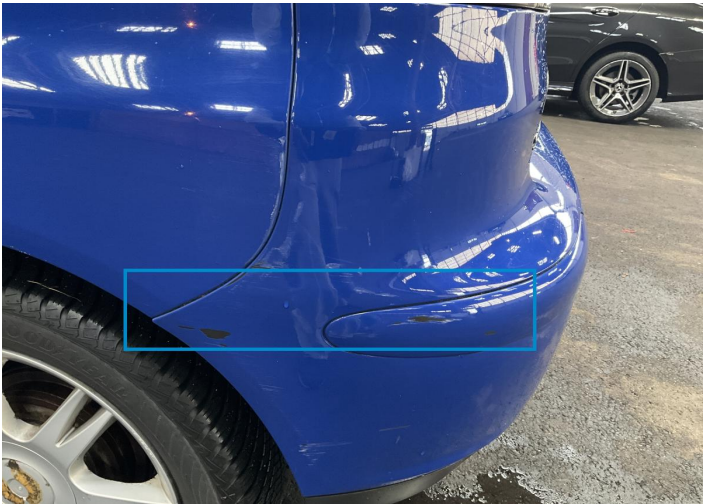
| Component | | Damage | Comments |
|---|---|---|---|
| 10 | Bumper / Back | Paint / Corrosion | |

10. Bumper / Back  
Paint / Corrosion -

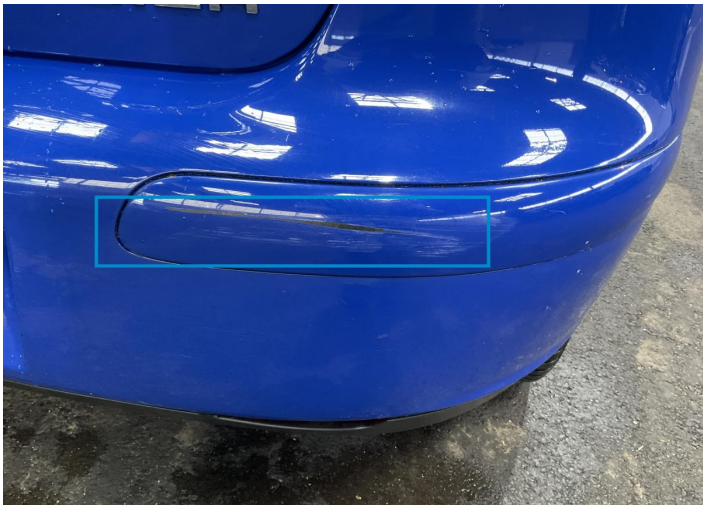
| Component | | Damage | Comments |
|---|---|---|---|
| 11 | Corner Bumper / Back Right | Paint / Scratch / Scuff | |

11. Corner Bumper / Back Right  
Paint / Scratch / Scuff -

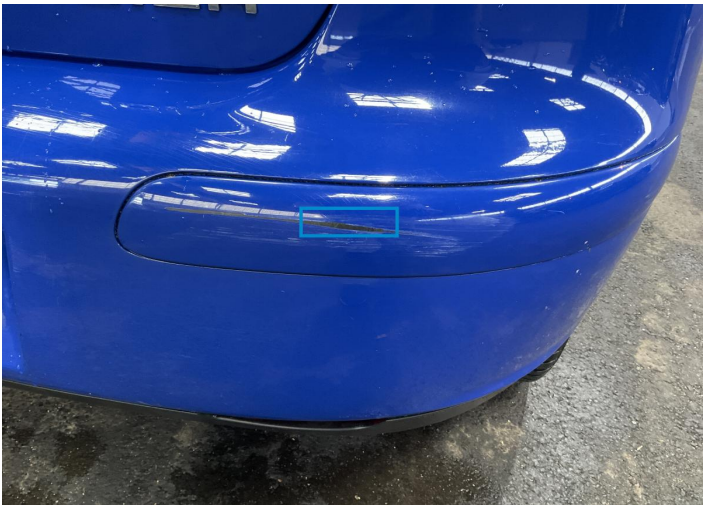
| Component | | Damage | Comments |
|---|---|---|---|
| 12 | Corner Bumper / Back Right | Paint / Corrosion | |

12. Corner Bumper / Back Right  
Paint / Corrosion -

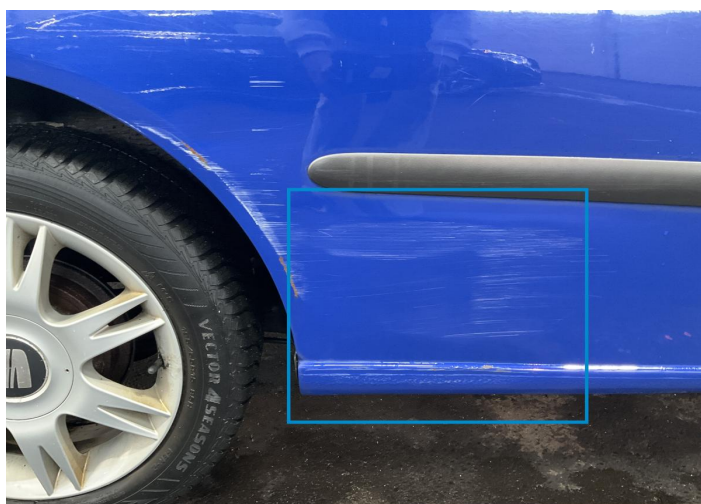
| Component | | Damage | Comments |
|---|---|---|---|
| 13 | Side Panel / Back Right | Paint / Scratch / Scuff | |

13. Side Panel / Back Right  
Paint / Scratch / Scuff -

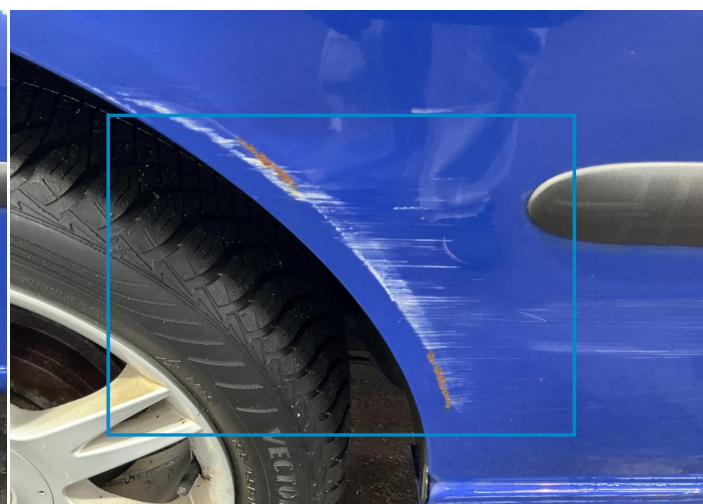
| 14 | Side Panel / Back Right | Paint / Corrosion |

14. Side Panel / Back Right  
Paint / Corrosion -

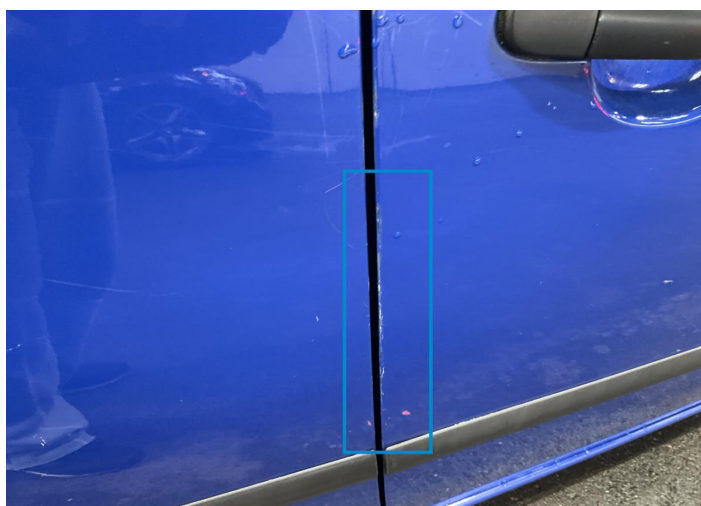
| 15 | Door / Front Right | Paint / Scratch / Scuff |

15. Door / Front Right  
Paint / Scratch / Scuff -

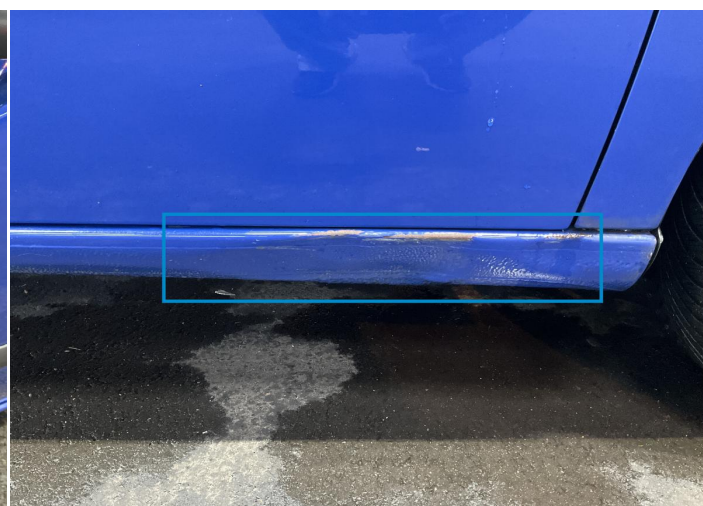
| 16 | Rocker Panel / Center Right | Bodywork / Dent / Dent |

16. Rocker Panel / Center Right  
Bodywork / Dent / Dent -

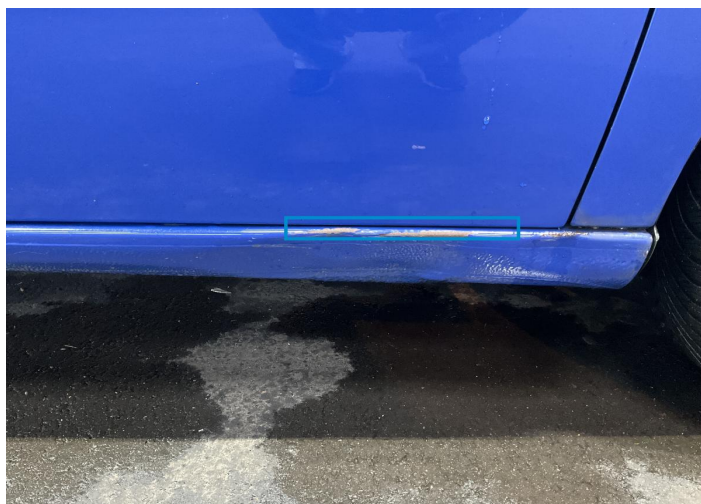
| 17 | Rocker Panel / Center Right | Paint / Corrosion |

17. Rocker Panel / Center Right  
Paint / Corrosion -

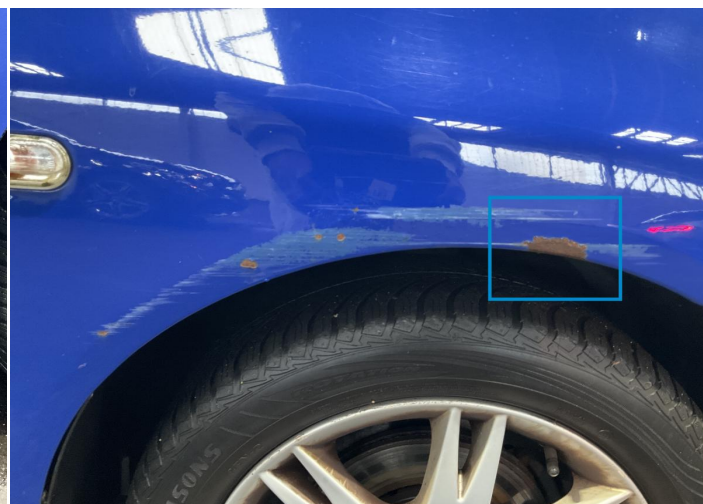
| 18 | Fender / Front Right | Paint / Corrosion |

18. Fender / Front Right  
Paint / Corrosion -

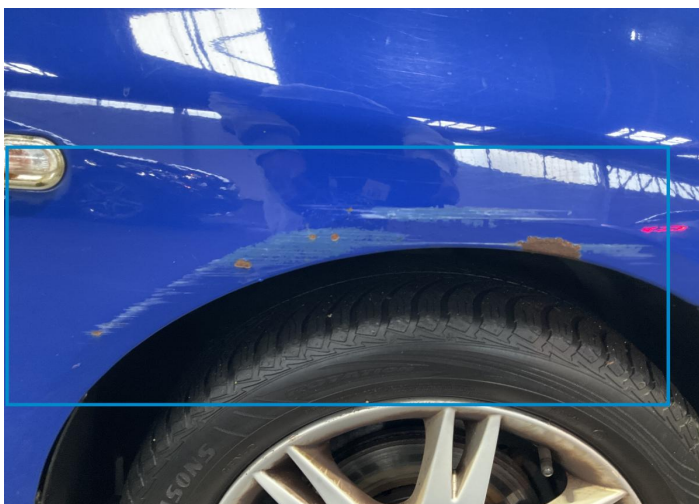
| 19 | Fender / Front Right | Paint / Scratch / Scuff |

19. Fender / Front Right  
Paint / Scratch / Scuff -

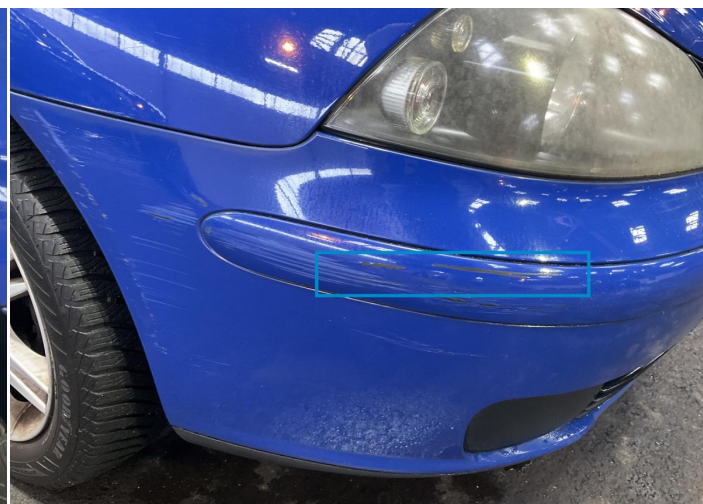
| 20 | Corner Bumper / Front Left | Paint / Corrosion |

20. Corner Bumper / Front Left  
Paint / Corrosion -

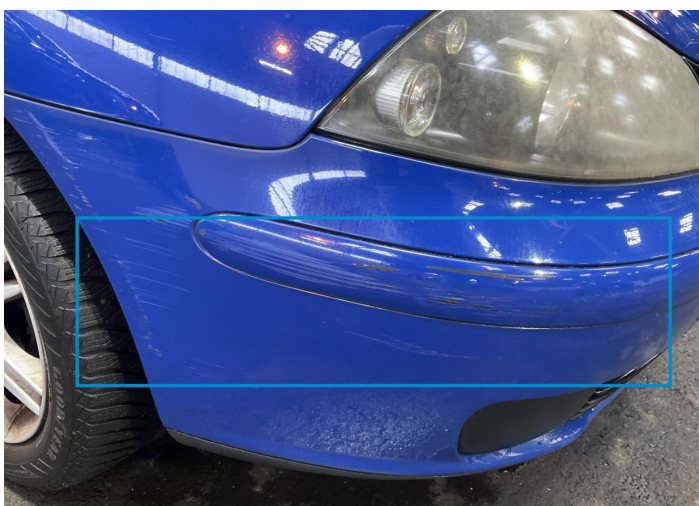
| 21 | Corner Bumper / Front Left | Paint / Scratch / Scuff |

21. Corner Bumper / Front Left  
Paint / Scratch / Scuff -

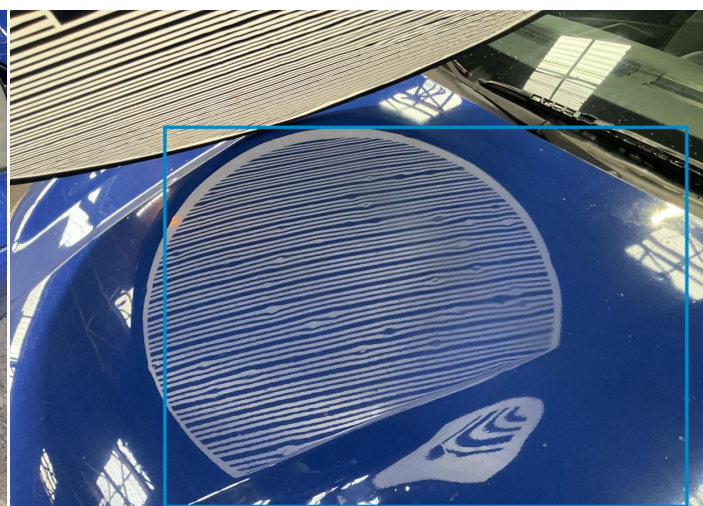
| 22 | Hood | Bodywork / Dent / Hail Area |

22. Hood  
Bodywork / Dent / Hail Area -

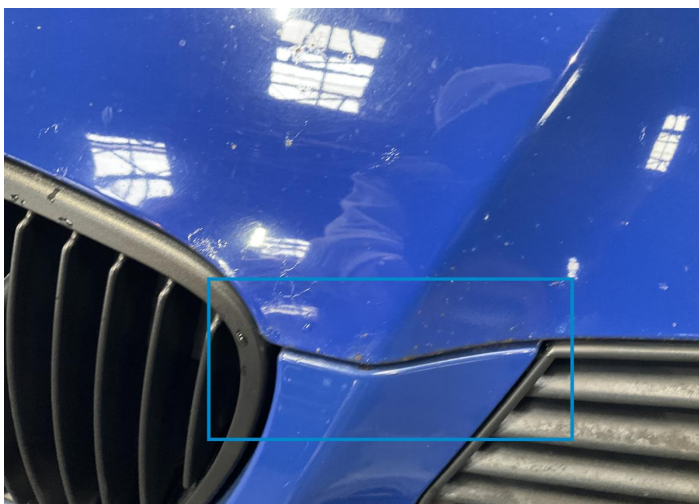
| 23 | Hood | Paint / Corrosion |

23. Hood  
Paint / Corrosion -

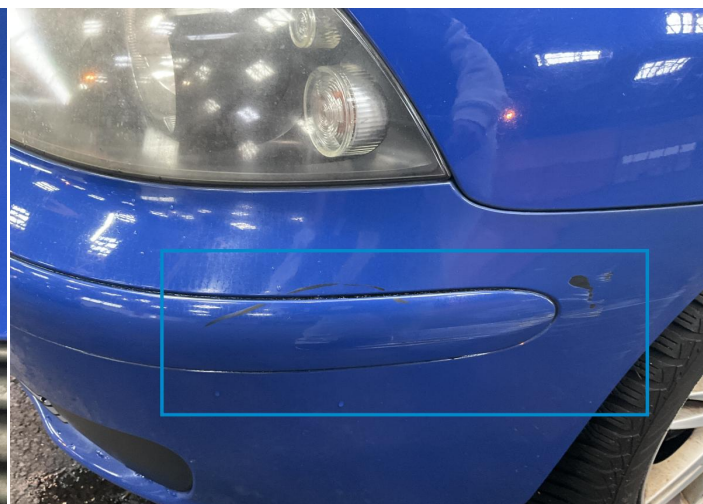
| 24 | Corner Bumper / Front Right | Paint / Scratch / Scuff |

24. Corner Bumper / Front Right  
Paint / Scratch / Scuff -
