Expertise

Protocol number: 40736501
Order No. / Reference: 24955585
Inspection date: 24 Jul 2025

Manufacturer: Seat

Model: Leon Sportstourer 2.0 TDI Style

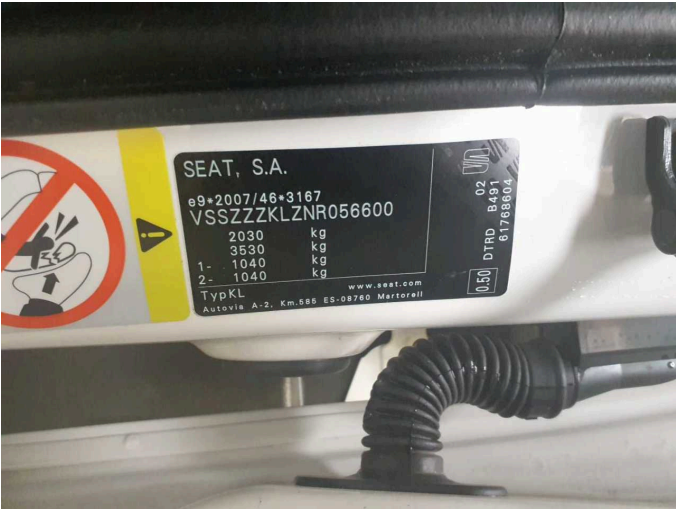
Figure 11: VIN

Documents submitted	At the time of the inspection, the registration certificate Part 2 (letter) was available, but the registration certificate Part 1 (certificate) was not. (Copy)
VIN comparison	The vehicle identification number (VIN) was read and the undersigned verified that it matched the documents submitted during the inspection.
Inspection	The inspection conditions were sufficient for the assessment of the vehicle. Lifting equipment and a pit were available for examining the vehicle.
Test drive	No test drive/maneuvering was carried out during the inspection of the vehicle.
Engine function test	An engine test run was performed.
Driving readiness	The vehicle was drivable at the time of inspection.

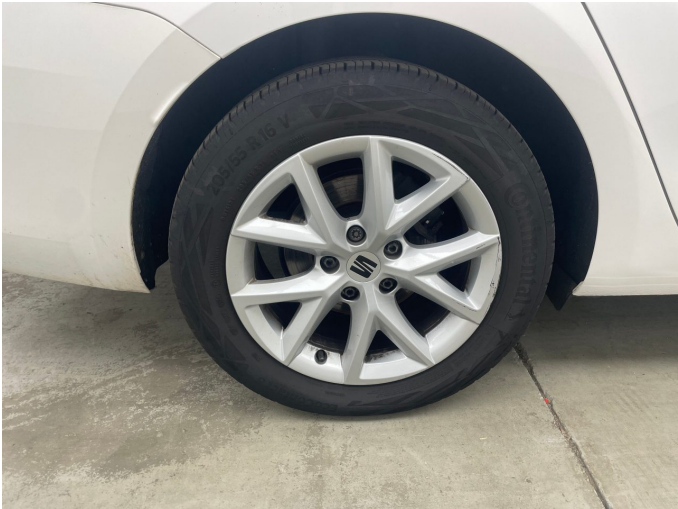
Figure 12: Mounted tyres

#	Tyre size	Type of tyre	Manufacturer	Tread depth
1)	205/55 R16 91V	Summer tyres on Light alloy	Continental	5mm / 5mm
2)	205/55 R16 91V	Summer tyres on Light alloy	Continental	4mm / 4mm

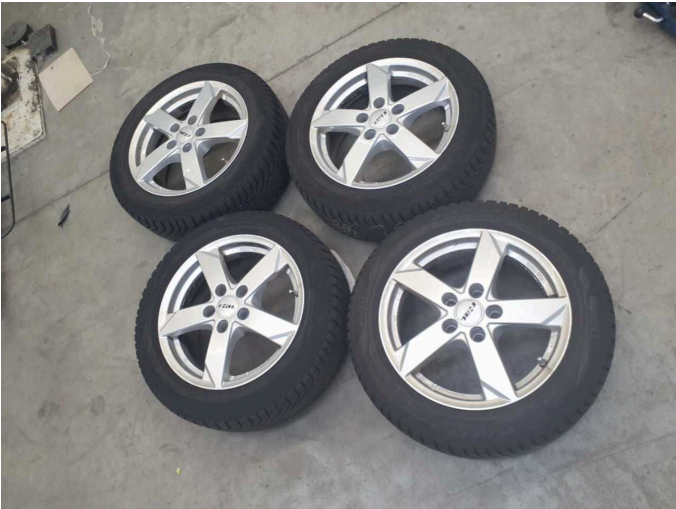
Figure 15: Additional tyres

#	Tyre size	Type of tyre	Manufacturer	Tread depth
1)	205/55 R16 91H	Winter tyres on Light alloy	Pirelli	7mm / 7mm
2)	205/55 R16 91H	Winter tyres on Light alloy	Pirelli	6mm / 6mm

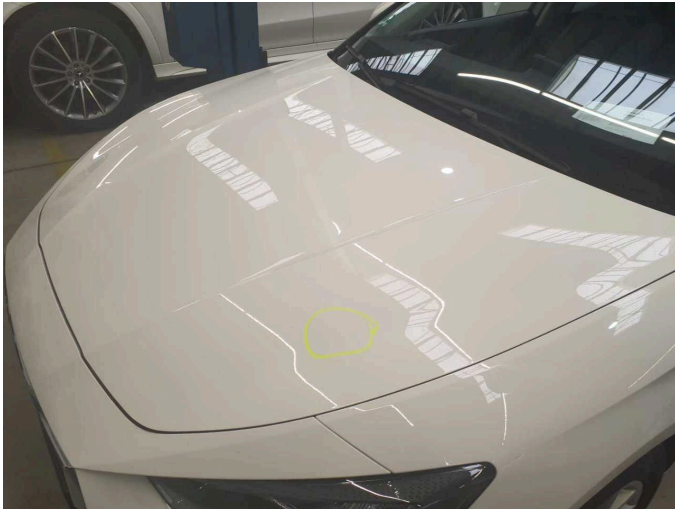
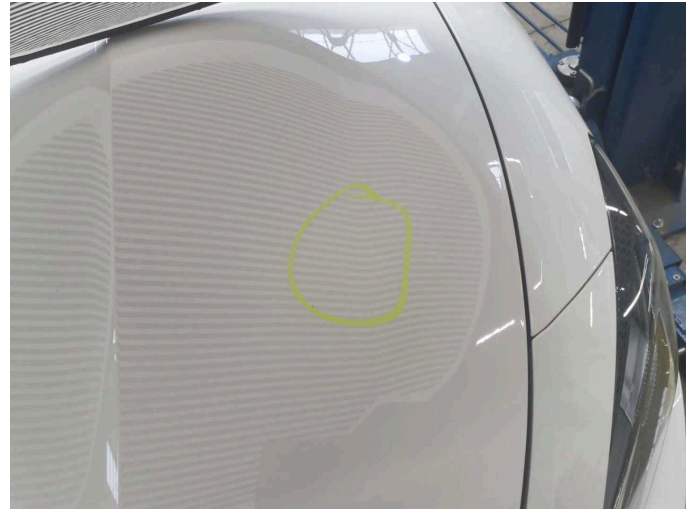
No.	Component group	Description
1	Bonnet	Bonnet - dent(s) - Smart repair
2	Roof	Roof - dent(s) - Smart repair

Damage 1: Bonnet: Bonnet - dent(s) - Smart repair

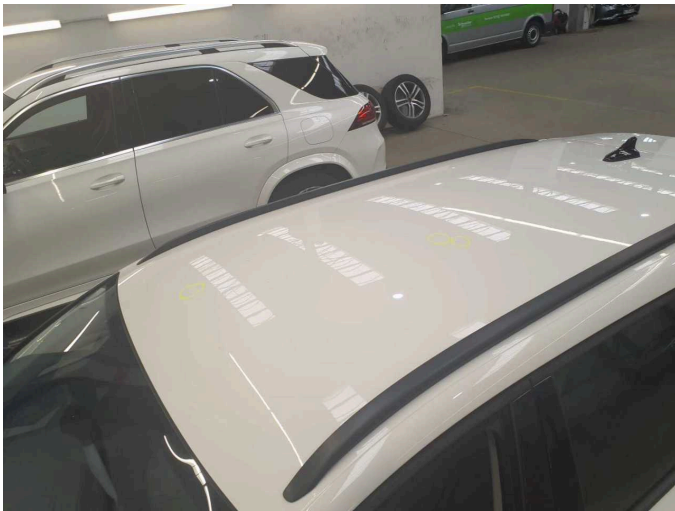
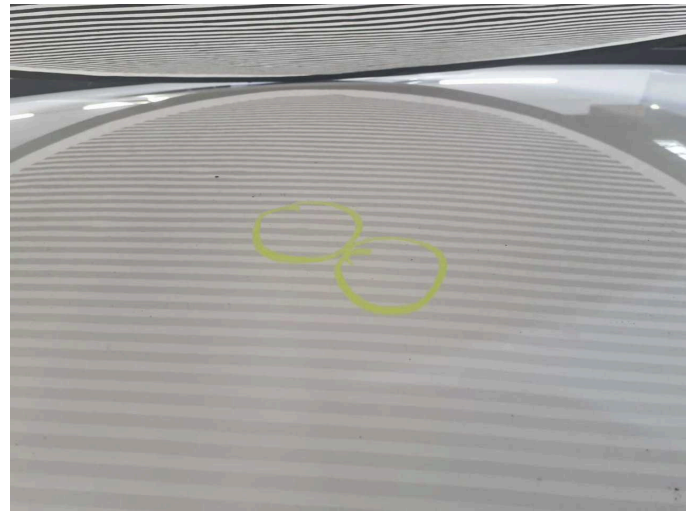
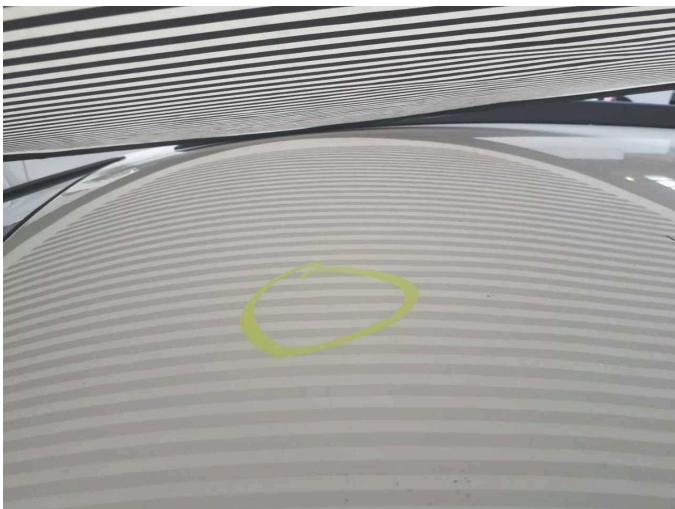
Damage 2: Roof: Roof - dent(s) - Smart repair

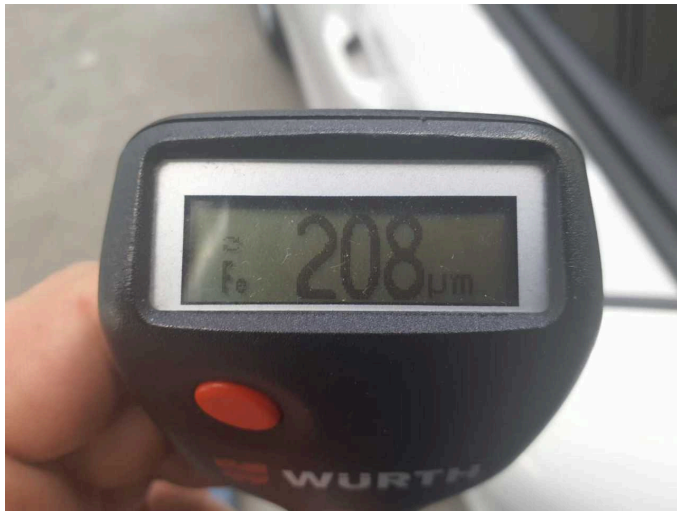
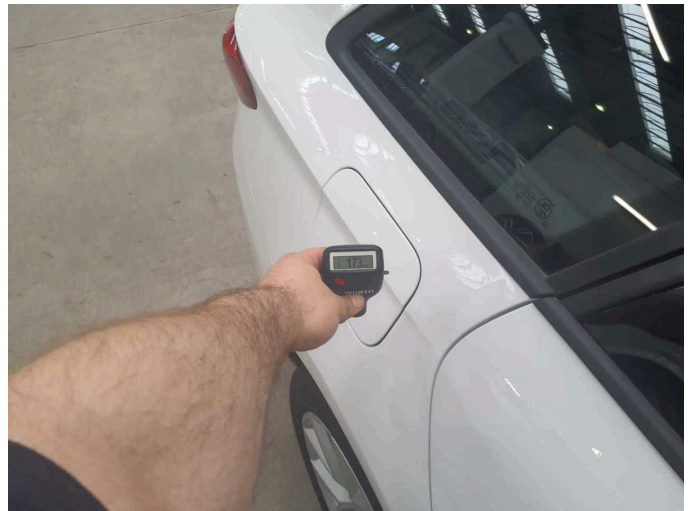
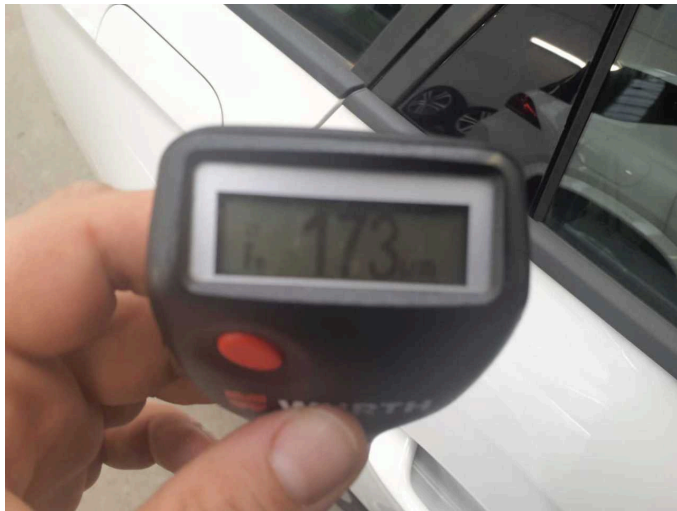
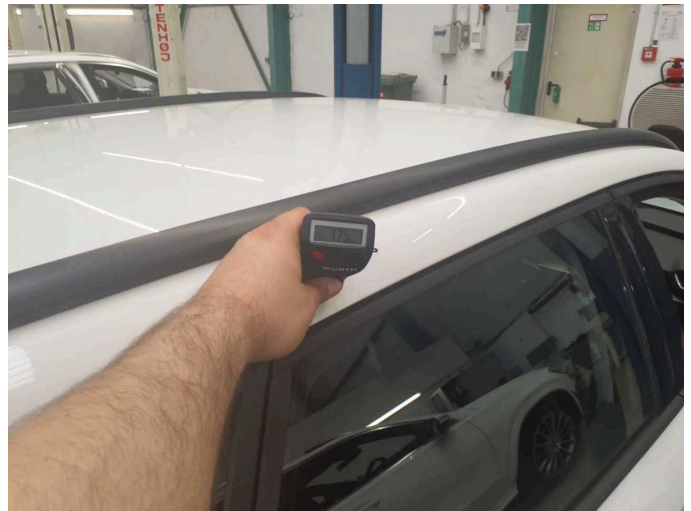
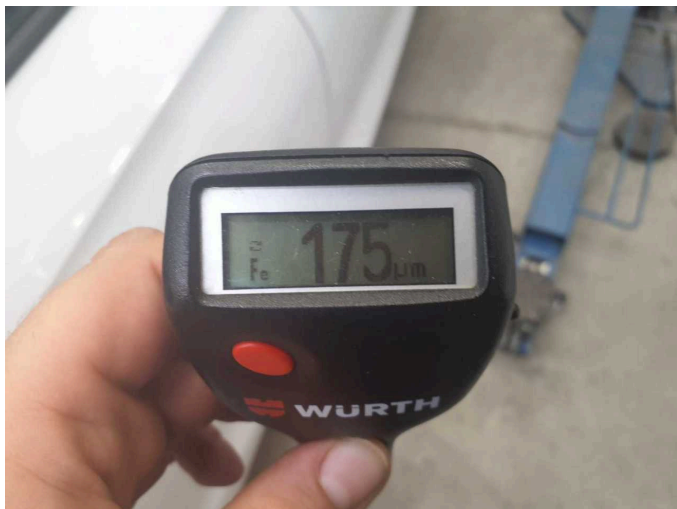
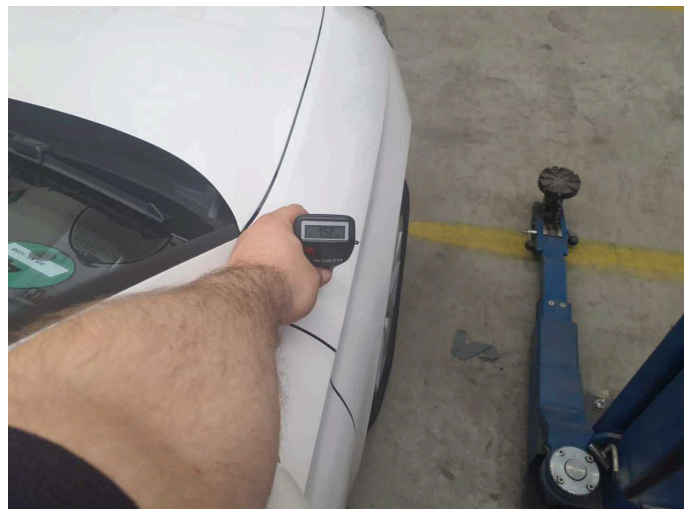
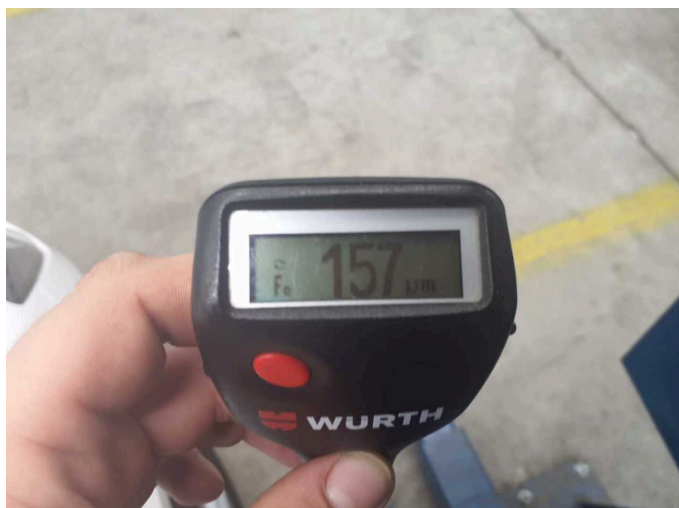
No.	Repainting
1	Roof rail - right side, Mudguard - right side, Side panel - rear right side, Door - front right side, Professionally carried out, Invoice of repair done Non-existent

Roof rail - right side	175 µm	Mudguard - right side	157 µm
Side panel - rear right side	173 µm	Door - front right side	205 µm

Repainting 1: Roof rail - right side, Mudguard - right side, Side panel - rear right side, Door - front right side
