# CUPRA Leon

## Leon 2.0 TSI DSG

VIN NO VSSZZZKLZNR062543  
Registration Number LZNR062543

### Inspection Report Summary

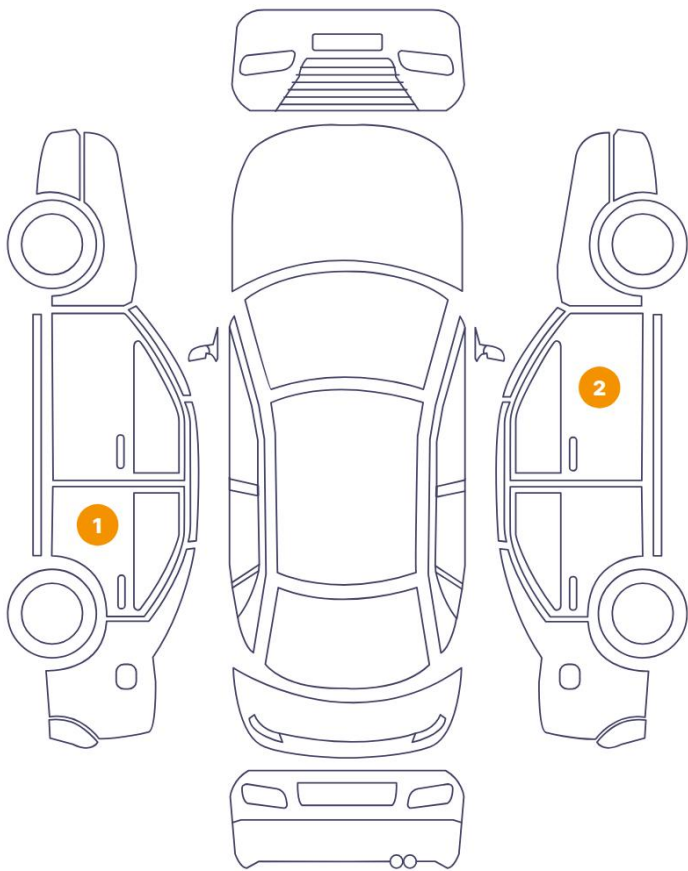
3 Schäden

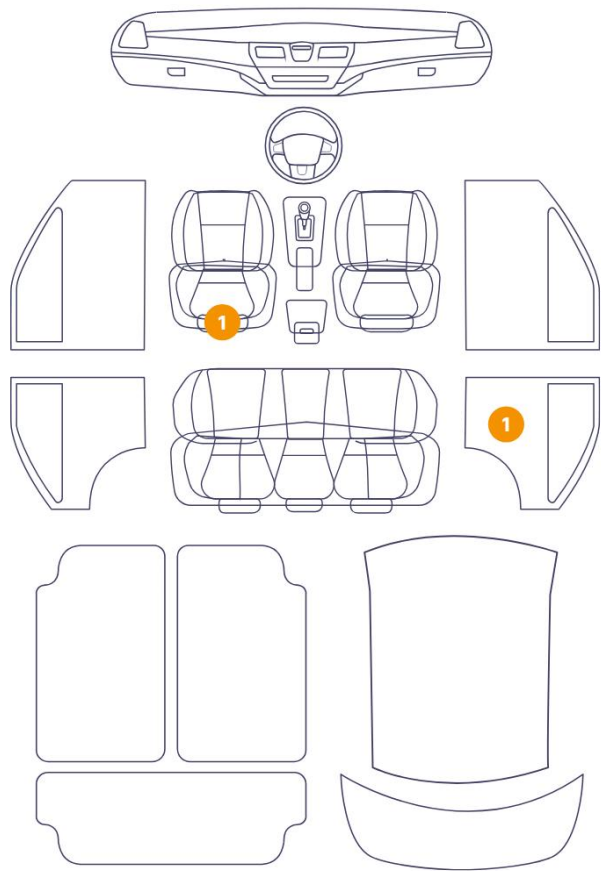
2 Schäden

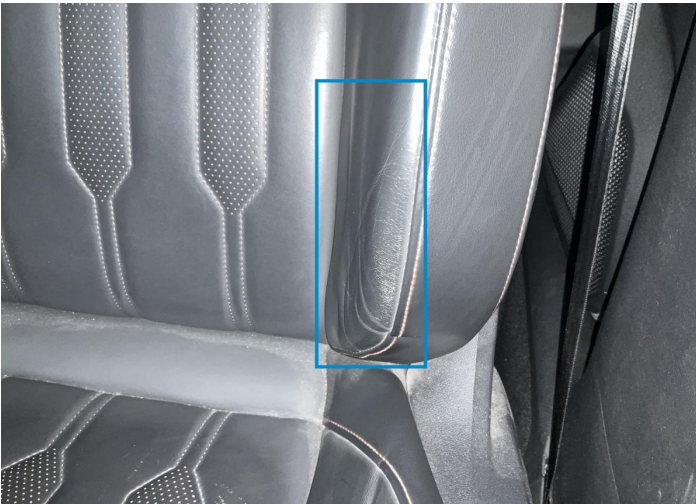
| Component | | Damage | Comments |
|---|---|---|---|
| 1 | Seat / Front Left | Interior / Scratched | |

1. Seat / Front Left  
Interior / Scratched -

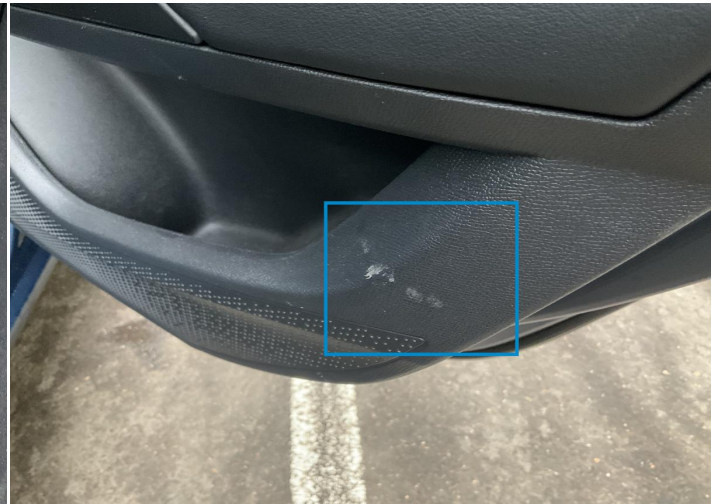
| Component | | Damage | Comments |
|---|---|---|---|
| 2 | Panel Filling / Back Right | Interior / Scratched | |

2. Panel Filling / Back Right  
Interior / Scratched -

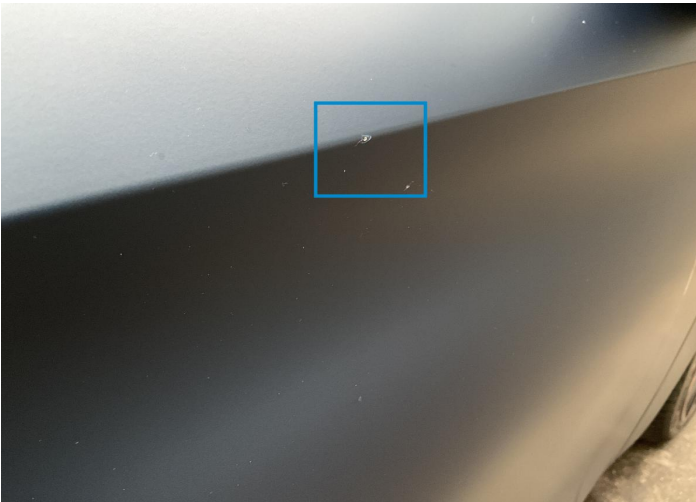
| Component | | Damage | Comments |
|---|---|---|---|
| 3 | Door / Front Right | Paint / Scratch / Scuff | |

3. Door / Front Right  
Paint / Scratch / Scuff -

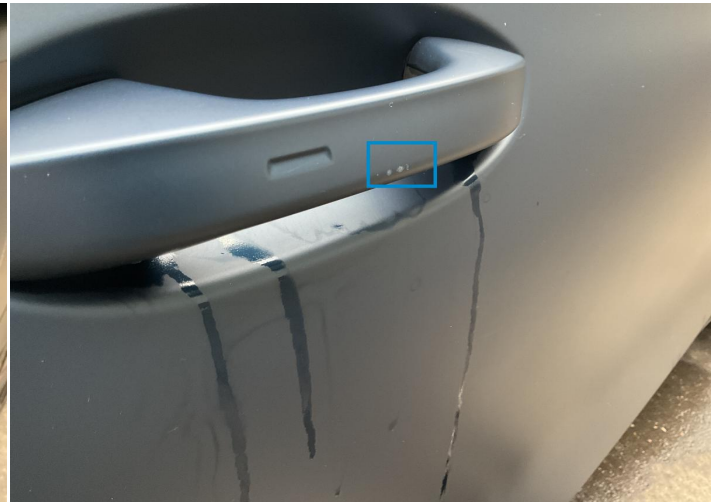
| Component | | Damage | Comments |
|---|---|---|---|
| 4 | Door Handle / Front Right | Paint / Scratch / Scuff | |

4. Door Handle / Front Right  
Paint / Scratch / Scuff -

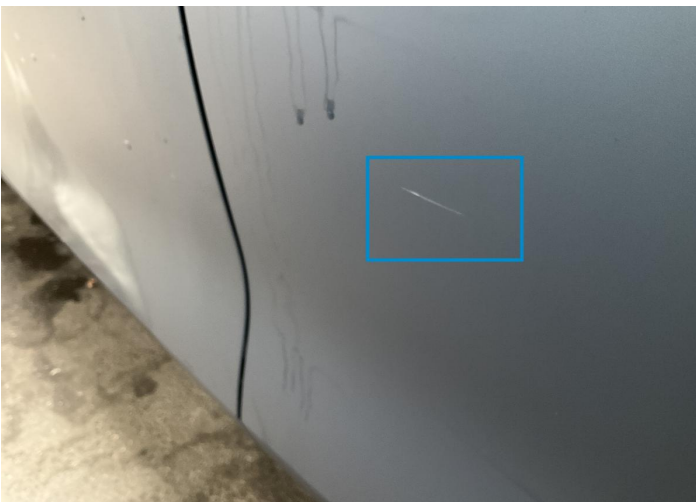
| Component | | Damage | Comments |
|---|---|---|---|
| 5 | Door / Back Left | Paint / Scratch / Scuff | |

5. Door / Back Left  
Paint / Scratch / Scuff -
