Expertise

Protocol number: 41294593  
Order No. / Reference: 25157262  
Inspection date: 27 Aug 2025

| Manufacturer: Opel | Model: Corsa 1.2 Direct Injection Turbo Start/Stop Edition |

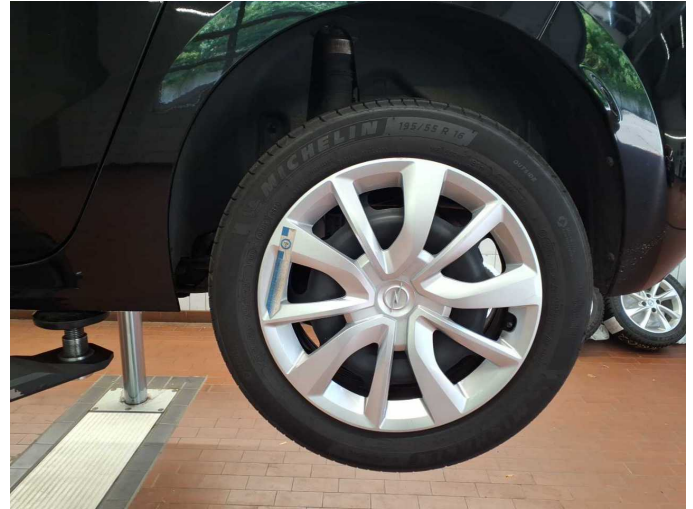
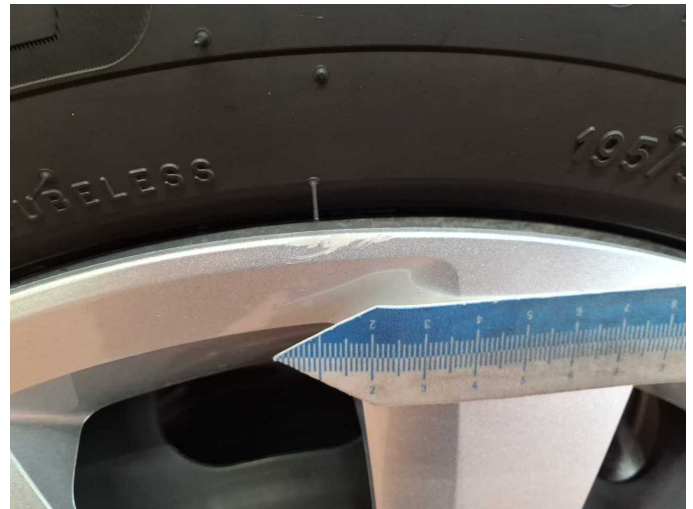
**Damage 1:** Wheel / tyres: Wheel cover - rear left side - Scratched - Replace

| No. | Component group | Description |
|---|---|---|
| 1 | Wheel / tyres | Wheel cover - rear left side - Scratched - Replace |

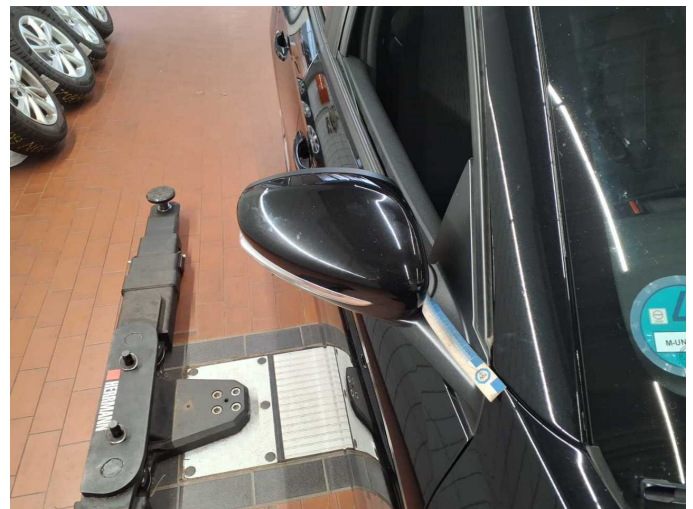
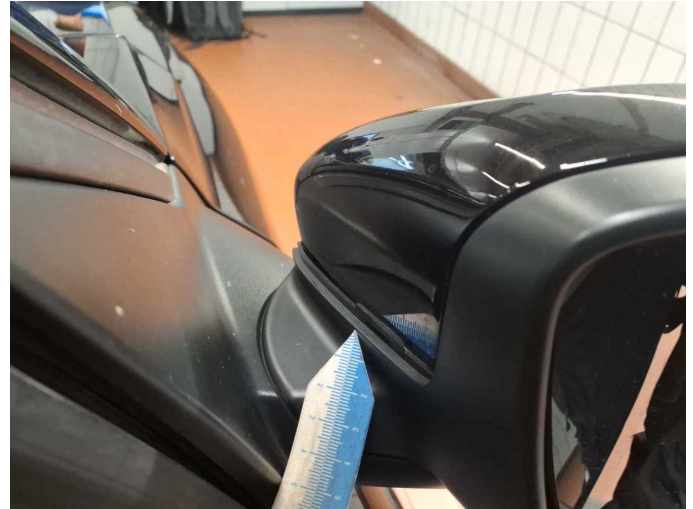
**Damage 2:** Wing mirror - right side: Cap (Folgekosten möglich) - Malposition - Un- / install

| No. | Component group | Description |
|---|---|---|
| 2 | Wing mirror - right side | Cap (Folgekosten möglich) - Malposition - Un- / install |

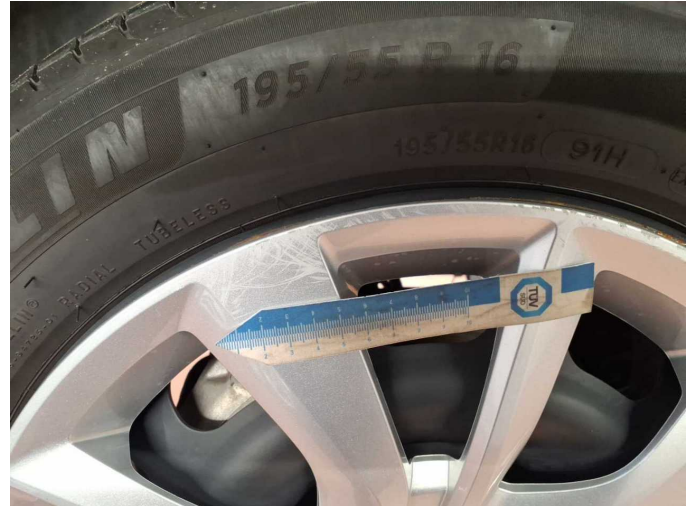
**Damage 3:** Wheel / tyres: Wheel cover - rear right side - Scratched - Replace

| No. | Component group | Description |
|---|---|---|
| 3 | Wheel / tyres | Wheel cover - rear right side - Scratched - Replace |

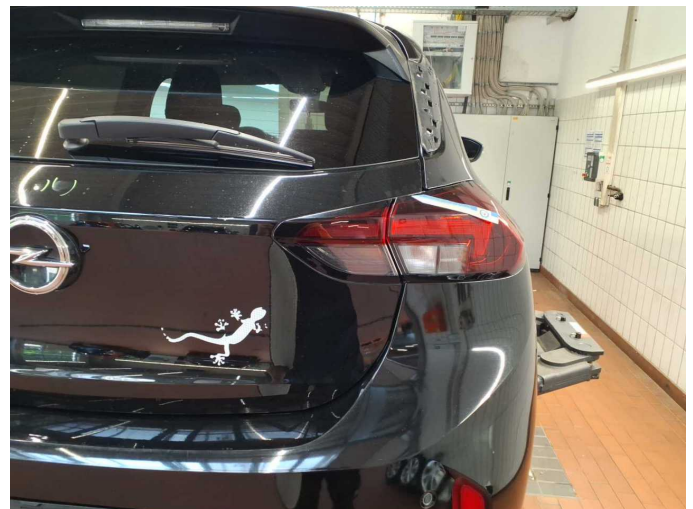
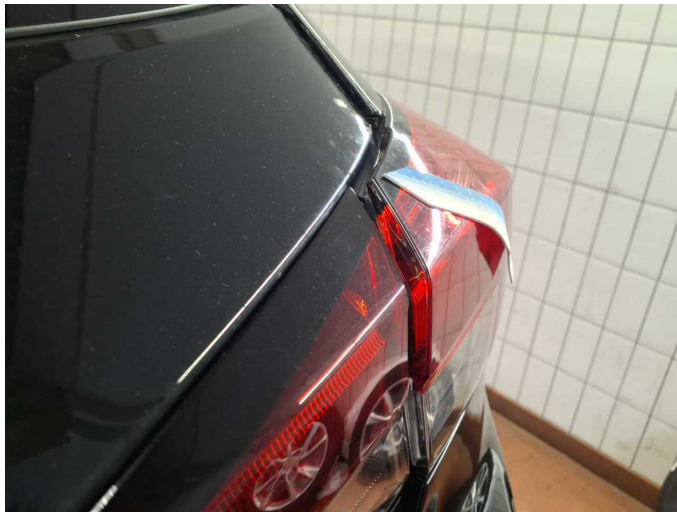
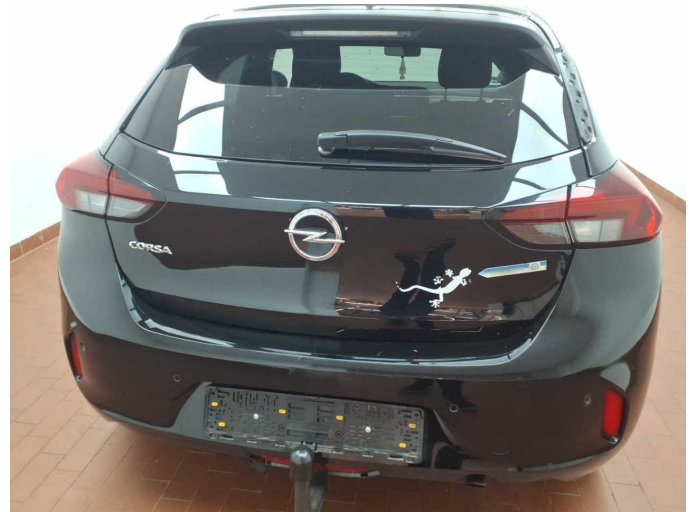
**Damage 4:** Boot lid / rear door: Boot lid (Spaltmaße) - Malposition - Set / adjust

| No. | Component group | Description |
|---|---|---|
| 4 | Boot lid / rear door | Boot lid (Spaltmaße) - Malposition - Set / adjust |

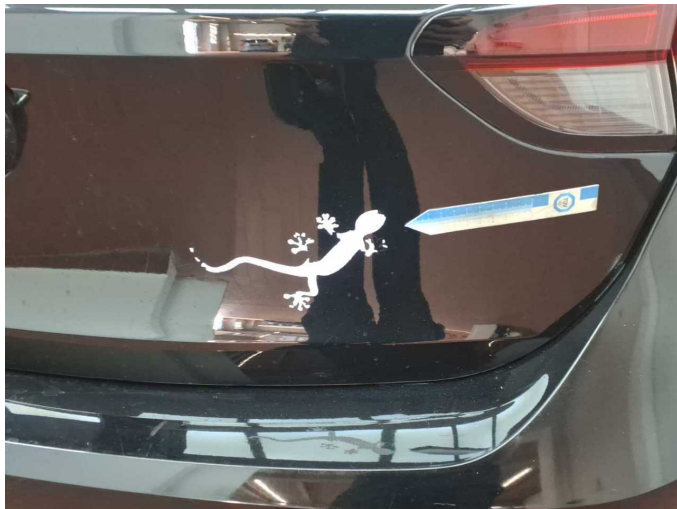
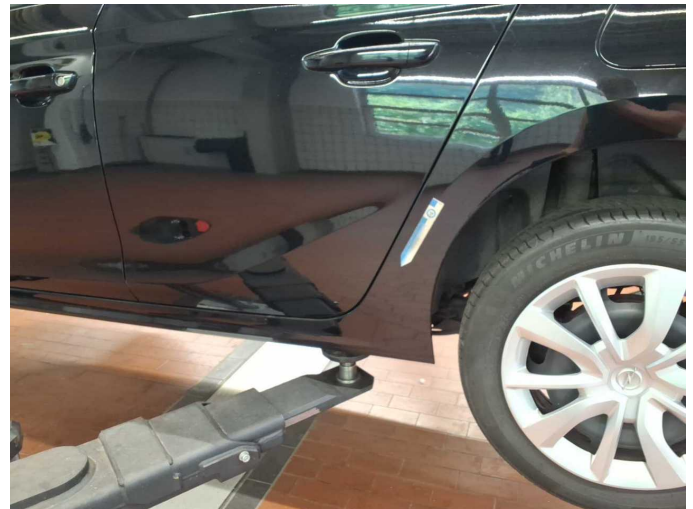
**Damage 5:** Boot lid / rear door: Boot lid - Glued / labelled - Remove

| No. | Component group | Description |
|---|---|---|
| 5 | Boot lid / rear door | Boot lid - Glued / labelled - Remove |

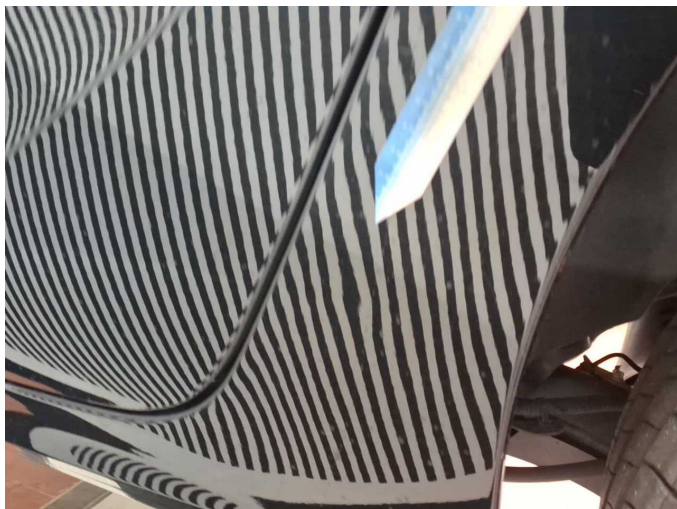
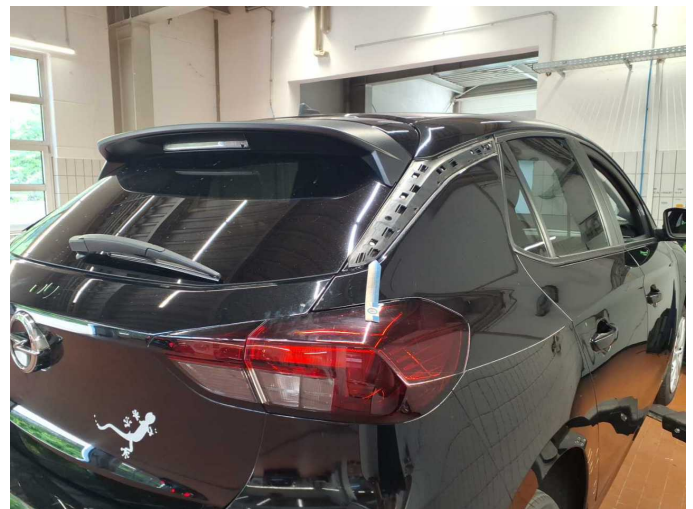
**Damage 6:** Side panel - rear left side: Elbow - dent(s) - Smart repair

| No. | Component group | Description |
|---|---|---|
| 6 | Side panel - rear left side | Elbow - dent(s) - Smart repair |

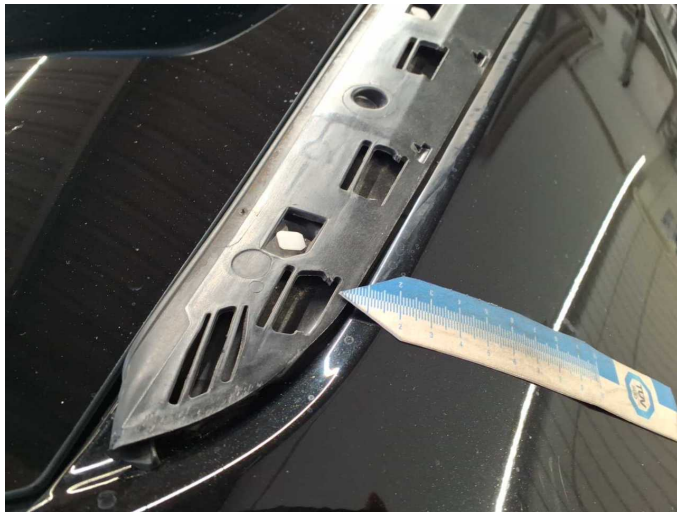
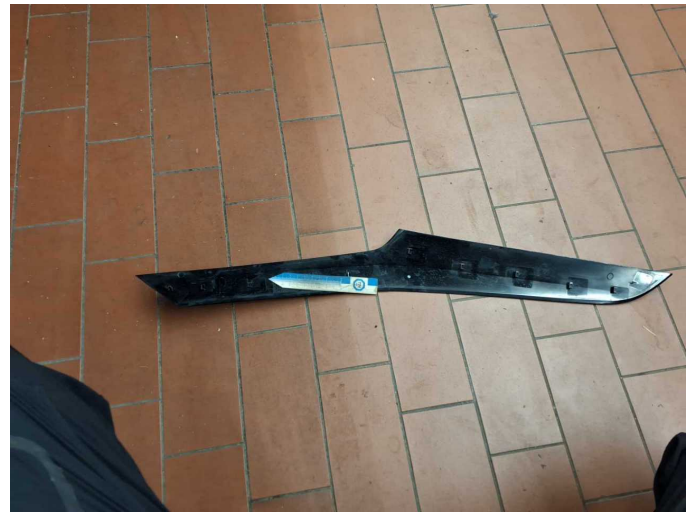
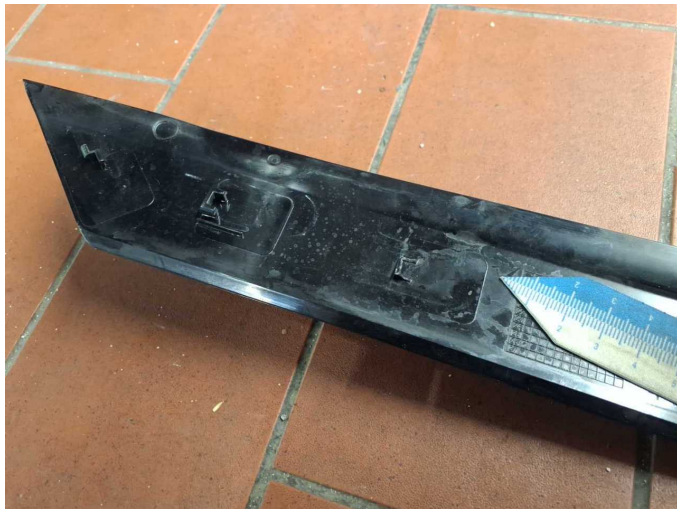
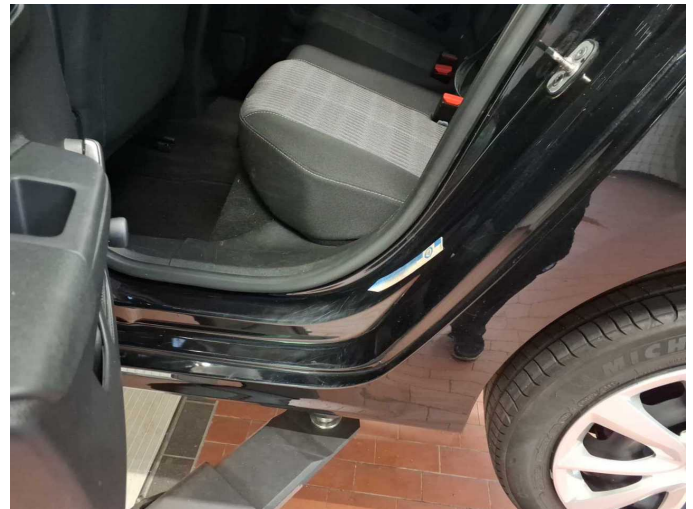
**Damage 7:** Side panel - rear right side: Protection strip (Hinten rechts) - Broken / torn - Replace

| No. | Component group | Description |
|---|---|---|
| 7 | Side panel - rear right side | Protection strip (Hinten rechts) - Broken / torn - Replace |

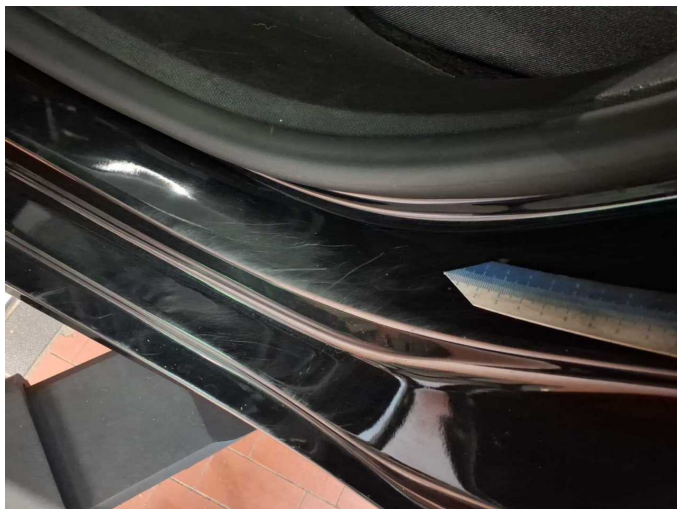
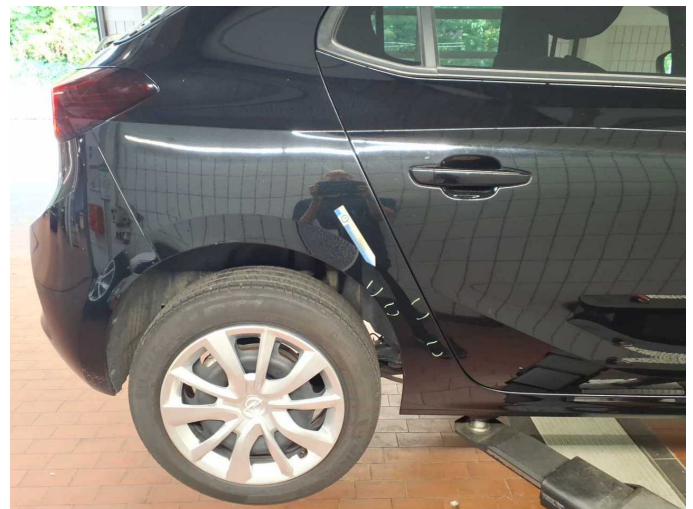
**Damage 8:** Side panel - rear left side: Sill - Scratch(es) - Smart repair

| No. | Component group | Description |
|---|---|---|
| 8 | Side panel - rear left side | Sill - Scratch(es) - Smart repair |

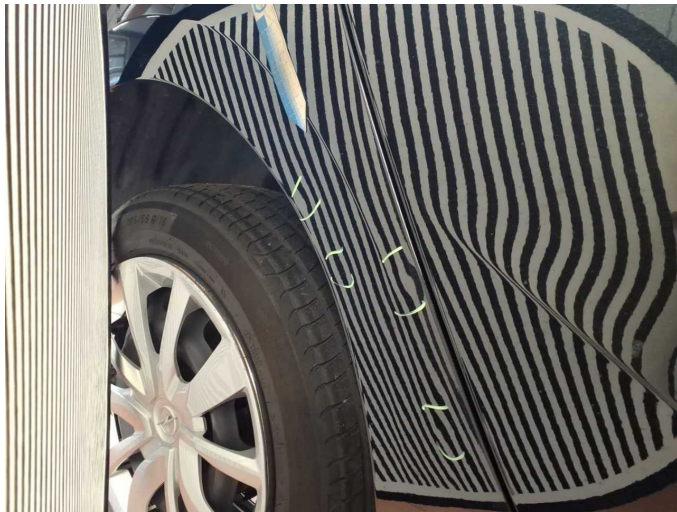
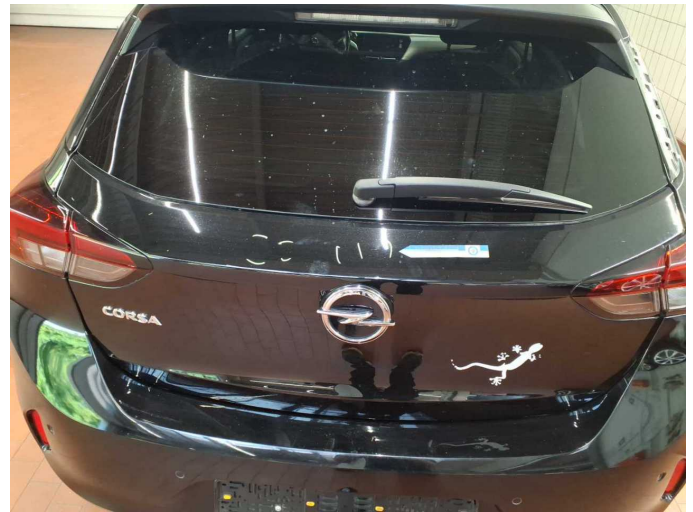
**Damage 9:** Side panel - rear right side: Elbow - dent(s) - Smart repair

| No. | Component group | Description |
|---|---|---|
| 9 | Side panel - rear right side | Elbow - dent(s) - Smart repair |

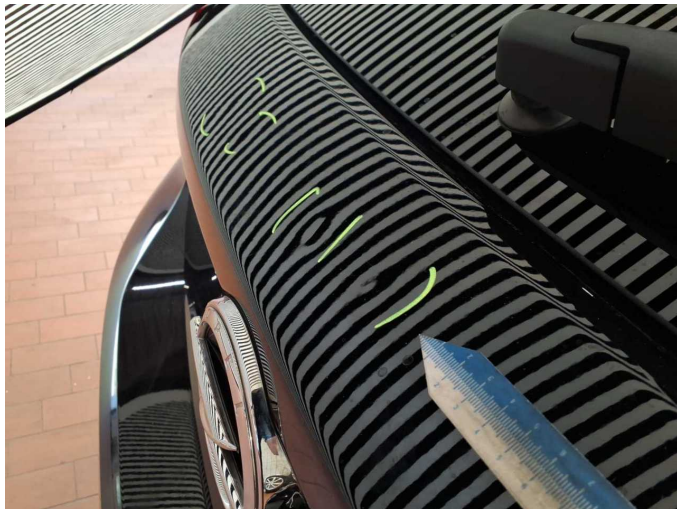
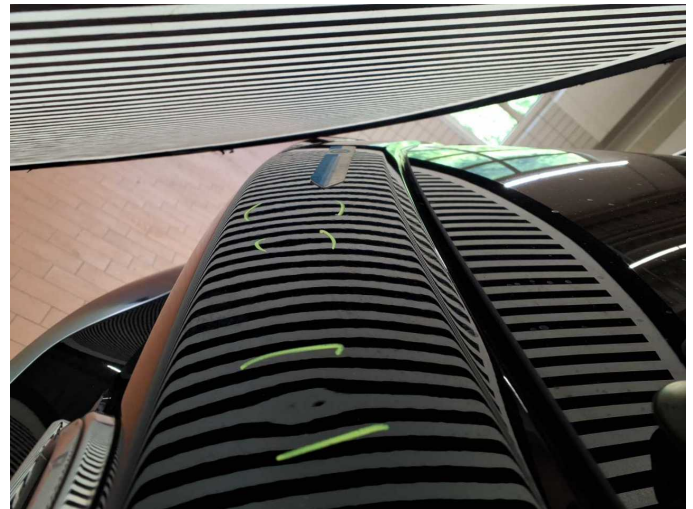
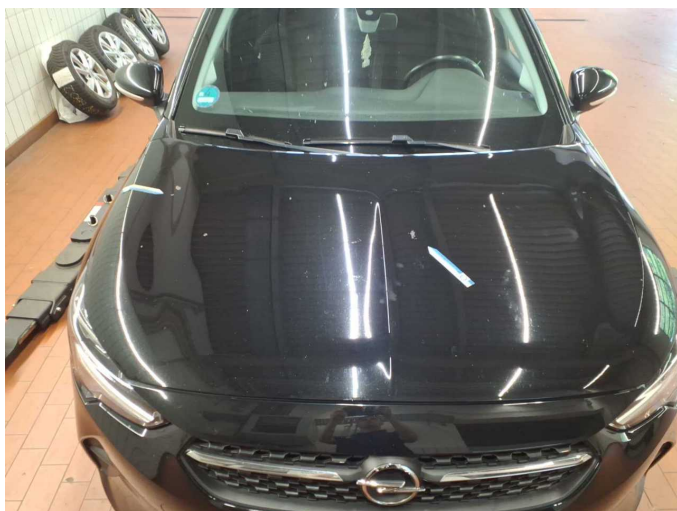
**Damage 10:** Boot lid / rear door: Boot lid - dent(s) - Smart repair

| No. | Component group | Description |
|---|---|---|
| 10 | Boot lid / rear door | Boot lid - dent(s) - Smart repair |

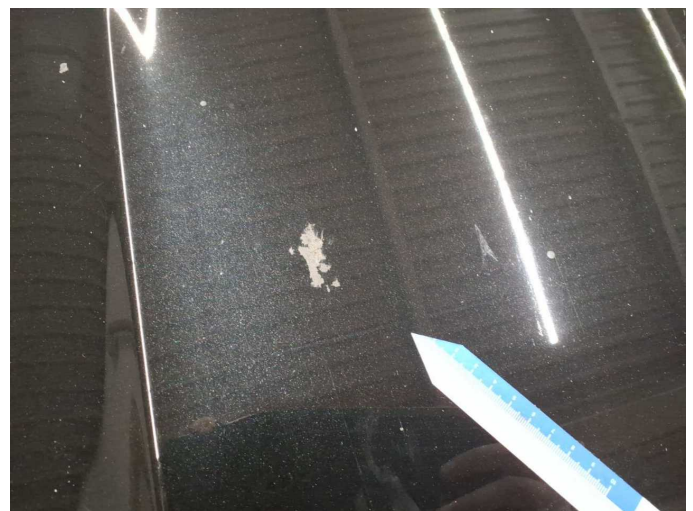
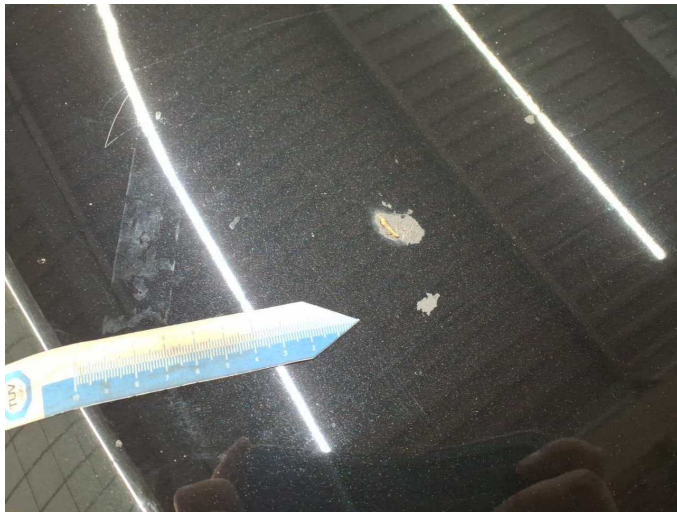
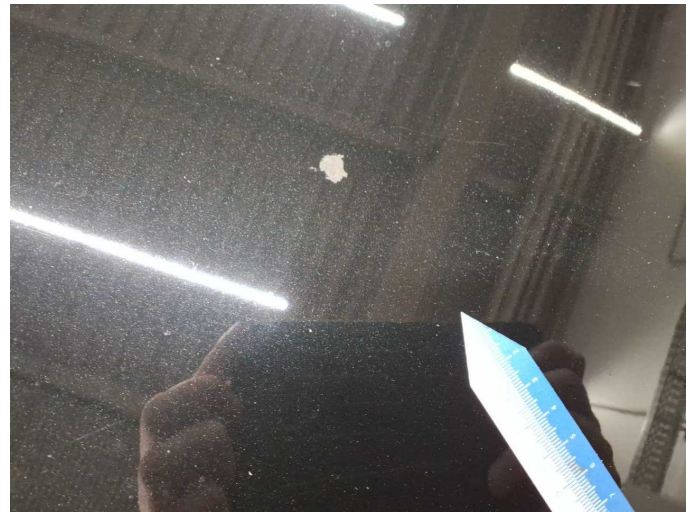
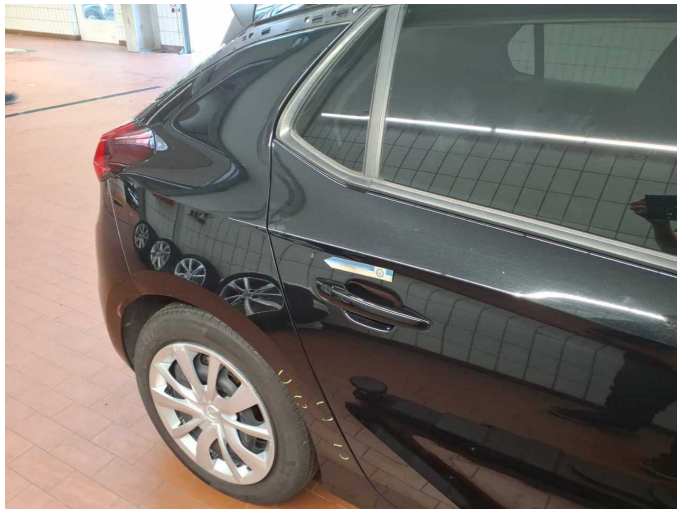
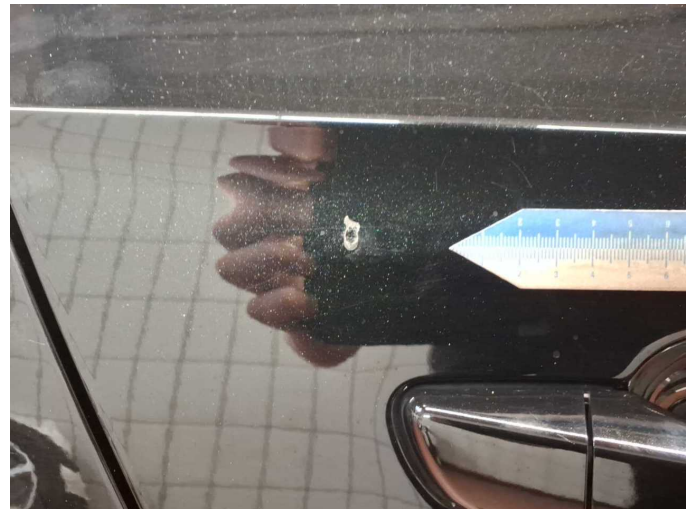
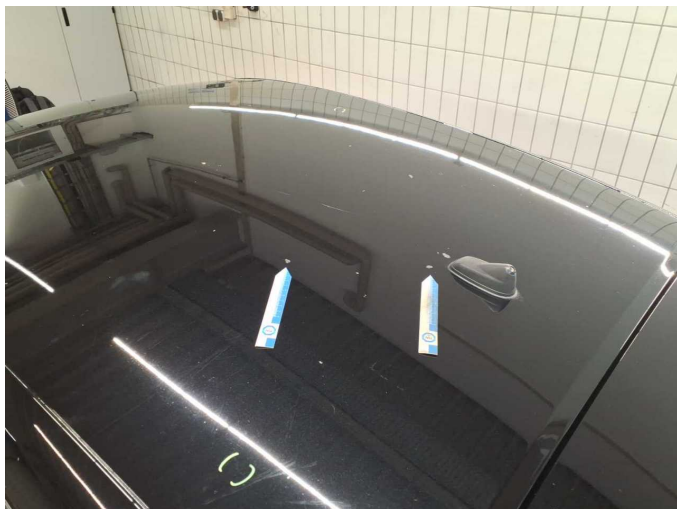
**Damage 11:** Body: Body (Harz) - Soiled - Conditioning

| No. | Component group | Description |
|---|---|---|
| 11 | Body | Body (Harz) - Soiled - Conditioning |

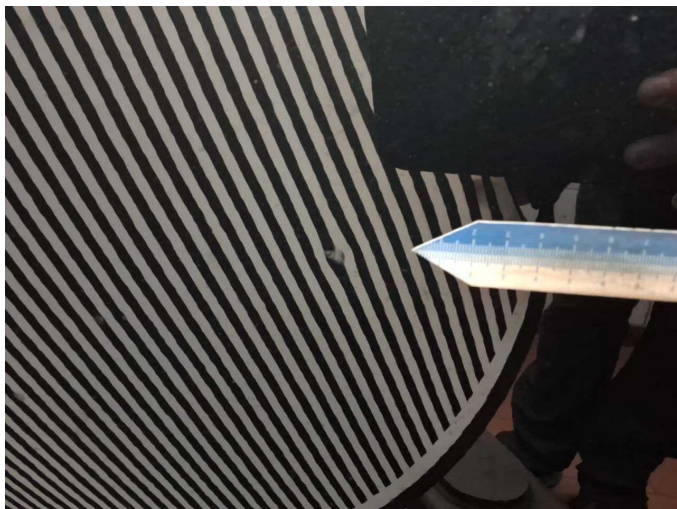
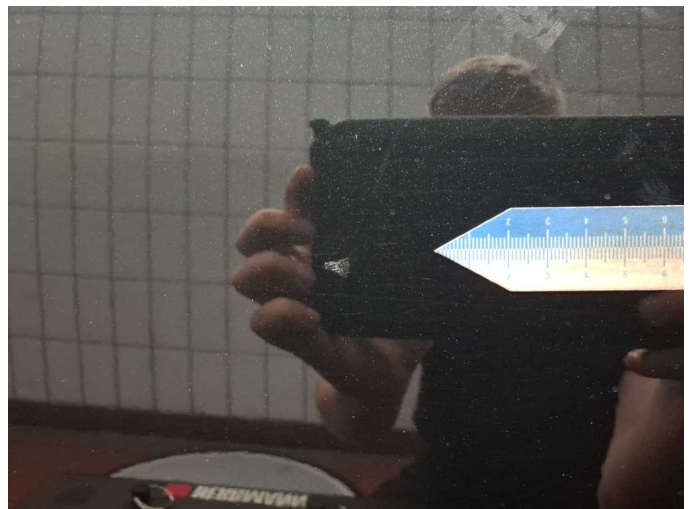
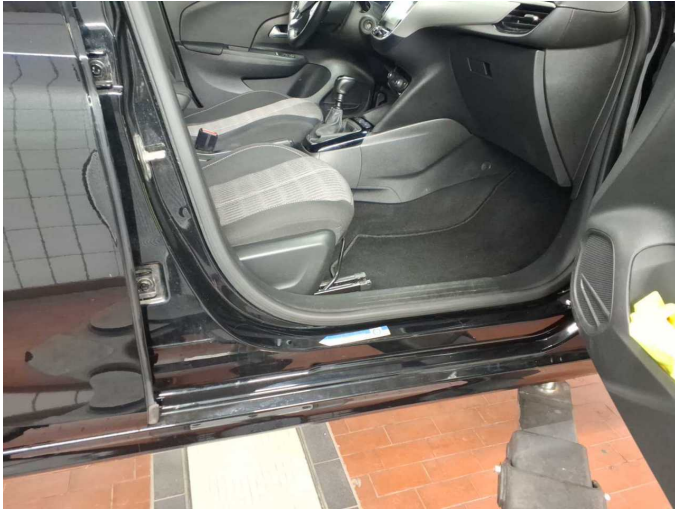
**Damage 12:** Door - front right side: Door - Dent / paintcoat damage - Smart repair

| No. | Component group | Description |
|---|---|---|
| 12 | Door - front right side | Door - Dent / paintcoat damage - Smart repair |

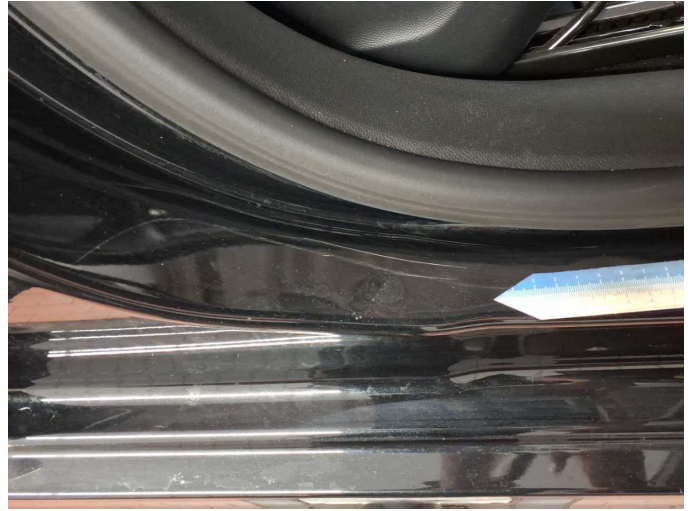
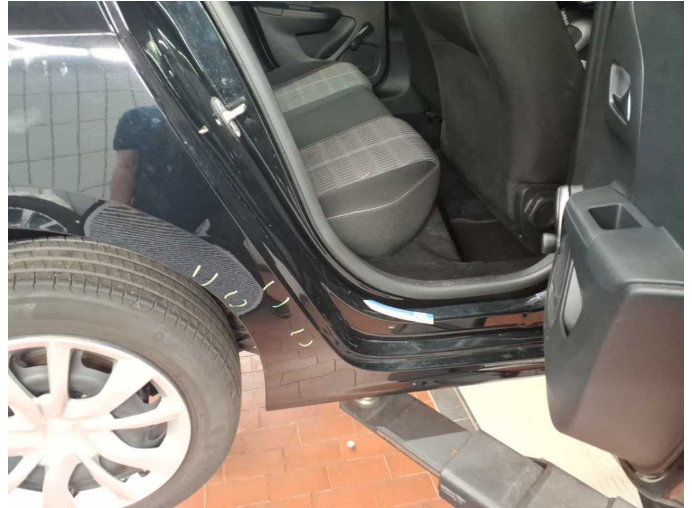
**Damage 13:** Sill - right side: Sill - Dent / paintcoat damage - Smart repair

| No. | Component group | Description |
|---|---|---|
| 13 | Sill - right side | Sill - Dent / paintcoat damage - Smart repair |

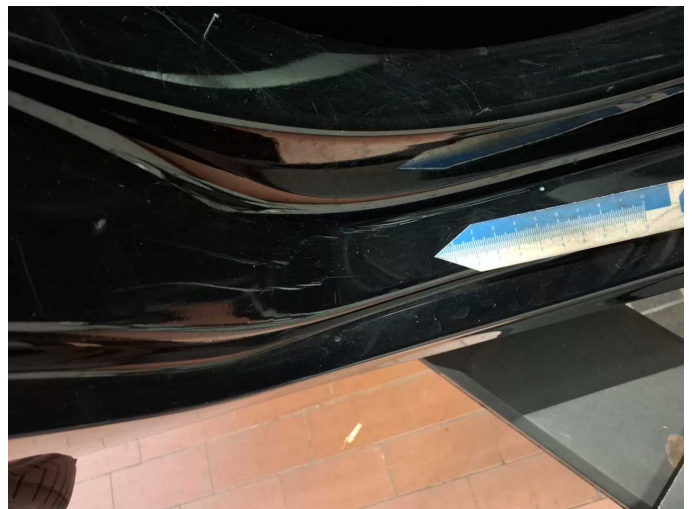
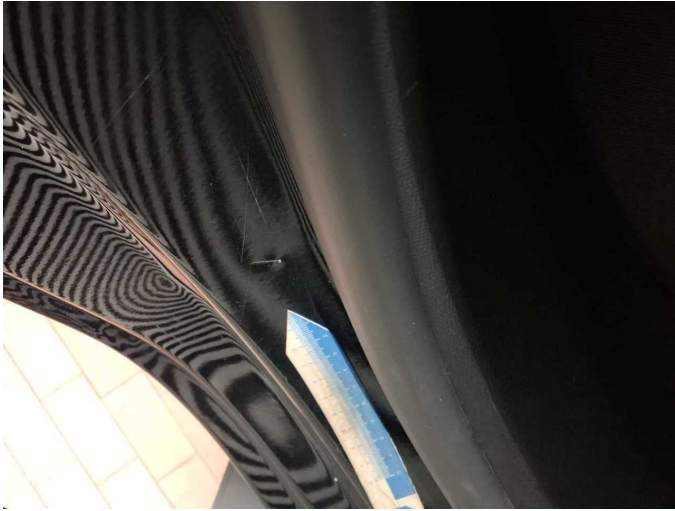
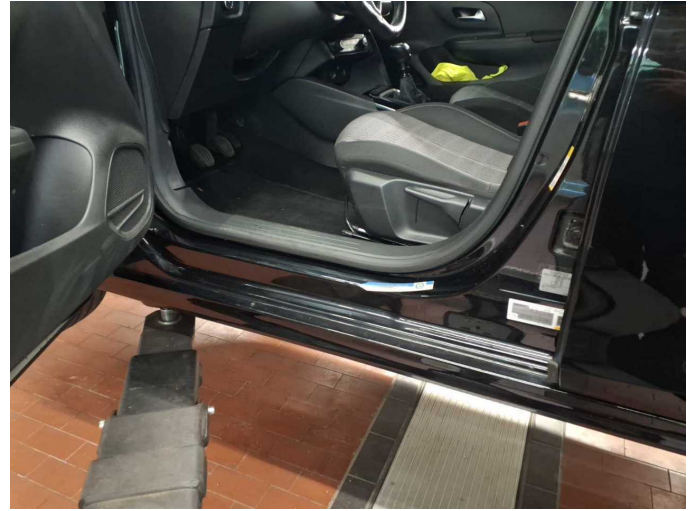
**Damage 14:** Side panel - rear right side: Sill - Dent / paintcoat damage - Smart repair

| No. | Component group | Description |
|---|---|---|
| 14 | Side panel - rear right side | Sill - Dent / paintcoat damage - Smart repair |

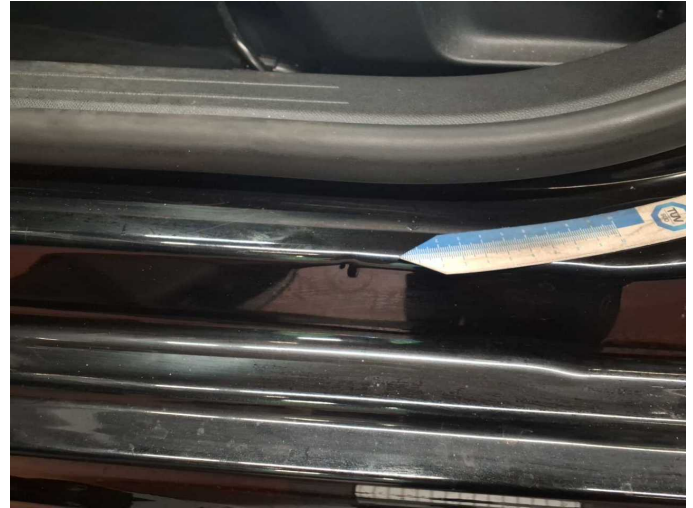
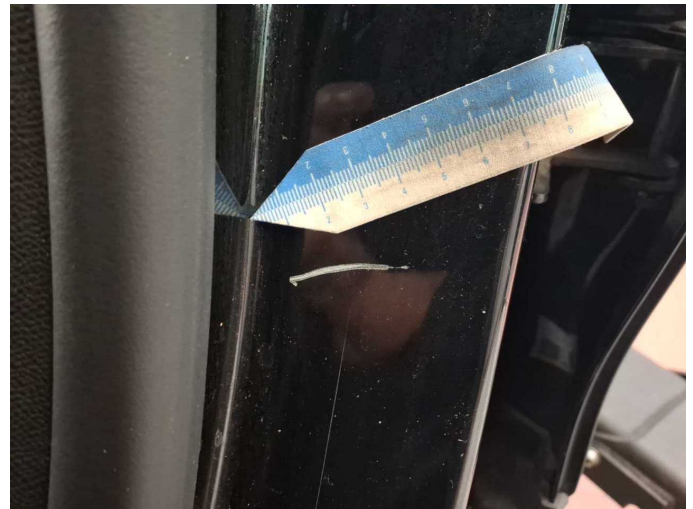
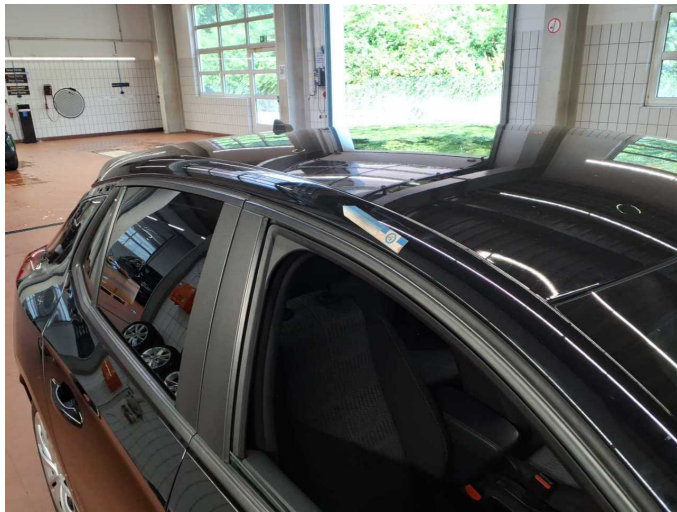
**Damage 15:** Sill - left side: Sill (erhöhter Aufwand; an Kante) - Dent / paintcoat damage - Smart repair

| No. | Component group | Description |
|---|---|---|
| 15 | Sill - left side | Sill (erhöhter Aufwand; an Kante) - Dent / paintcoat damage - Smart repair |

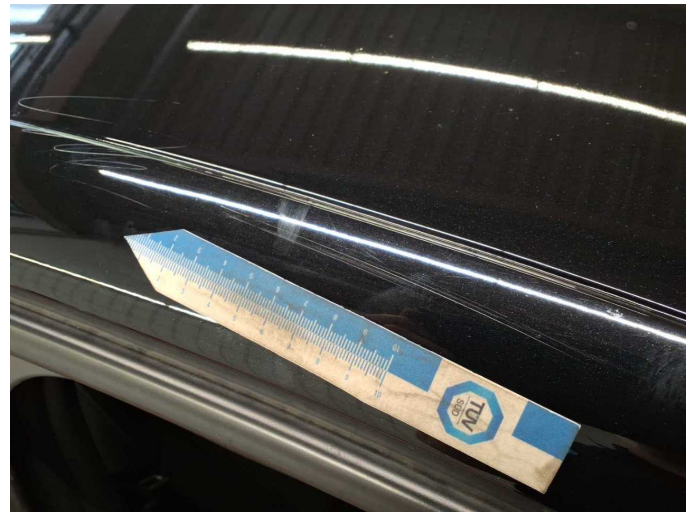
**Damage 16:** Roof: Roof rail - right side - Scratch(es) - Paint

| No. | Component group | Description |
|---|---|---|
| 16 | Roof | Roof rail - right side - Scratch(es) - Paint |

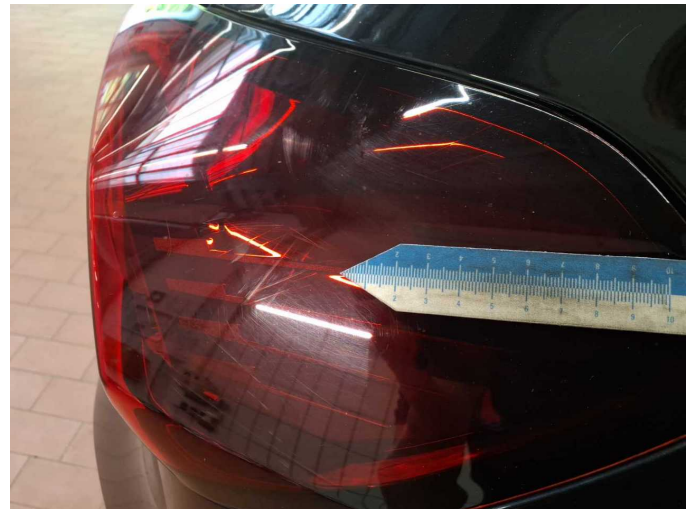
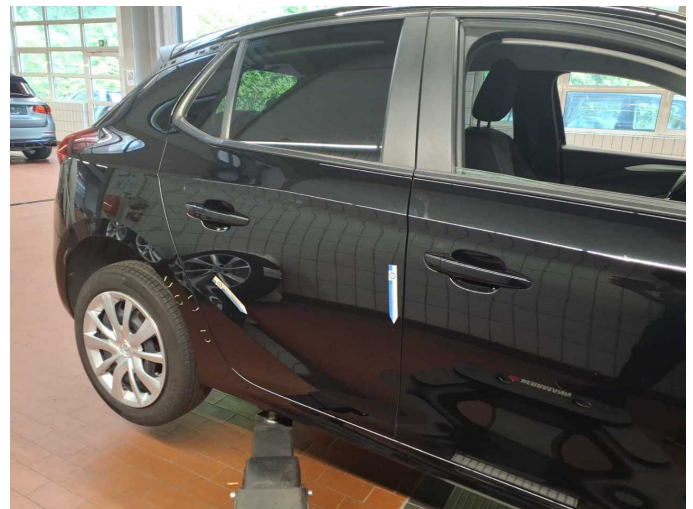
**Damage 17:** Tail light: Tail lamp - right side - Scratch(es) - Replace

| No. | Component group | Description |
|---|---|---|
| 17 | Tail light | Tail lamp - right side - Scratch(es) - Replace |

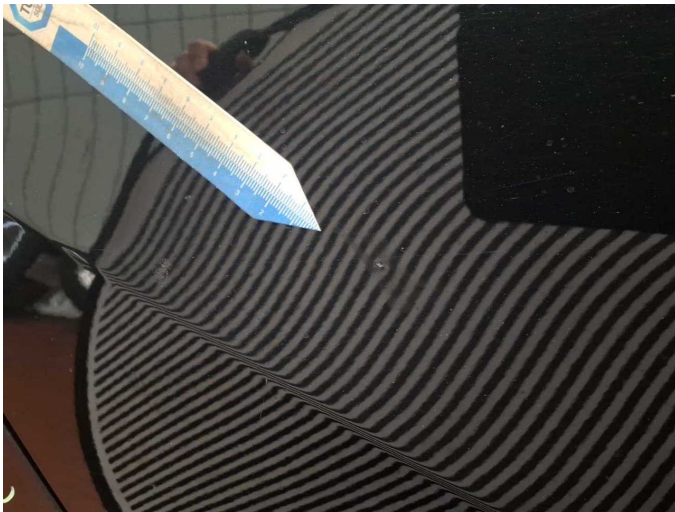
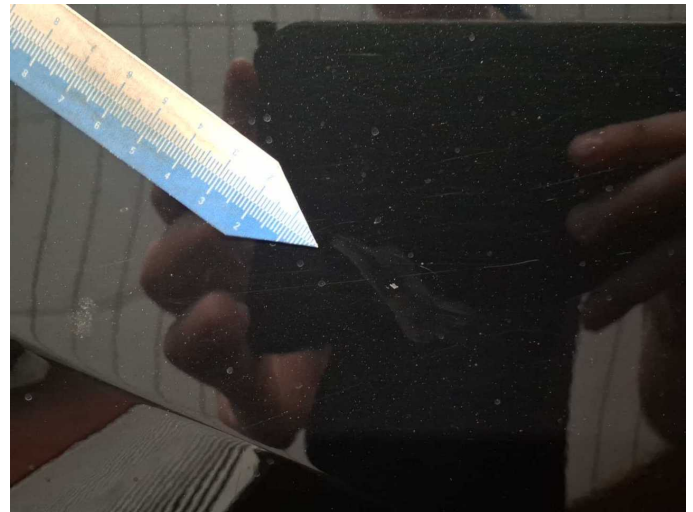
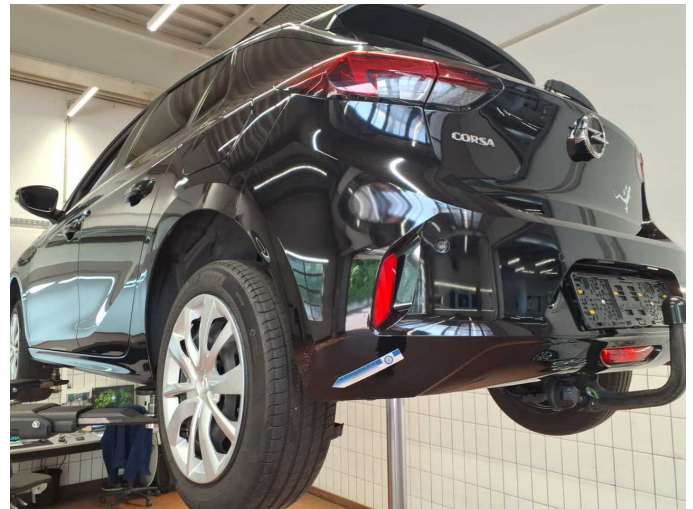
**Damage 18:** Door - rear right side: Door - Dent / paintcoat damage - Repair and paint

| No. | Component group | Description |
|---|---|---|
| 18 | Door - rear right side | Door - Dent / paintcoat damage - Repair and paint |

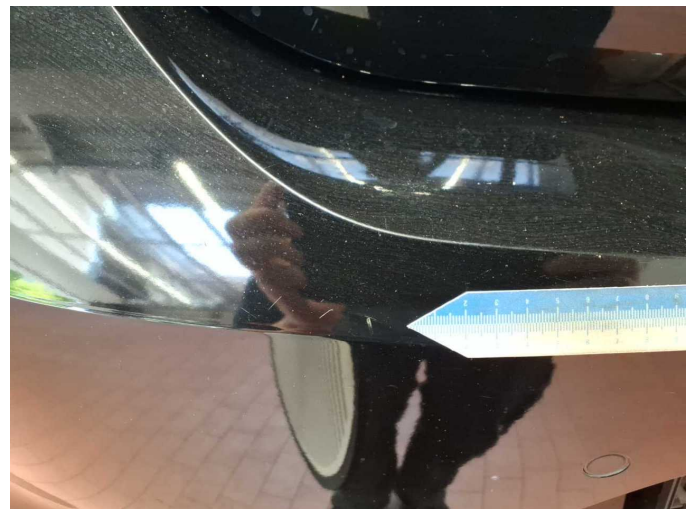
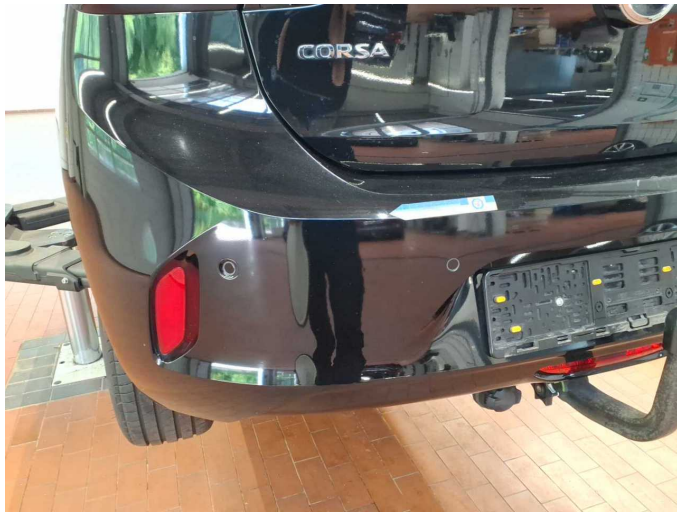
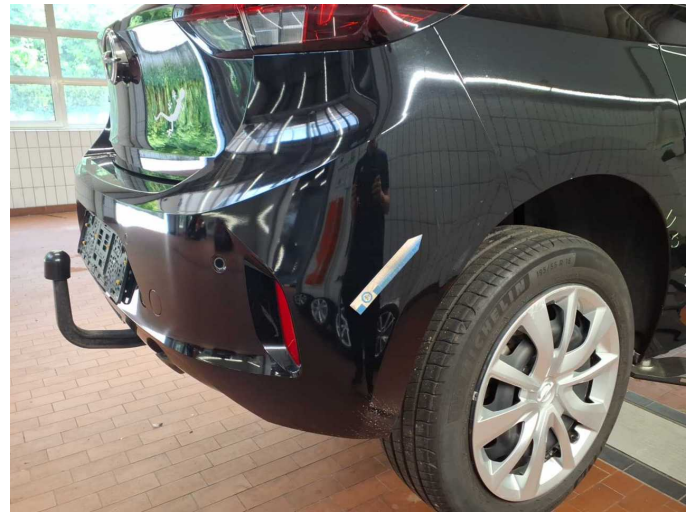
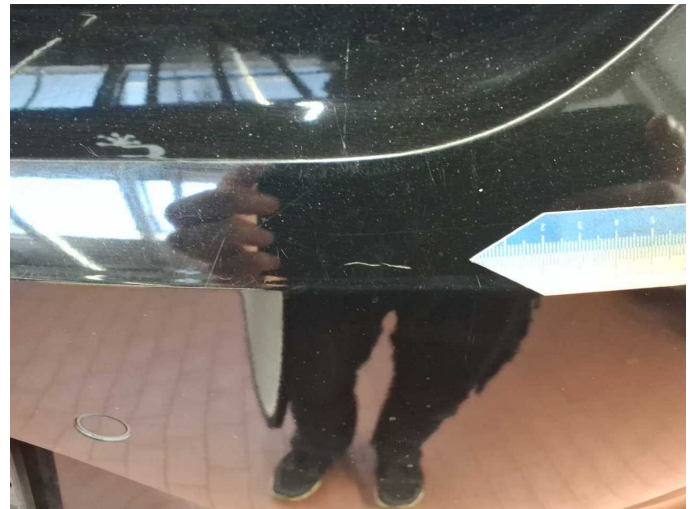
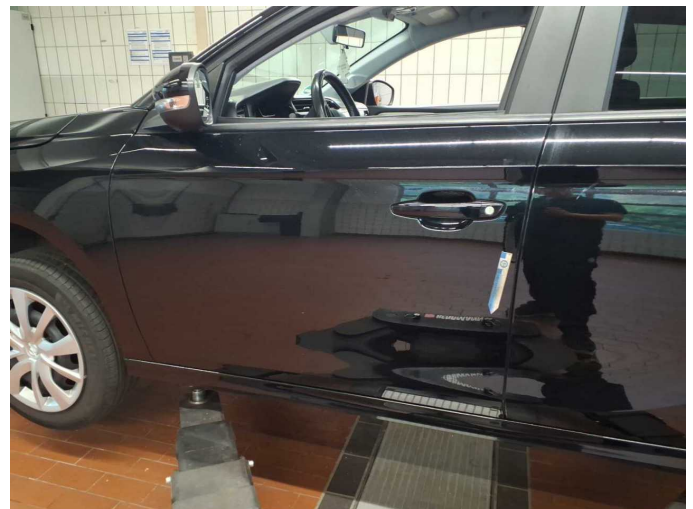
**Damage 19:** Rear bumper: Rear bumper - Scratch(es) - Paint

| No. | Component group | Description |
|---|---|---|
| 19 | Rear bumper | Rear bumper - Scratch(es) - Paint |

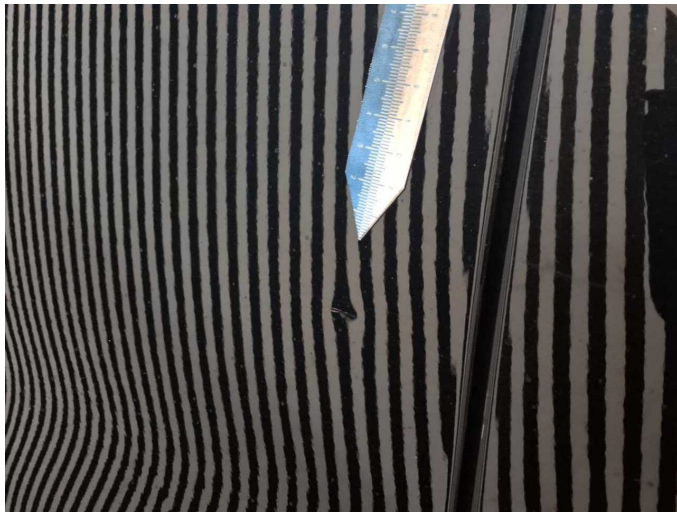
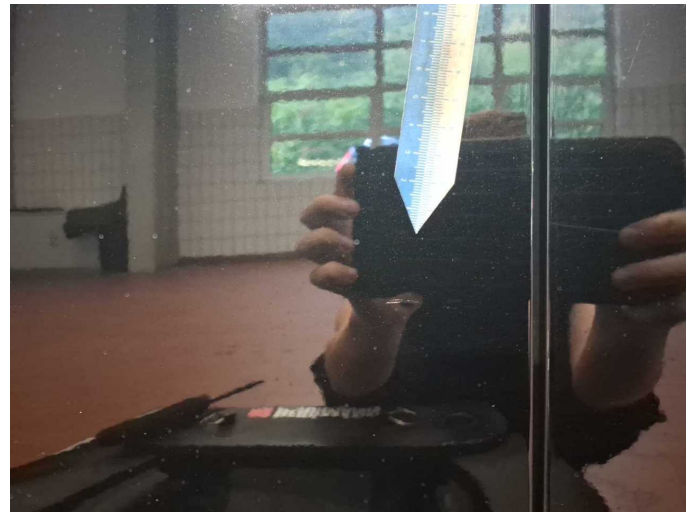
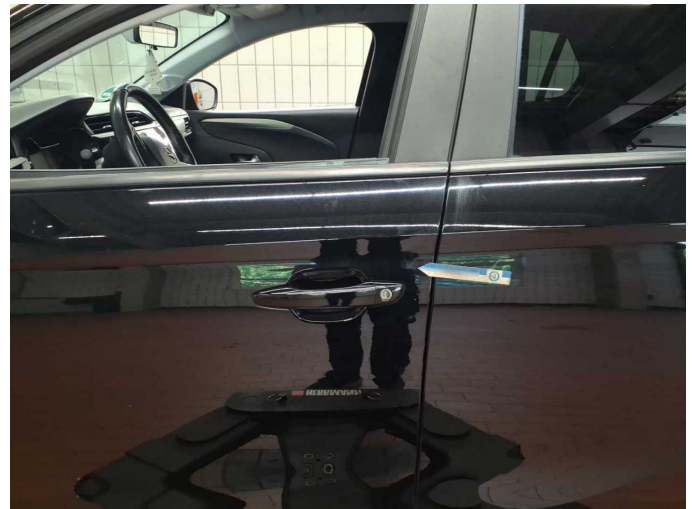
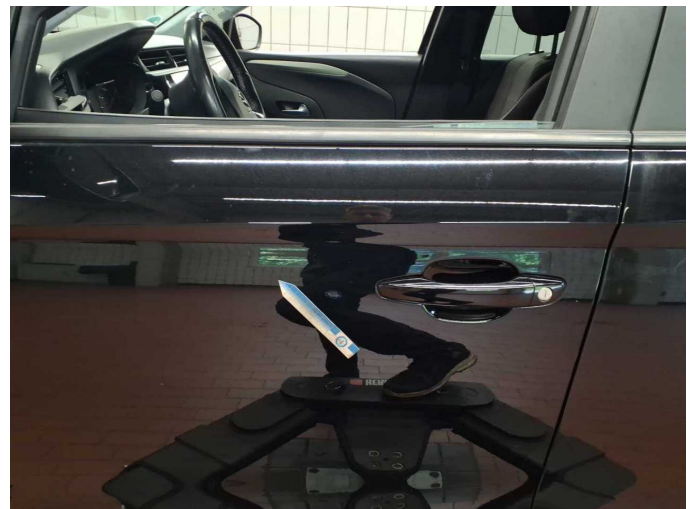
**Damage 20:** Door - front left side: Door - Dent / paintcoat damage - Repair and paint

| No. | Component group | Description |
|---|---|---|
| 20 | Door - front left side | Door - Dent / paintcoat damage - Repair and paint |

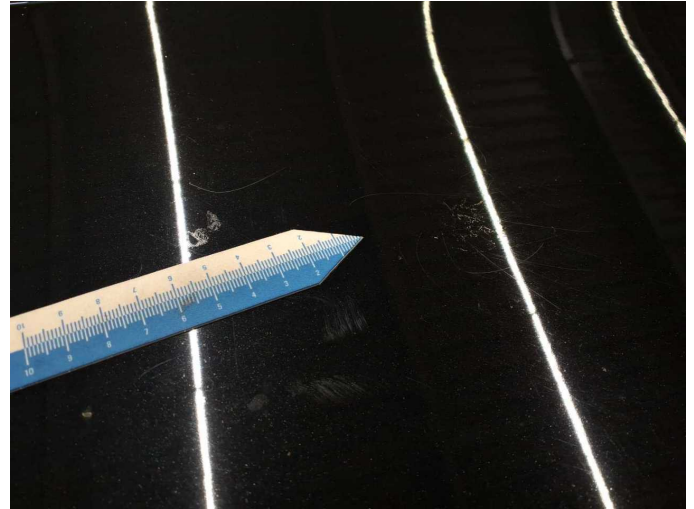
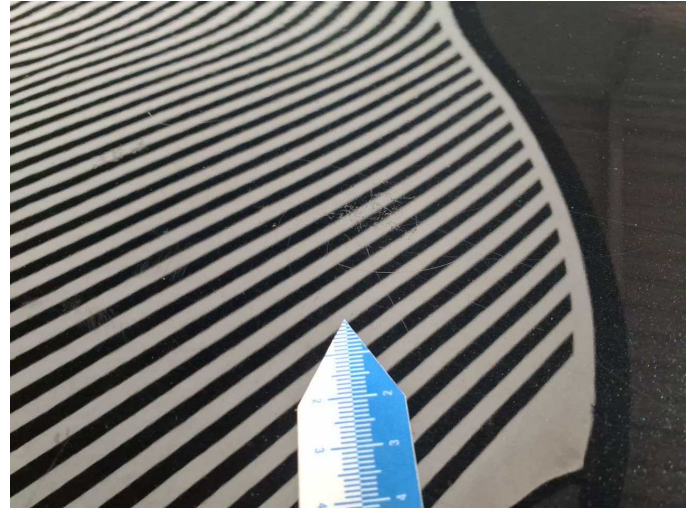
**Damage 21:** Bonnet: Bonnet (Verätzungen + Kratzer) - Paint defect - Repair and paint

| No. | Component group | Description |
|---|---|---|
| 21 | Bonnet | Bonnet (Verätzungen + Kratzer) - Paint defect - Repair and paint |

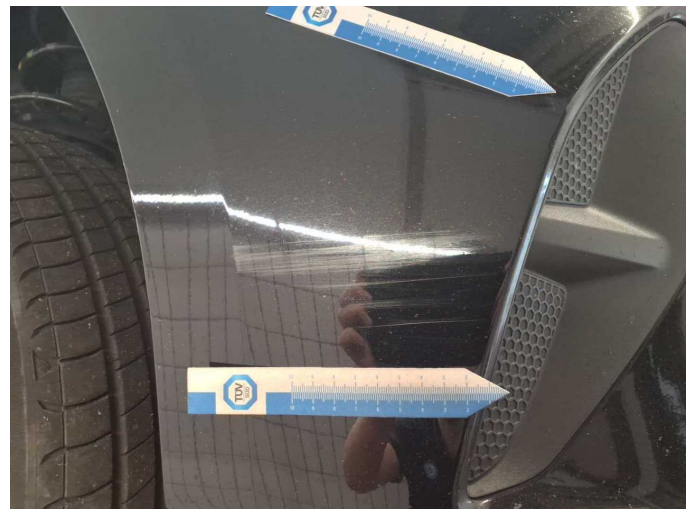
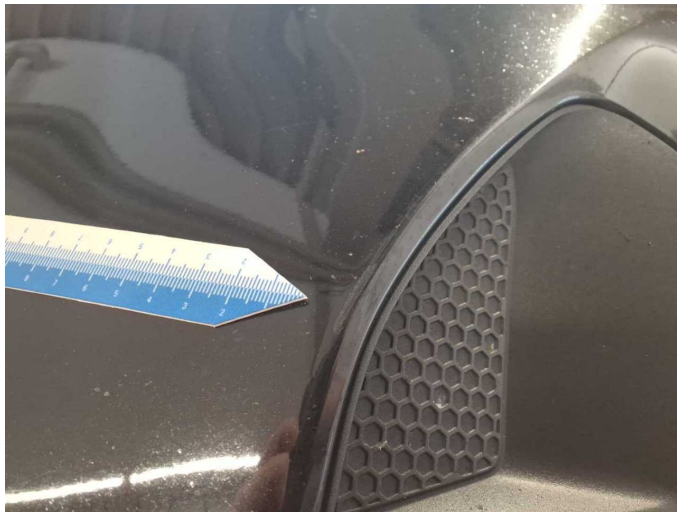
**Damage 22:** Front bumper: Front bumper - Scratched - Paint

| No. | Component group | Description |
|---|---|---|
| 22 | Front bumper | Front bumper - Scratched - Paint |

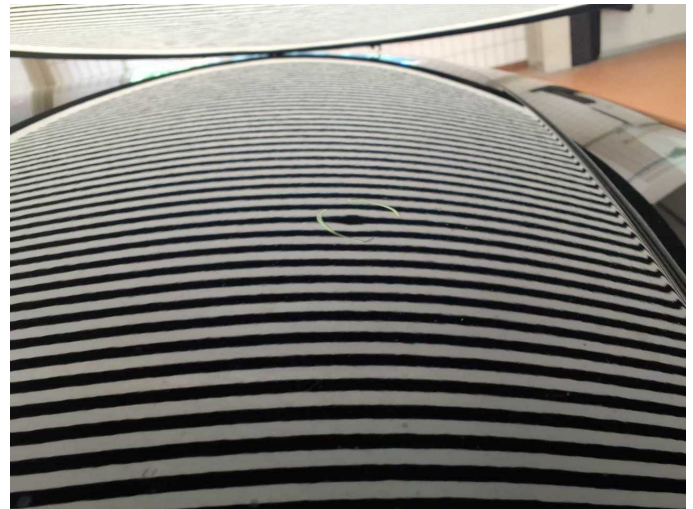
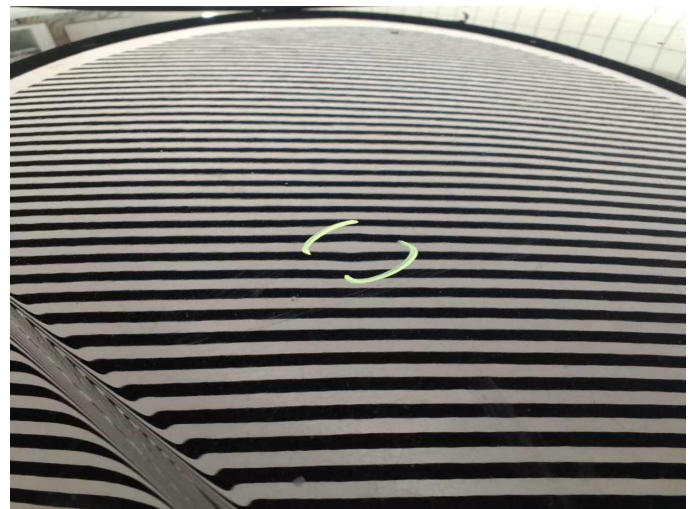
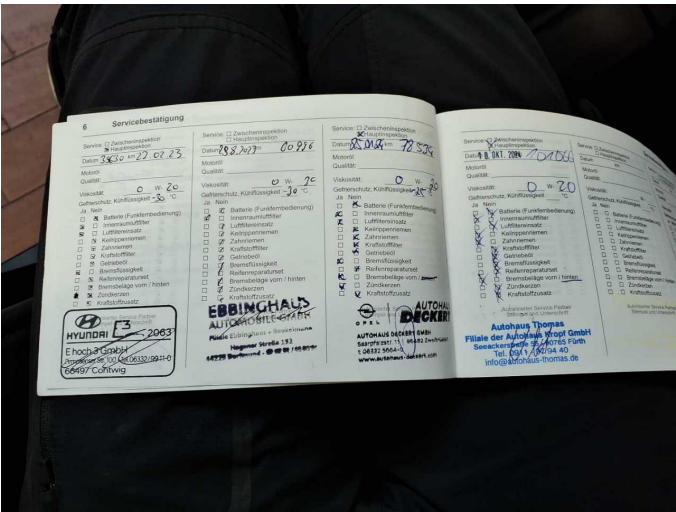
**Damage 23:** Roof: Roof (3 Dellen) - Dent / paintcoat damage - Repair and paint

| No. | Component group | Description |
|---|---|---|
| 23 | Roof | Roof (3 Dellen) - Dent / paintcoat damage - Repair and paint |
