Expertise

Protocol number: 41294593  
Order No. / Reference: 25157262  
Inspection date: 27 Aug 2025

| Manufacturer: Opel | Model: Corsa 1.2 Direct Injection Turbo Start/Stop Edition |

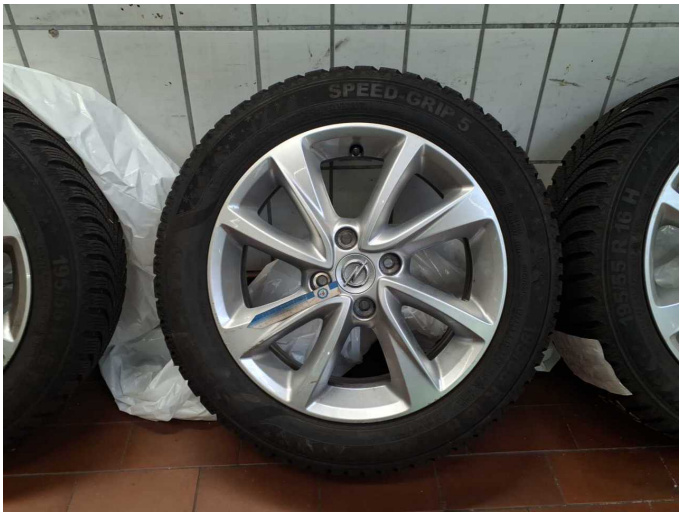
**Wear and tear 3:** 2nd wheel set: 2 alloy rims (Kein Teil der Ausstattung) - Scratched - No deduction
