# OPEL Astra

## Astra 1.7 CDTI Caravan DPF

### Inspection Report Summary

| Customer | BCA Online | Report Number | P20250922104042 |

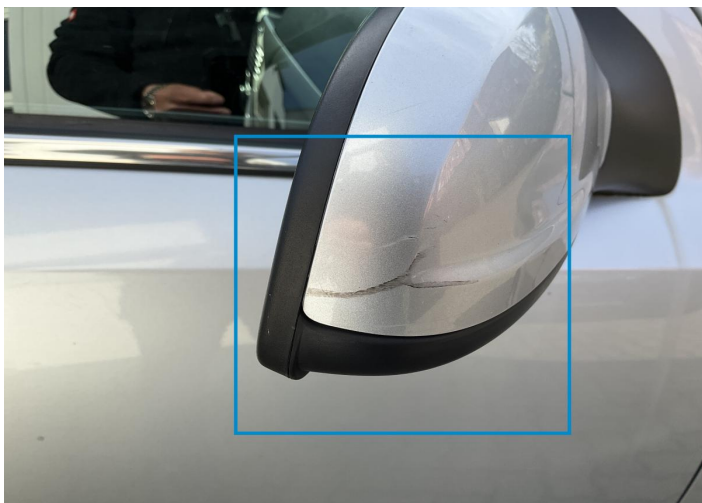
| Component | | Damage | Comments |
|---|---|---|---|
| 3 | Mirror / Front Right | Paint / Scratch / Scuff | |

3. Mirror / Front Right  
Paint / Scratch / Scuff -

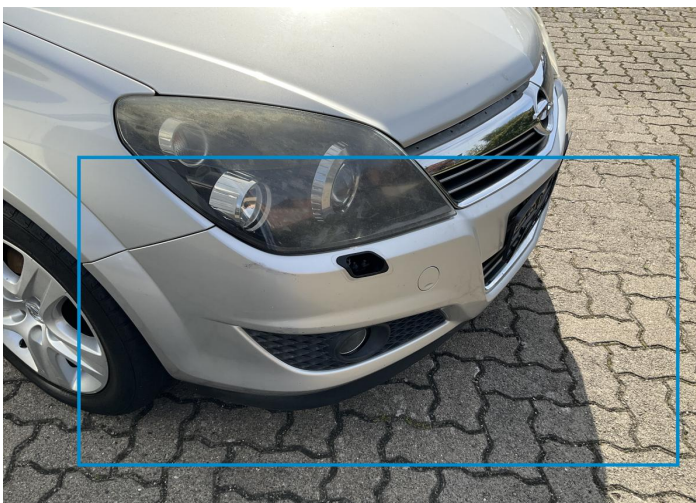
| Component | | Damage | Comments |
|---|---|---|---|
| 4 | Bumper / Front | Paint / Scratch / Scuff | |

4. Bumper / Front  
Paint / Scratch / Scuff -

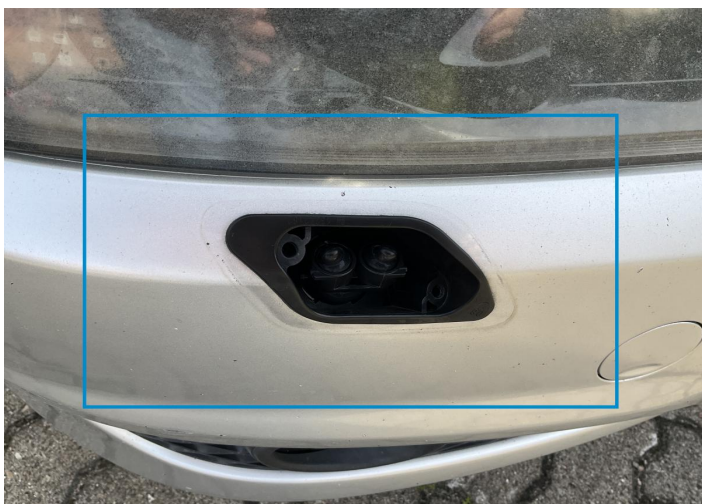
| Component | | Damage | Comments |
|---|---|---|---|
| 5 | Bumper / Front | Missing Part | |

5. Bumper / Front  
Missing Part -

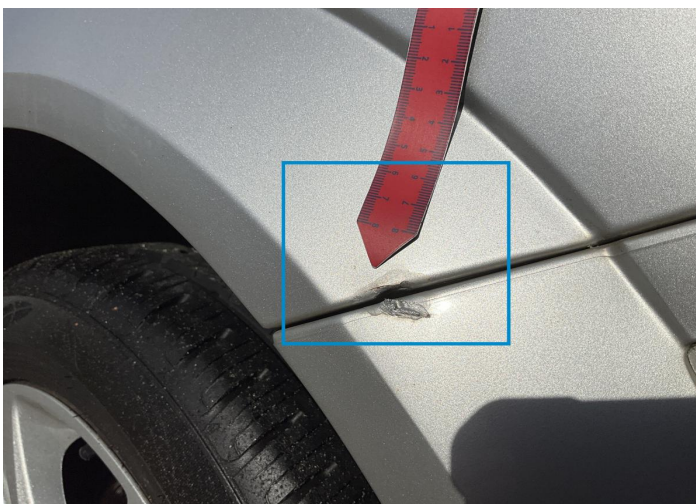
| Component | | Damage | Comments |
|---|---|---|---|
| 6 | Fender / Back Left | Bodywork / Dent / Deformation | |

6. Fender / Back Left  
Bodywork / Dent / Deformation -

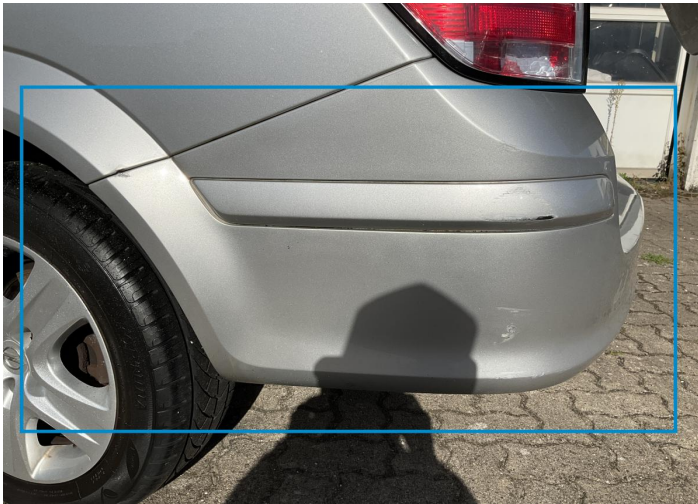
| Component | | Damage | Comments |
|---|---|---|---|
| 7 | Bumper / Back | Paint / Scratch / Scuff | |

7. Bumper / Back  
Paint / Scratch / Scuff -

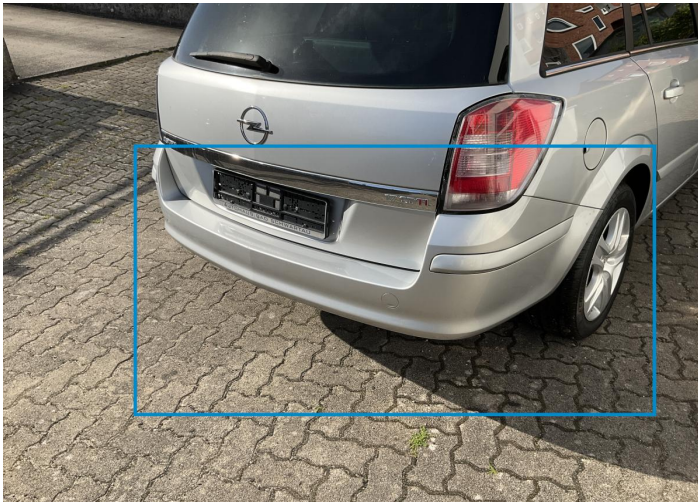
| Component | | Damage | Comments |
|---|---|---|---|
| 9 | Bumper / Back | Paint / Scratch / Scuff | |

9. Bumper / Back  
Paint / Scratch / Scuff -

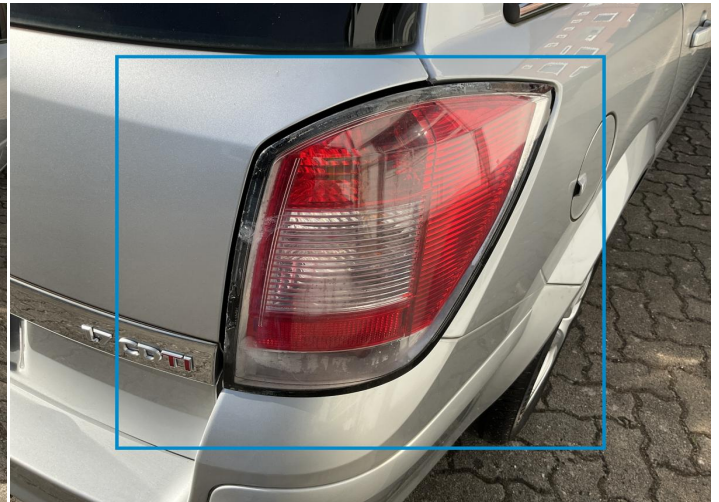
| Component | | Damage | Comments |
|---|---|---|---|
| 10 | Back Light / Right | Paint / Chemical Damage | |

10. Back Light / Right  
Paint / Chemical Damage -
