Expertise

Protocol number: 41690119
Order No. / Reference: 25210542
Inspection date: 25 Sept 2025

Manufacturer: Opel	Model: Grandland 1.5 D Automatik Business Elegance
VIN: W0VZCYHZ1N6828973

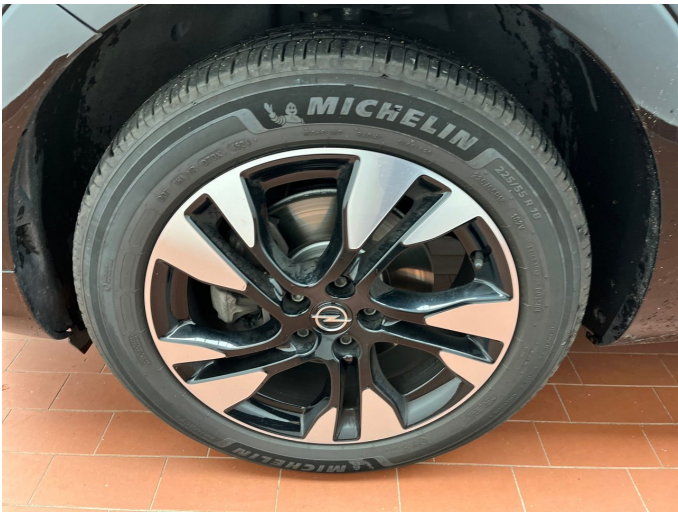
#	Tyre size	Type of tyre	Manufacturer	Tread depth
1)	225/55 R18 102V	Summer tyres on Light alloy	Michelin	6mm / 6mm
2)	225/55 R18 102V	Summer tyres on Light alloy	Michelin	6mm / 6mm

Figure 12: Mounted tyres

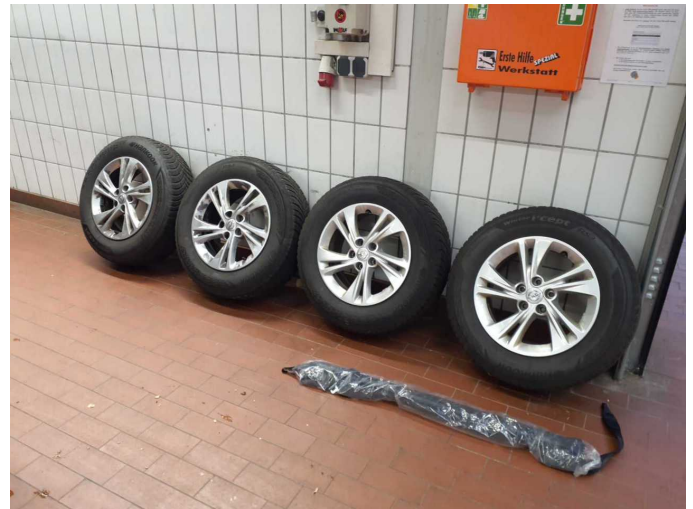
#	Tyre size	Type of tyre	Manufacturer	Tread depth
1)	215/70 R16 100T	Winter tyres on Light alloy	Hankook	4mm / 4mm
2)	215/70 R16 100T	Winter tyres on Light alloy	Hankook	4mm / 4mm

Figure 16: Additional tyres

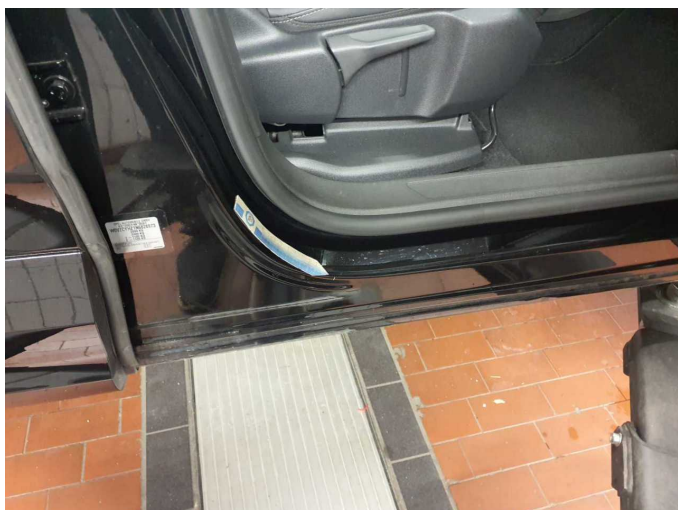
No.	Component group	Description
1	Sill - right side	Sill - Scratch(es) - Smart repair
2	Side panel - rear right side	Sill - Scratch(es) - Smart repair
3	Boot lid / rear door	Boot lid - Scratch(es) - Smart repair
4	Side panel - rear right side	Side panel - dent(s) - Repair and paint

Damage 1: Sill - right side: Sill - Scratch(es) - Smart repair

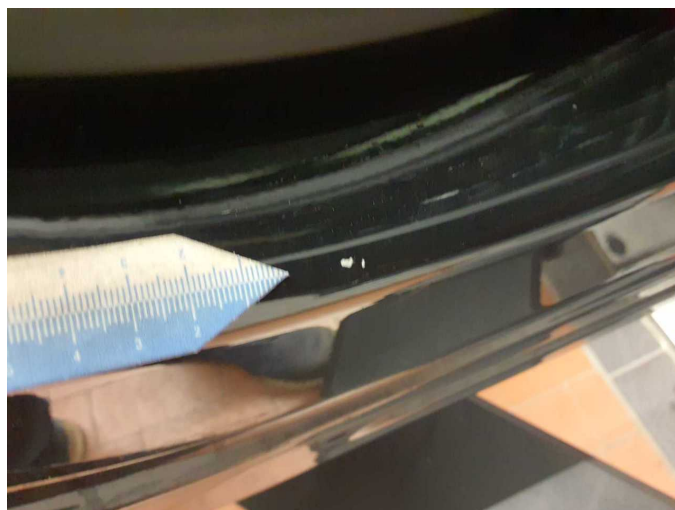
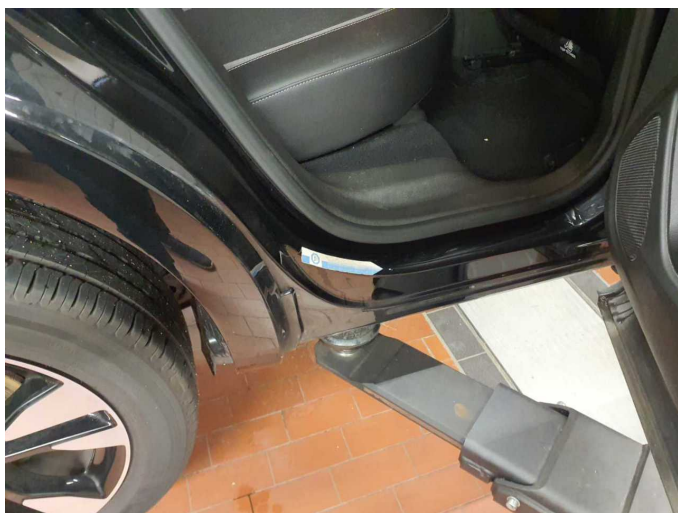
Damage 2: Side panel - rear right side: Sill - Scratch(es) - Smart repair
