Expertise

Protocol number: 41663030  
Order No. / Reference: 25233669  
Inspection date: 22 Sept 2025

Manufacturer: Opel

Model: Insignia Sports Tourer 1.5 Diesel Elegance

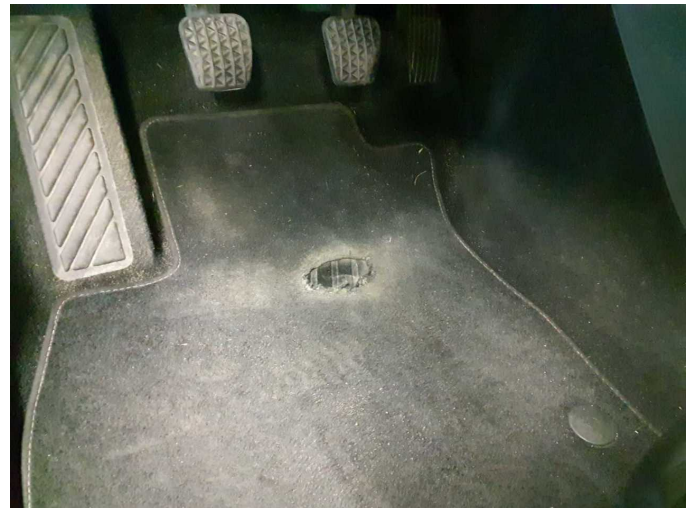
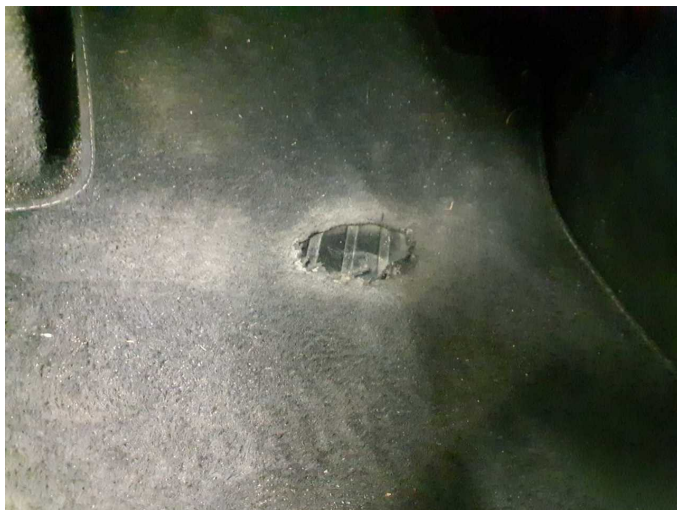
**Damage 1:** Trim / covers: Floor mats (Vorne links) - Holes - Replace

| No. | Component group | Description |
|---|---|---|
| 1 | Trim / covers | Floor mats (Vorne links) - Holes - Replace |

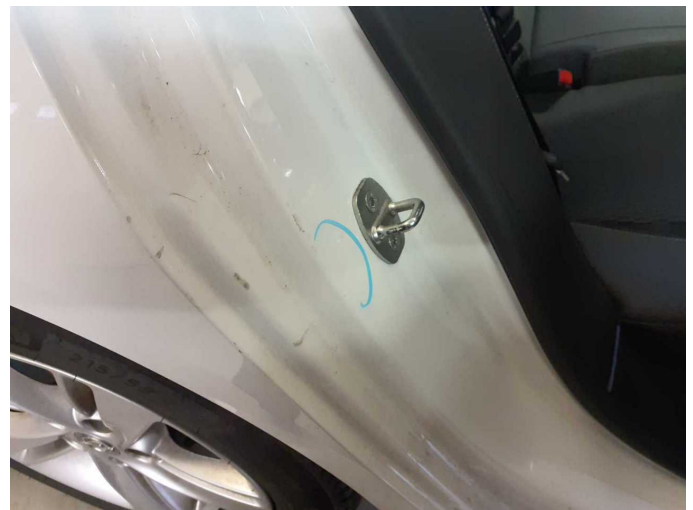
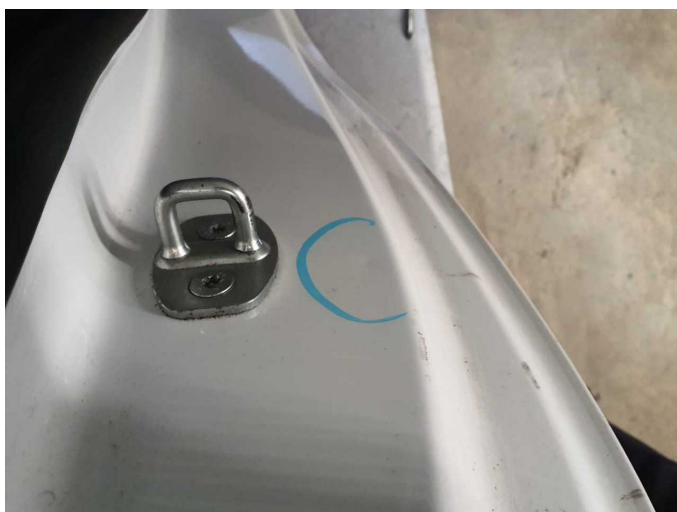
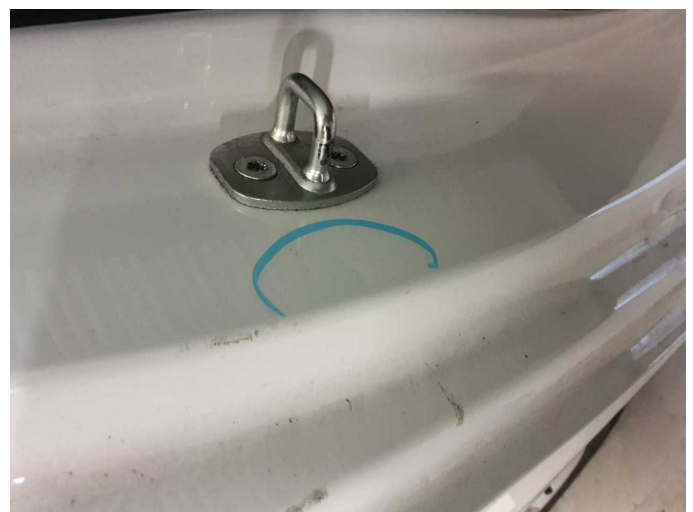
**Damage 2:** Side panel - rear right side: Sill ((Keine Kratzer nur Dreck)) - dent(s) - Smart repair

| No. | Component group | Description |
|---|---|---|
| 2 | Side panel - rear right side | Sill ((Keine Kratzer nur Dreck)) - dent(s) - Smart repair |

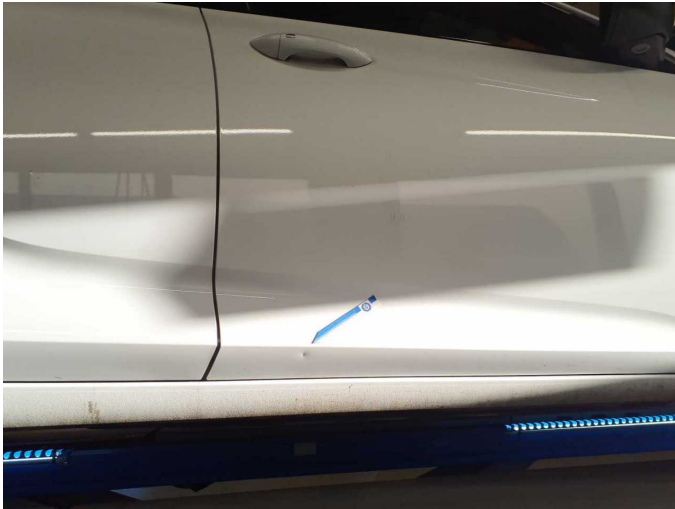
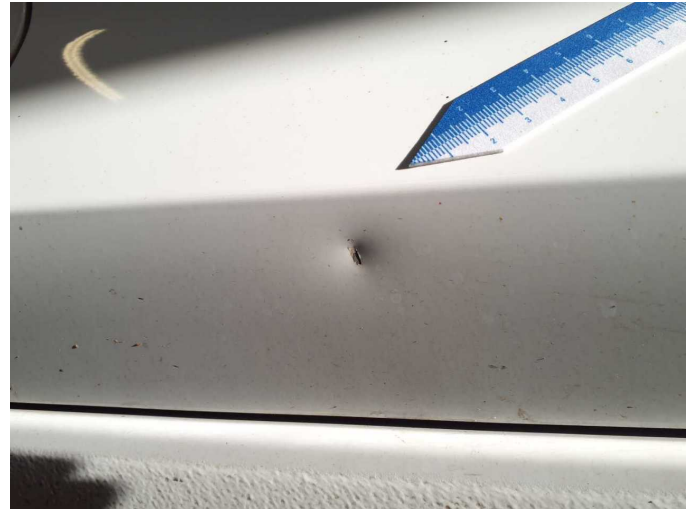
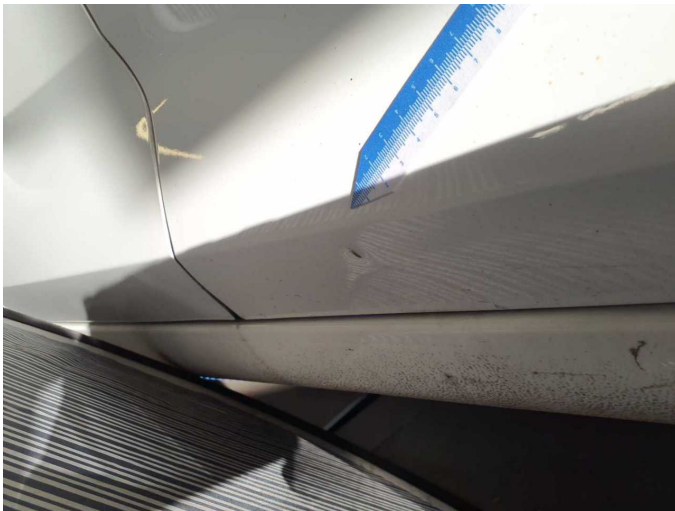
**Damage 3:** Door - front right side: Door - Dent / paintcoat damage - Smart repair

| No. | Component group | Description |
|---|---|---|
| 3 | Door - front right side | Door - Dent / paintcoat damage - Smart repair |

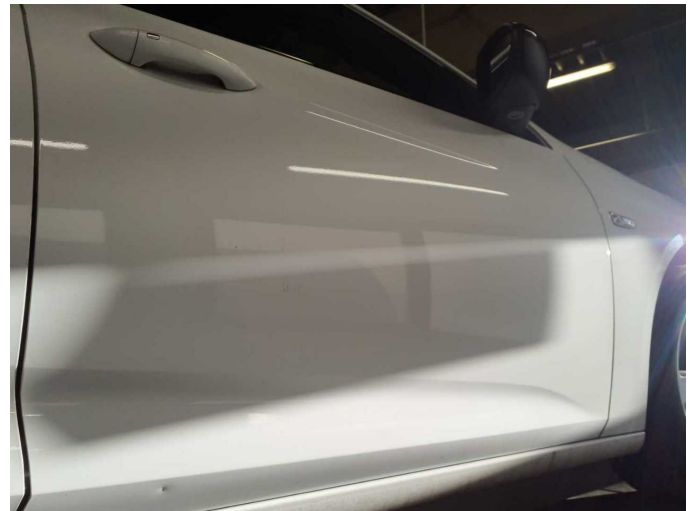
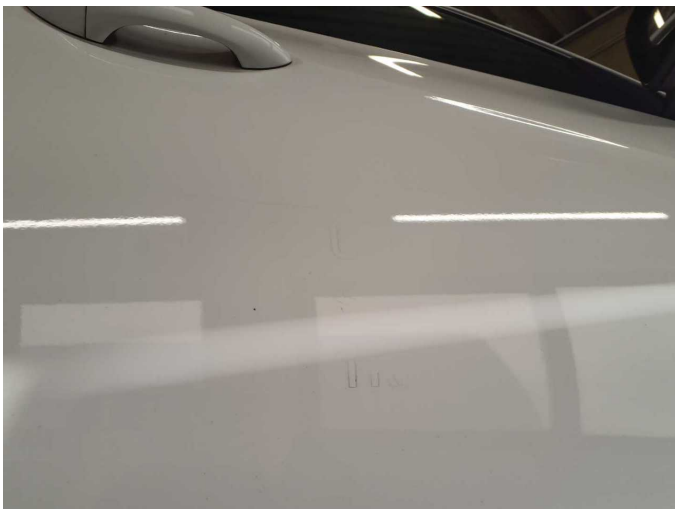
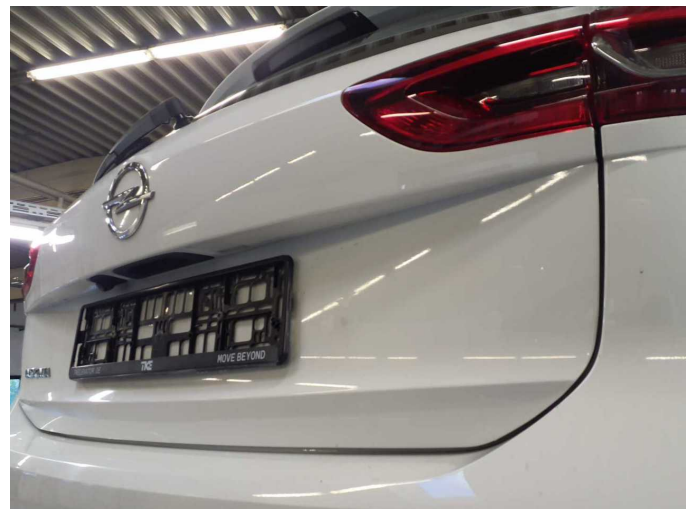
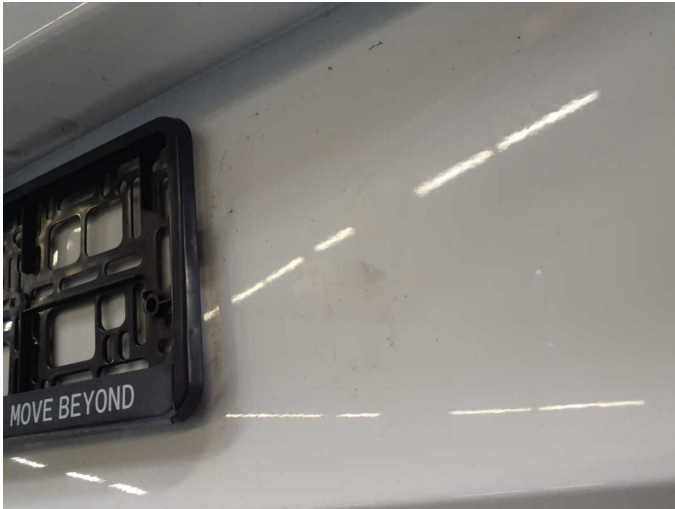
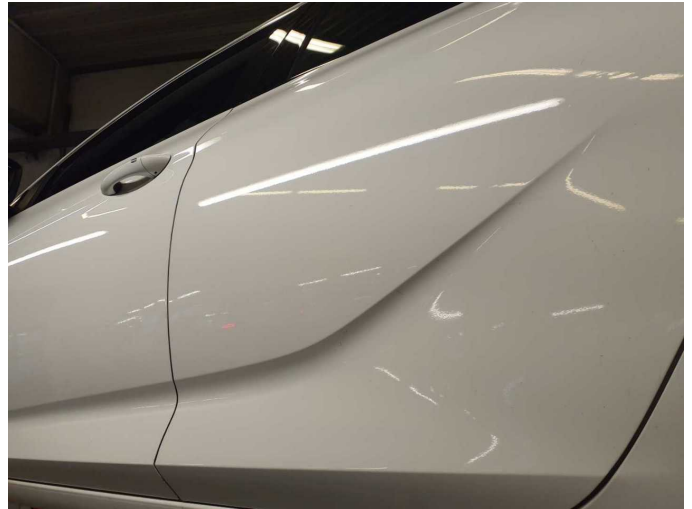
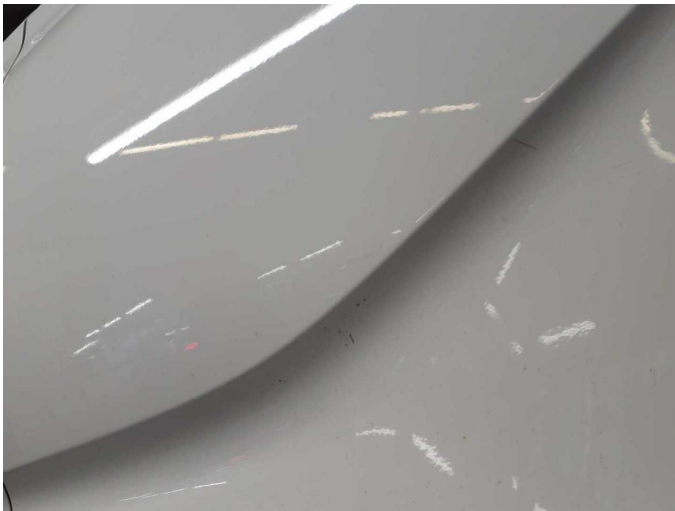
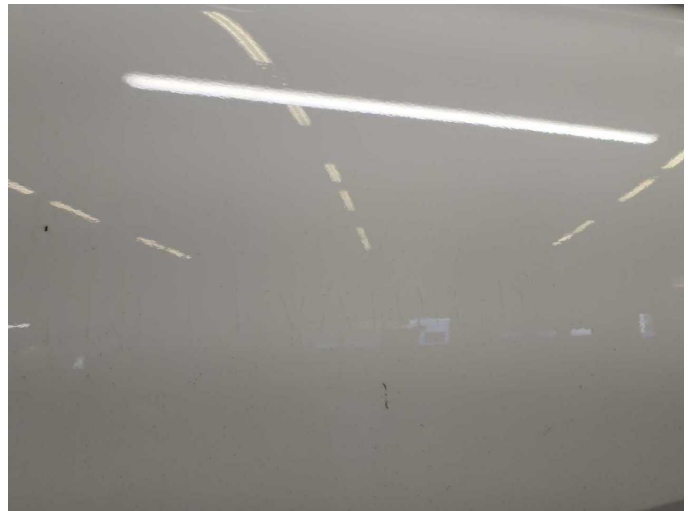
**Damage 4:** Body: Body (Umrandungen-Schriftzug) - Glued / labelled - De-glue / neutralise

| No. | Component group | Description |
|---|---|---|
| 4 | Body | Body (Umrandungen-Schriftzug) - Glued / labelled - De-glue / neutralise |

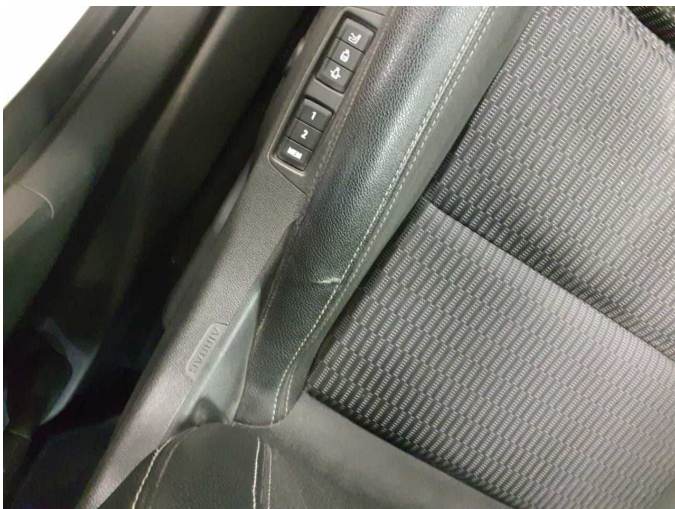
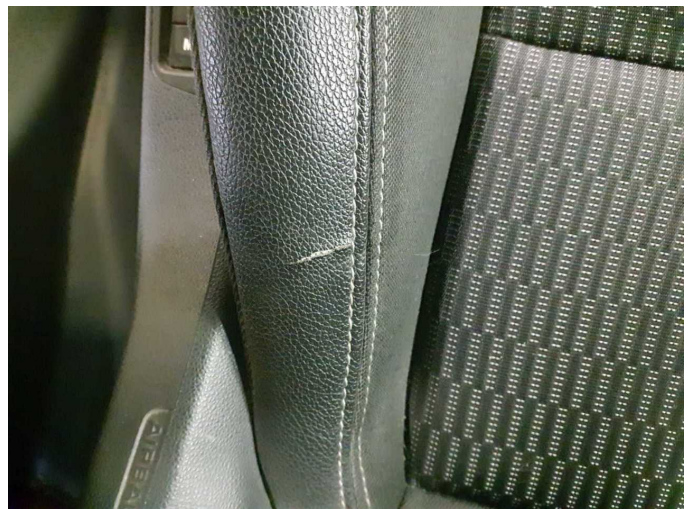
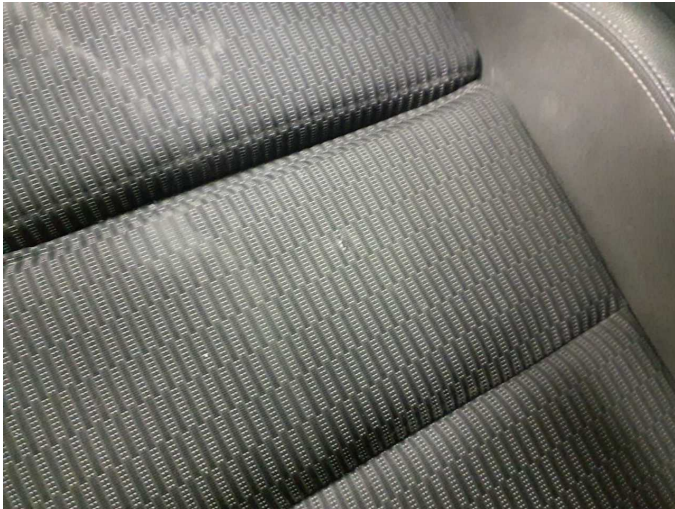
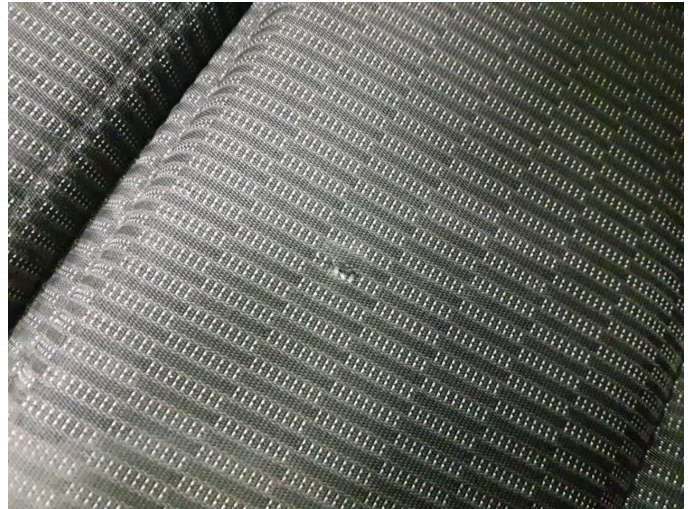
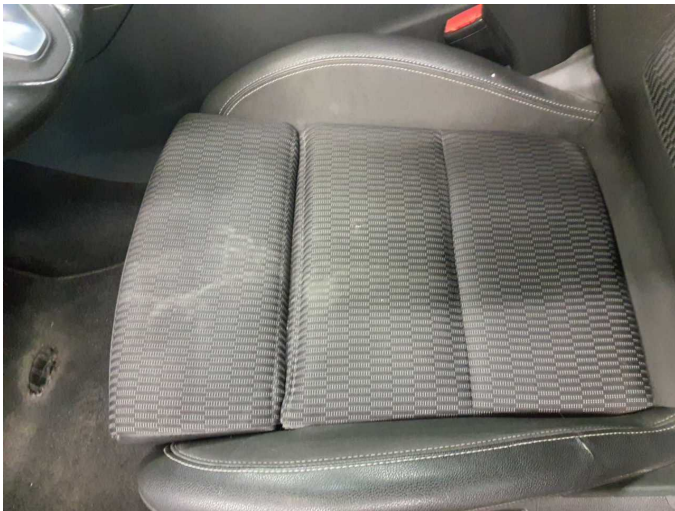
**Damage 5:** Seat - front: Seat cover - left side (+verschmutzt) - Holes - Smart repair

| No. | Component group | Description |
|---|---|---|
| 5 | Seat - front | Seat cover - left side (+verschmutzt) - Holes - Smart repair |

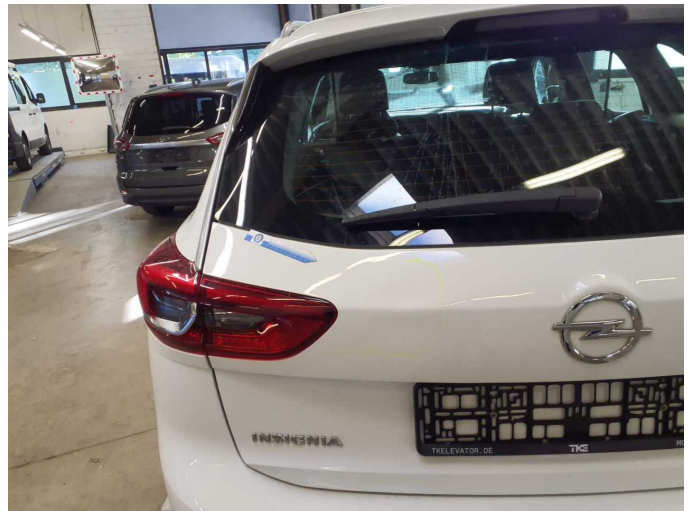
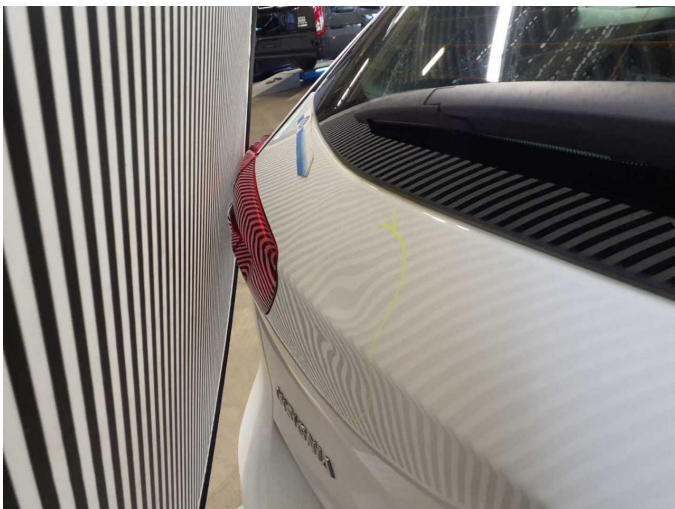
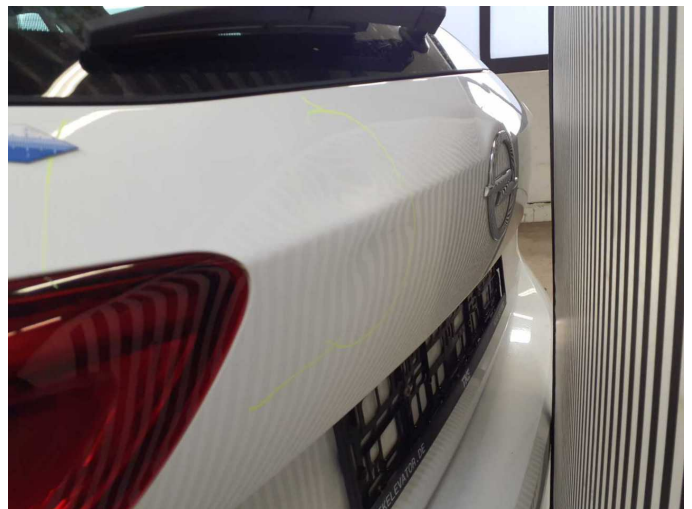
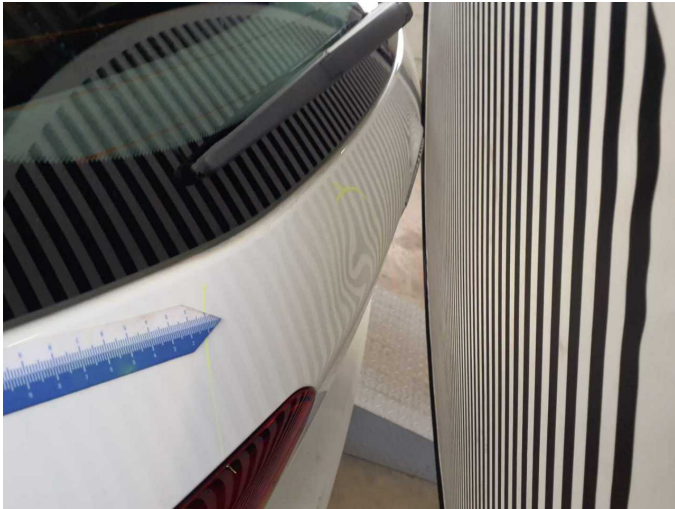
**Damage 6:** Boot lid / rear door: Boot lid - Deformed - Repair and paint

| No. | Component group | Description |
|---|---|---|
| 6 | Boot lid / rear door | Boot lid - Deformed - Repair and paint |

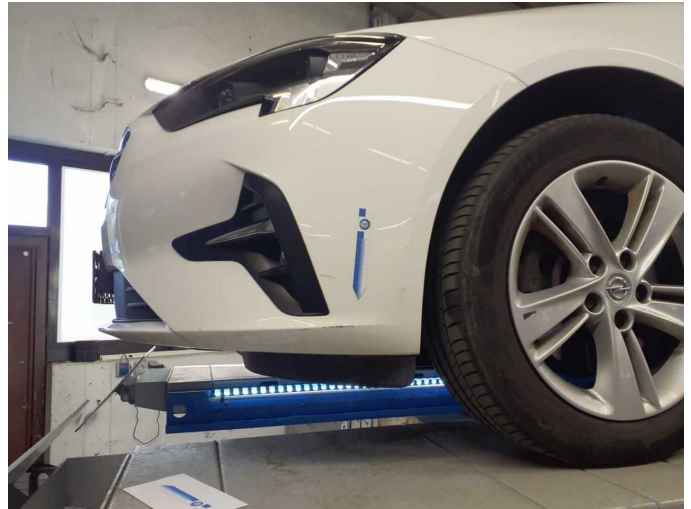
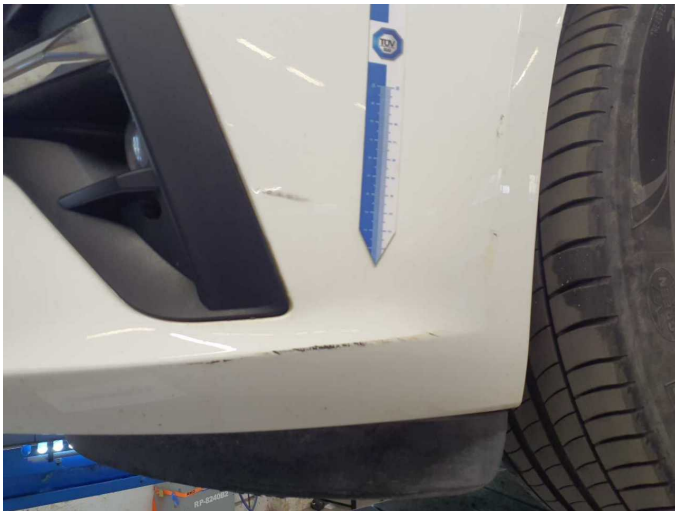
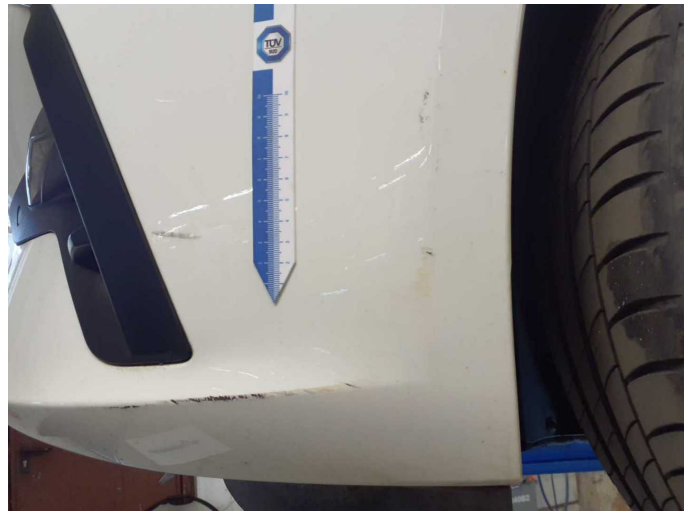
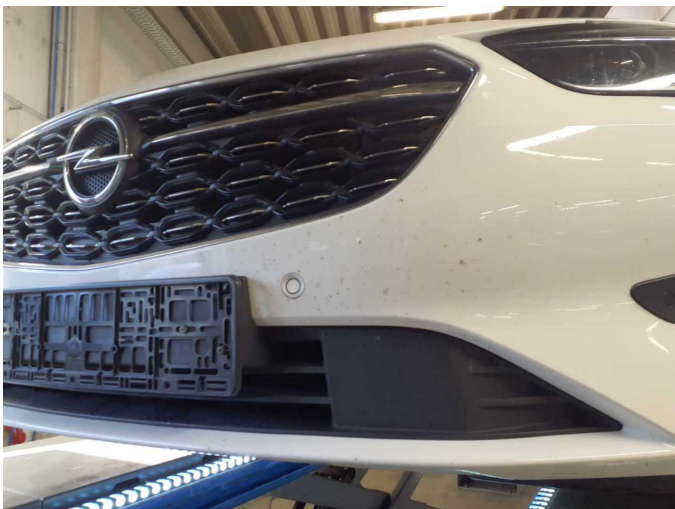
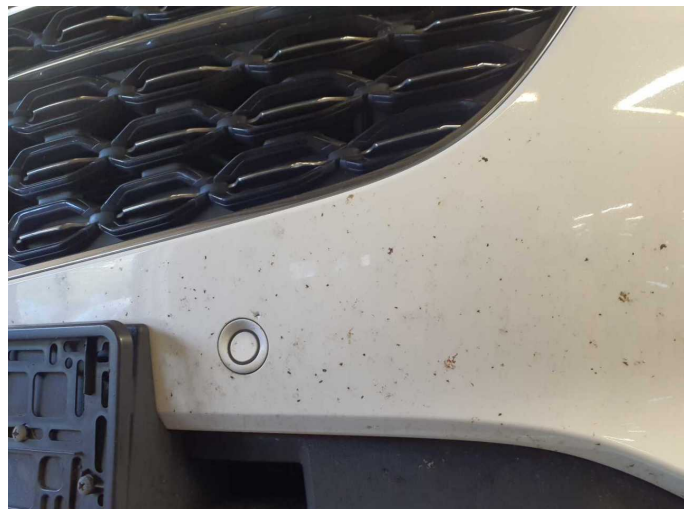
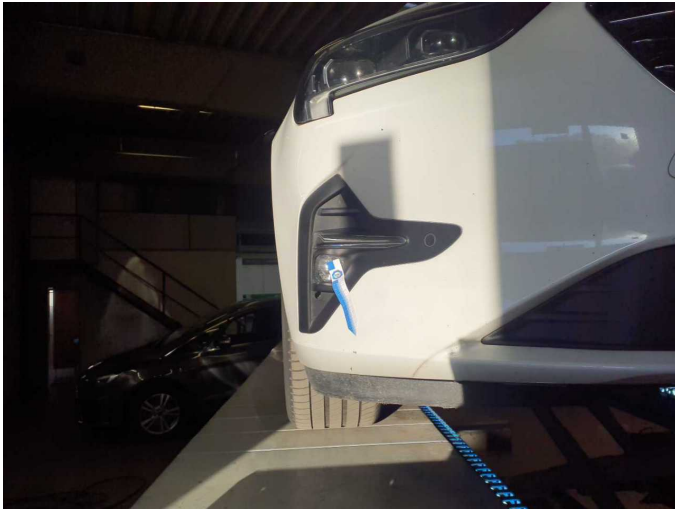
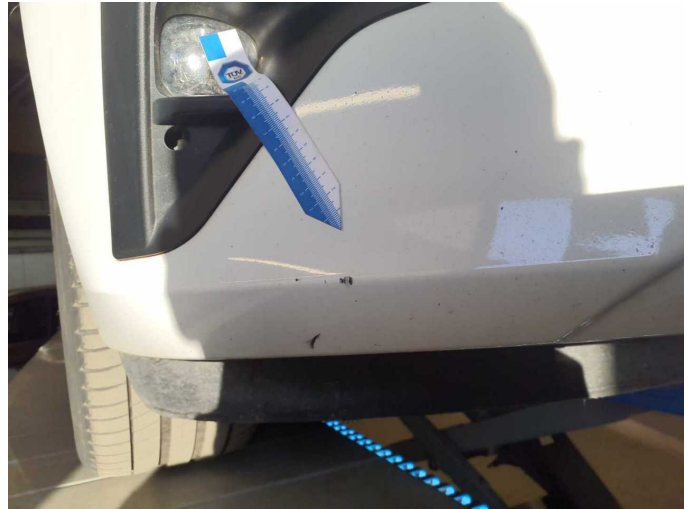
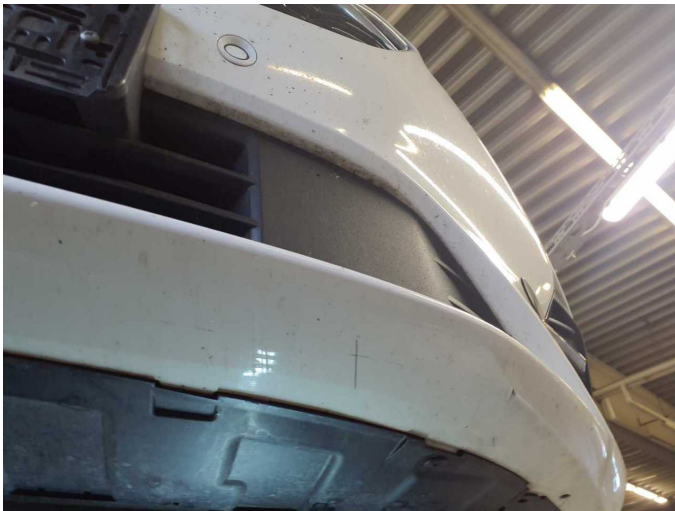
**Damage 7:** Front bumper: Front bumper - Scratch(es) - Paint

| No. | Component group | Description |
|---|---|---|
| 7 | Front bumper | Front bumper - Scratch(es) - Paint |

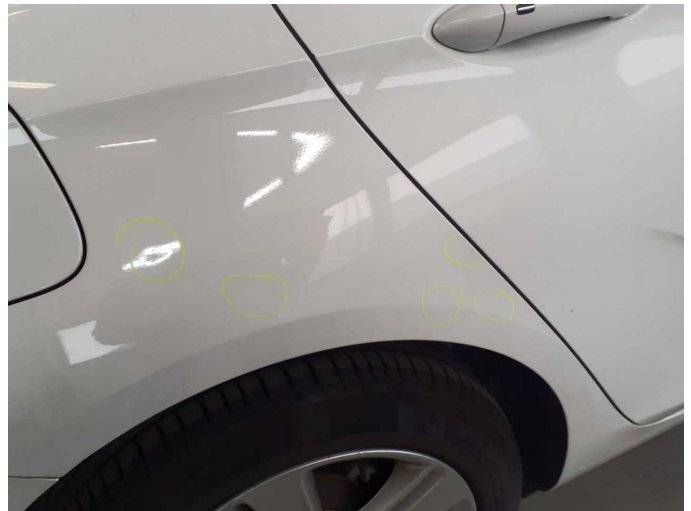
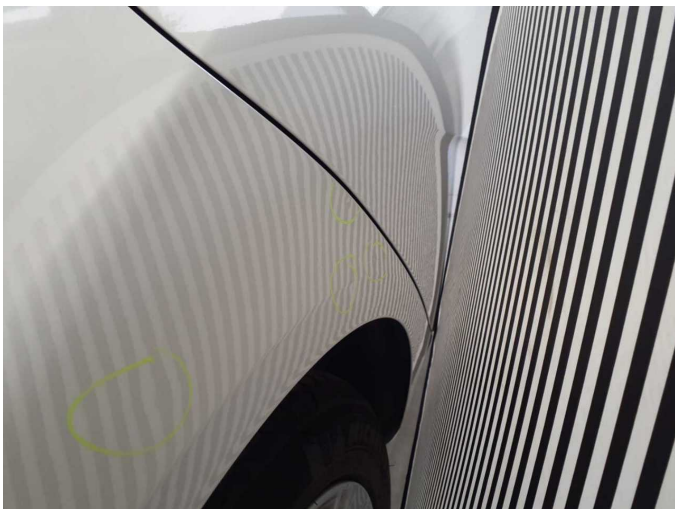
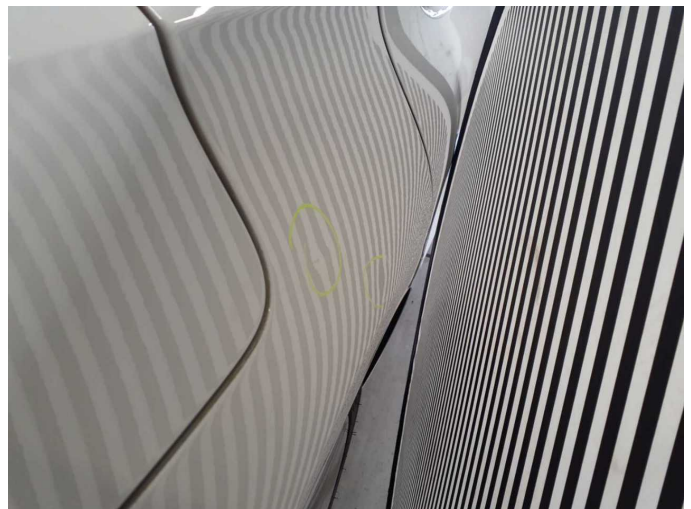
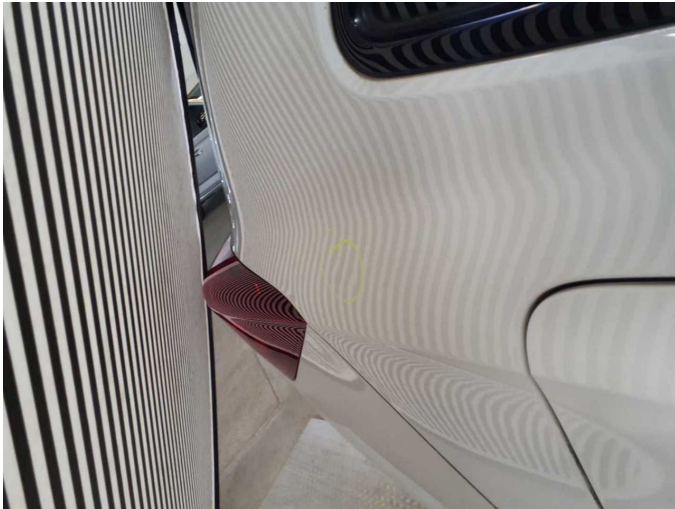
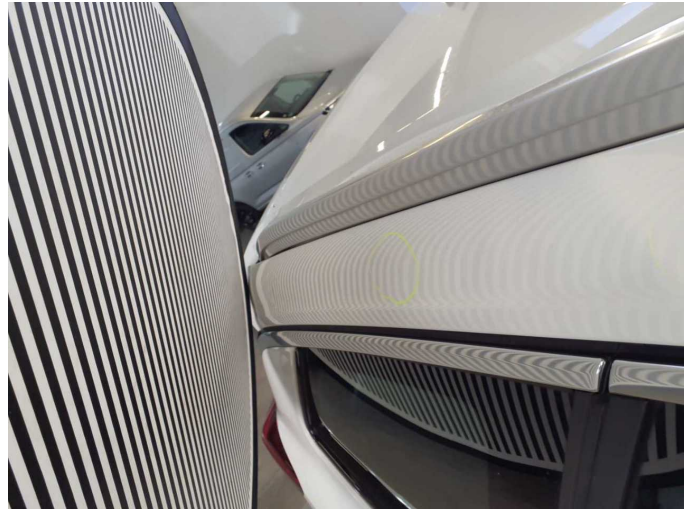
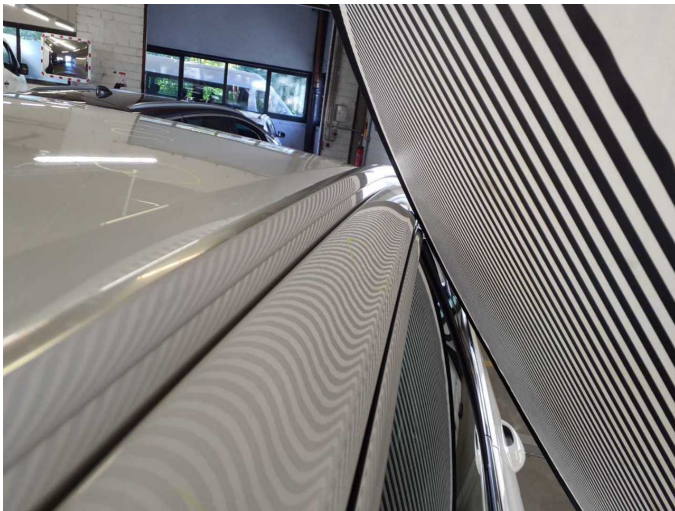
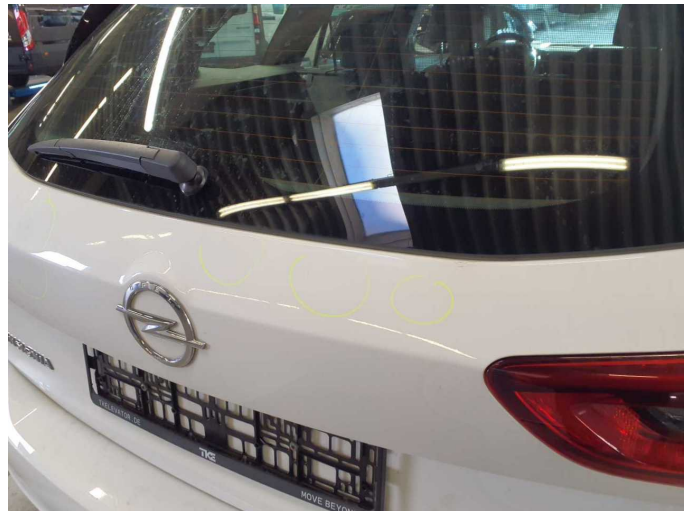
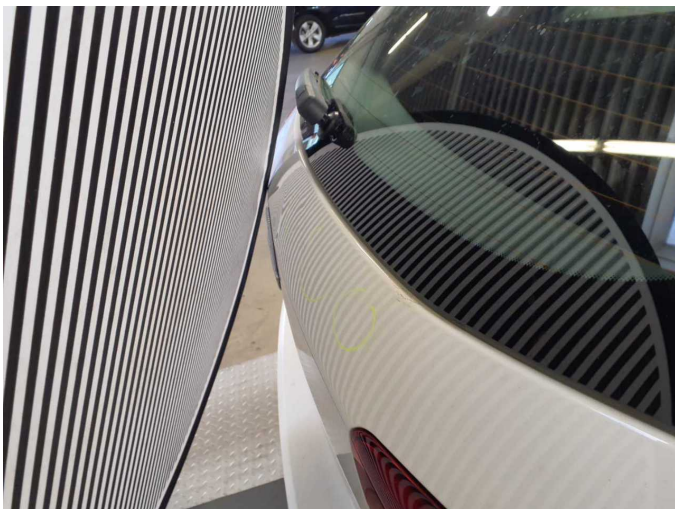
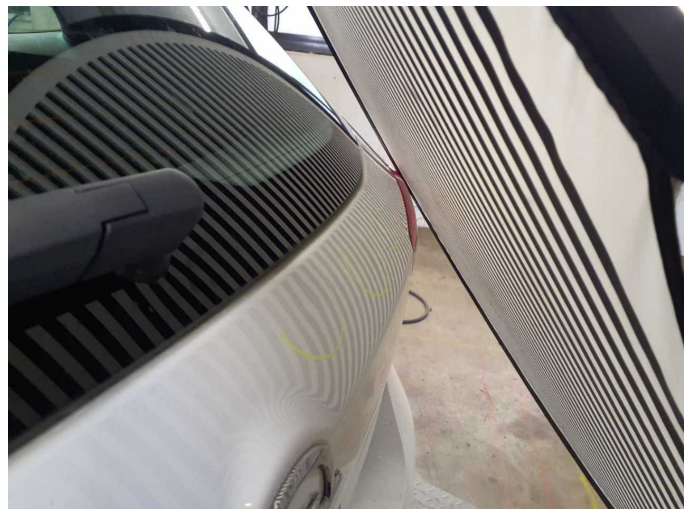
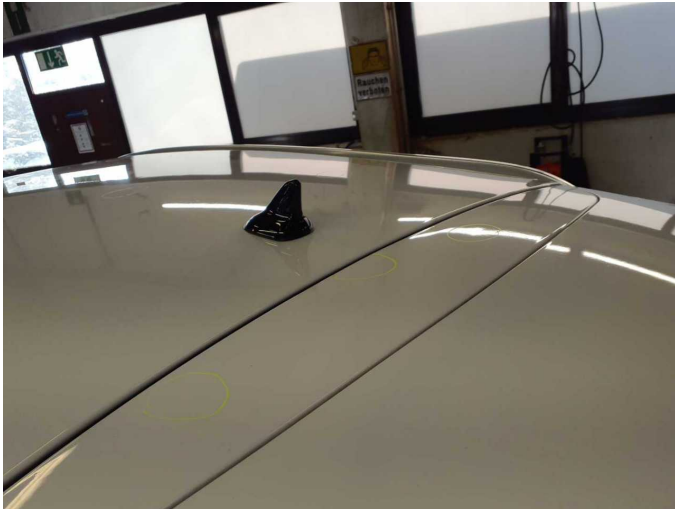
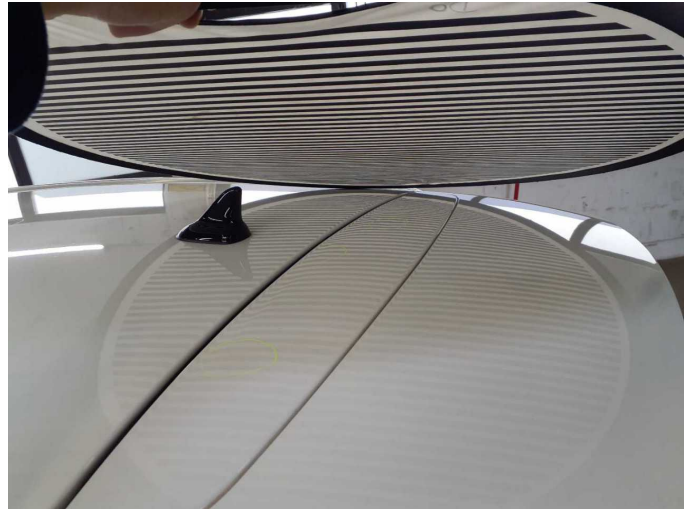
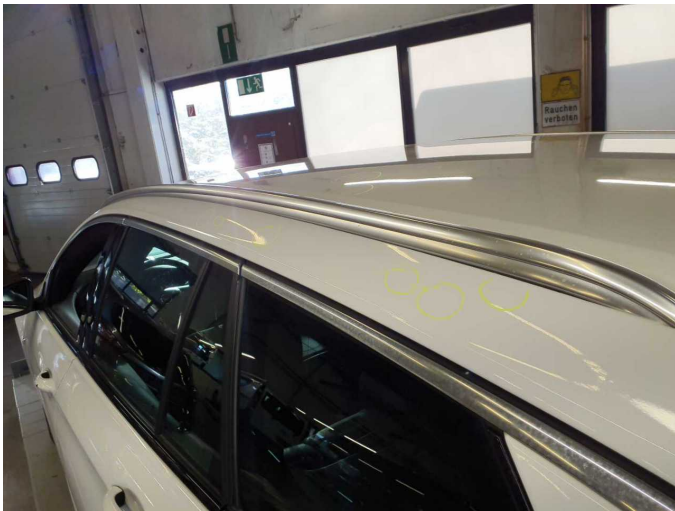
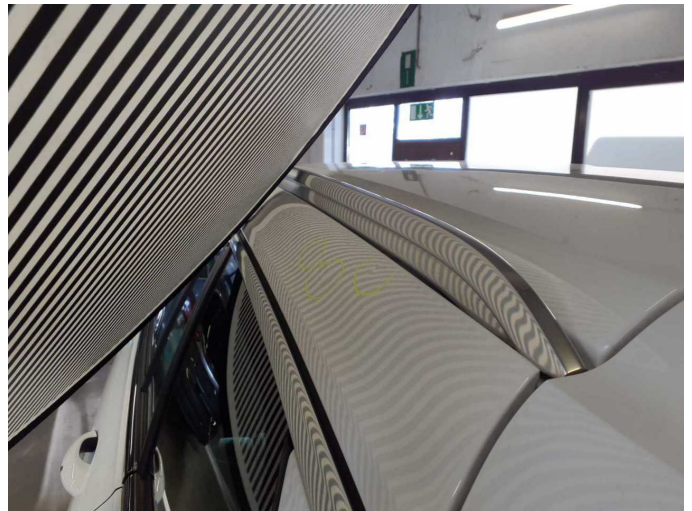
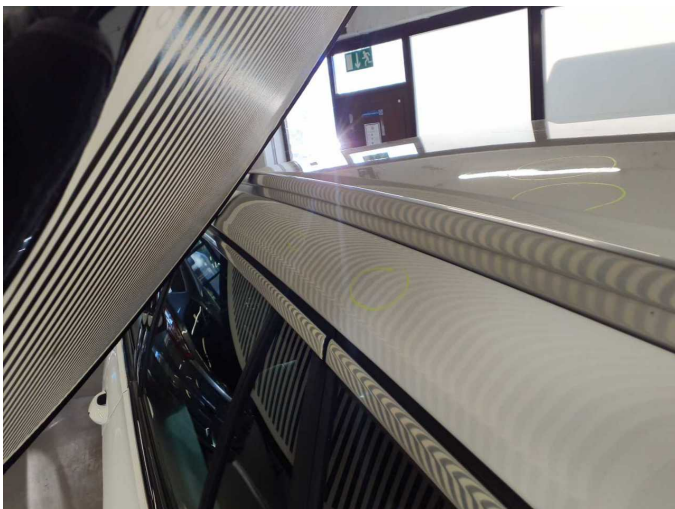
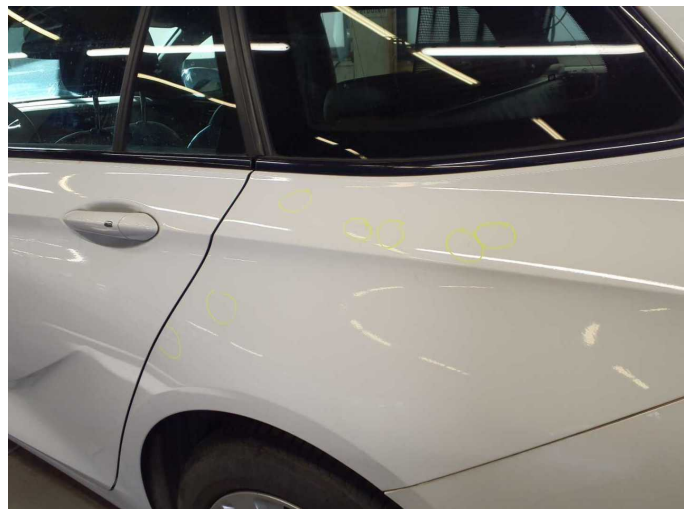
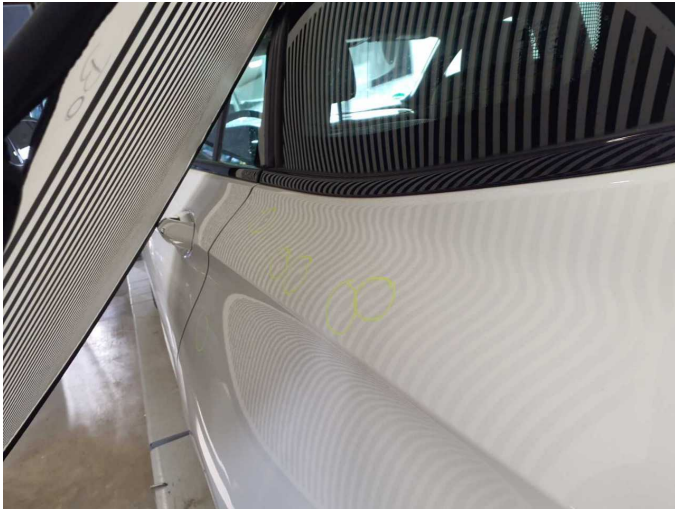
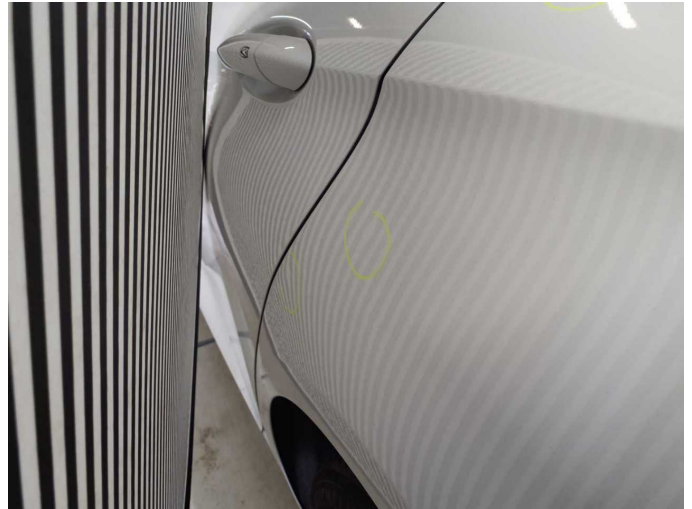
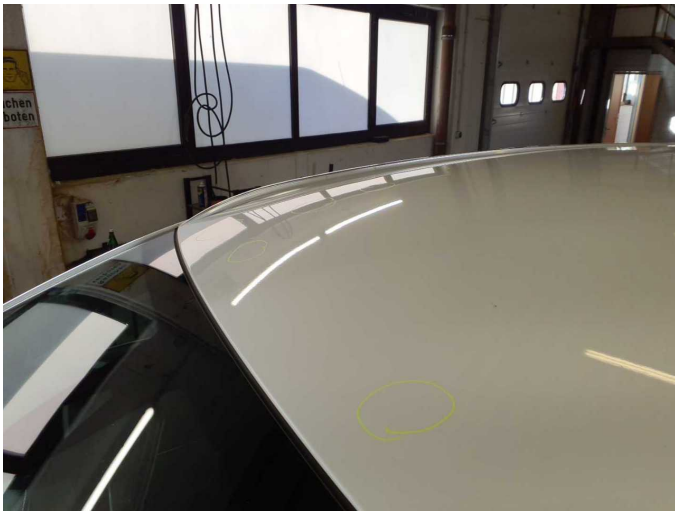
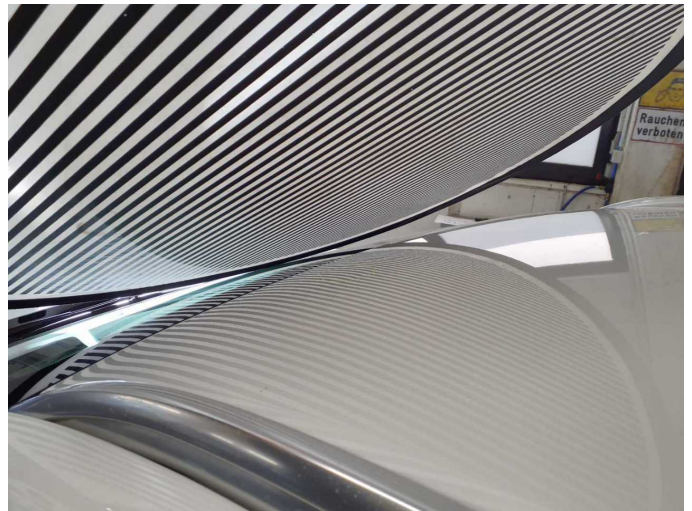
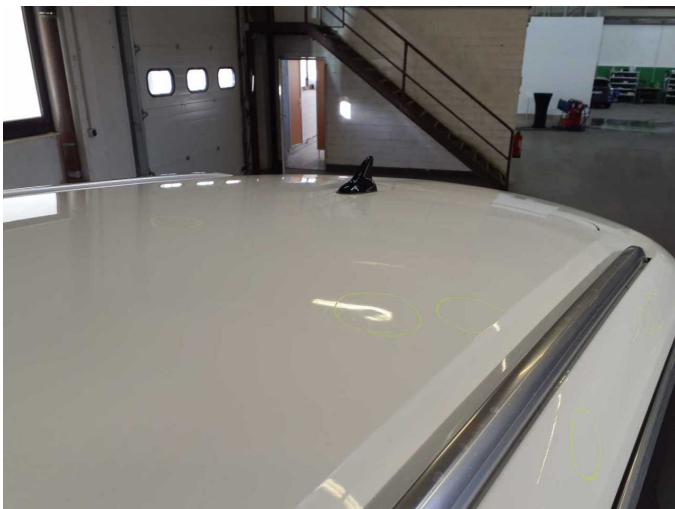
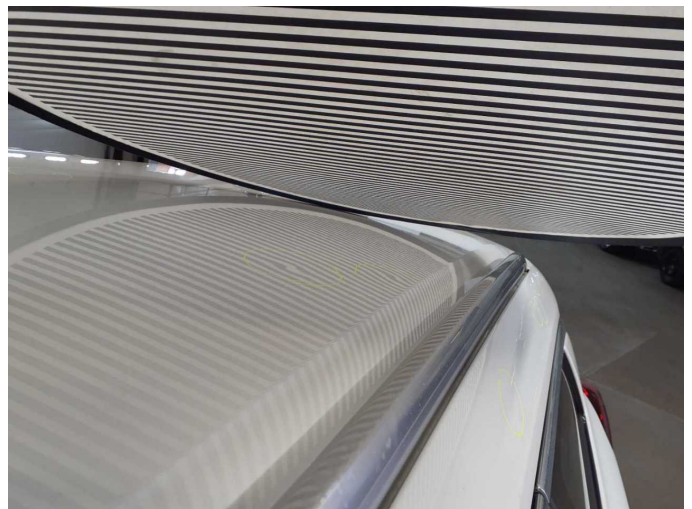
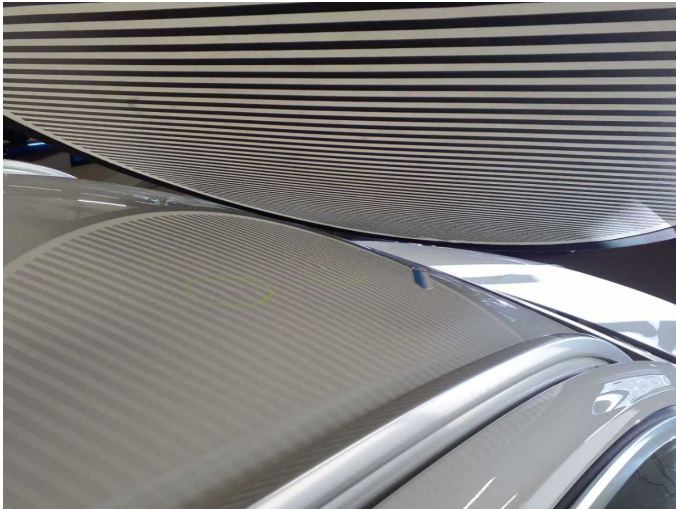
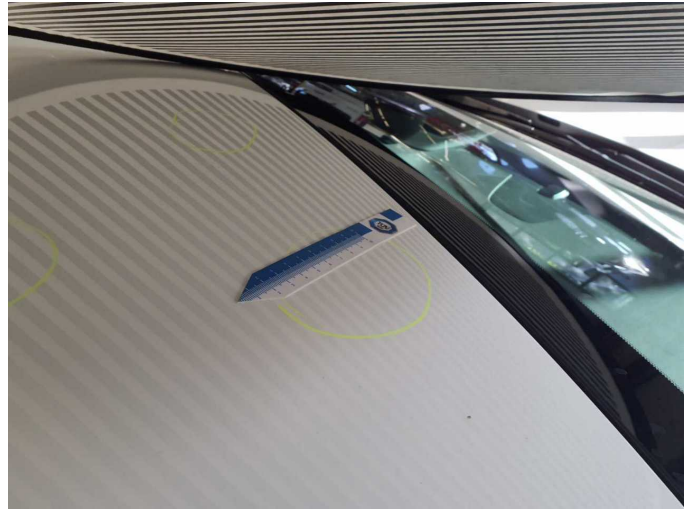
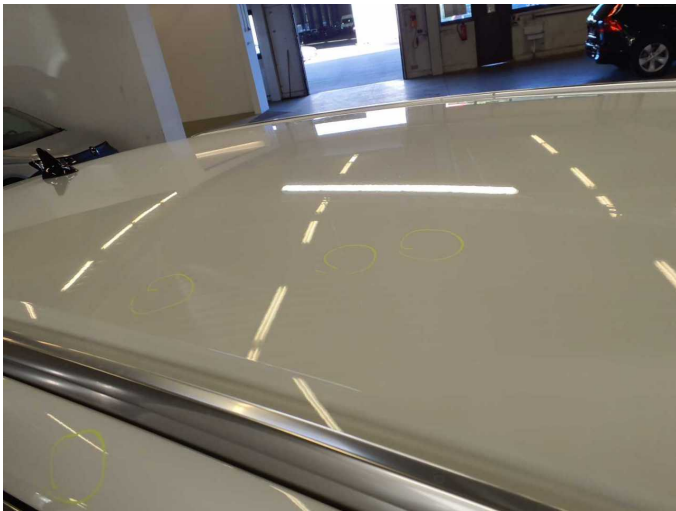
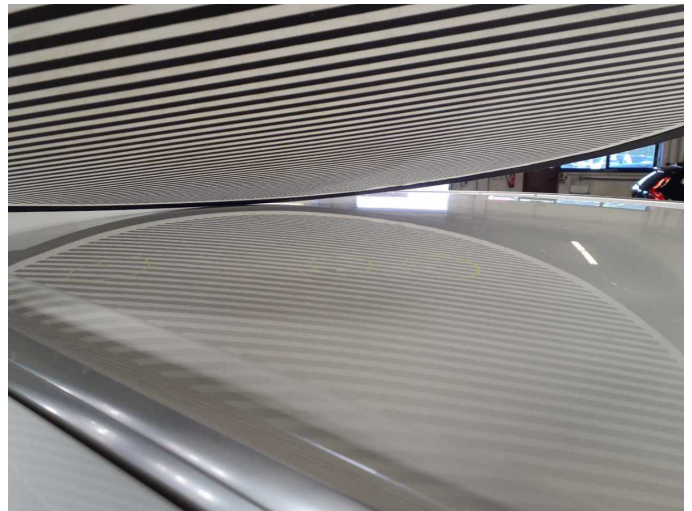
**Damage 8:** Body: Body - Damage by hail - repair according to calculation

| No. | Component group | Description |
|---|---|---|
| 8 | Body | Body - Damage by hail - repair according to calculation |

Die beigefügte Reparaturkostenkalkulation wurde nach bestem Wissen und Gewissen im demontagefreien Zustand erstellt. Es können Mehrkosten und somit Abweichung der für den Hagelschaden ausgewiesener Reparaturkosten nicht ausgeschlossen werden.
