Expertise

Protocol number: 39905399
Order No. / Reference: 24614594
Inspection date: 26 May 2025

| Manufacturer: Opel | Model: Insignia Sports Tourer 2.0 Direct InjectionTurbo Elegance |
| VIN: W0VZT8ER1N1005204 | |

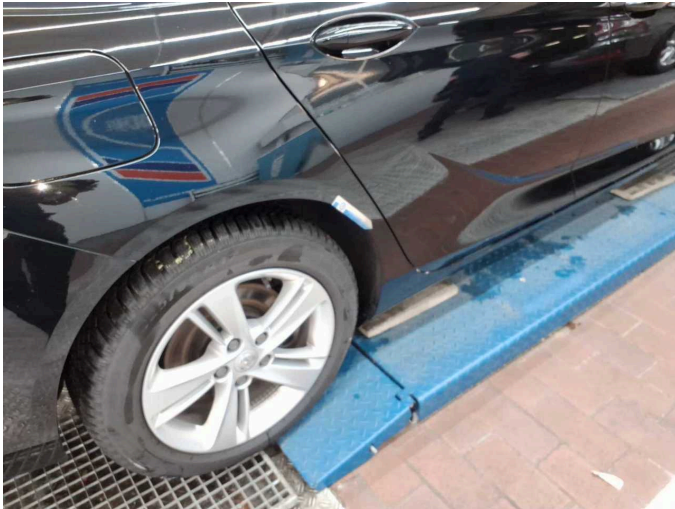
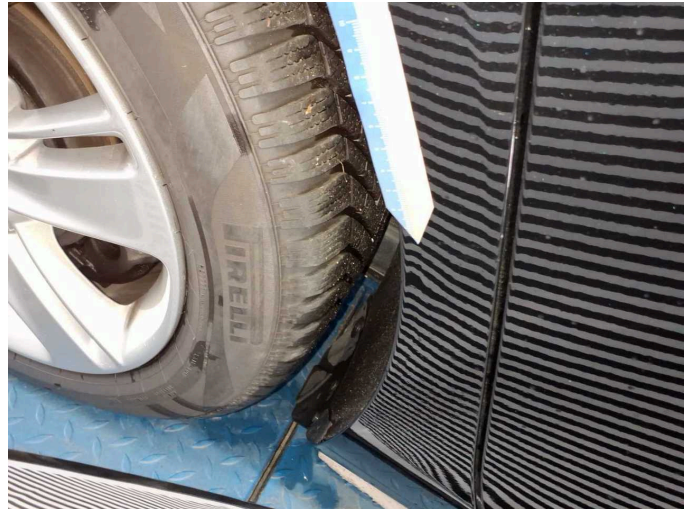
| No. | Component group | Description |
|---|---|--|
| 1 | Side panel - rear right side | Elbow - dent(s) - Smart repair |

Damage 1: Side panel - rear right side: Elbow - dent(s) - Smart repair

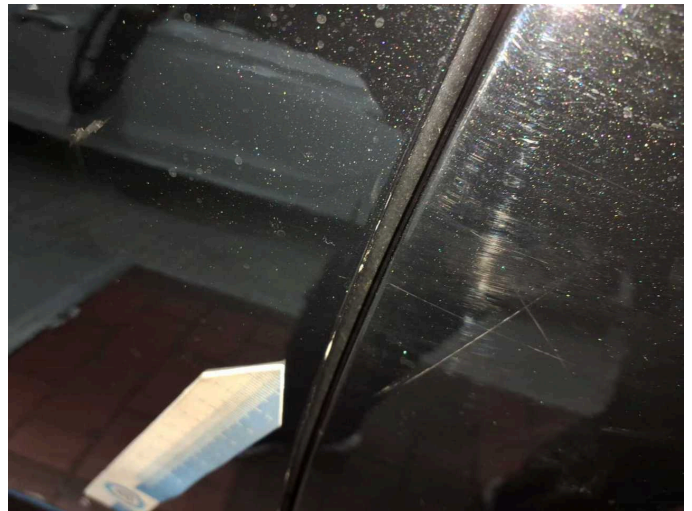
| No. | Component group | Description |
|---|---|--|
| 2 | Door - front left side | Door - Scratch(es) - Smart repair |

Damage 2: Door - front left side: Door - Scratch(es) - Smart repair

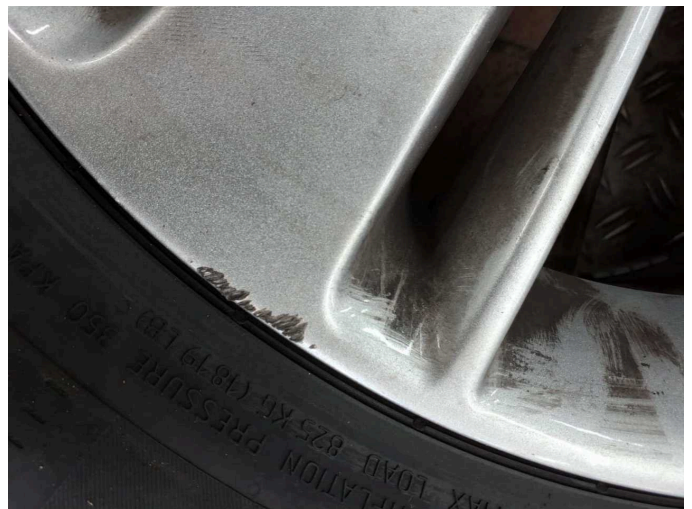
| No. | Component group | Description |
|---|---|--|
| 3 | 2nd wheel set | 1 alloy rim - Scratched - Loss in value |

Damage 3: 2nd wheel set: 1 alloy rim - Scratched - Loss in value

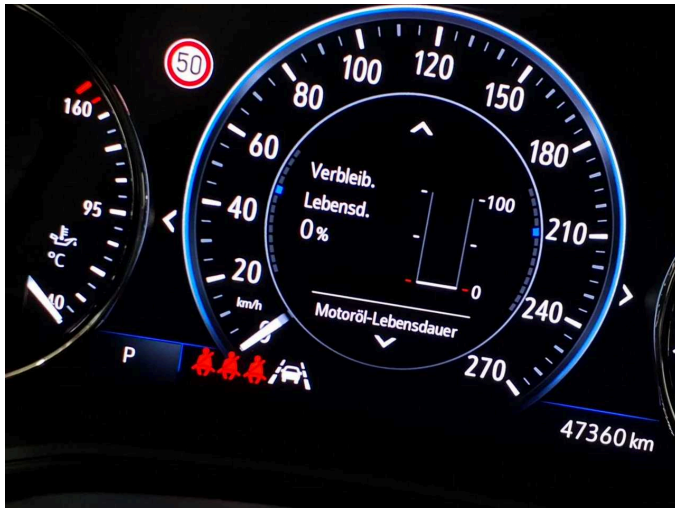
| No. | Component group | Description |
|---|---|--|
| 4 | Misc. | Inspection / maintenance - Expired - Replace |

Damage 4: Misc.: Inspection / maintenance - Expired - Replace

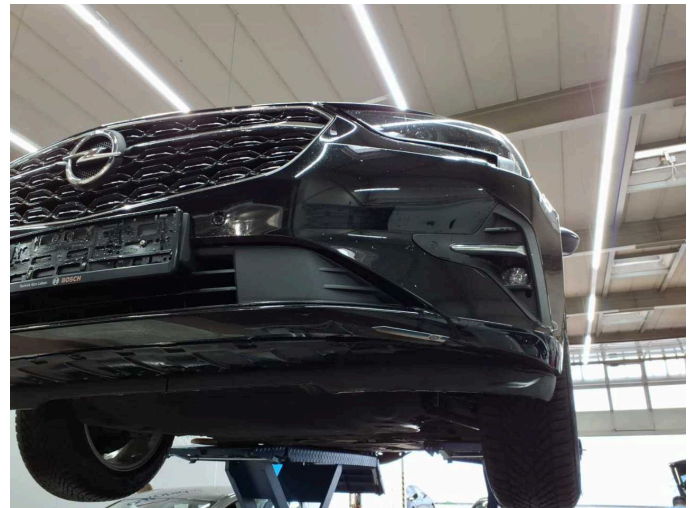
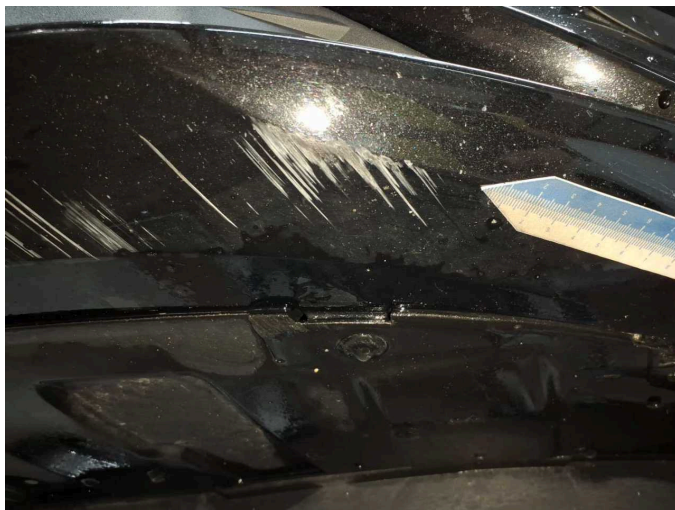
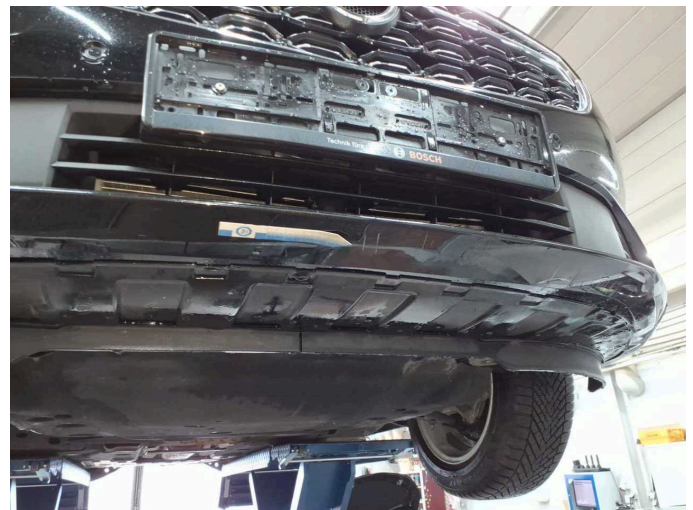
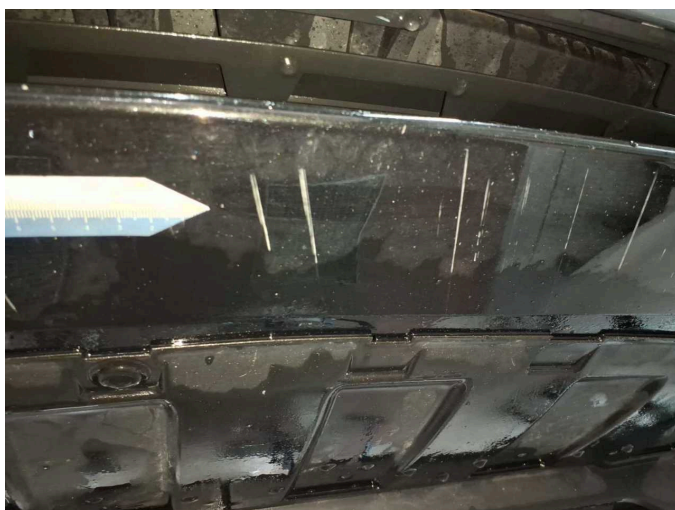
| No. | Component group | Description |
|---|---|--|
| 5 | Front bumper | Front bumper - Scratched - Paint |

Damage 5: Front bumper: Front bumper - Scratched - Paint

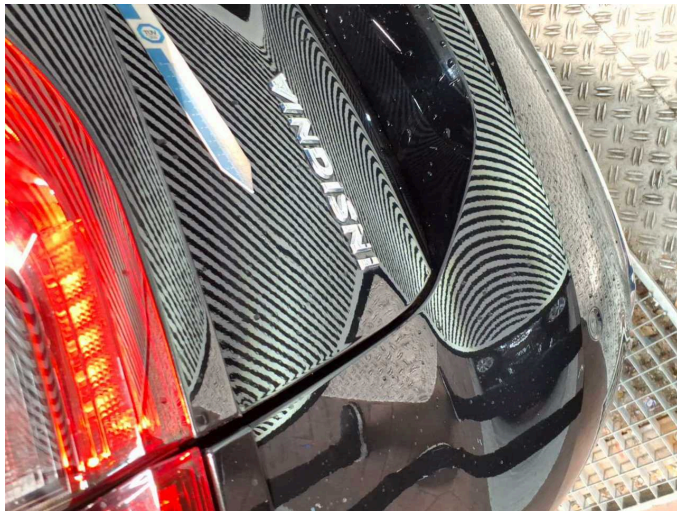
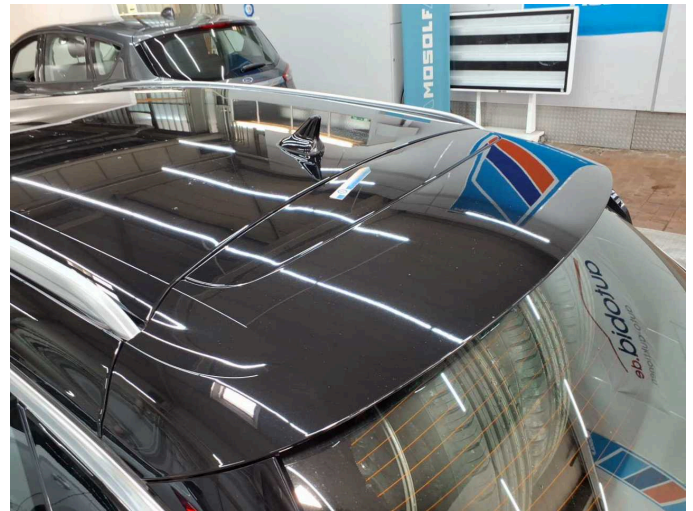
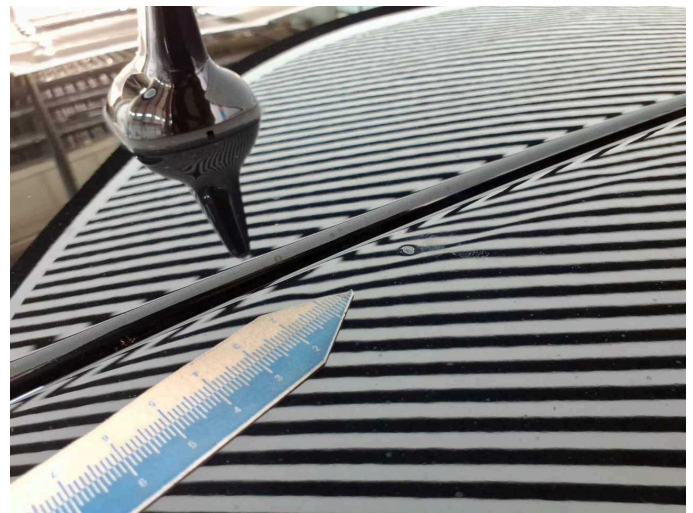
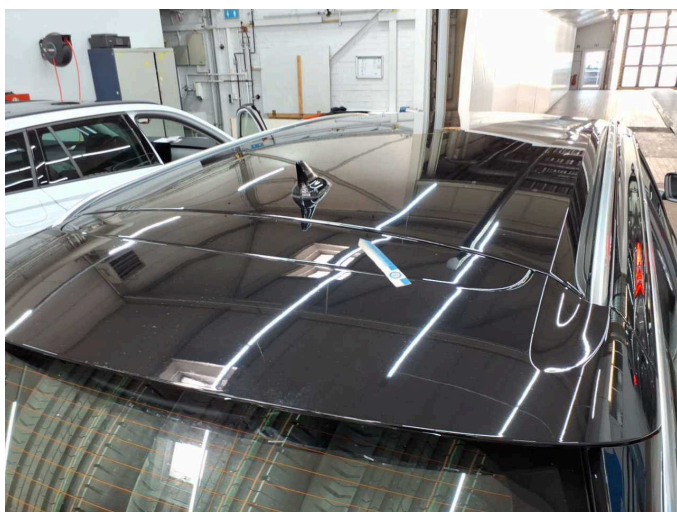
| No. | Component group | Description |
|---|---|--|
| 6 | Boot lid / rear door | Boot lid - Dent / paintcoat damage - Paint |

Damage 6: Boot lid / rear door: Boot lid - Dent / paintcoat damage - Paint

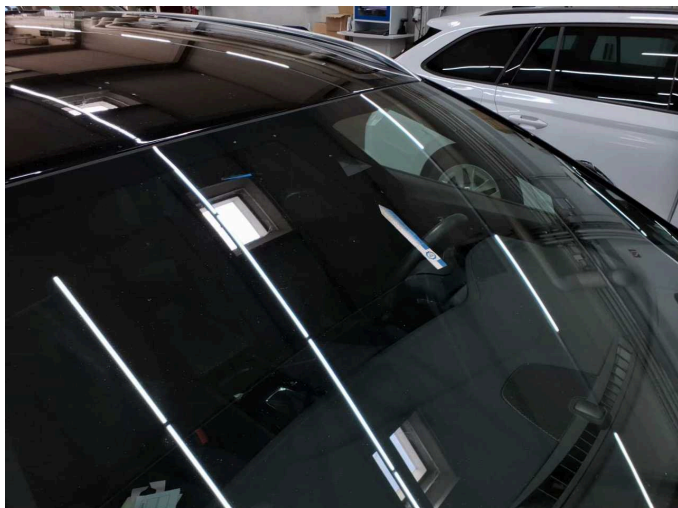
| No. | Component group | Description |
|---|---|--|
| 7 | Vehicle glazing | Windscreen - Stone chips - Replace |

Damage 7: Vehicle glazing: Windscreen - Stone chips - Replace
