# INSPECTION REPORT

**End Of Contract**

| License plate | RP7284 |
| Make | Mercedes A 180 136 Aut |

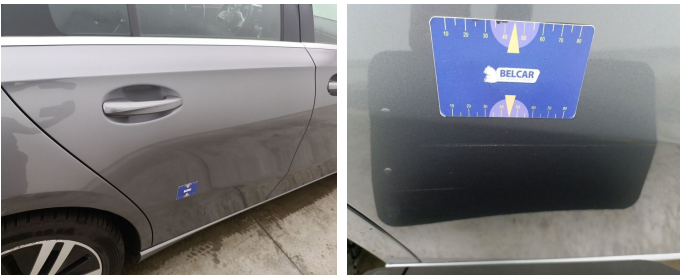
| Damages | Type | Acceptable |
|---|---|---|
| 196 | Door Rear Right // Polish | Y |

Door Rear Right // Polish-scratch

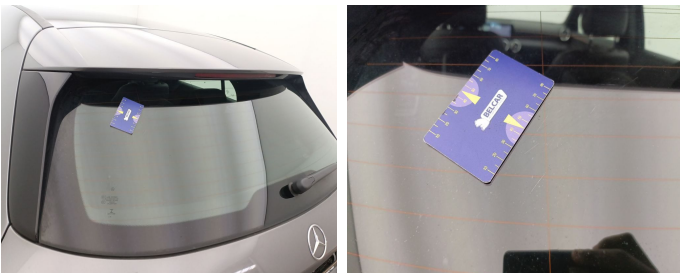
| Damages | Type | Acceptable |
|---|---|---|
| 159 | Rear Bonnet / Rear Window / Replace | Y |

Rear Bonnet / Rear Window / Replace-scratch

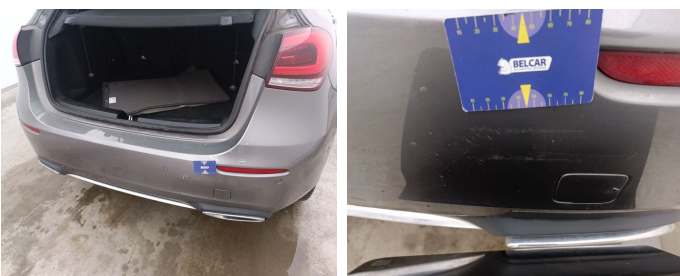
| Damages | Type | Acceptable |
|---|---|---|
| 136 | Bumper Rear // Polish | Y |

Bumper Rear // Polish-scratch

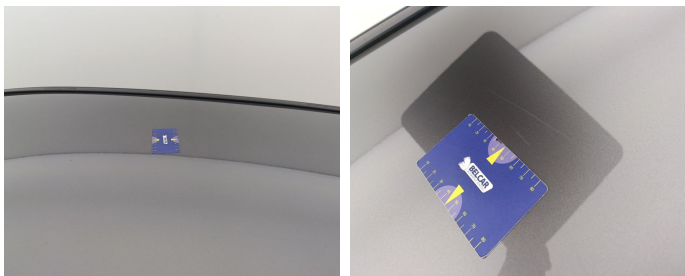
| Damages | Type | Acceptable |
|---|---|---|
| 165 | Roof // Polish | Y |

Roof // Polish-scratch

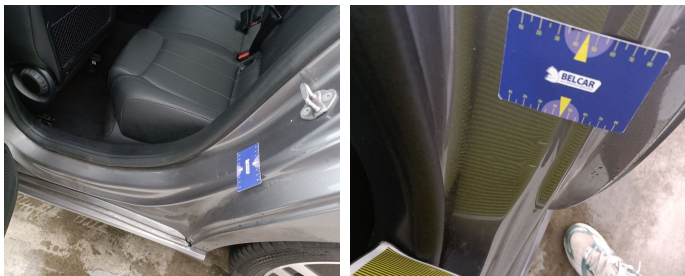
| Damages | Type | Acceptable |
|---|---|---|
| 91 | Rocker Panel Left // Smart Repair Medium | N |

Rocker Panel Left // Smart Repair Medium-scratch + dent

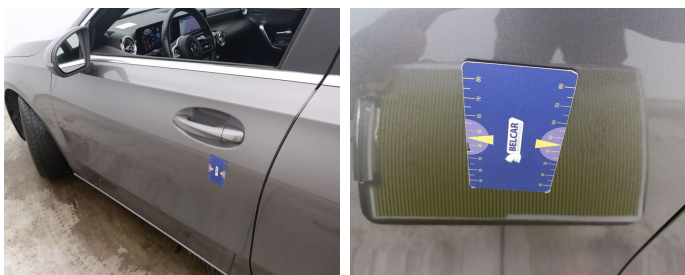
| Damages | Type | Acceptable |
|---|---|---|
| 84 | Door Front Left // Repair & Painting | N |

Door Front Left // Repair & Painting-scratch + dent

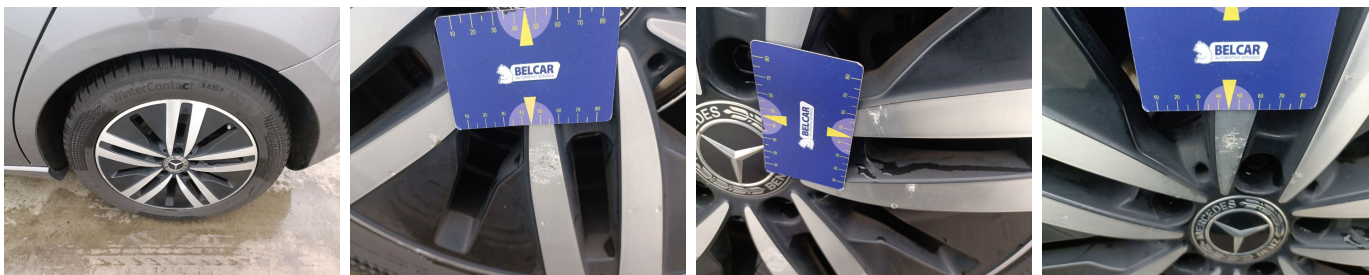
| Damages | Type | Acceptable |
|---|---|---|
| 320 | Wheel Two Tone Rear Left // Repair | Y |

Wheel Two Tone Rear Left // Repair-Chemical reaction

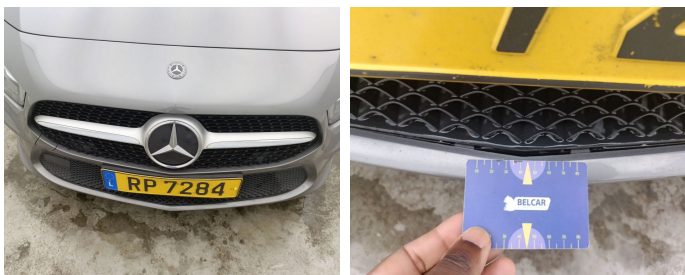
| Damages | Type | Acceptable |
|---|---|---|
| 274 | Bumper Front / Grid Central / Replace | N |

Bumper Front / Grid Central / Replace-bad position

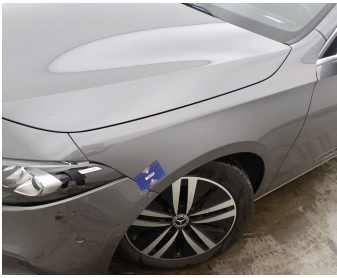
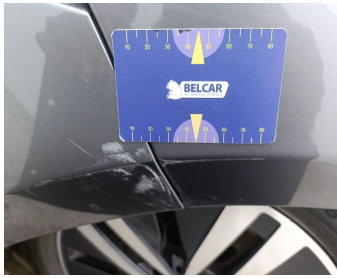
| Damages | Type | Acceptable |
|---|---|---|
| 61 | Wing Front Left // Smart Repair Medium | N |

Wing Front Left // Smart Repair Medium-scratch

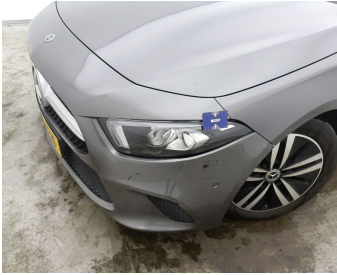
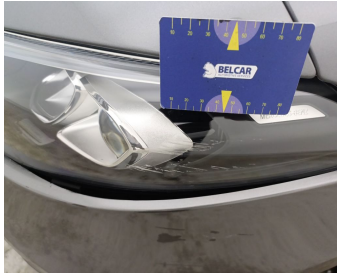
| Damages | Type | Acceptable |
|---|---|---|
| 54 | Headlight / Front left / Replace | N |

Headlight / Front left / Replace-scratch

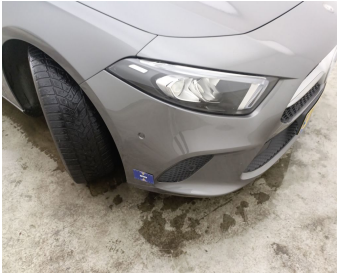
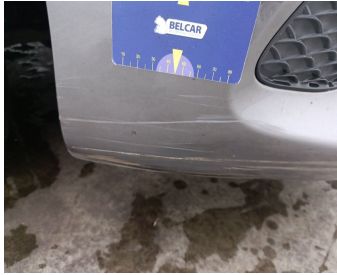
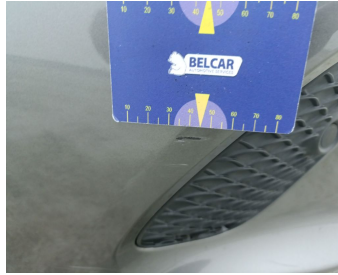
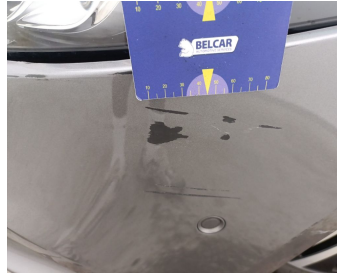
| Damages | Type | Acceptable |
|---|---|---|
| 13 | Bumper Front // Painting | N |

Bumper Front // Painting-scratch
