Expertise

Protocol number: 39466550  
Order No. / Reference: 24621473  
Inspection date: 23 Apr 2025

Manufacturer: Mercedes-Benz

Model: A 250 e 8G-DCT Progressive

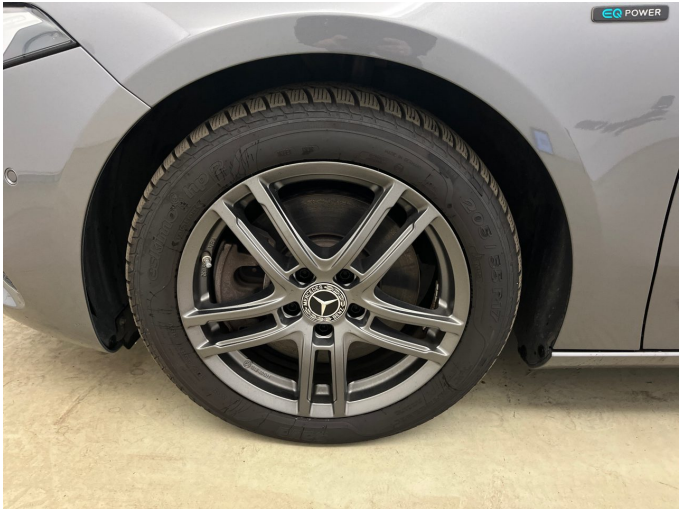
Figure 12: Mounted tyres

#	Tyre size	Type of tyre	Manufacturer	Tread depth
1)	205/55 R17 95V	Winter tyres on Light alloy	Sonstige	6mm / 6mm
2)	205/55 R17 95V	Winter tyres on Light alloy	Sonstige	5mm / 5mm

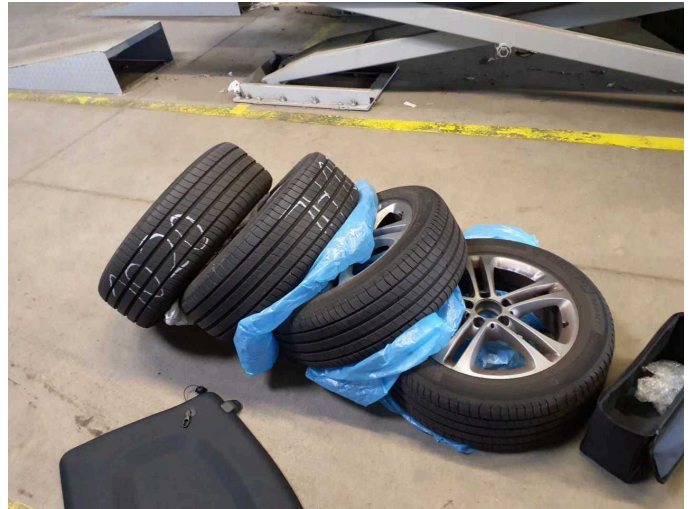
Figure 14: Additional tyres

#	Tyre size	Type of tyre	Manufacturer	Tread depth
1)	205/55 R17 91W	Summer tyres on Light alloy	Michelin	5mm / 5mm
2)	205/55 R17 91W	Summer tyres on Light alloy	Michelin	5mm / 5mm

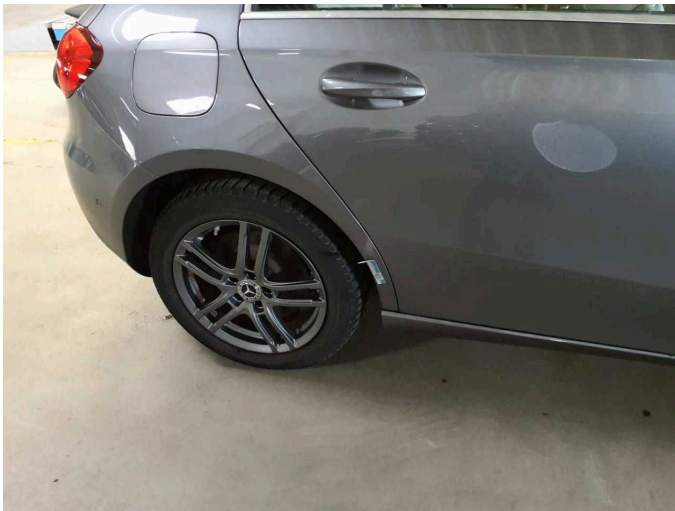
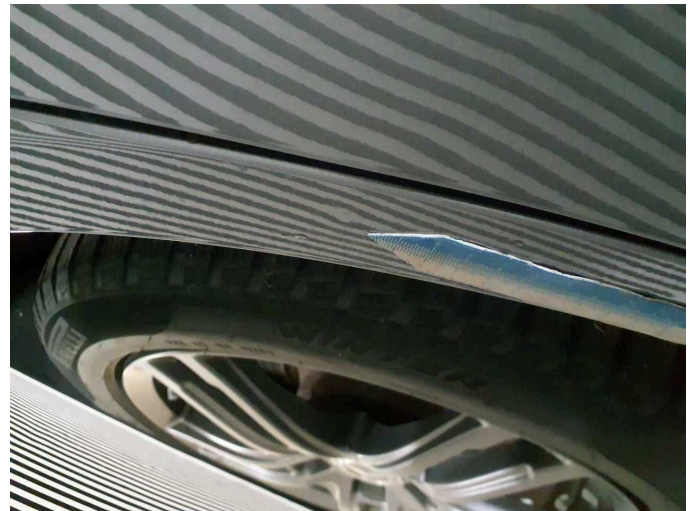
**Damage 1:** Side panel - rear right side: Side panel - dent(s) - Smooth repair work

No.	Component group	Description
1	Side panel - rear right side	Side panel - dent(s) - Smooth repair work
2	Boot lid / rear door	Boot lid - dent(s) - Smooth repair work
3	Bonnet	Bonnet - Stone chips - Paint

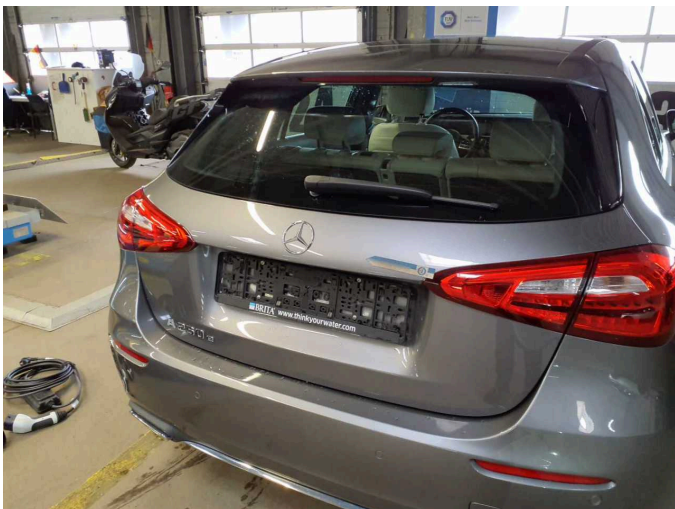
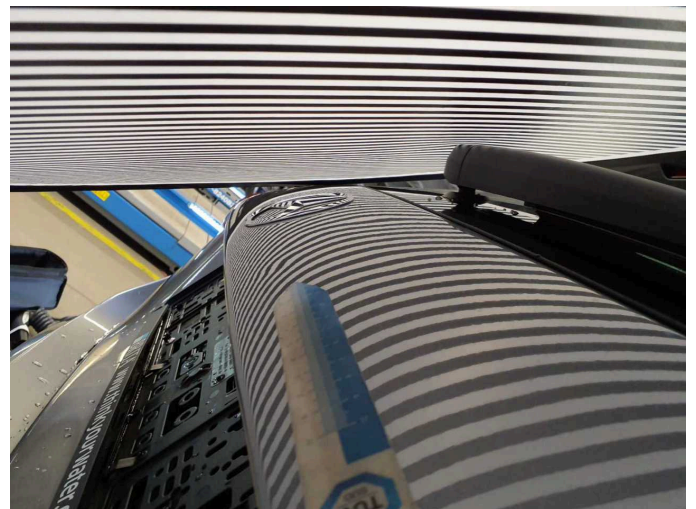
**Damage 2:** Boot lid / rear door: Boot lid - dent(s) - Smooth repair work

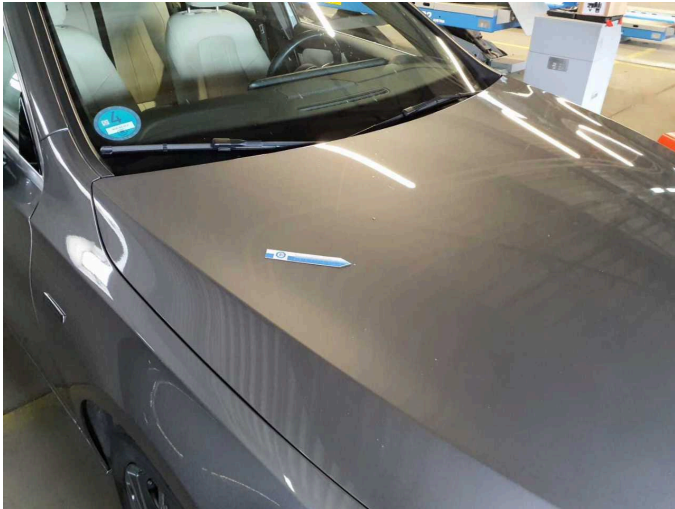
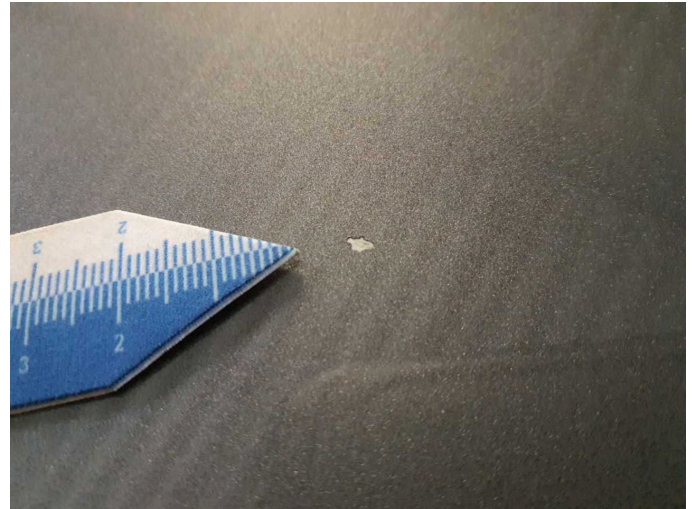
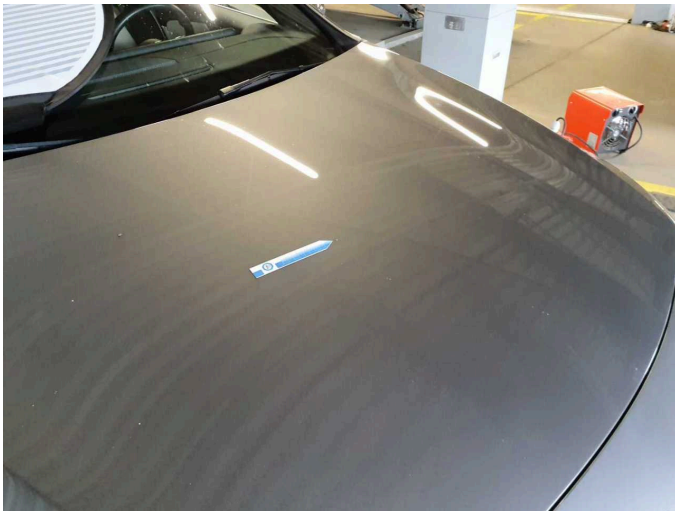
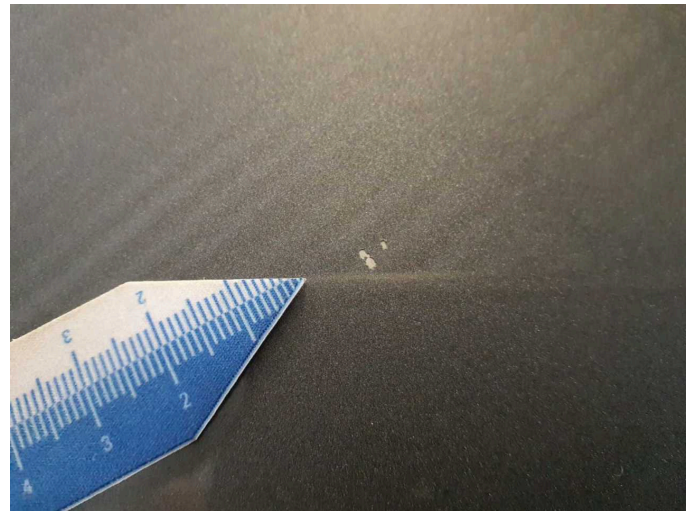
**Damage 3:** Bonnet: Bonnet - Stone chips - Paint
