Expertise

Protocol number: 41503171
Order No. / Reference: 25100297
Inspection date: 12 Sept 2025

Manufacturer: Mercedes-Benz

Model: C 200 d T 9G-TRONIC Avantgarde

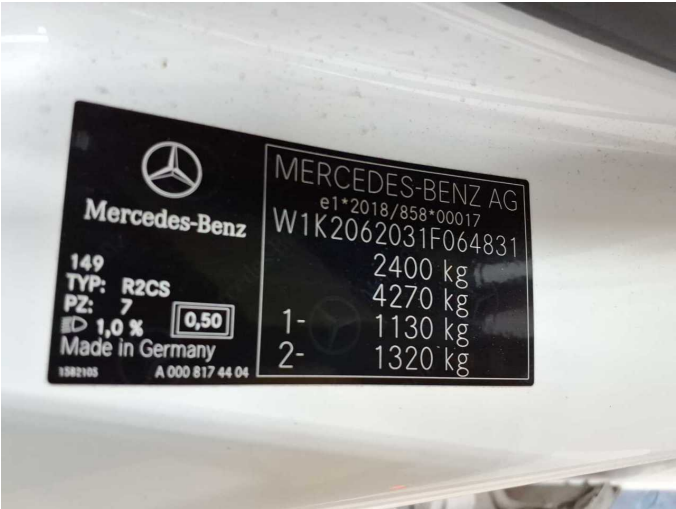
| VIN comparison | The vehicle identification number (VIN) was read from the vehicle and its conformity with the submitted documents was verified during the inspection by the undersigned. |

Figure 11: VIN

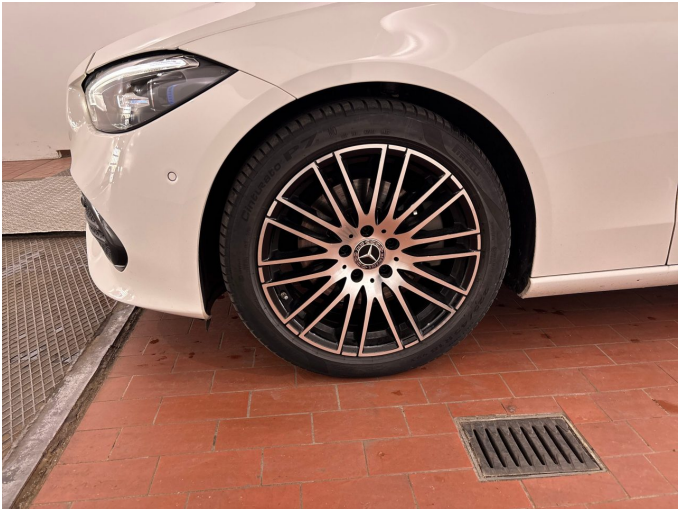
| # | Tyre size | Type of tyre | Manufacturer | Tread depth |
|---|---|---|---|---|
| 1) | 225/45 R18 95Y | Summer tyres on Light alloy | Pirelli | 5mm / 5mm |
| 2) | 245/40 R18 97Y | Summer tyres on Light alloy | Pirelli | 5mm / 5mm |

Figure 12: Mounted tyres

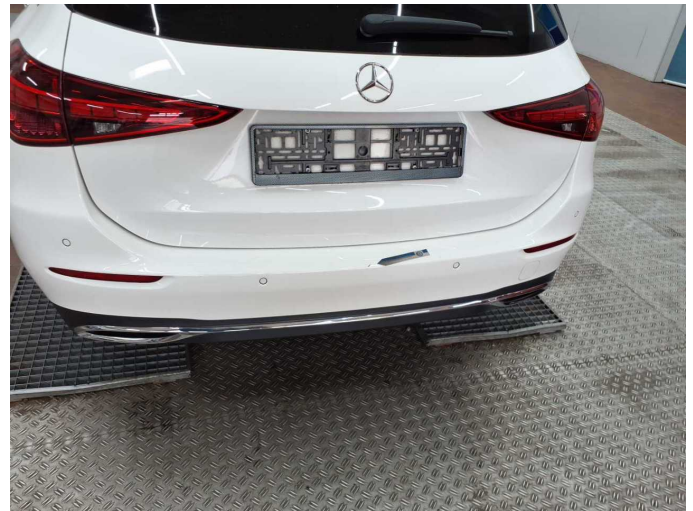
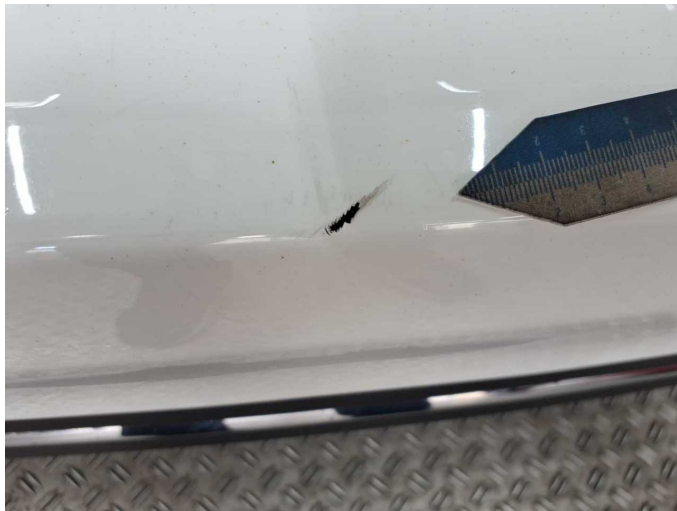
| No. | Component group | Description |
|---|---|---|
| 1 | Rear bumper | Rear bumper - Scratched - Paint |

Damage 1: Rear bumper: Rear bumper - Scratched - Paint

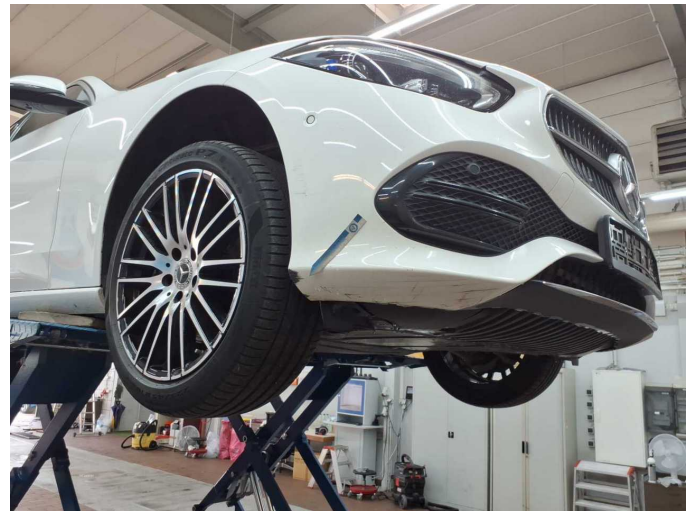
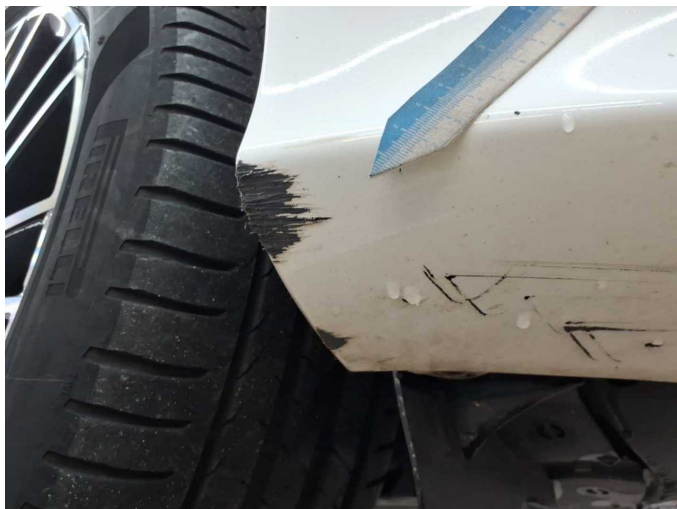
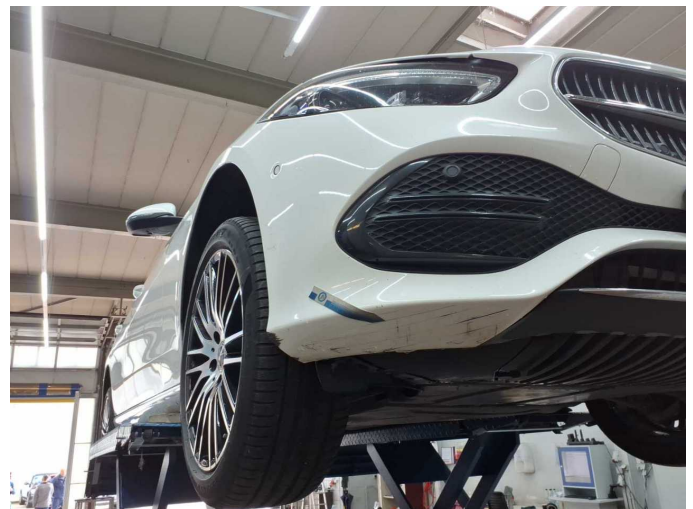
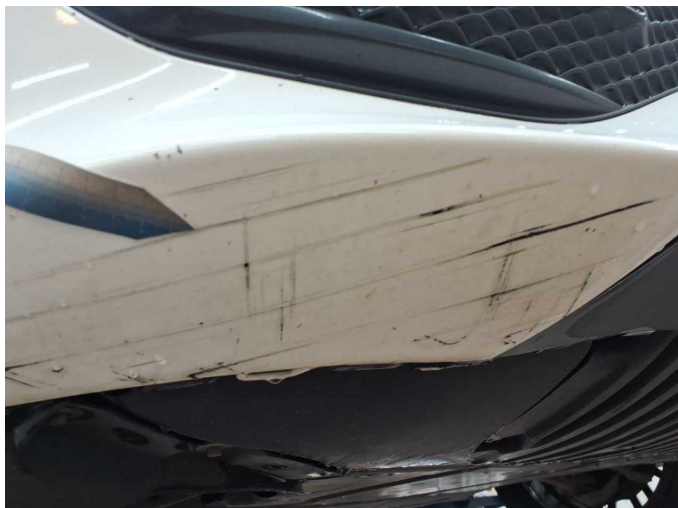
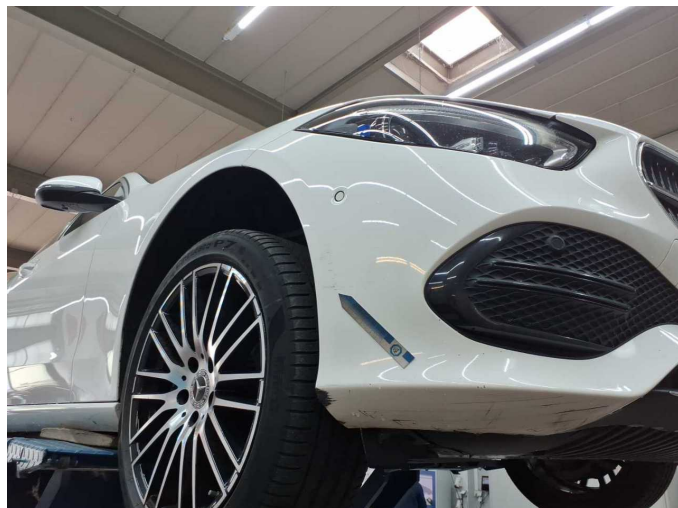
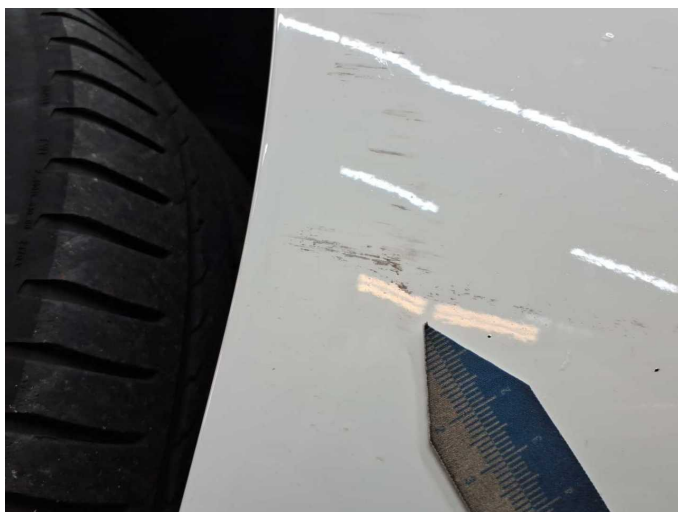
| No. | Component group | Description |
|---|---|---|
| 2 | Front bumper | Front bumper - Scratched - Repair and paint |

Damage 2: Front bumper: Front bumper - Scratched - Repair and paint

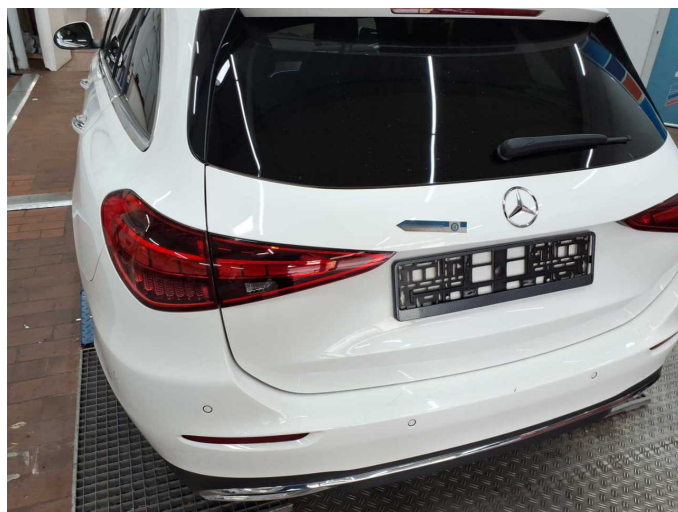
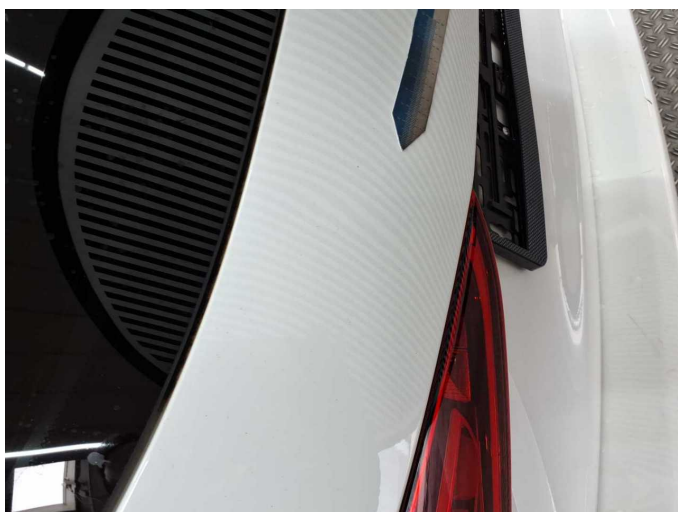
| No. | Component group | Description |
|---|---|--|
| 4 | Boot lid / rear door | Boot lid - dent(s) - No deduction |

Wear and tear 4: Boot lid / rear door: Boot lid - dent(s) - No deduction
