Expertise

Protocol number: 41275631  
Order No. / Reference: 25005895  
Inspection date: 28 Aug 2025

Model: C 220 d T 9G-TRONIC Avantgarde

VIN: W1K2062041F064250

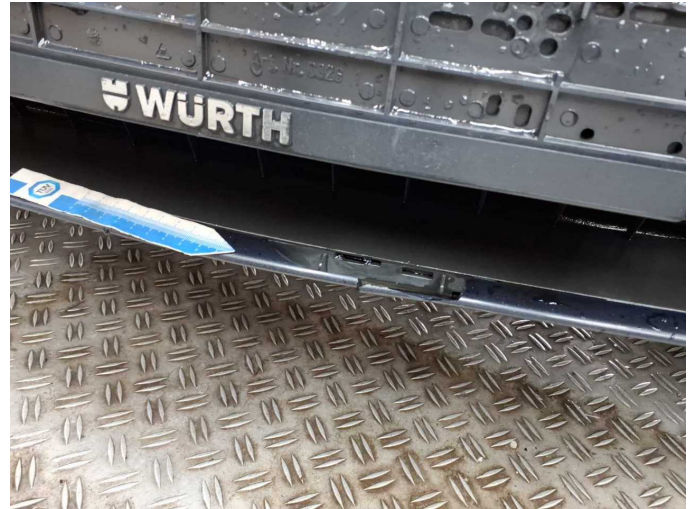
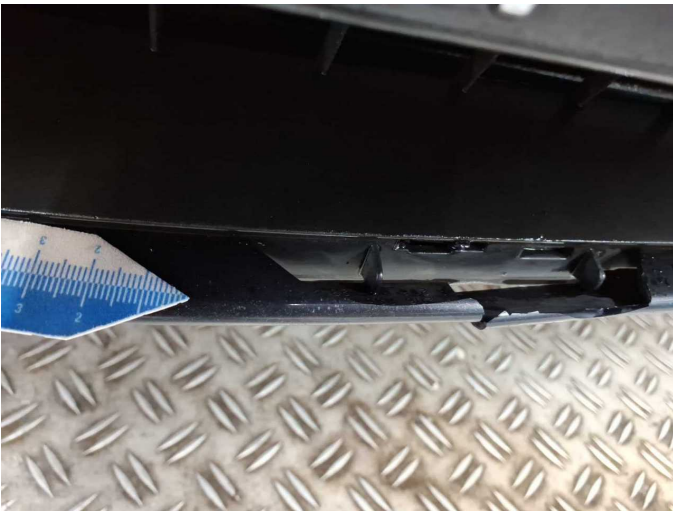
| No. | Component group | Description |
|---|---|---|
| 2 | Front bumper | Front bumper (Leiste) - Broken / torn - Replace |

**Damage 2:** Front bumper: Front bumper (Leiste) - Broken / torn - Replace

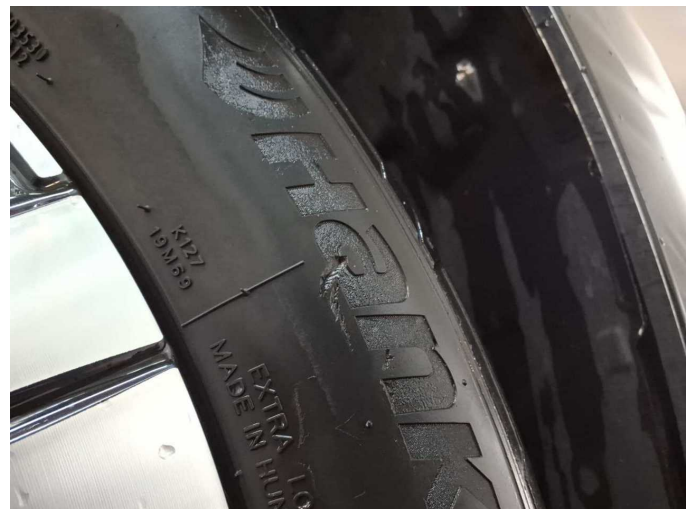
| No. | Component group | Description |
|---|---|---|
| 3 | Wheel / tyres | Tyre - front right side - Damaged - Replace |

**Damage 3:** Wheel / tyres: Tyre - front right side - Damaged - Replace
