Expertise

Protocol number: 41617161
Order No. / Reference: 25121080
Inspection date: 19 Sept 2025

Manufacturer: Mercedes-Benz

Model: E 300 de T 9G-TRONIC AMG Line

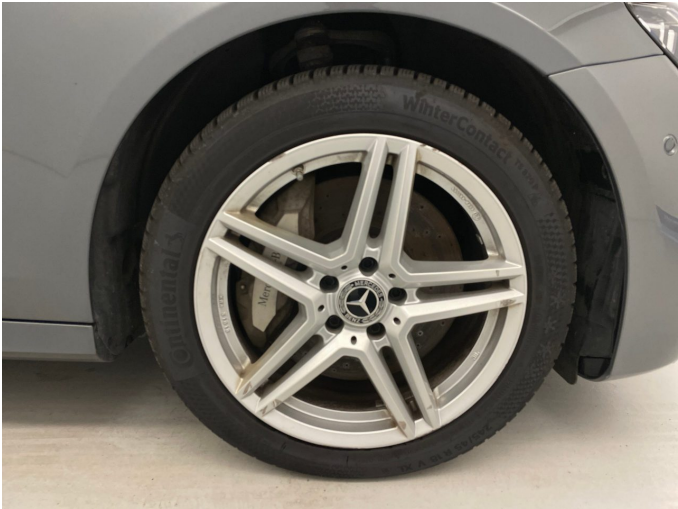
| # | Tyre size | Type of tyre | Manufacturer | Tread depth |
|---|---|---|---|---|
| 1) | 245/45 R18 100V | Winter tyres on Light alloy | Continental | 7mm / 7mm |
| 2) | 275/40 R18 103V | Winter tyres on Light alloy | Continental | 7mm / 7mm |

Figure 12: Mounted tyres

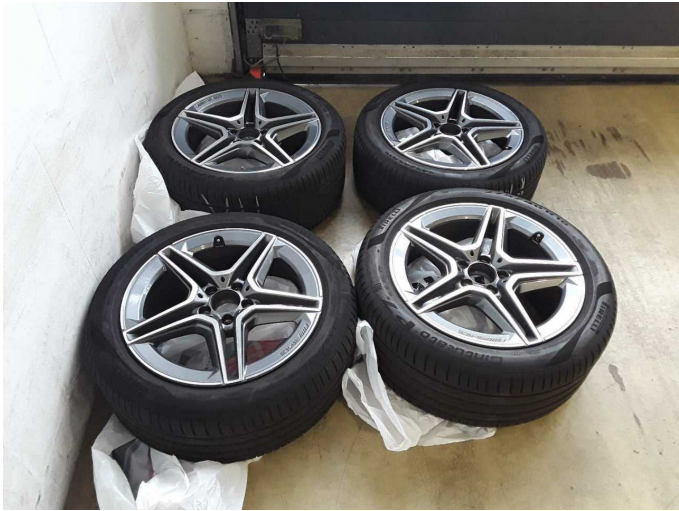
| # | Tyre size | Type of tyre | Manufacturer | Tread depth |
|---|---|---|---|---|
| 1) | 245/45 R18 100Y | Summer tyres on Light alloy | Pirelli | 5mm / 5mm |
| 2) | 275/40 R18 103Y | Summer tyres on Light alloy | Pirelli | 4mm / 4mm |

Figure 16: Additional tyres

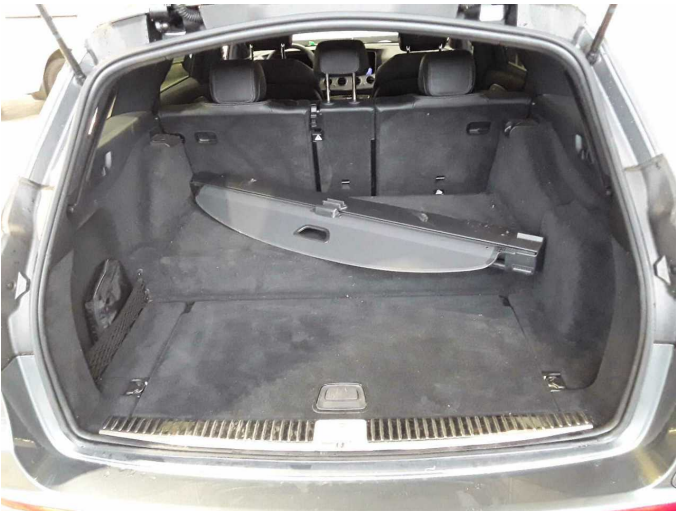
| No. | Component group | Description |
|---|---|--|
| 1 | Interior | Interior (Tierhaare) - Soiled - Clean |

Damage 1: Interior: Interior (Tierhaare) - Soiled - Clean

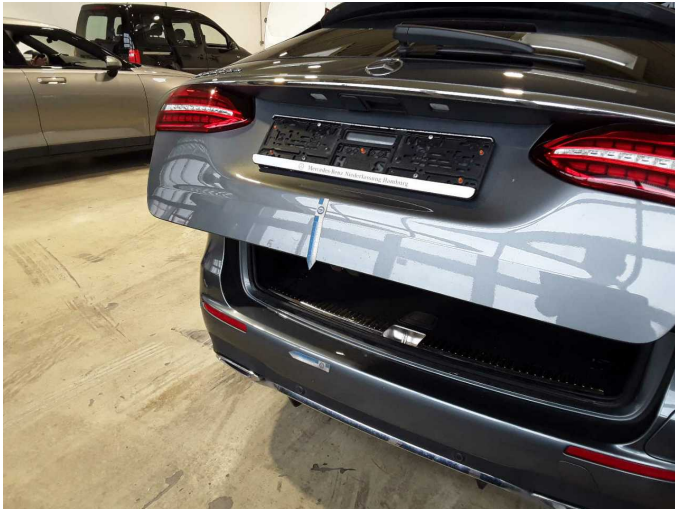
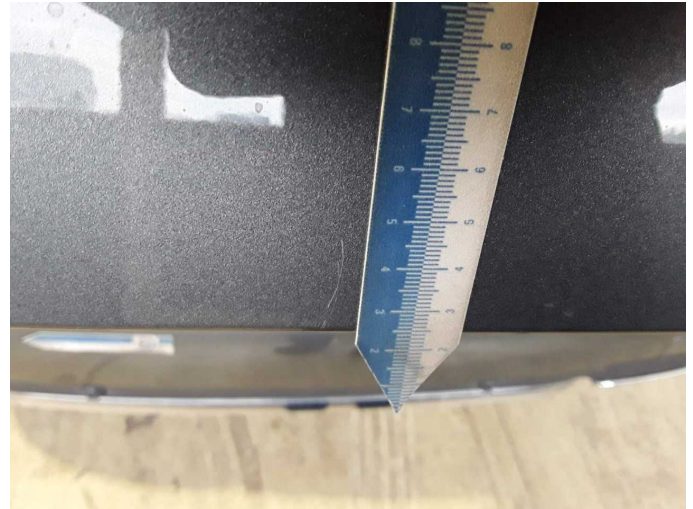
| No. | Component group | Description |
|---|---|--|
| 3 | Boot lid / rear door | Boot lid - Scratch(es) - Smart repair |

Damage 3: Boot lid / rear door: Boot lid - Scratch(es) - Smart repair

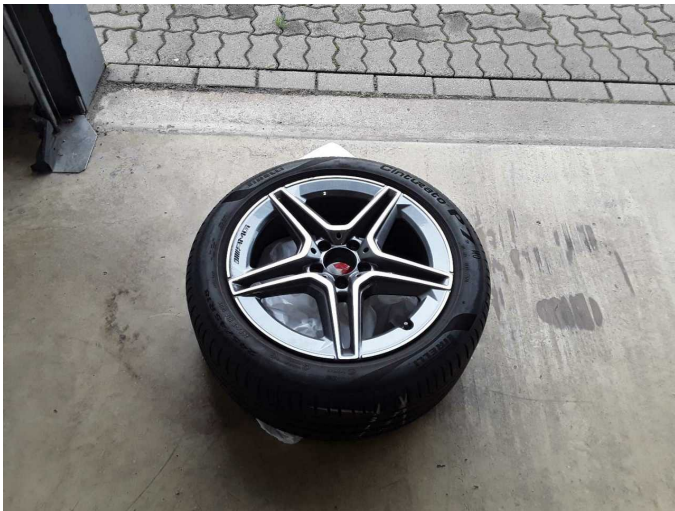
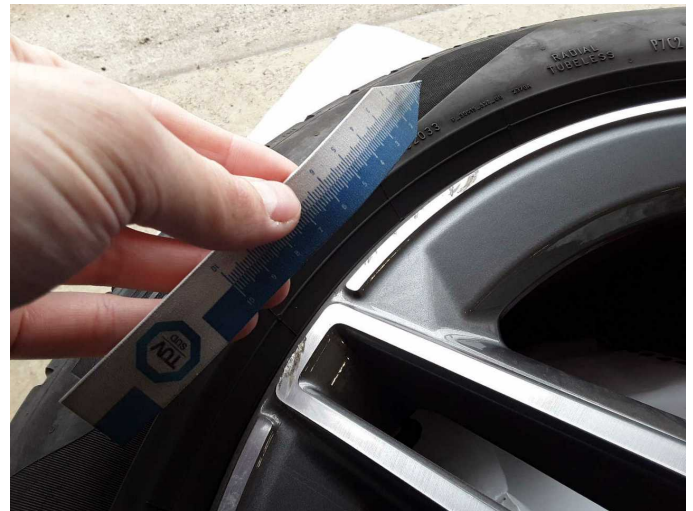
| No. | Component group | Description |
|---|---|--|
| 4 | 2nd wheel set | 1 alloy rim - Scratch(es) - Loss in value |

Damage 4: 2nd wheel set: 1 alloy rim - Scratch(es) - Loss in value

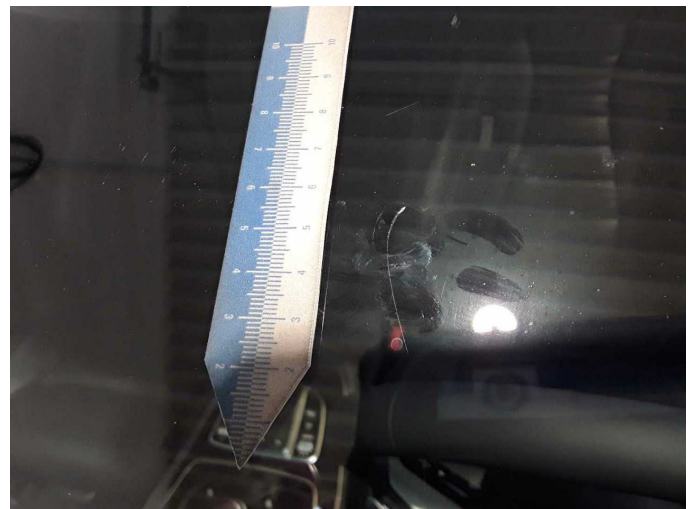
| No. | Component group | Description |
|---|---|--|
| 5 | Vehicle glazing | Windscreen (Innen) - Scratch(es) - Replace |

Damage 5: Vehicle glazing: Windscreen (Innen) - Scratch(es) - Replace

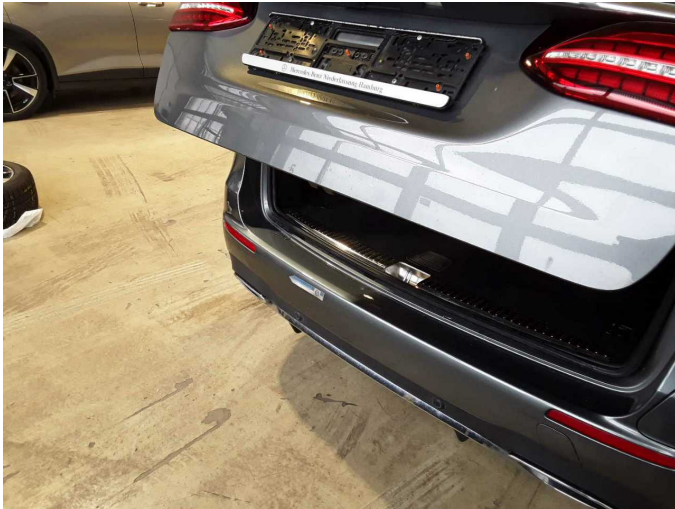
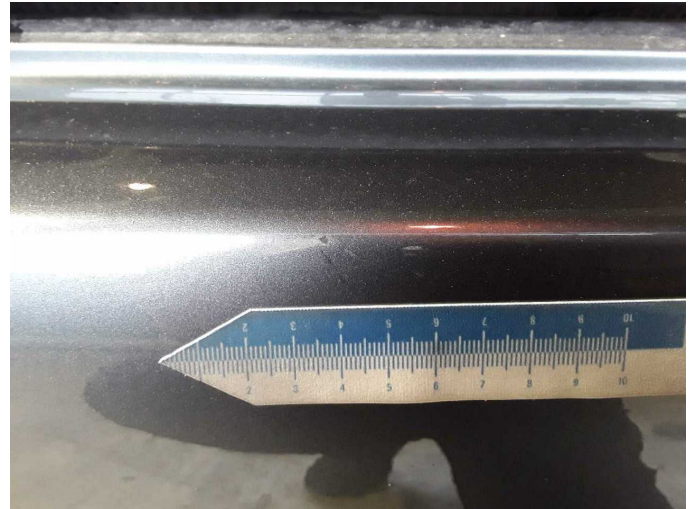
| No. | Component group | Description |
|---|---|--|
| 4 | Rear bumper | Rear bumper - Scratch(es) - No deduction |

Wear and tear 4: Rear bumper: Rear bumper - Scratch(es) - No deduction

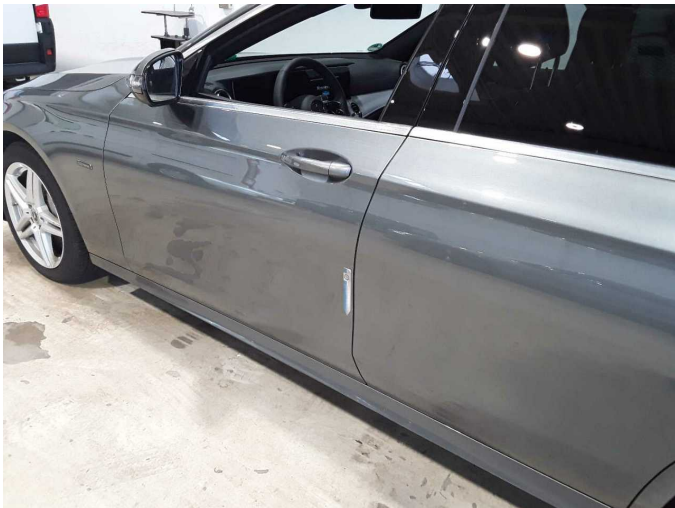
| No. | Component group | Description |
|---|---|--|
| 5 | Door - front left side | Door edge - Scratch(es) - No deduction |

Wear and tear 5: Door - front left side: Door edge - Scratch(es) - No deduction

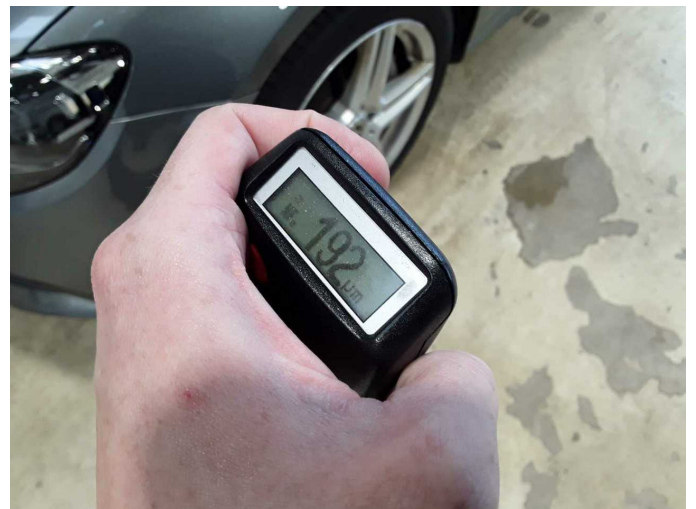
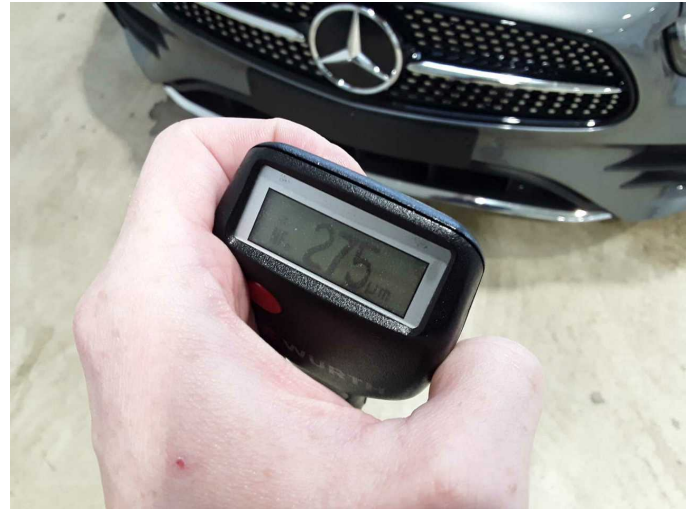
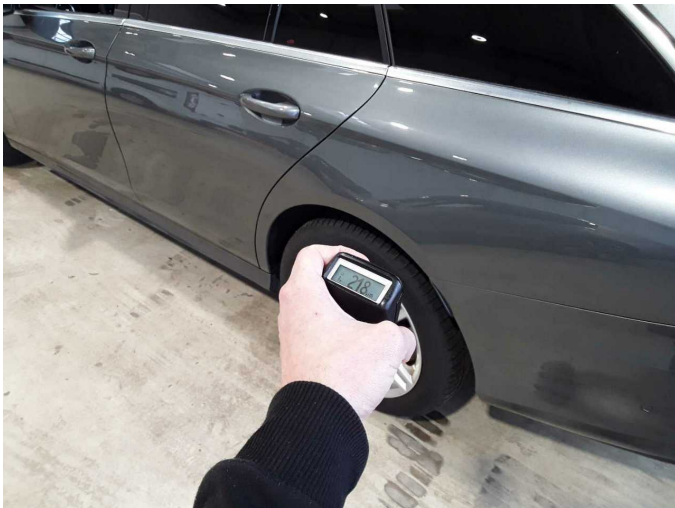
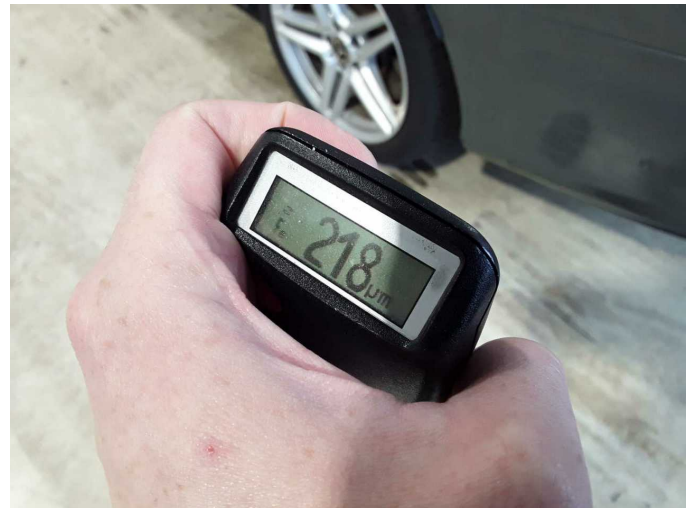
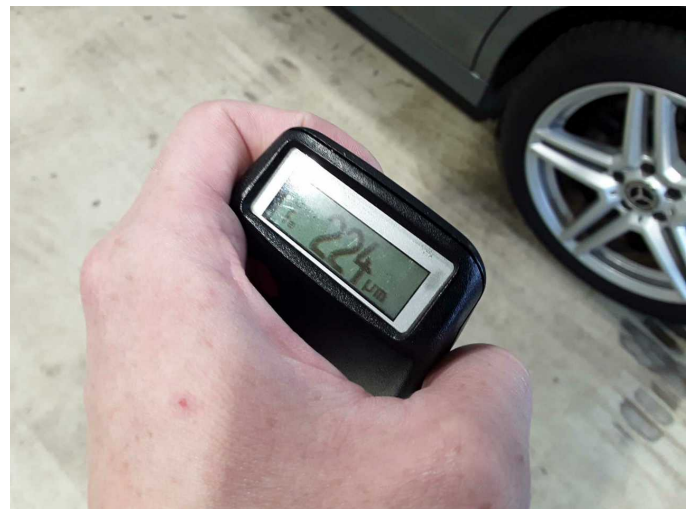
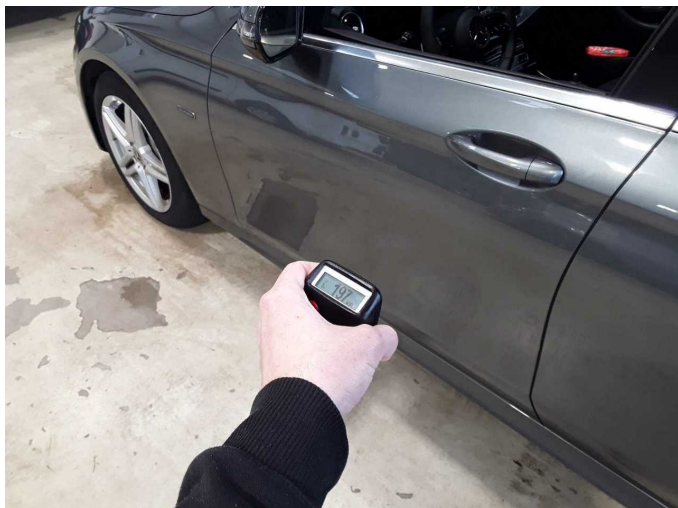
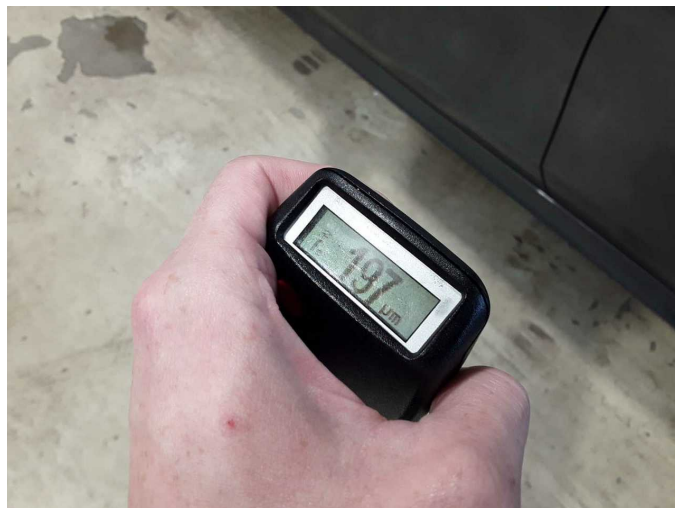
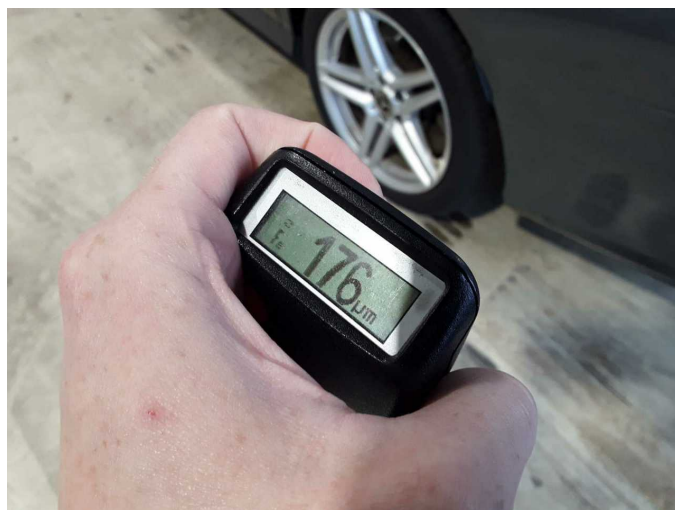
| 1 | Roof rail - left side, Mudguard - left side, Bonnet, Side panel - rear left side, Door - rear left side, Door - front left side, Professionally carried out, Invoice of repair done Non-existent |

| Roof rail - left side | 176 µm | Mudguard - left side | 192 µm |
| Bonnet | 275 µm | Side panel - rear left side | 218 µm |
| Door - rear left side | 224 µm | Door - front left side | 197 µm |

Repainting 1: Roof rail - left side, Mudguard - left side, Bonnet, Side panel - rear left side, Door - rear left side, Door - front left side
