Expertise

Protocol number: 41761114
Order number / reference: 25194710
Inspection date: 30 Sept 2025

Manufacturer: Mercedes-Benz
VIN: W1KAH0DB7PF114633

Model: C 200 d T 9G-TRONIC Avantgarde

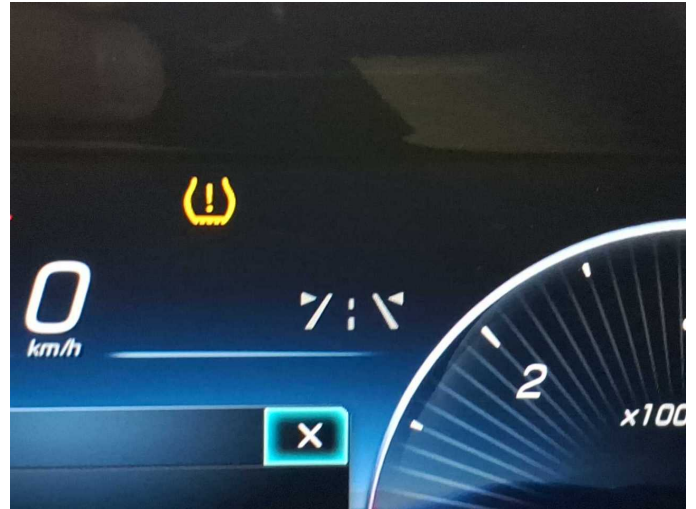
Damage 1: Instrument panel: Indicator light (Reifendruck kontrolleuchte)
- on - Perform diagnosis

No.	Component group	Description
1	Instrument panel	Indicator light (Reifendruck kontrolleuchte) - on - Perform diagnosis
2	Door - front left side	Door - Scratch(es) - Smart repair
3	Front bumper	Front bumper - Scratched - Repair and paint

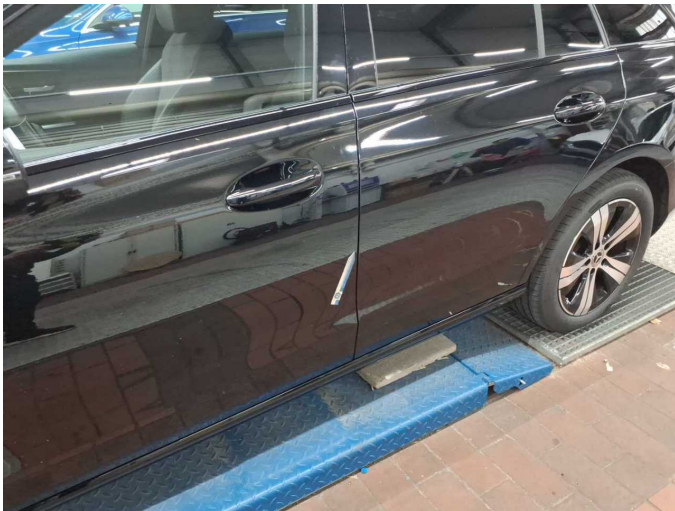
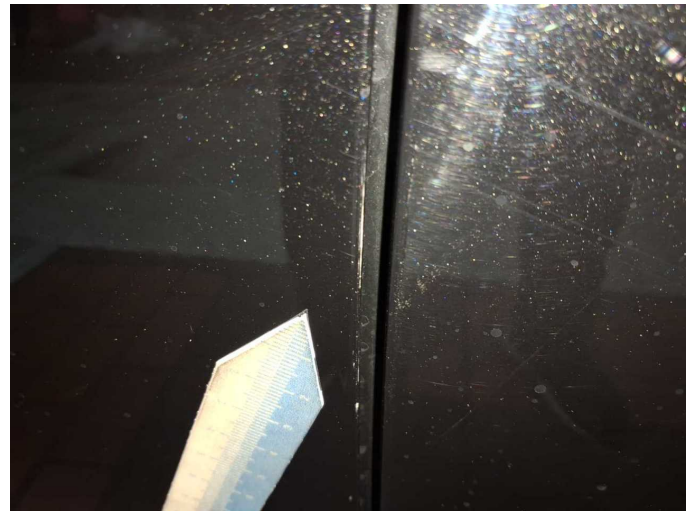
Damage 2: Door - front left side: Door - Scratch(es) - Smart repair

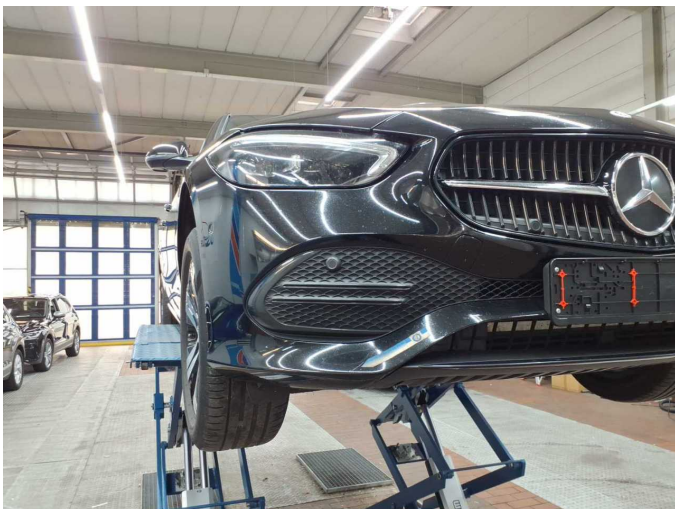
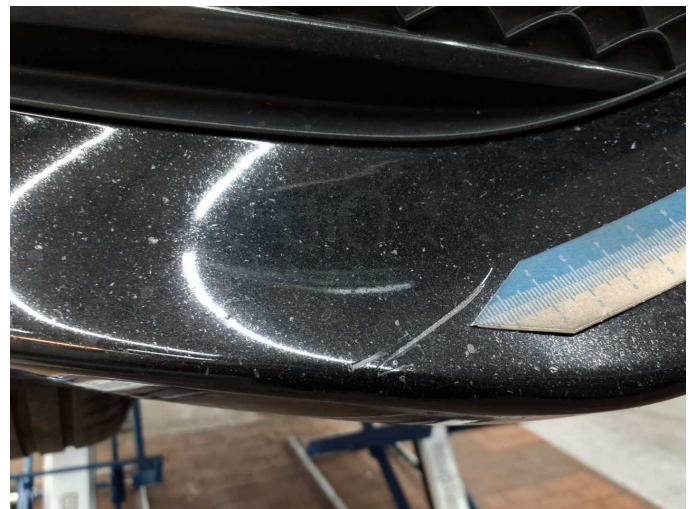
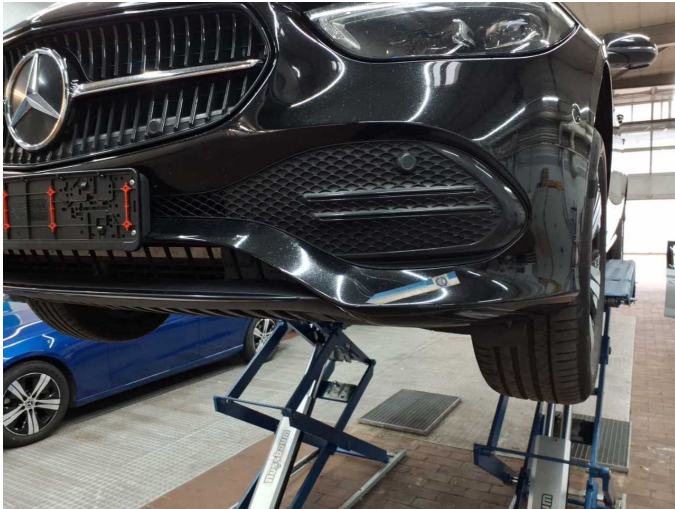
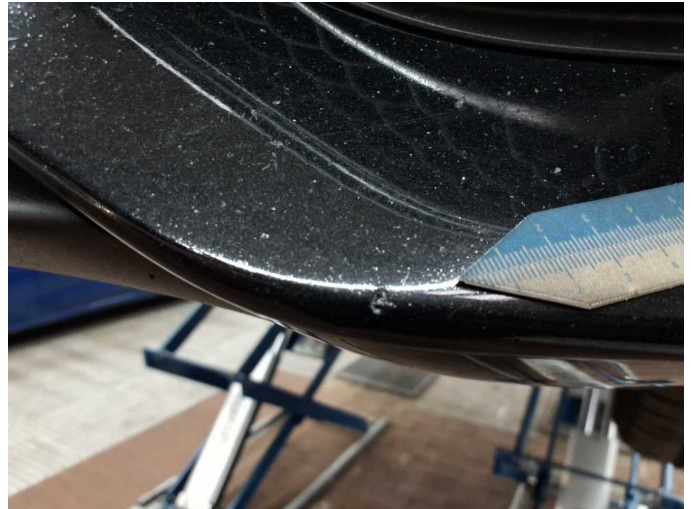
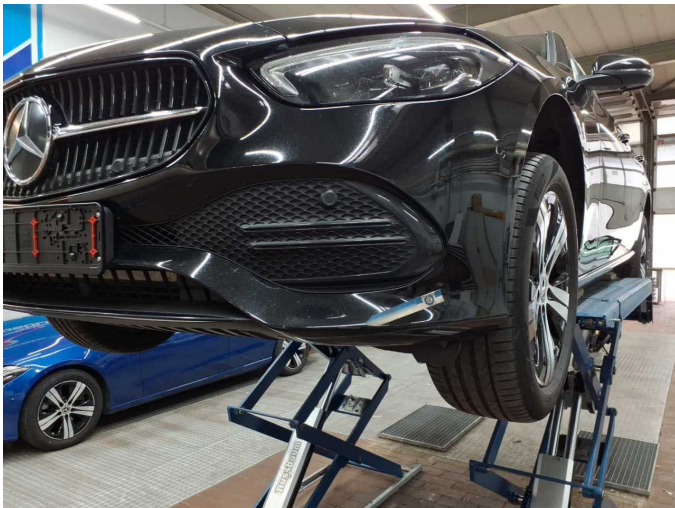
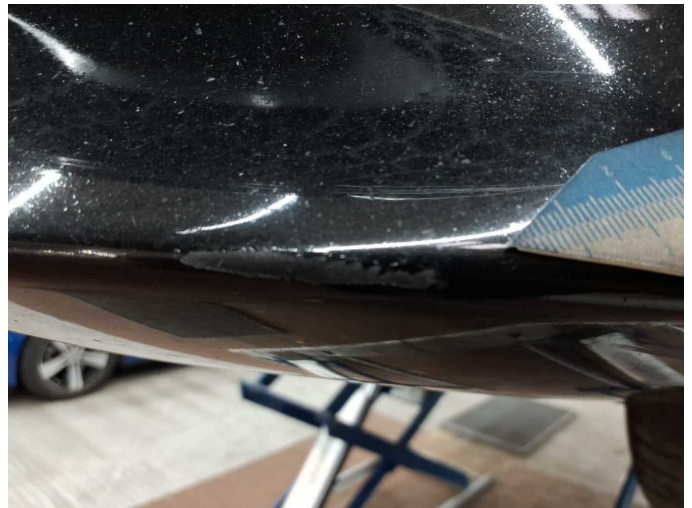
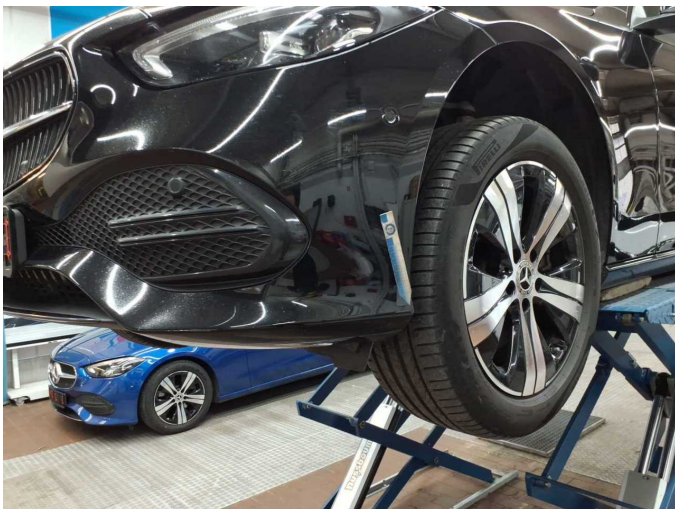
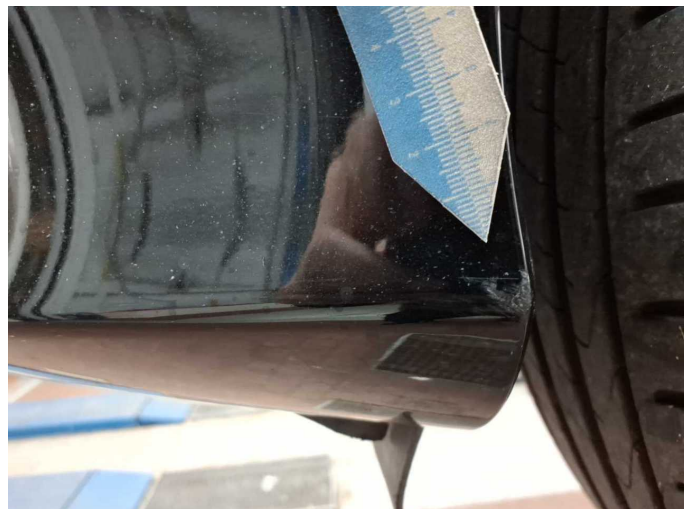
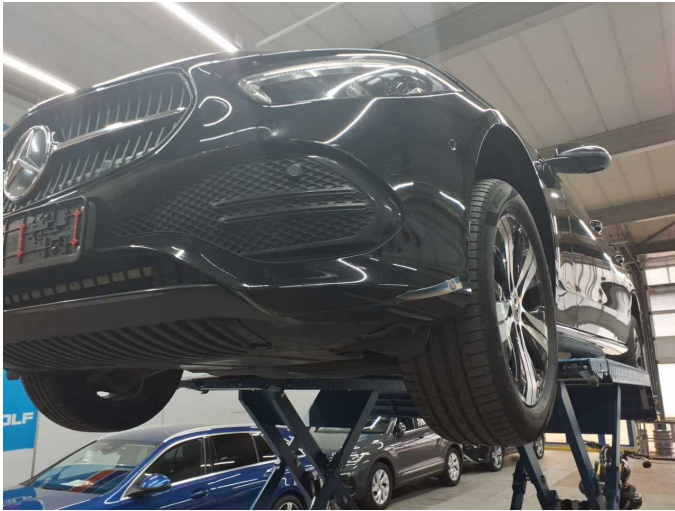
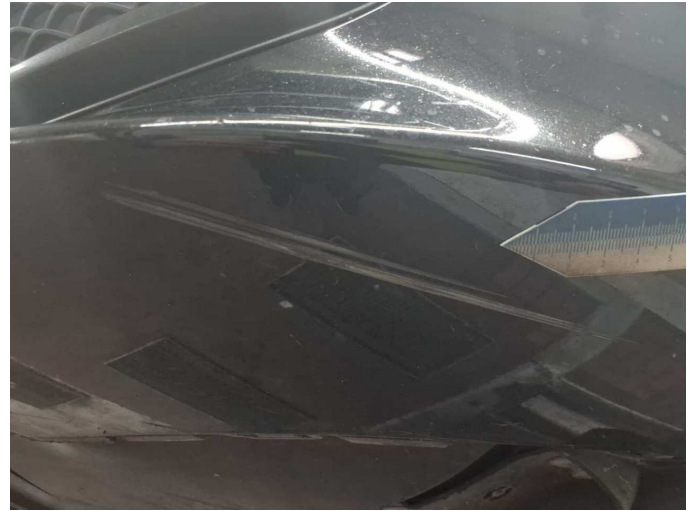
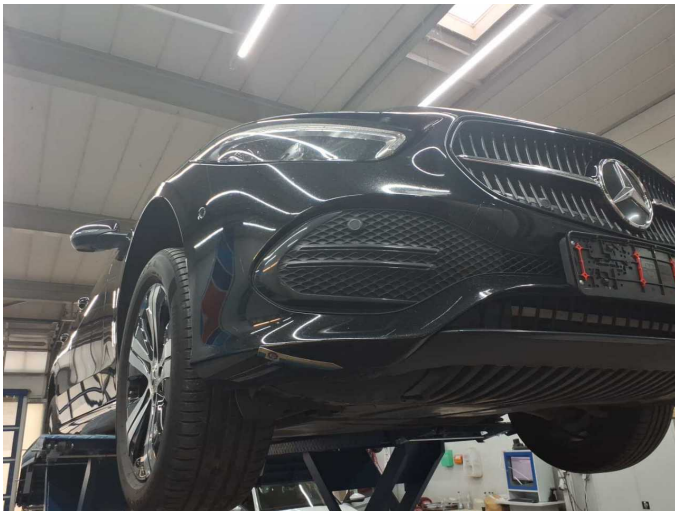
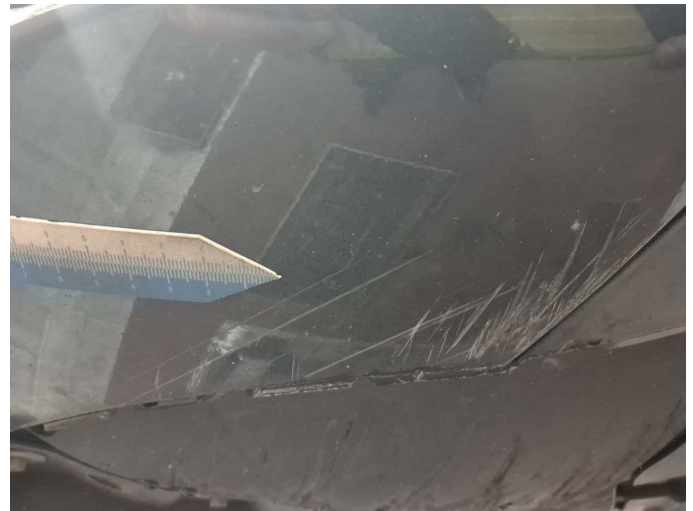
Damage 3: Front bumper: Front bumper - Scratched - Repair and paint

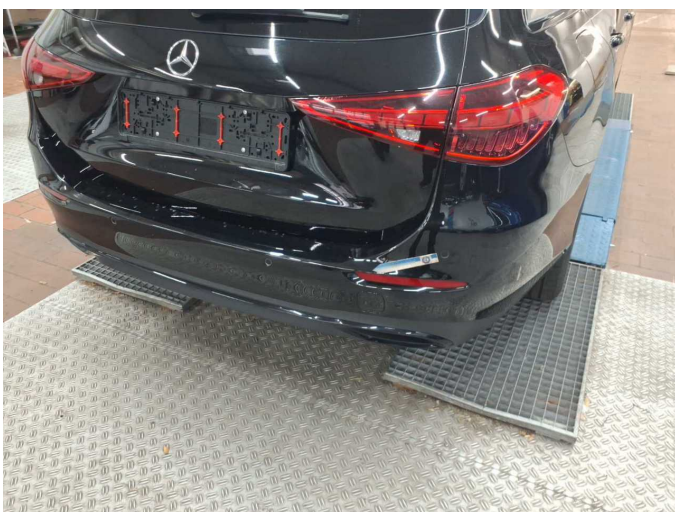
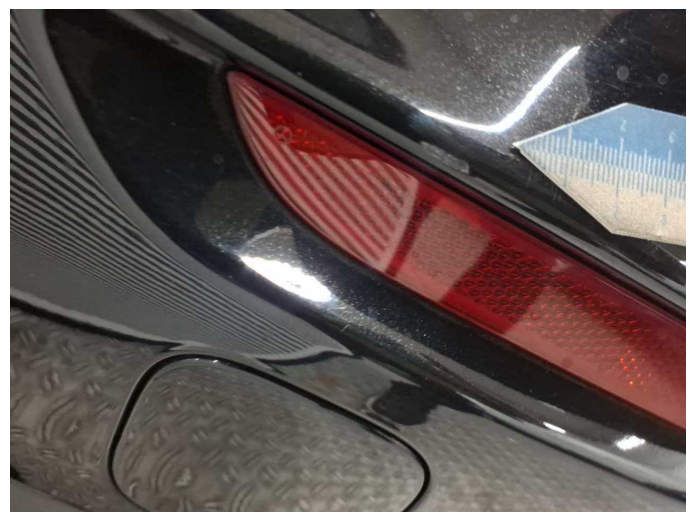
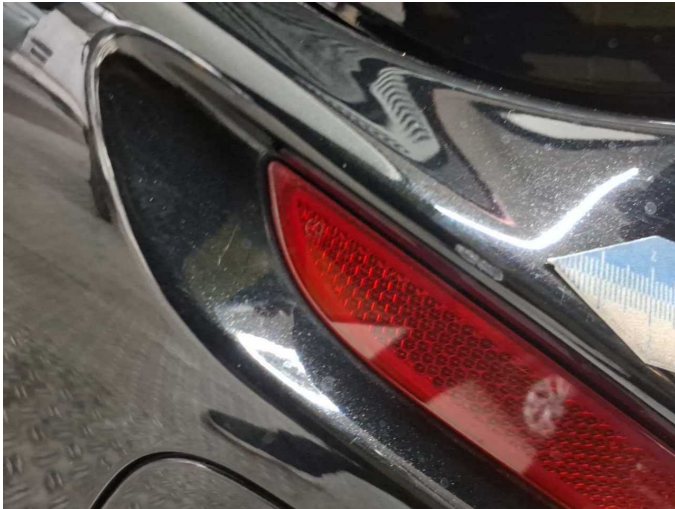
No.	Component group	Description
1	Body	Underbody panelling - Scratched - No deduction
2	Vehicle glazing	Windscreen - Stone chips - No deduction
3	Bonnet	Bonnet - Stone chips - No deduction
4	Rear bumper	Rear bumper - Scratch(es) - No deduction

Wear and tear 4: Rear bumper: Rear bumper - Scratch(es) - No deduction

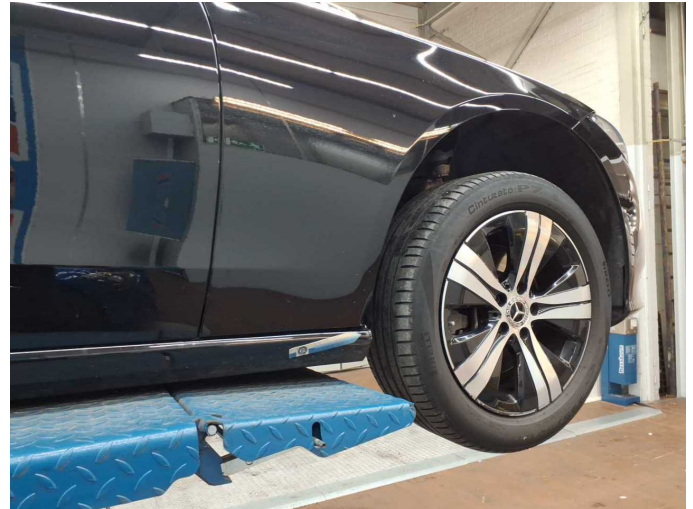
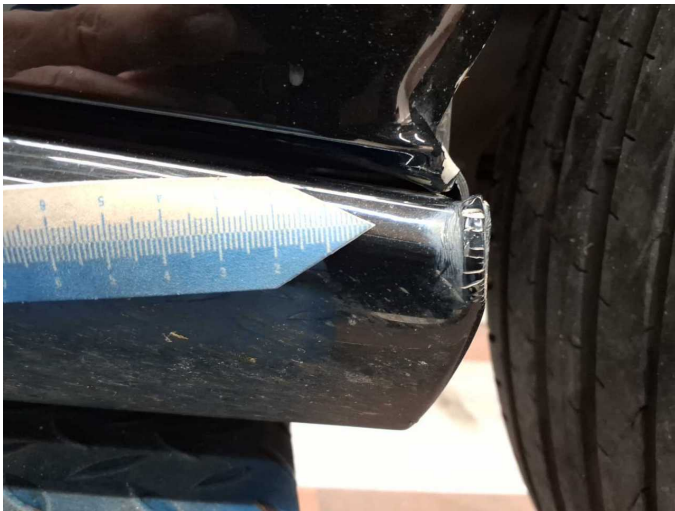
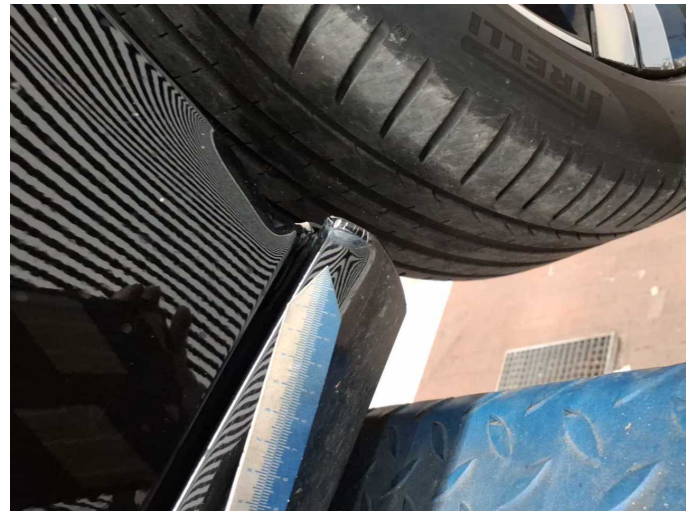
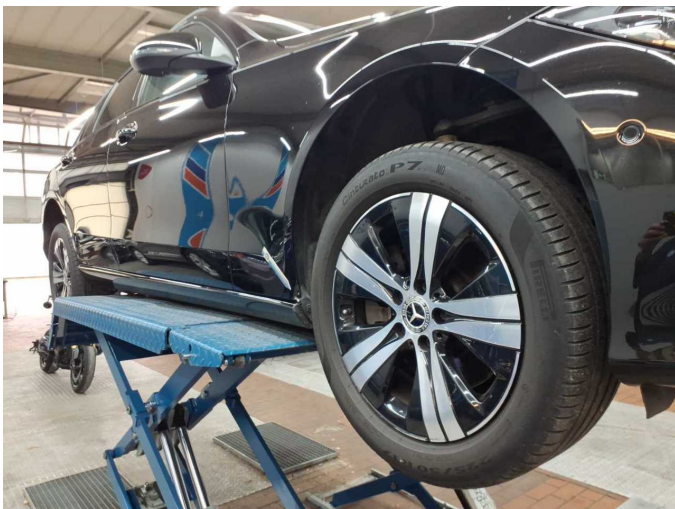
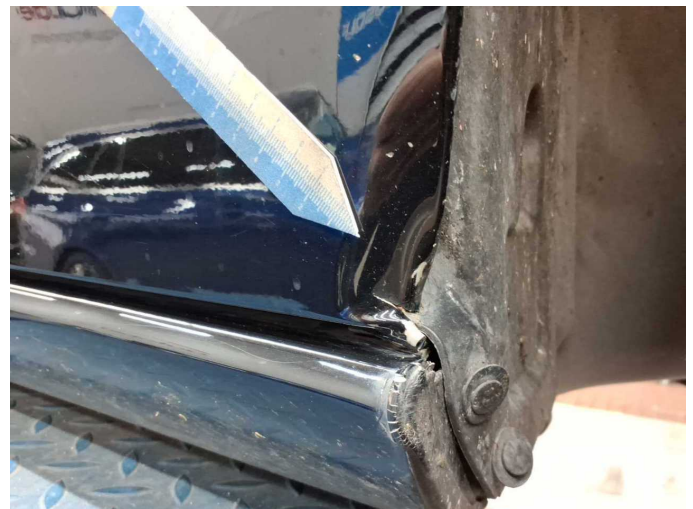
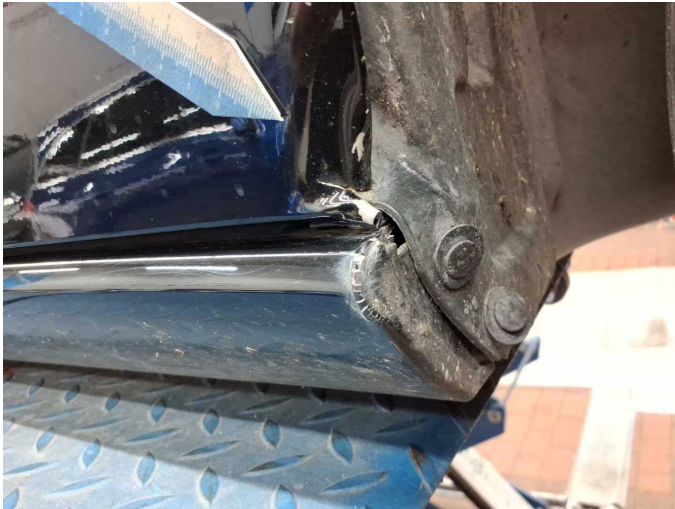
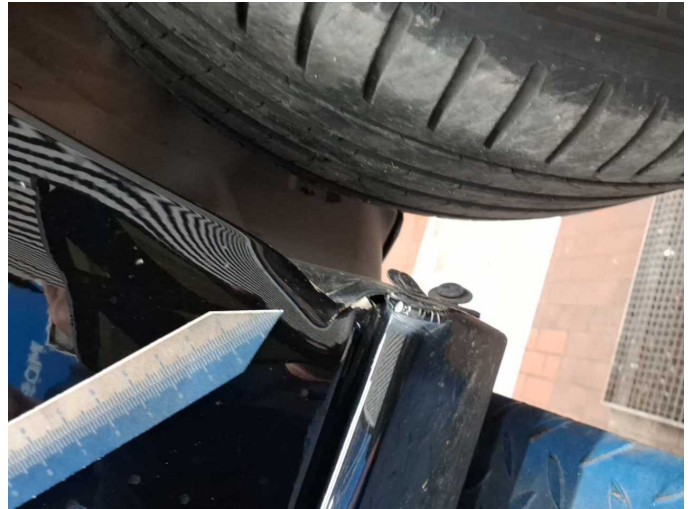
No.	Accident
1	Side right

Accident 1: Side right

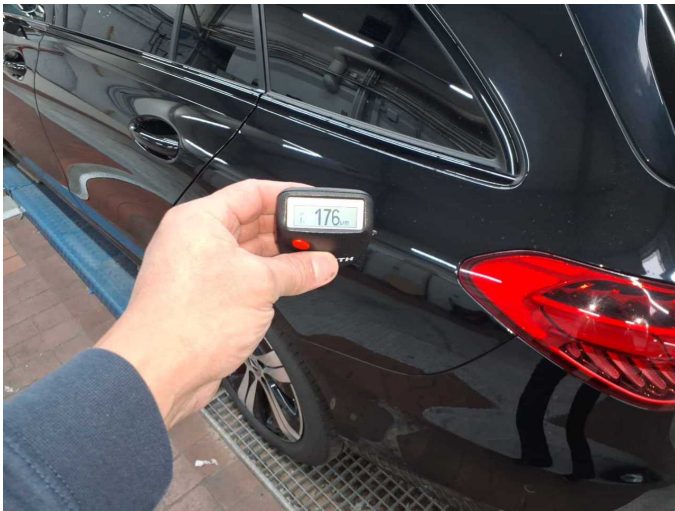
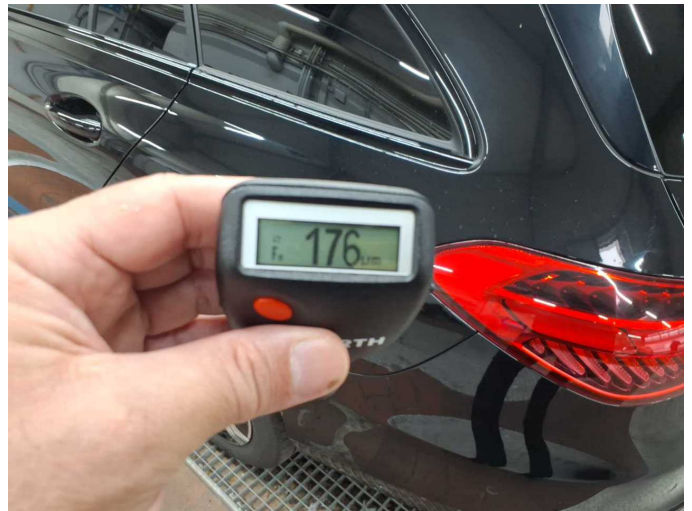
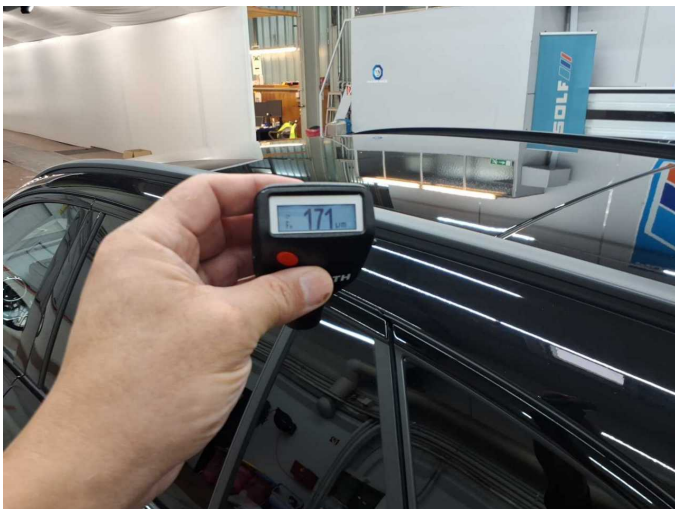
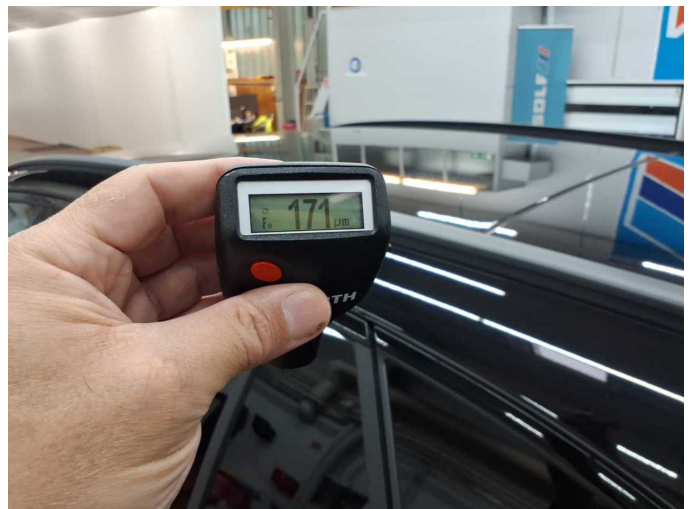
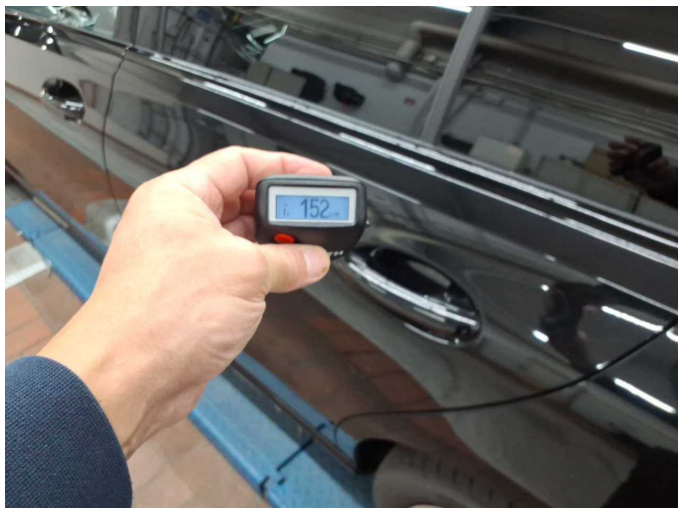
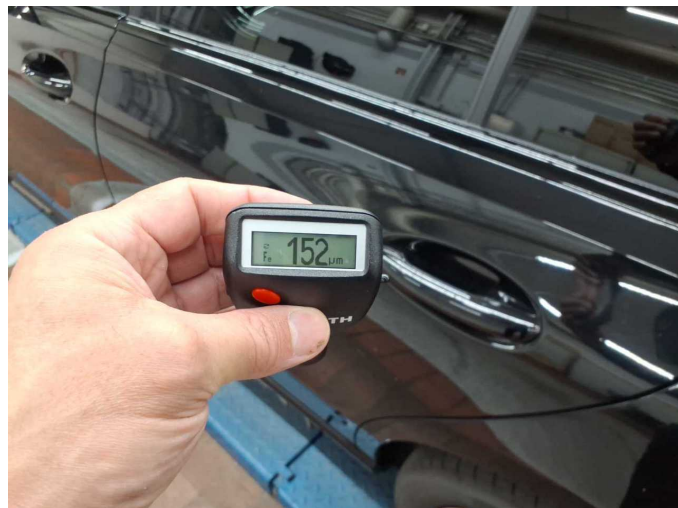
No.	Repainting
1	Roof rail - left side, Side panel - rear left side, Door - rear left side, Professionally carried out, Invoice of repair done Non-existent

Roof rail - left side	171 µm	Side panel - rear left side	176 µm
Door - rear left side	152 µm

Repainting 1: Roof rail - left side, Side panel - rear left side, Door - rear left side
